**Informal Group on gtr No 9 – Phase 2 (IG GTR9-PH2)  
1<sup>st</sup> meeting, Geneva/Switzerland, 1 – 2 December 2011**

# **FlexPLI Version GTR Prototype SN-02 - Durability Assessment**

Presented by the pedestrian safety experts of the  
International Automobile Manufacturers' Organization (OICA)

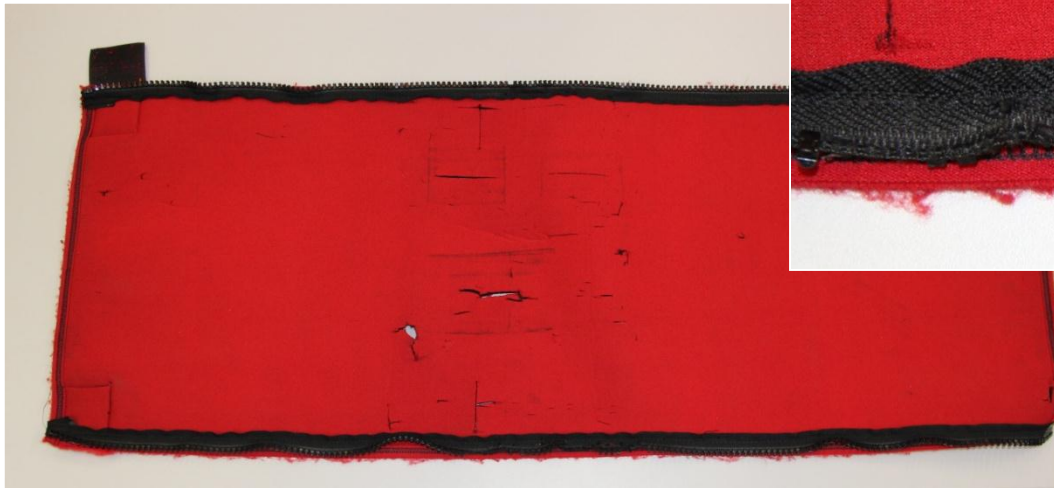
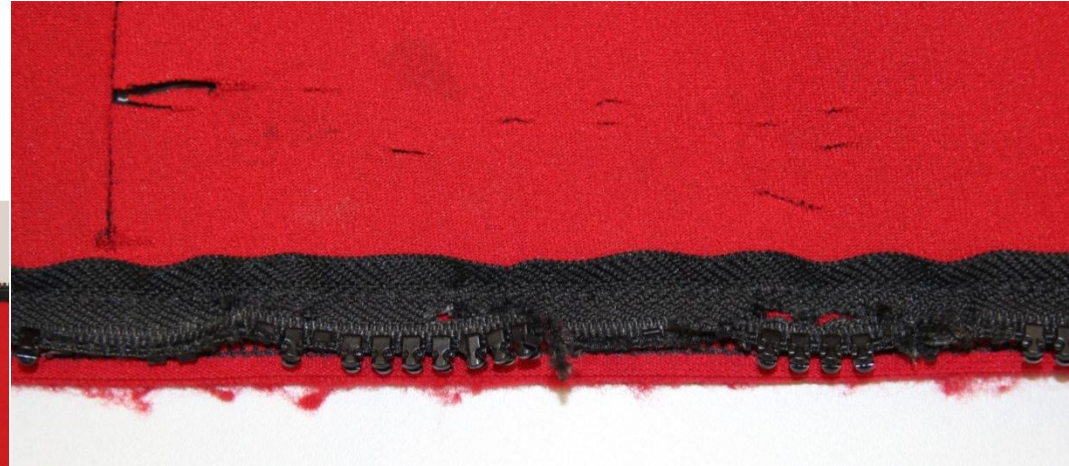
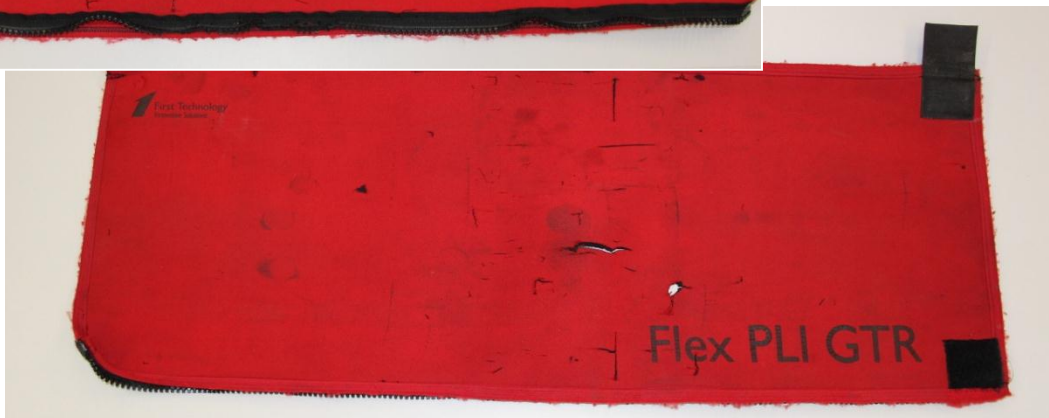
- Skin well used after 50 – 100 tests, depending on structures/objects struck
- Zippers and zipper handle frequently break / wear out

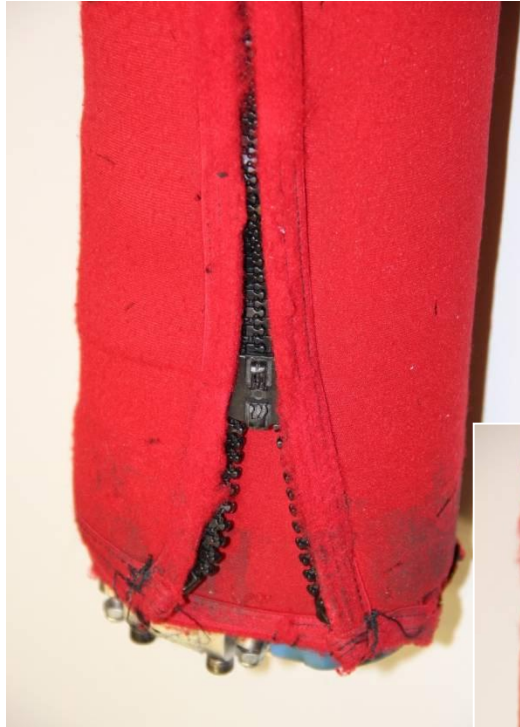
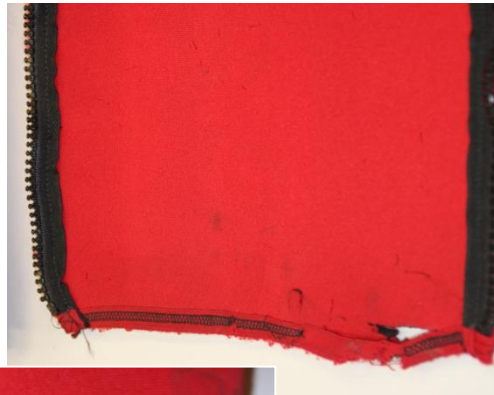
- Innermost skin parts with clear marks of tibia/femur segments

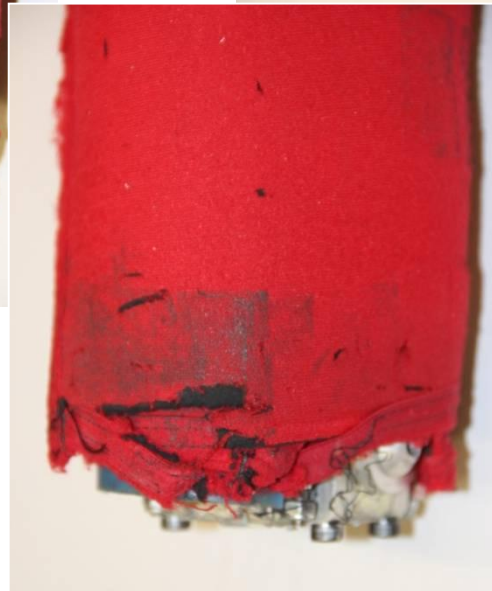
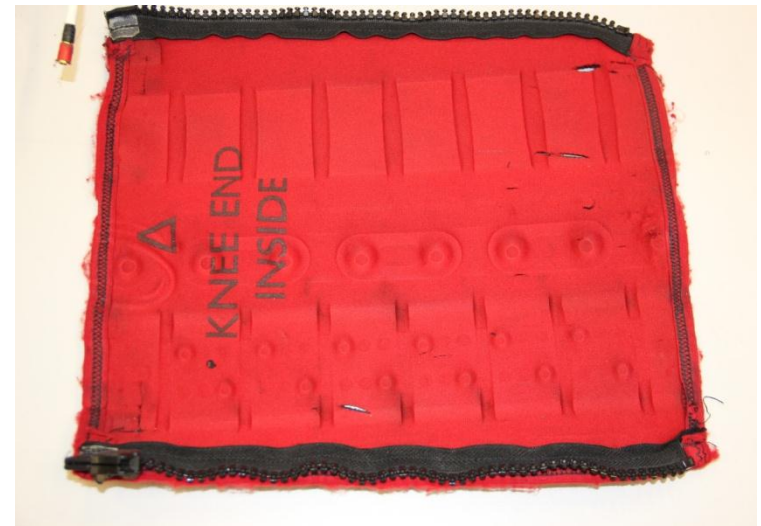
- Skins well used
- Zipper handles broken / worn out

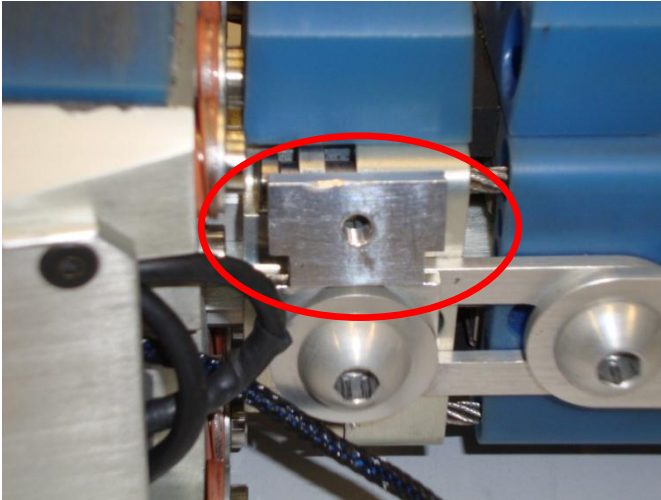
- Stress relief for trigger cable at knee element missing

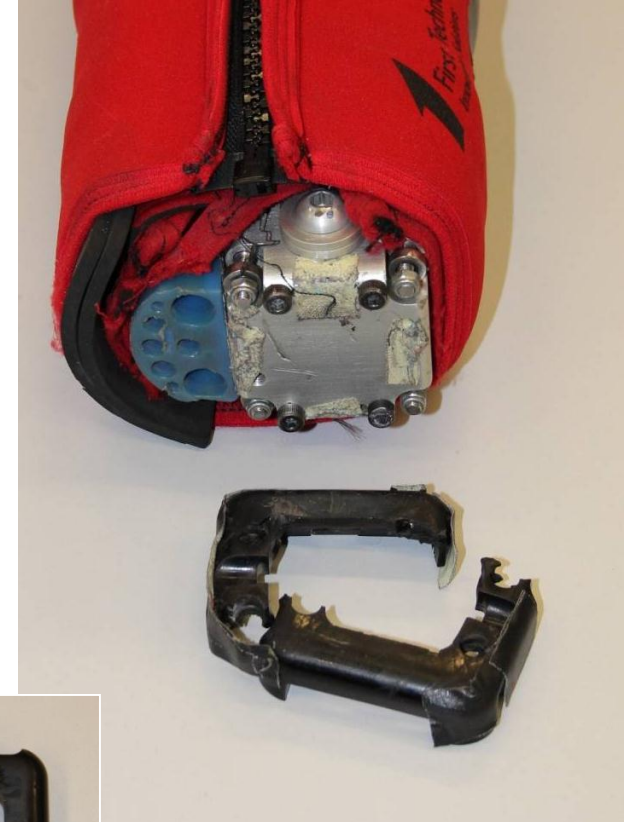
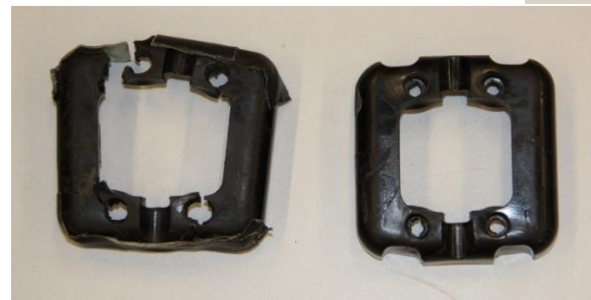
- Lower protective cap broken (plastic part)

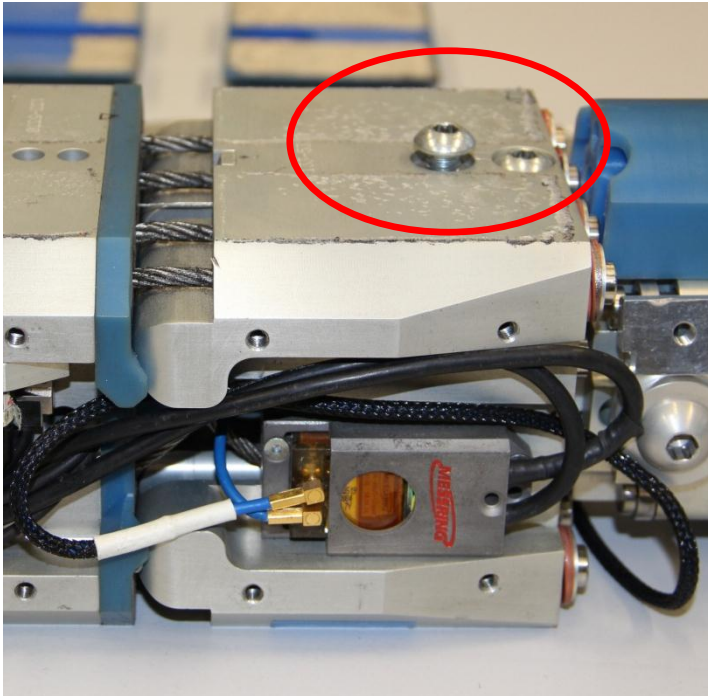
- Loose screw at knee element, only visible after removal of plastic parts
- Further loose screws were found at inner parts, which are not regularly checked

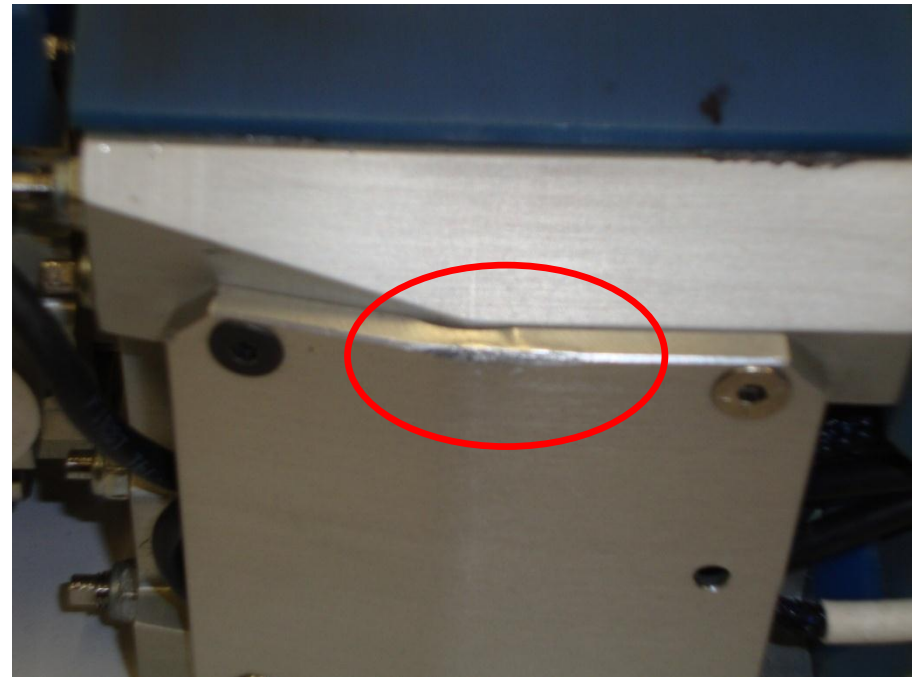
- Mechanical damages to metal parts (hard impacts, misuse?)

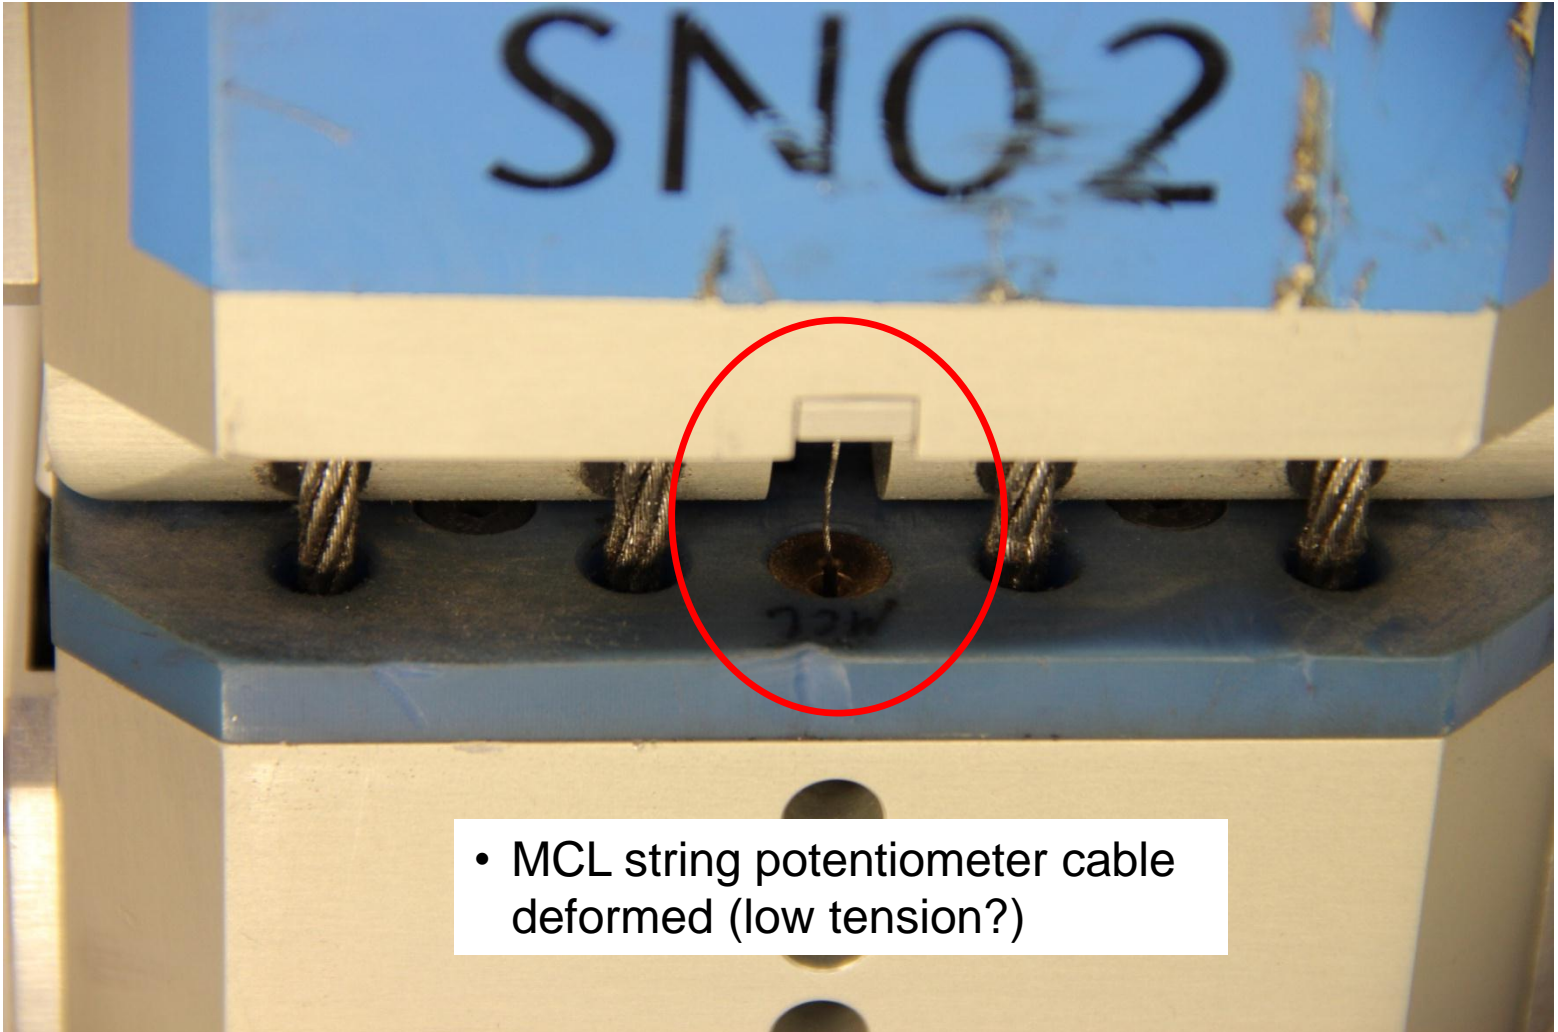
- MCL string potentiometer cable deformed (low tension?)

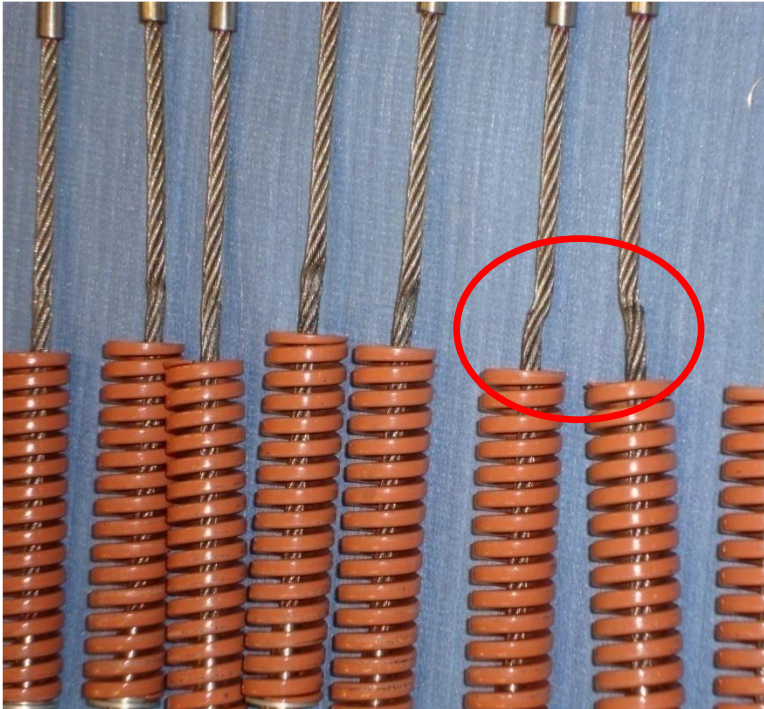
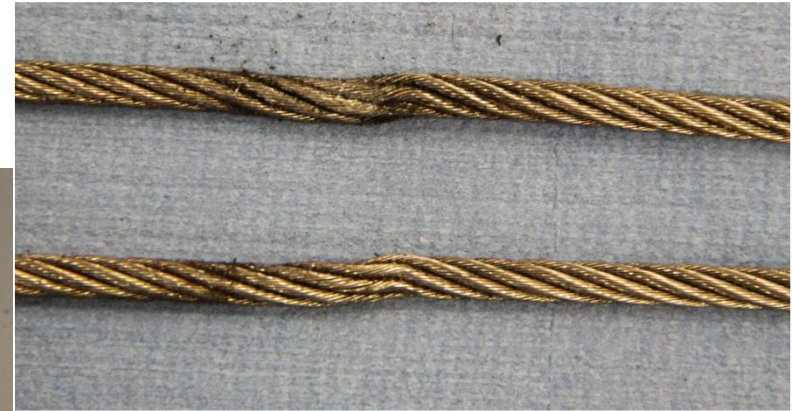
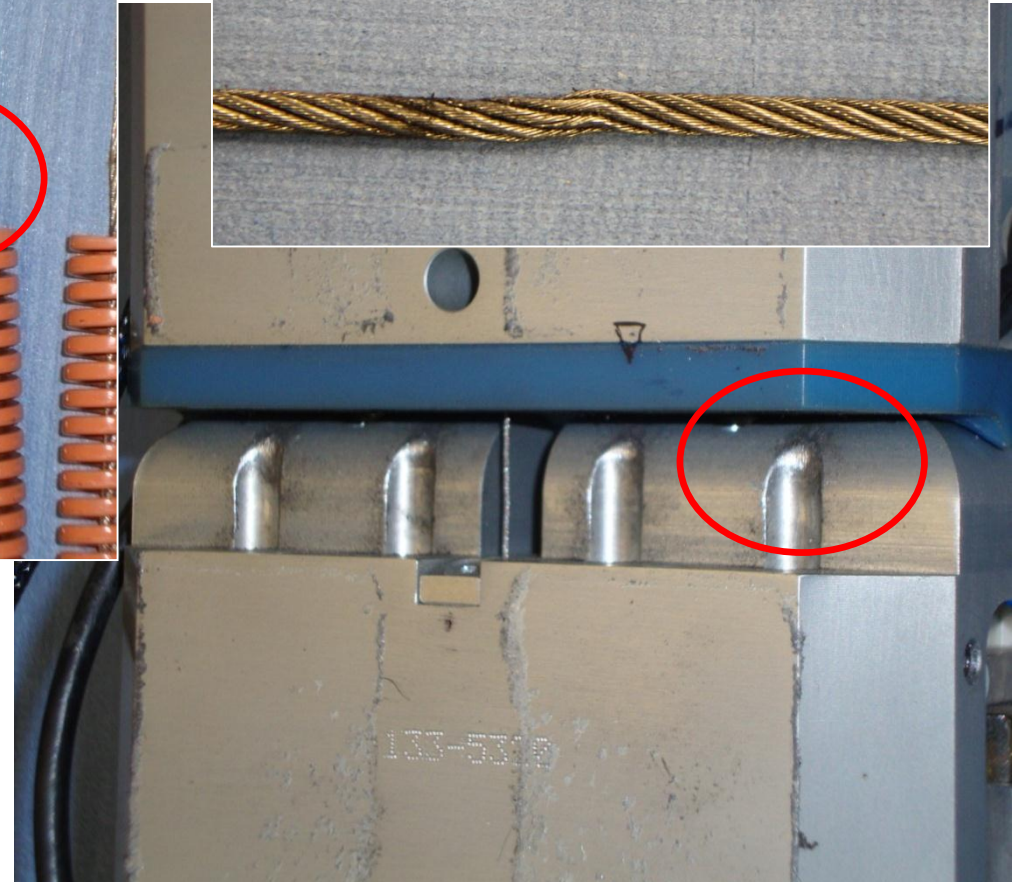
- Wearing at steel cables representing collateral ligaments as well as at their housing

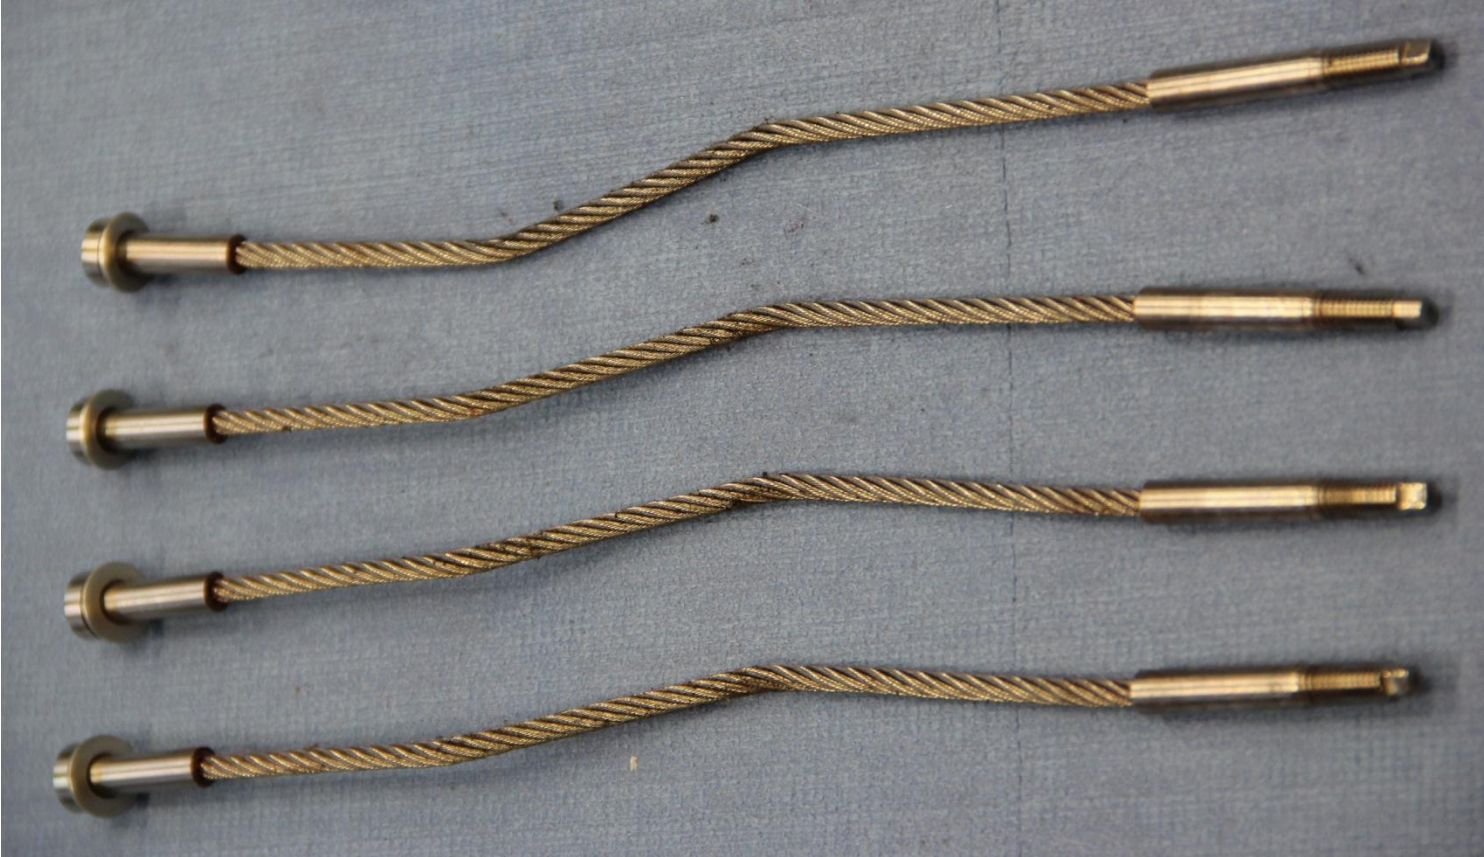
- Wearing/deformation at steel cables representing cruciate ligaments

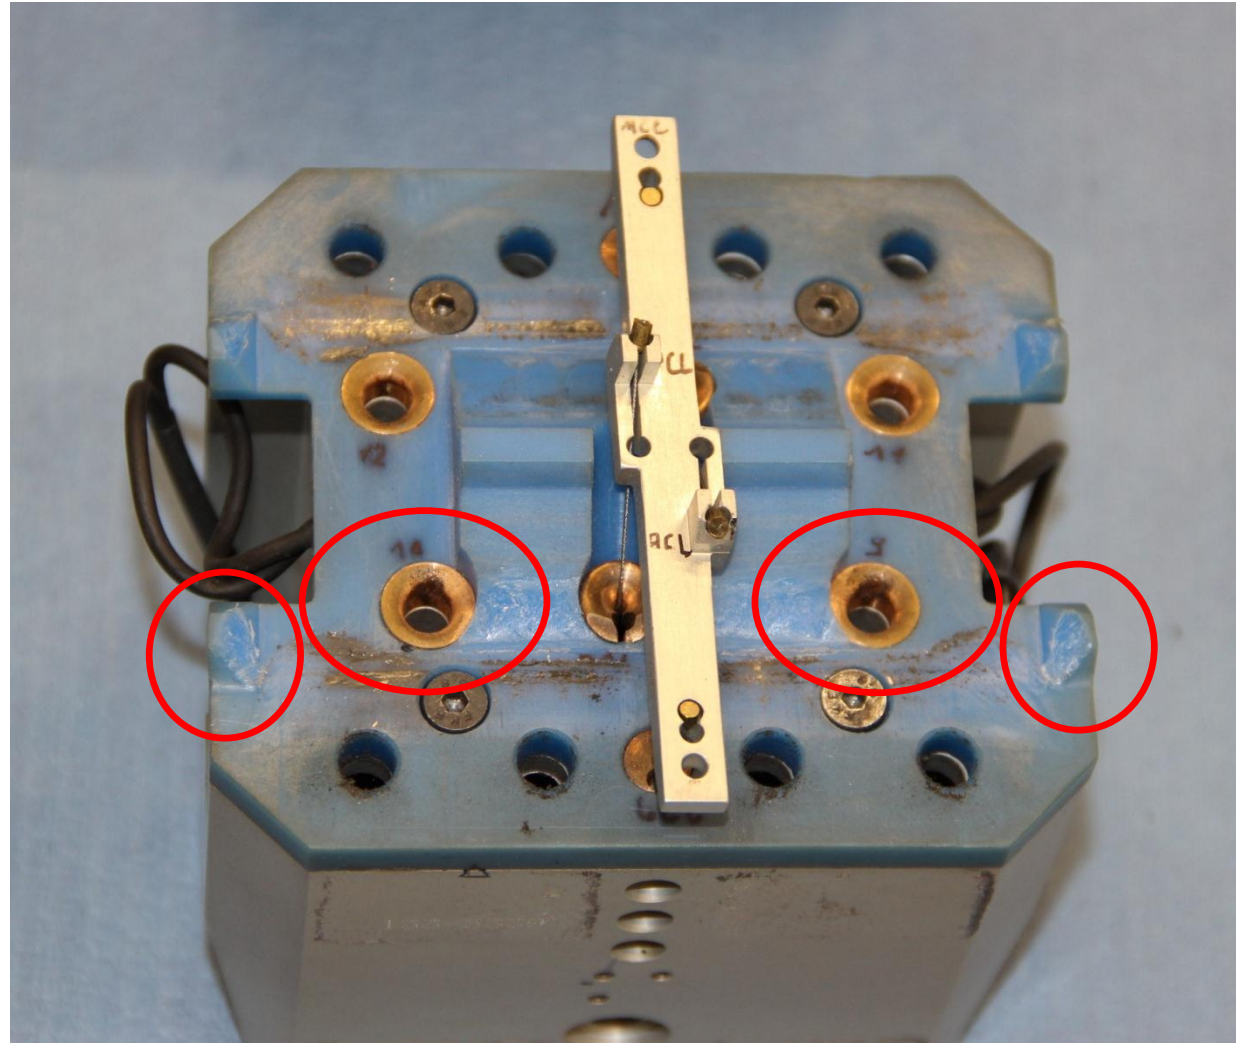
Top view of lower knee segment:

- Wearing at cruciate ligament cable bushes (bronze)
- Wearing at plastic material

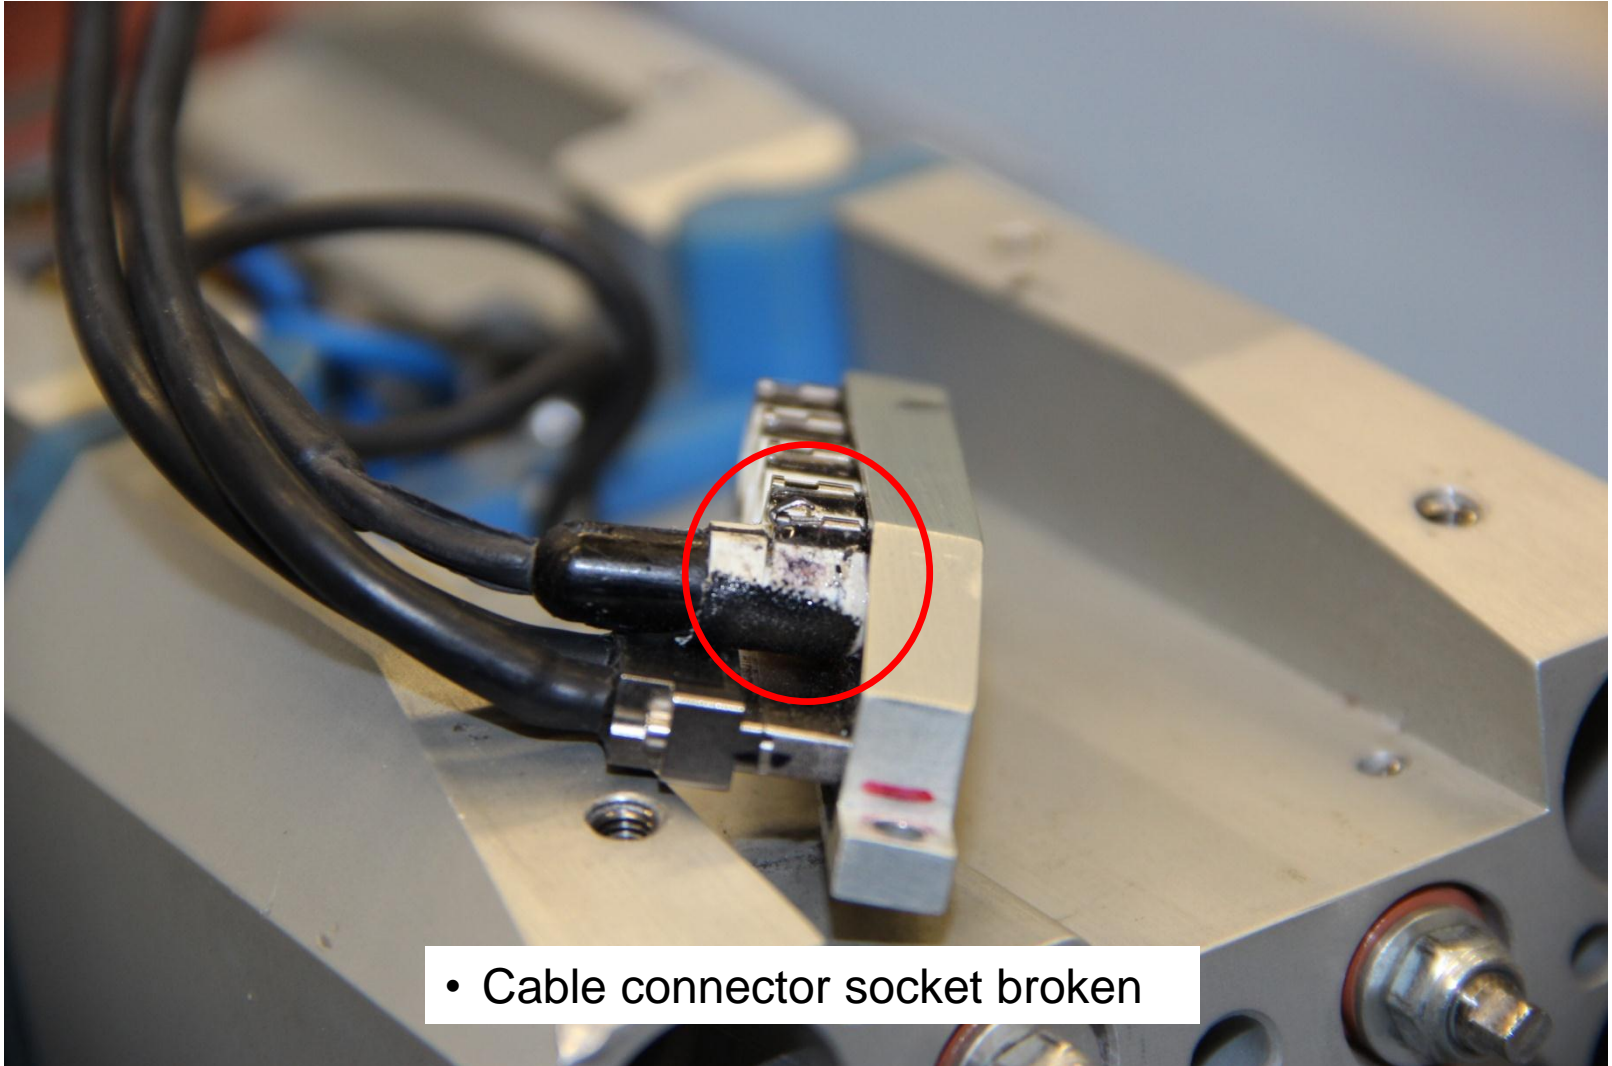
- Cable connector socket broken

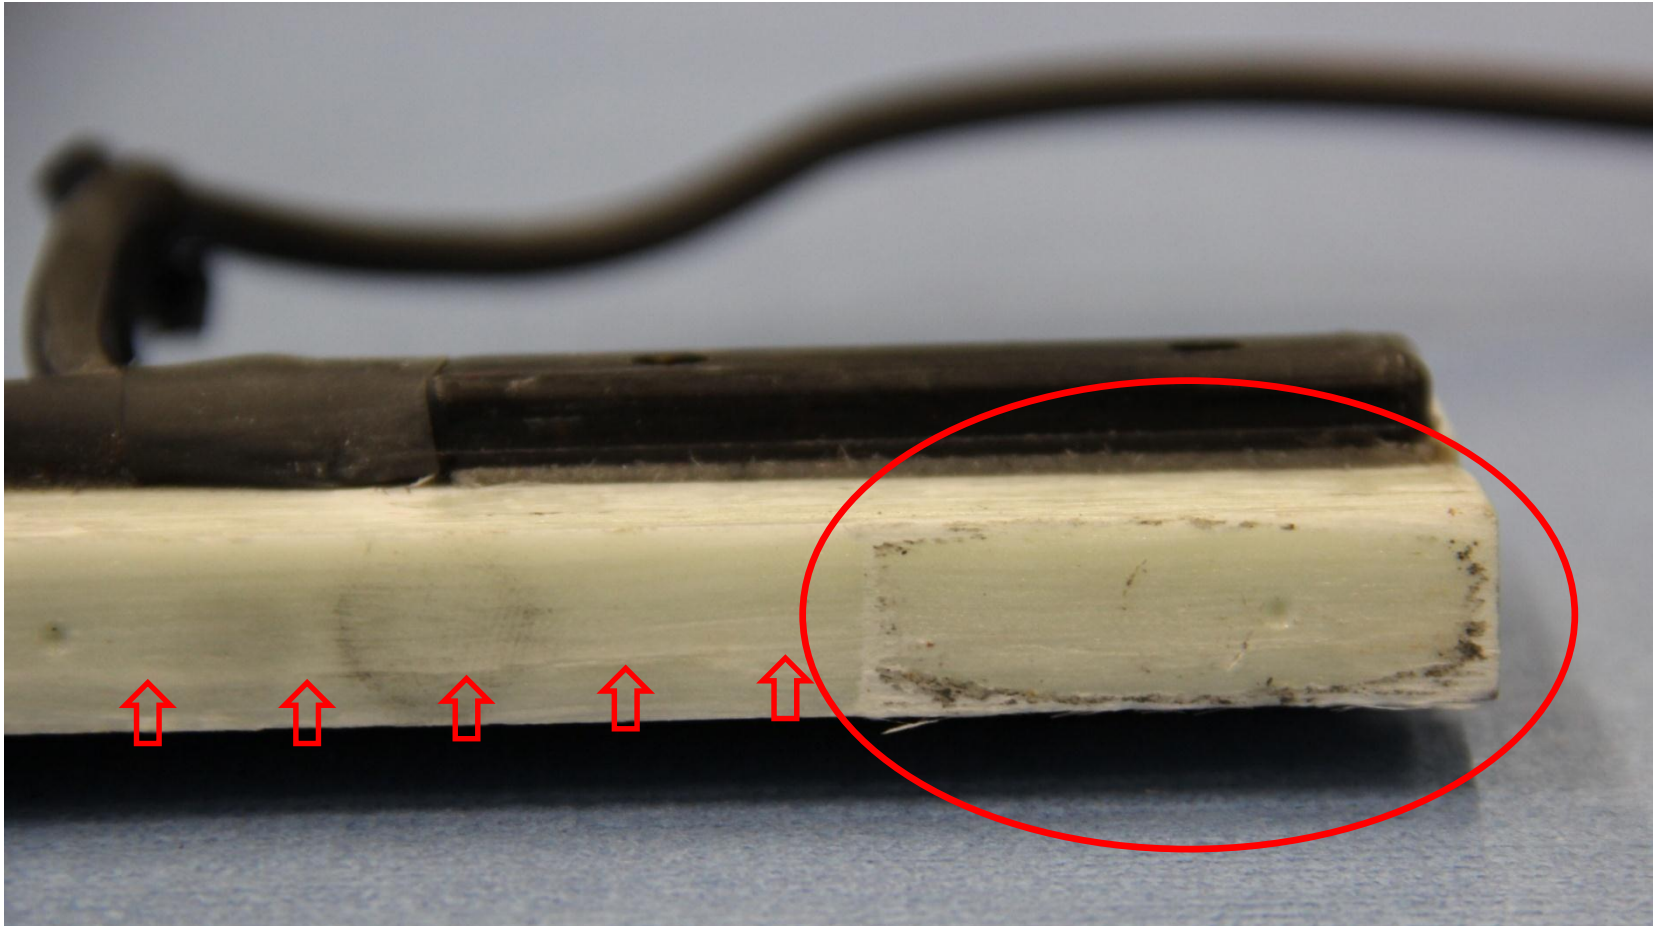
- Wearing and white cracks near/at knee clamping area

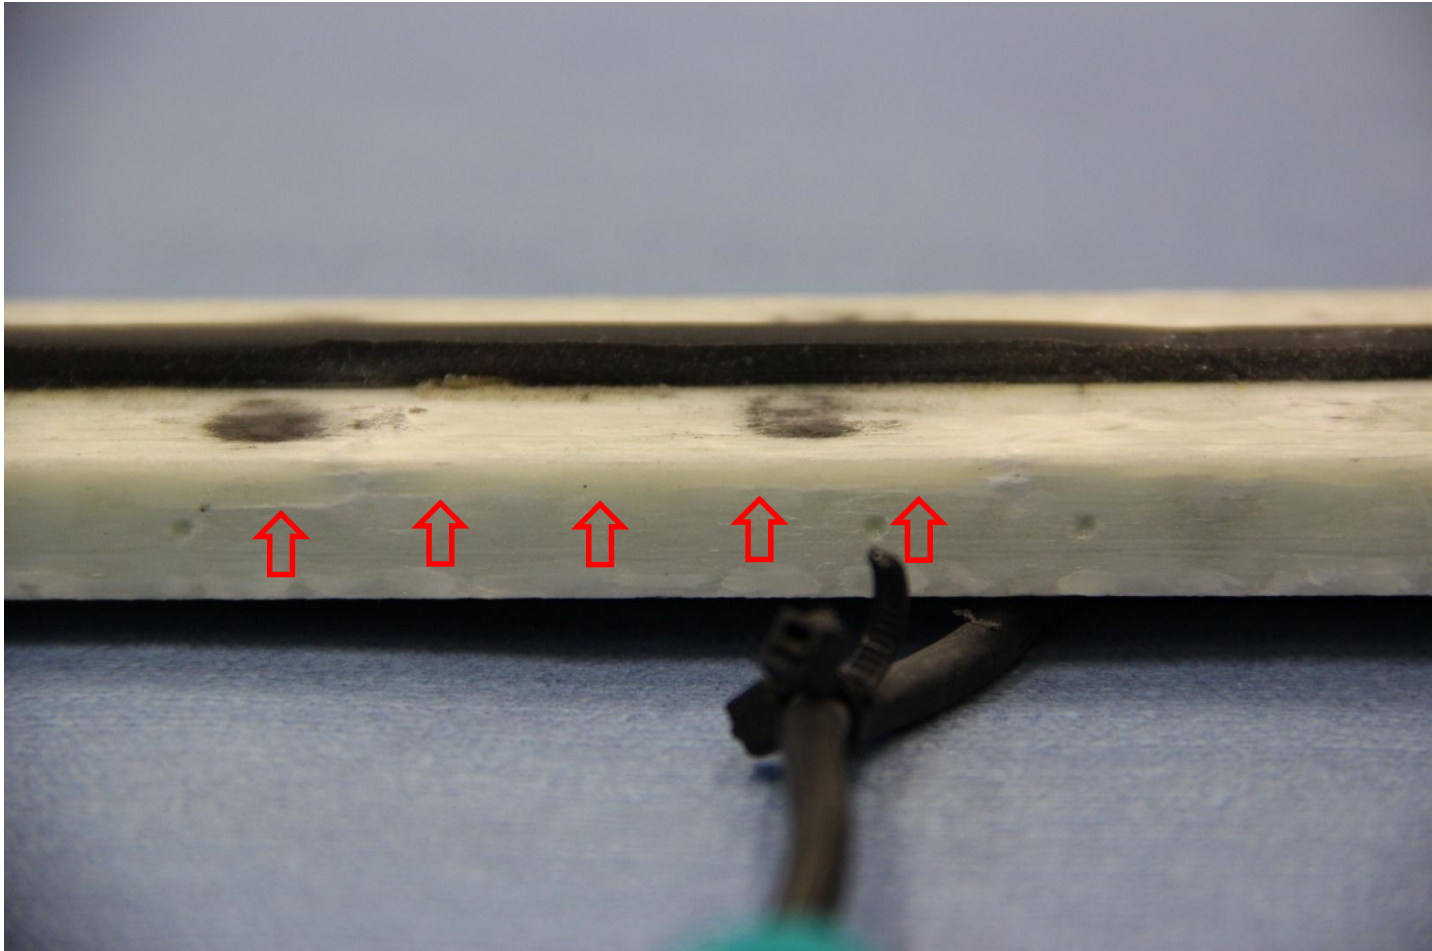
- White cracks (femur section)

- Further assessment needed if bone core material is changed
