Test of fixed glass breaking devices

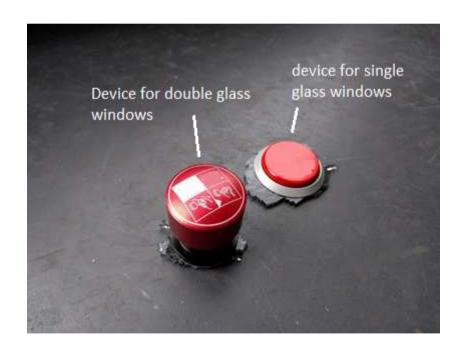
Equipment under test

The required force on the emergency button to break a single glass window is too high and therefore this button is not acceptable.

The required force on the emergency button to break a double glass windows is higher than prescribed by the manufacturer, but acceptable. Though for an emergency device, the risk of a first strike shattering only the first window (e.G. due to forgotten seal removal or lack of force/improper use by the applier) is not acceptable when no device for the second window is available.

For both of the emergency buttons the force required to break the glass was excessively higher than specified by the supplier.

An emergency button can be used to break the glass, but the button is certainly not superior to the emergency hammer. We therefore would not support making permanently fixed devices like the emergency button mandatory and exclude the use of emergency hammers.
