Research Review about Fuel Integrity Safety Assessment from Rollover Test of Hydrogen Bus in Korea

Vehicle Safety Research Office
Chief Researcher

Korea Transportation Safety Authority
Korea Automobile Testing & Research Institute

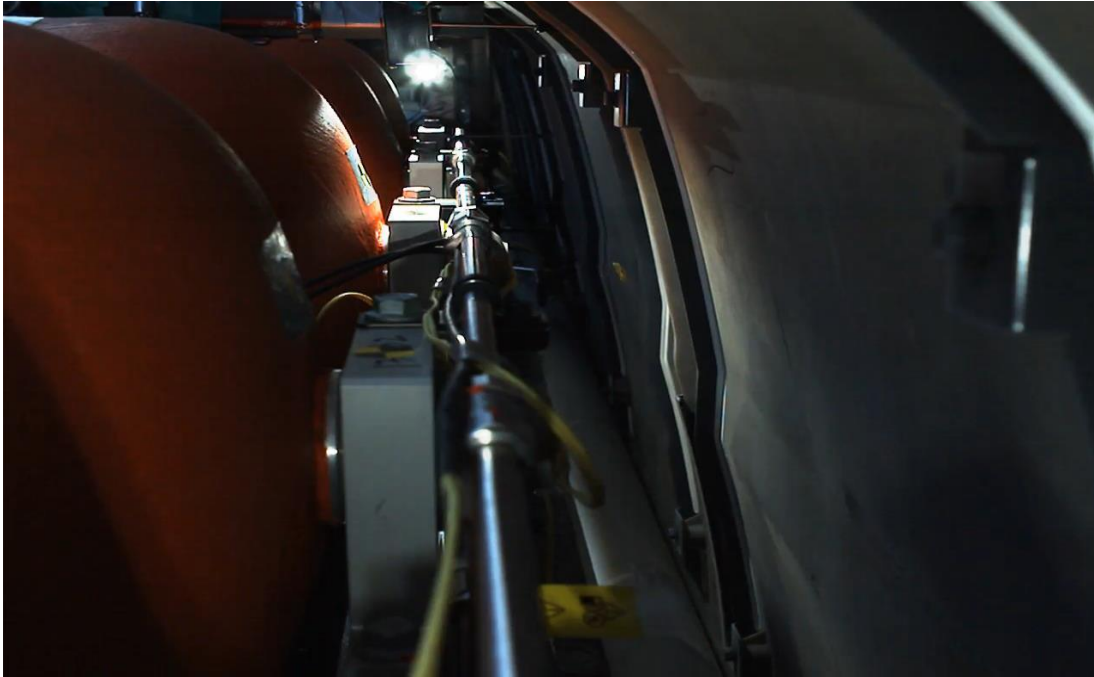
Fuel system (Fuel Tanks and Shut-off valves)

- Direct contacts were observed between fuel system (fuel lines and valves) and vehicle side wall during rollover test.
 - High accelerations of 60 ~ 80g were measured in terms of impact severity of fuel tanks. But no leak of hydrogen gas.
- Direct contacts were observed between REESS and vehicle side wall during rollover test, too.
 - Failure of isolation resistance between high voltage bus and electrical chassis.
 - ※ 65~90 Ω/V were measured from the test (Regulation : equal or over 500 $\Omega/V(A/C)$)

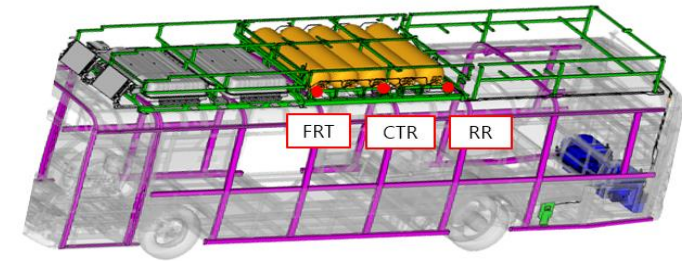
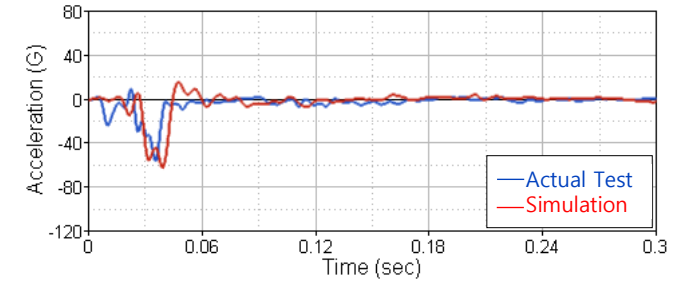
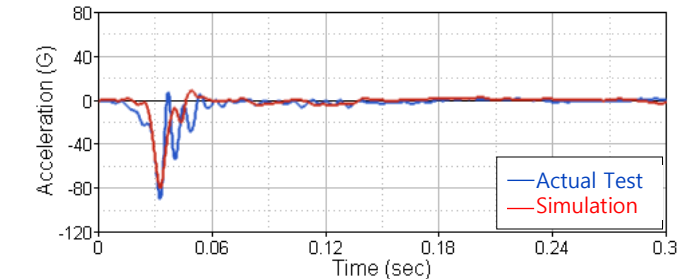
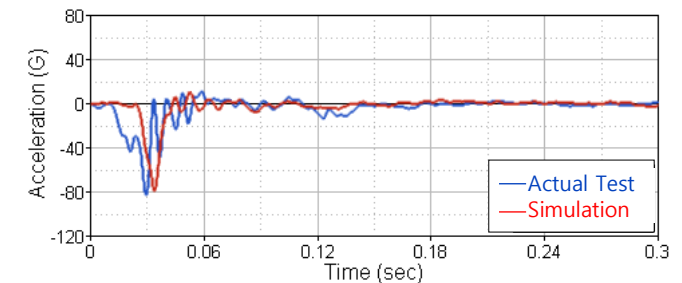
< Acceleration on frame structure of hydrogen fuel tank >

- Confirm the good correlation (equivalent level) about measurement data of both fuel tanks and main body regions between actual test and computer simulation.
- Accelerations of roof structure (Fuel tanks): peaks, shapes and event times are similar between test and simulation data.

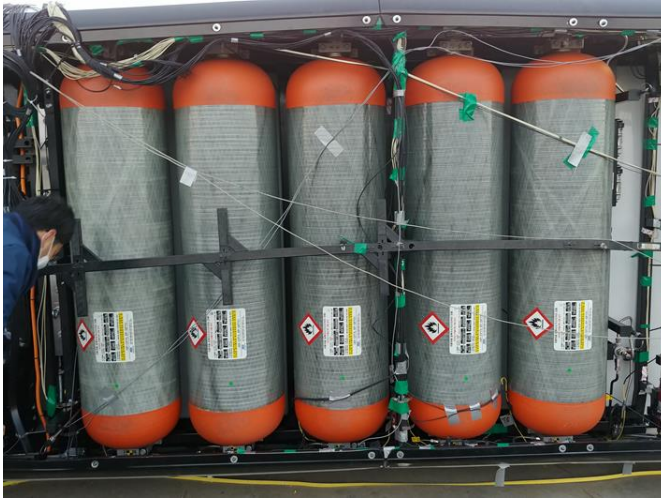
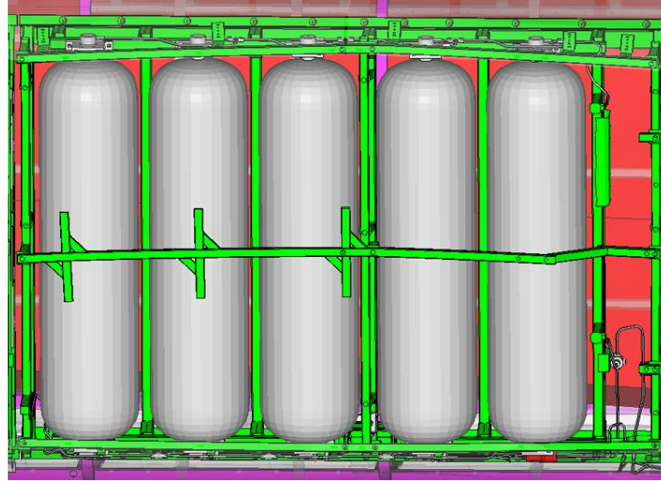
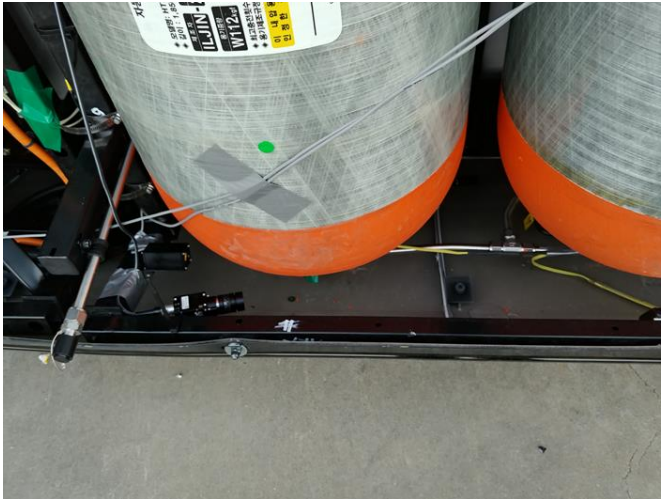
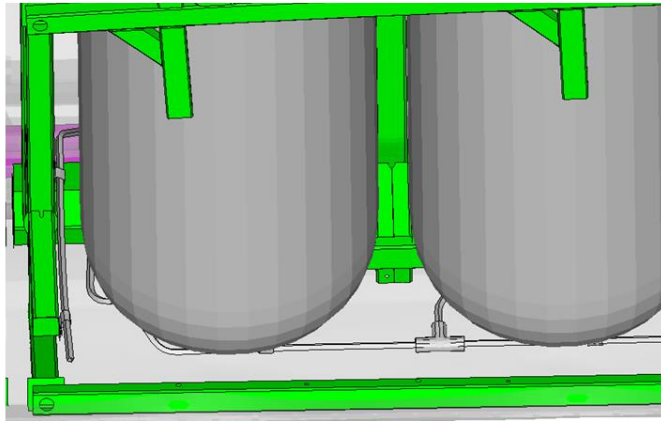
<Comparison of FECV bus rollover crash between test and simulation>

- Confirm the good correlation (equivalent level) about deformed shape of fuel system and structure.
 - 1) Direct contacts are observed between fuel system and vehicle side wall in both test and simulation.
 - 2) Deformed shapes of vehicle structures are similar.
