# Ensuring life time performance of Advanced Driver Assistant Systems:

## Risk Analysis of Lane Keeping Assistant Systems / WP.29

Dr. Matthias Schubert / TÜV Rheinland

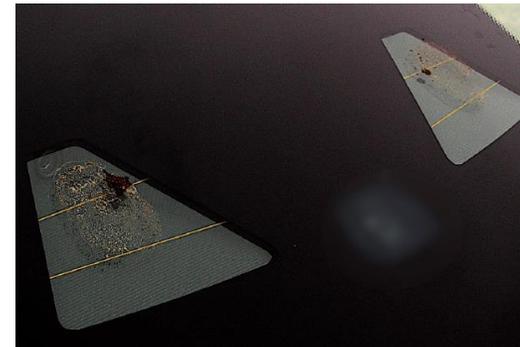
Dirt Stain in front of cameras

<ul style="list-style-type: none"> <li>Restriction of visibility</li> </ul>	<ul style="list-style-type: none"> <li>A thin film of dirt was applied to the windscreen directly in front of the camera</li> </ul>	<ul style="list-style-type: none"> <li>Vehicle <b>moved out of the lane</b> without warning</li> <li>MIL <b>warning only</b> activated when the <b>vehicle significantly moved out of the lane</b> in the curved section</li> </ul>

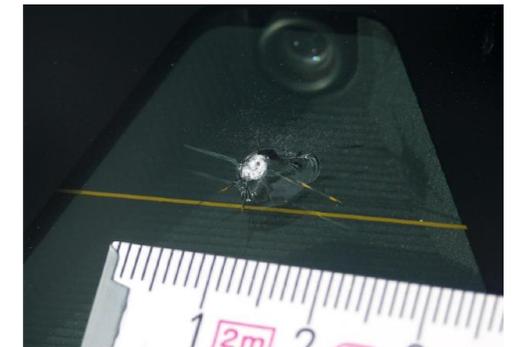
Stone chip in front of camera

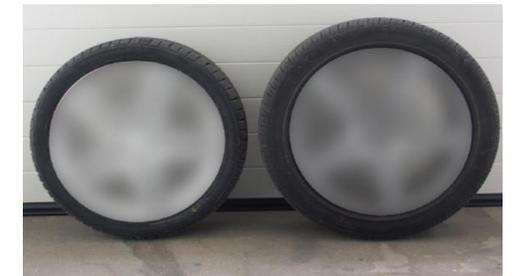
Different wheels  
(original wheel on the right)
