End-of-Life Evaluation of Compressed Natural Gas Vehicle Fuel Tanks

National Renewable Energy Laboratory

Technical Report NREL/TP-5400-80446 July 2021

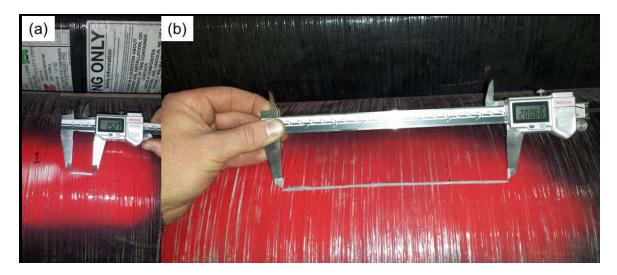
Figure 3. (a) Representative short notch with deep depth and (b) representative long notch with shallow depth

Eight of 20 artificially damaged tanks were notched before pressurized until burst. Two notches were imposed along the axial direction of four Type III cylinders and four Type IV cylinders according to Section A.17 of ISO 11439. One notch was shorter in length with a deeper depth, and the second notch was longer in length with a shallower depth. The shorter notch was 1.0 inch long and 0.05 inches deep, whereas the longer notch was 8.0 inches long and 0.03 inches deep, as show in Figure 3.

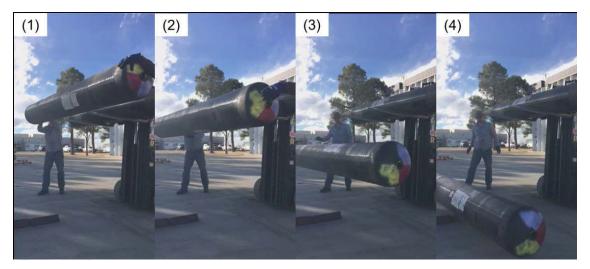
Figure 4. (1) Tank at testing height; (2) drop initiation of the tank; (3) tank dropping; (4) impact of the tank onto the steel angle iron

Twelve of the 20 CNG fuel tanks were artificially damaged through horizontal impact events as defined in Section A.20 of ISO 11439. Four of the tanks—two Type III cylinders and two Type IV cylinders—were subjected to impact damage as specified in the test procedure by dropping the tanks from the specified height onto a flat concrete surface. In order to represent a worst-case scenario of real-world failure modes of impact damage experienced by CNG fuel tanks in service, the remaining cylinders were dropped onto a modified surface from an adjusted height from that defined in the test procedure. Two Type III and two Type IV fuel tanks were dropped onto a 4 in. x 6 in. x 36 in. piece of angled steel located on the ground at the impact location. The angled steel localized the impact onto the tank to increase the severity of the damage. Another two additional Type III and two Type IV fuel tanks were dropped from twice the defined height onto a $4 \times 6 \times 36$ -in. piece of angled steel located on the ground at the impact location, as the increased height from which the tanks were dropped doubled the amount of potential energy of the impact event. These modified test conditions were a better representation of severe damage inflicted onto CNG fuel tanks in actual operating environments. Figure 4 depicts a time lapse of the representative localized impact event onto the steel angle iron.
