Rapid Heating Test Methodology : Vehicle (using cylindrical cells) Test

November, 2022

EVS 25 – GTR

Vehicle test with cylindrical cell pack architecture

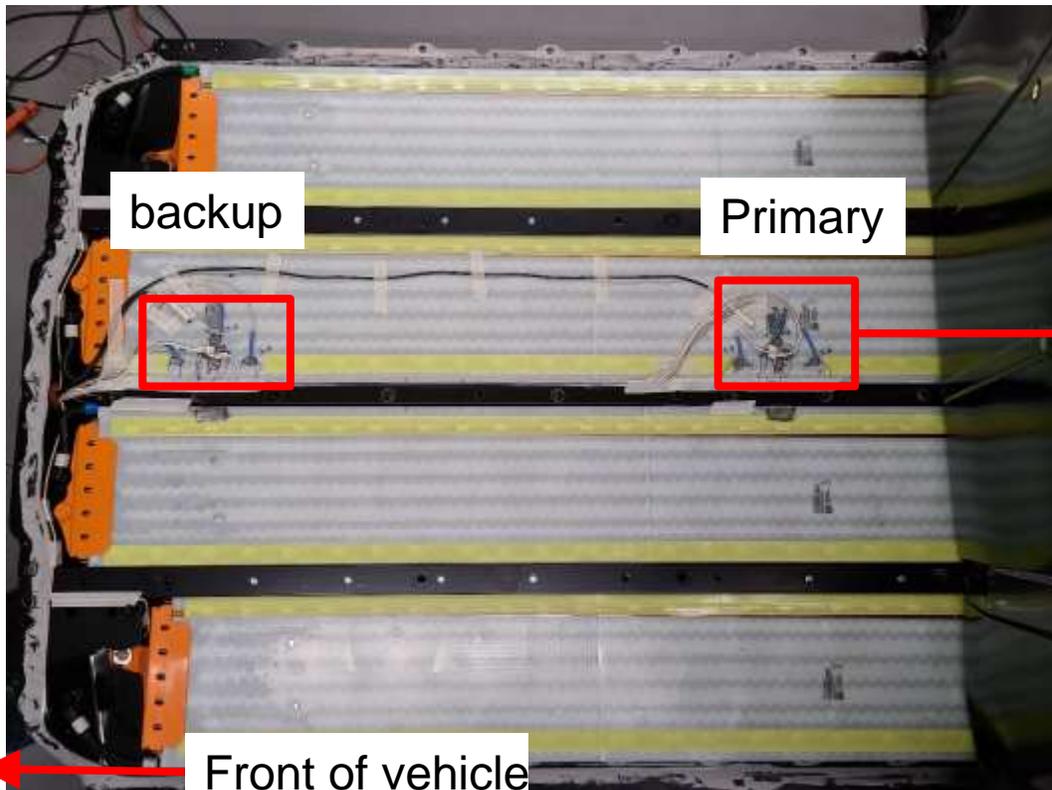
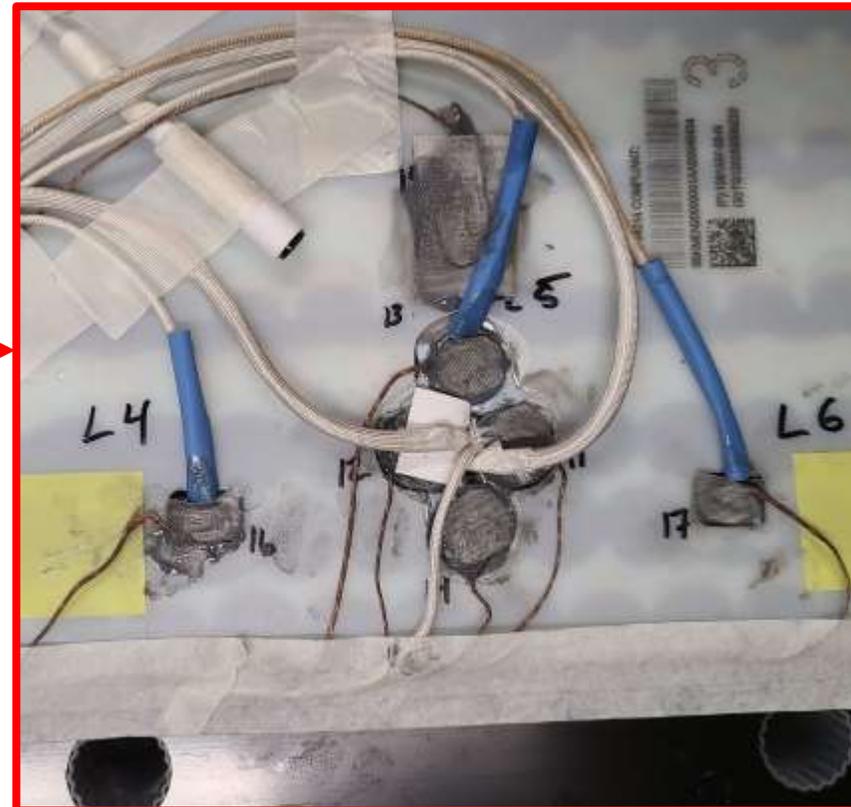
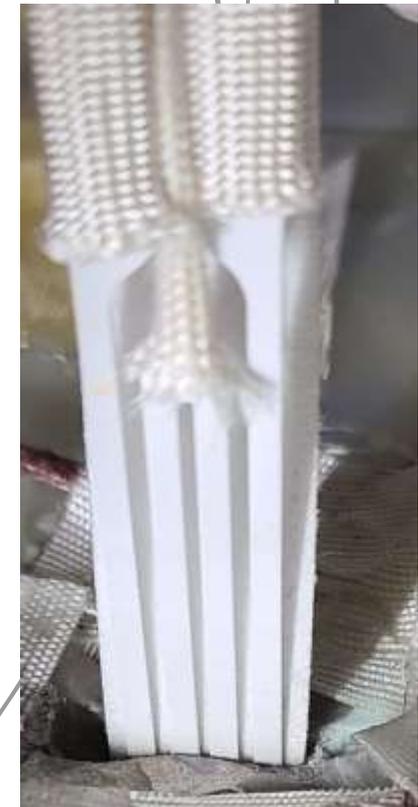
Extraction / heater install / reseal / reinstallation following OEM service manual;
No battery related error codes present after reinstallation and vehicle could be placed in drive or charge mode (heater is “invisible”).

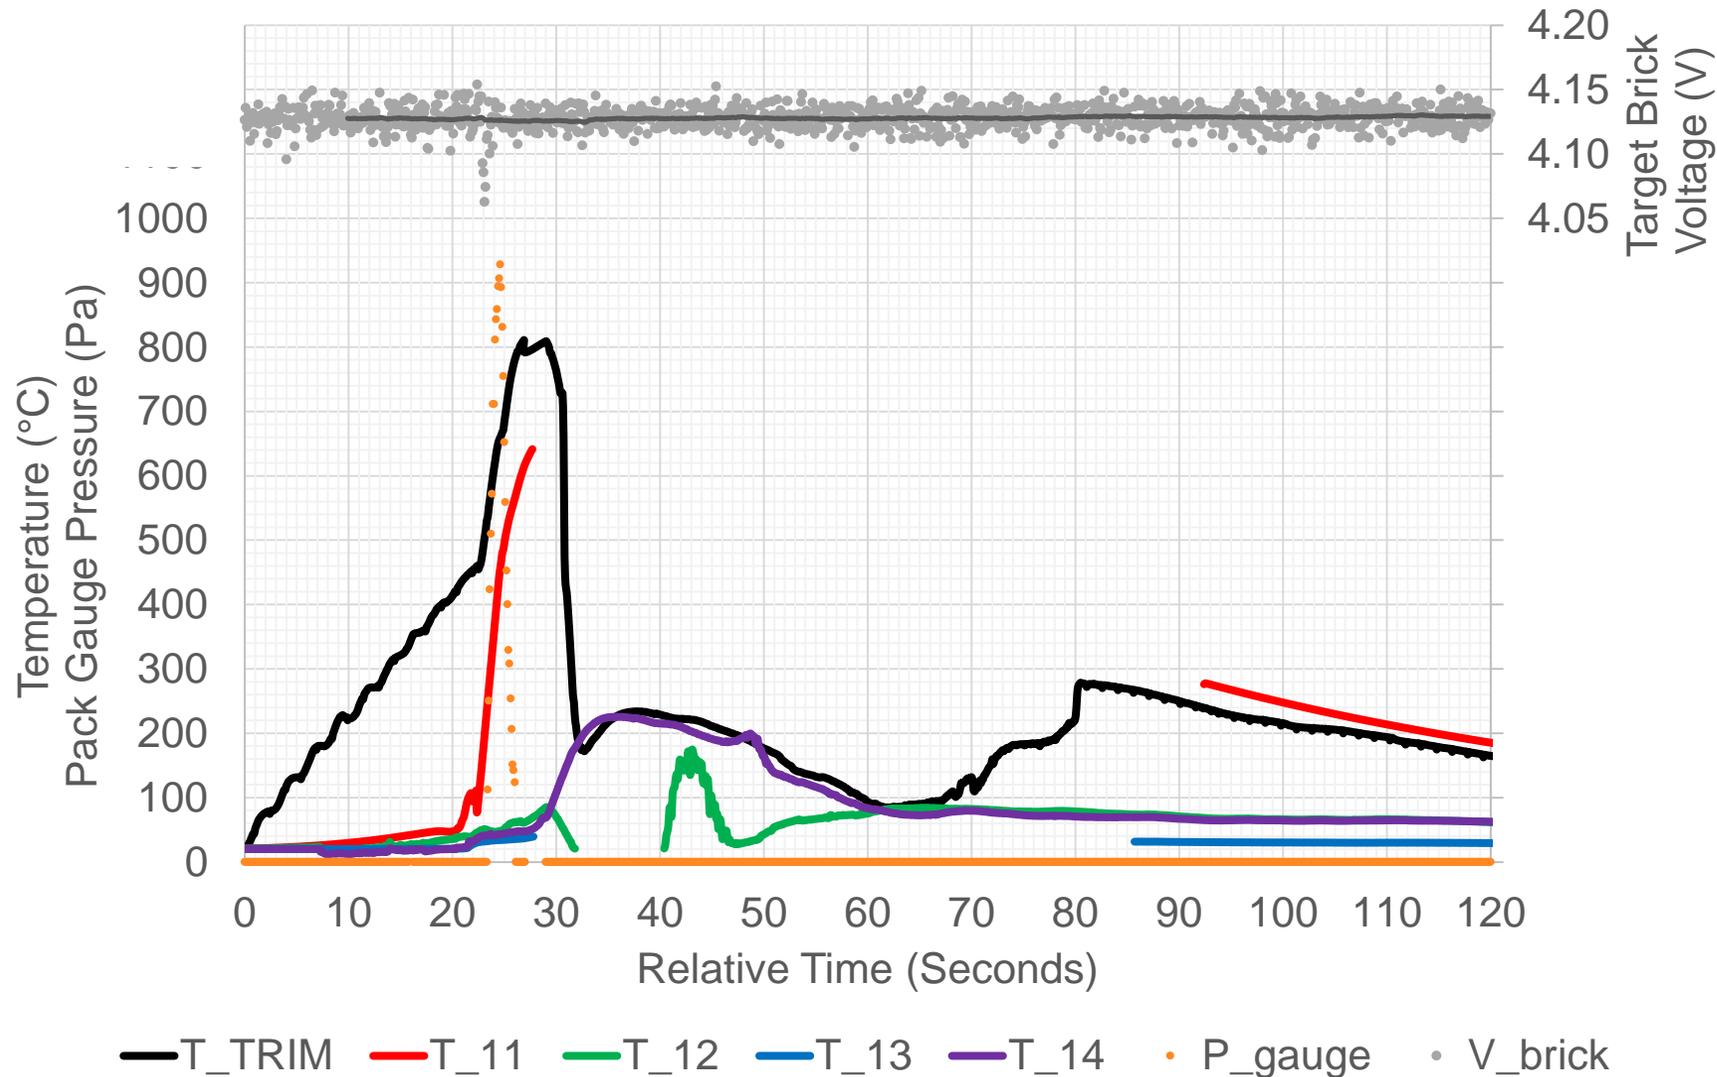
Temperature/Voltage Data

- Heater set to 20°C/sec to 500°C, TR in 23 sec;
- Electrical disturbances on some temp. signals between 30 and 90 sec;
- Instantaneous voltage drop by 66 mV, detected by high speed data acquisition;
- Peak Pack Pressure measured during SCTR: 930 Pa;
- No change is coolant flow throughout experiment;
- ~3 ppm CO detected, as measured by FTIR, at top of tent roughly 4 min after heating.

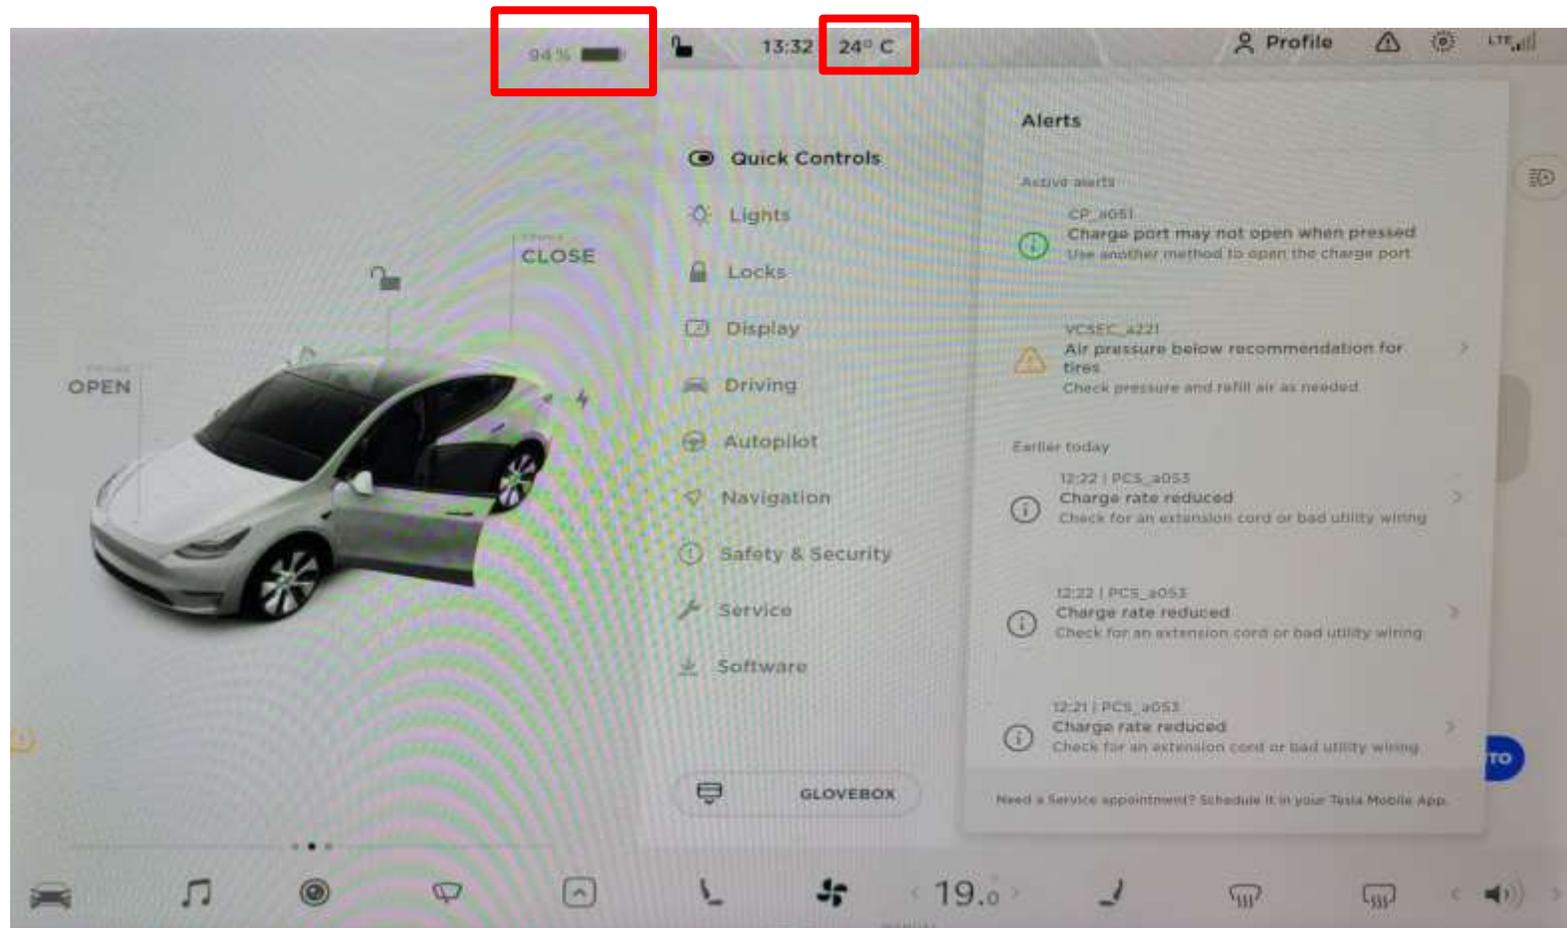
Dashboard Display (same before and after)

- Charge port door not latching due to rear end crash damage
- Tires were removed
- Charging by generator
- **NO** other active alerts

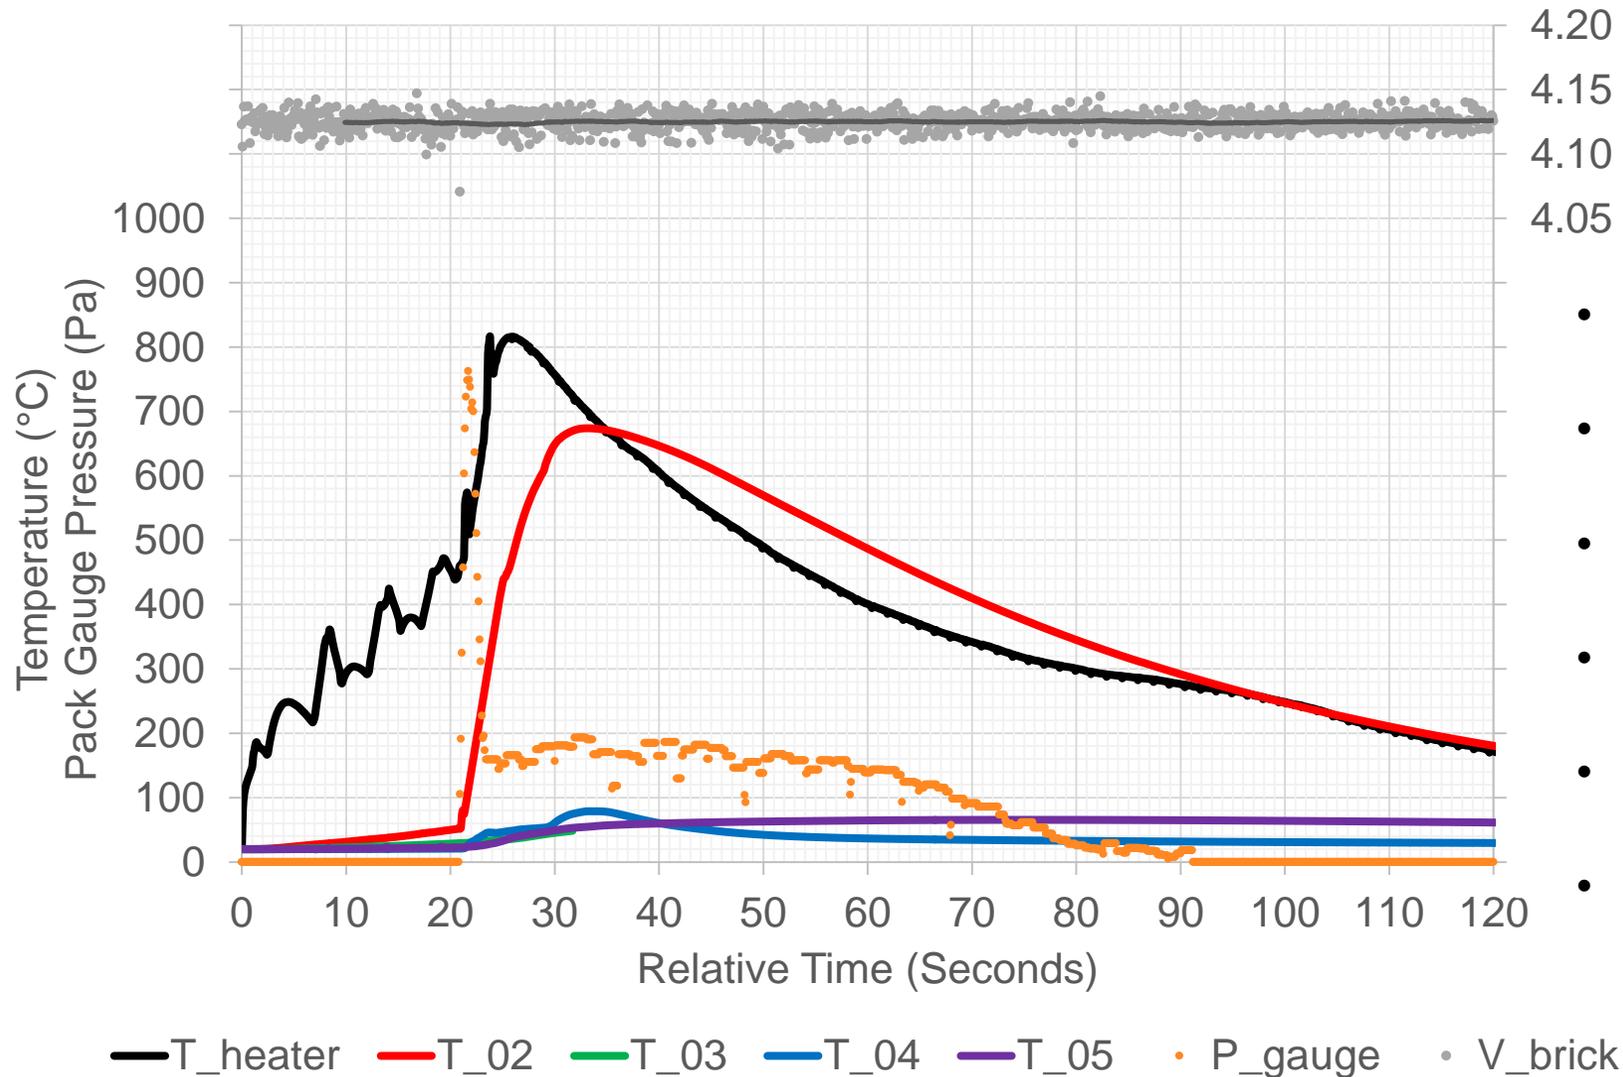
Back up Site Activation

After waiting for area around Primary heater to cool down, Backup heater was activated

- TR in 22 sec
- Instantaneous voltage drop = 54 mV
- Peak pack pressure = 760 Pa
- No change in coolant flow
- ~3 ppm CO detected at top of tent
- **NO Change** in the dashboard display
