Li-Ion Battery Pack Immersion Exploratory Investigation

UN GTR No. 20 – EVS 25th IWG

November 2022

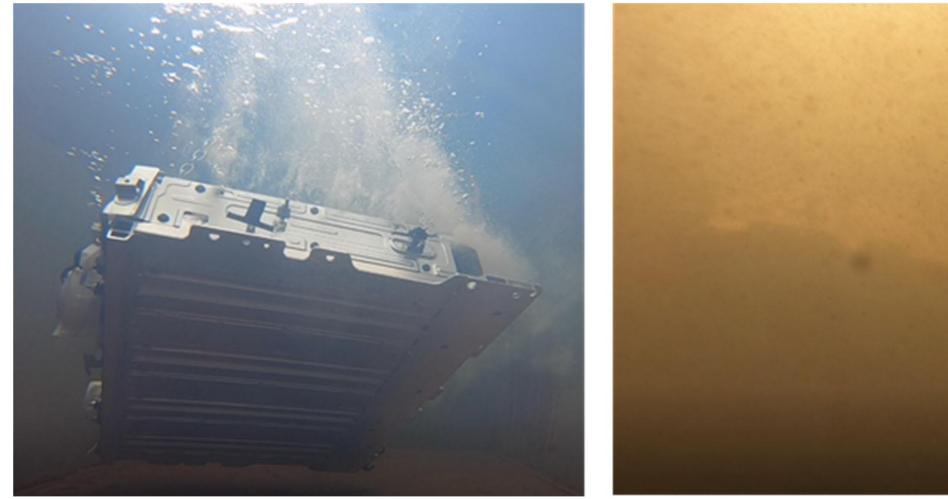
Immediately After Immersion & 10 minutes later

- All the batteries degraded with no adverse reaction while immersed
- 2 batteries had smoke/venting issues post-immersion:
 - ¹st Battery was immersed for 20 minutes in water (3.5% salinity)
 - 2nd Battery was immersed for 15 minutes in water (0.1% salinity)
- Primary reactions during immersion appeared to last between roughly 30 minutes and 1 hour. Larger capacity batteries took longer.
- Post immersion batteries were under 50V
- Battery degradation/discharge occurred quicker in 3.5% salinity water.
