National Highway Traffic Safety Administration

Lithium-ion based Rechargeable Energy Storage System Real-World Incident Review

GTR Status Update

May 2014

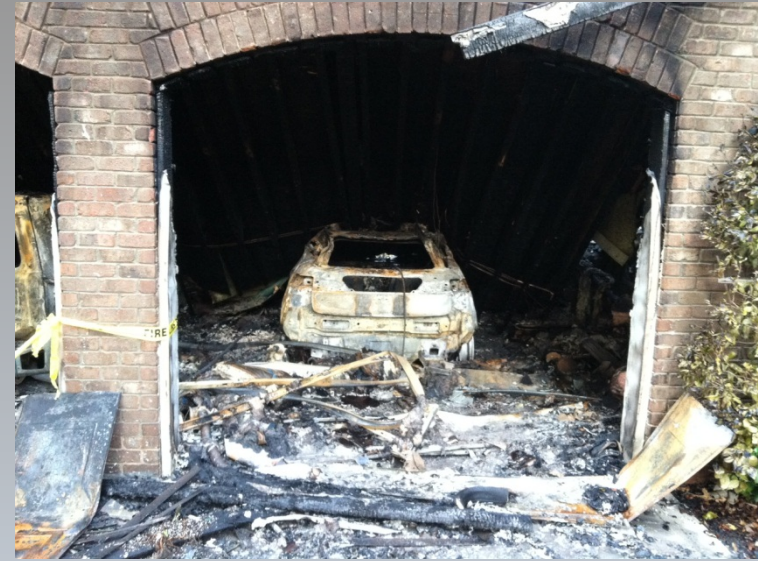
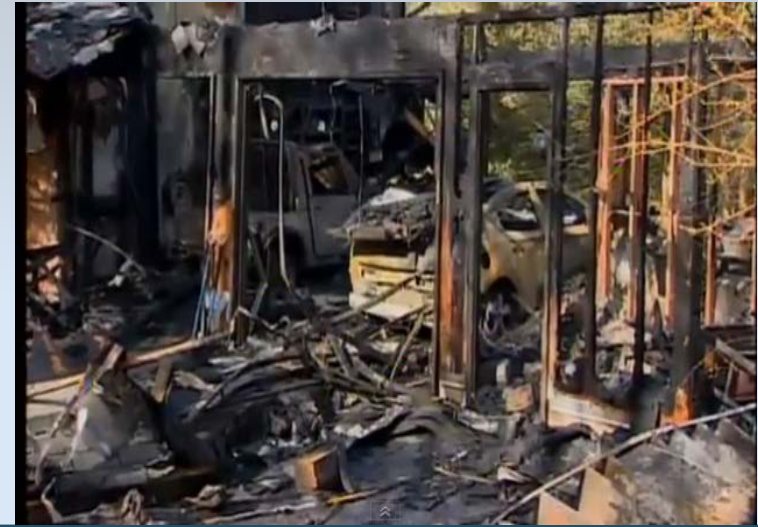
Chevrolet Volt Incidents

- Two vehicles involved in fires while parked
- Safety related concerns
 - First responders actions
 - Stranded Energy
 - Rekindle events
 - External fire exposure protection

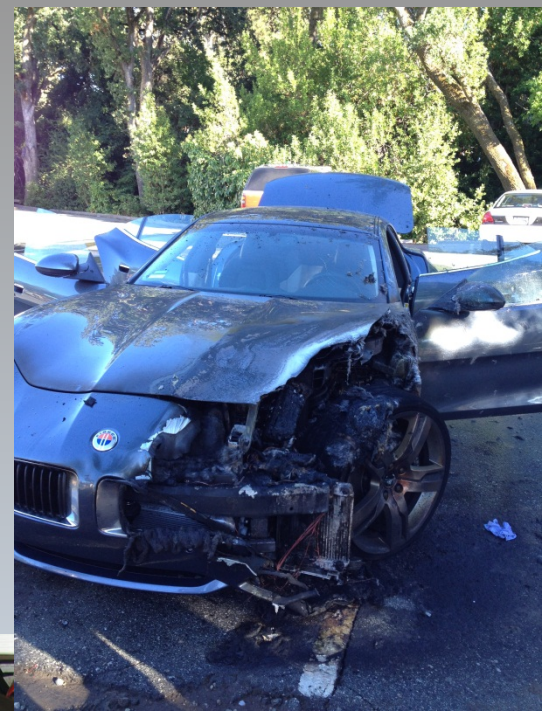
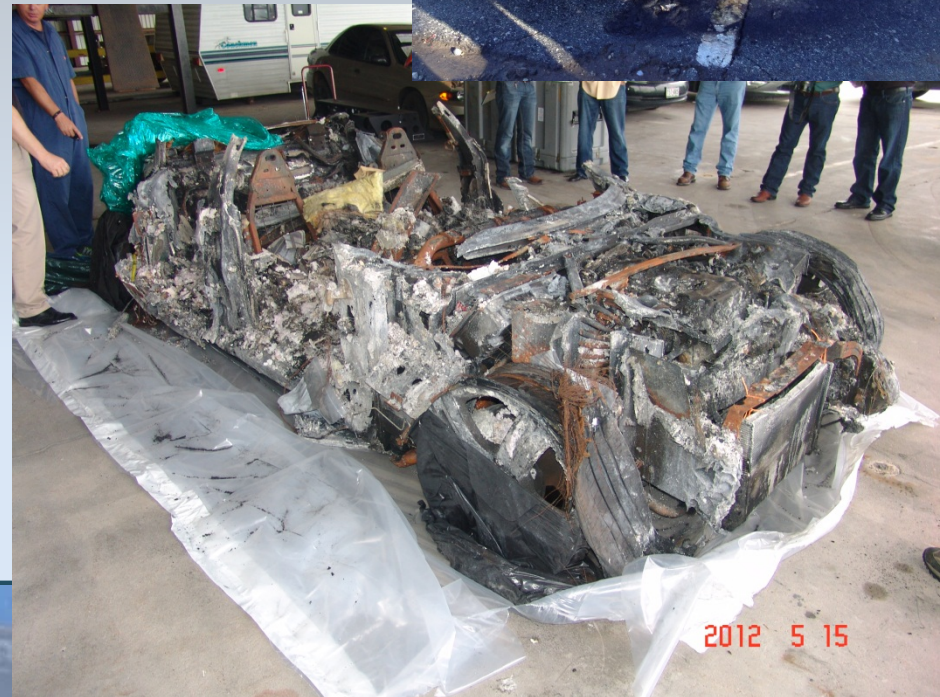
Fisker Karma Incident

- Vehicle fire due to non-high voltage vehicle component
- Safety related concerns
 - Stranded Energy
 - First Responder Actions
 - External Fire Exposure

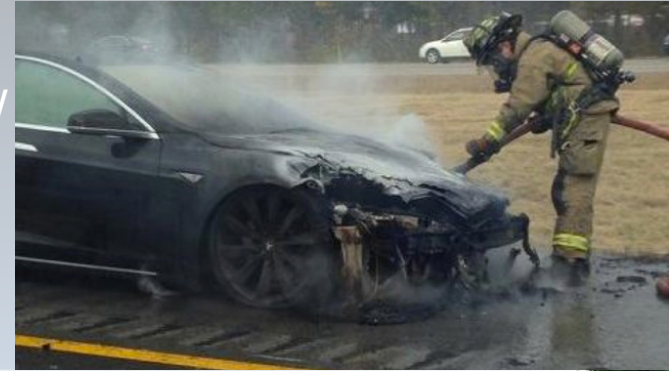
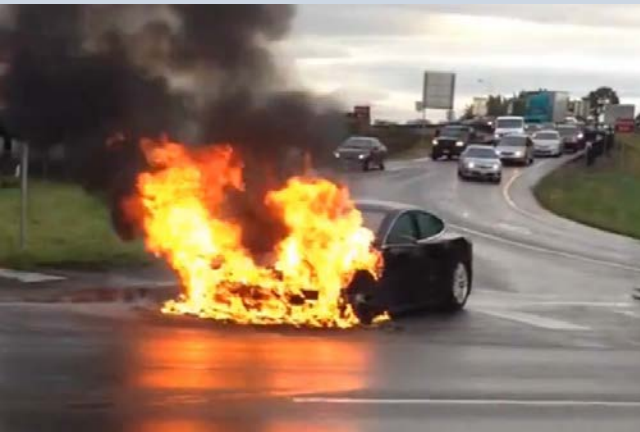
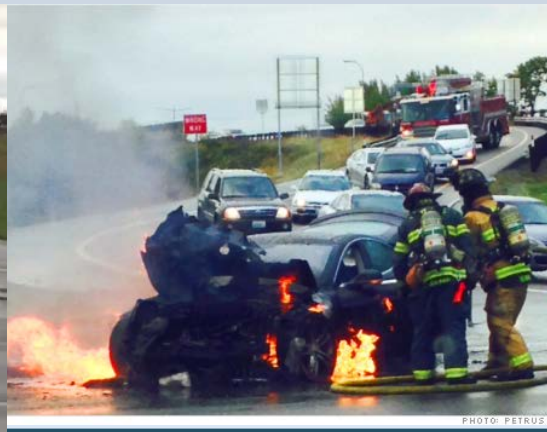
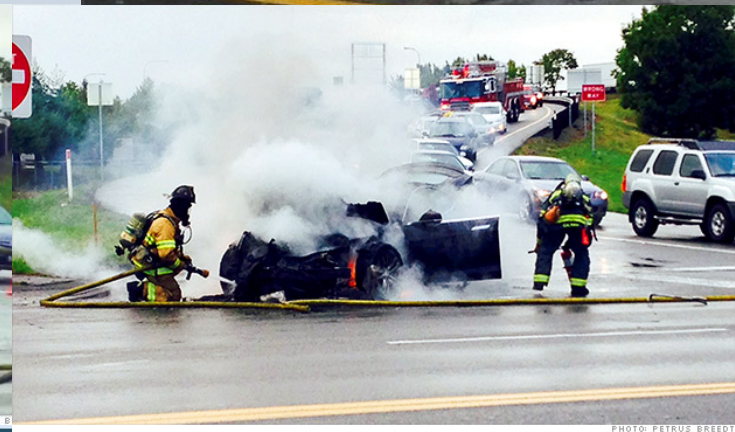
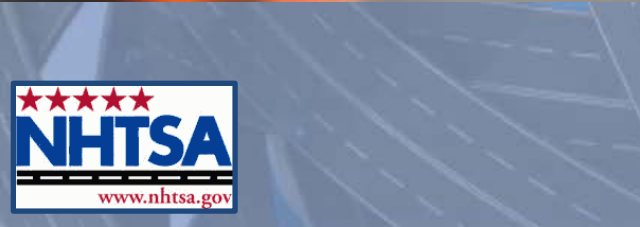
Tesla Model S Incidents

- Two vehicles strike objects on roadway
 - Objects penetrate HV battery enclosure
 - Mechanical abuse triggers thermal activity

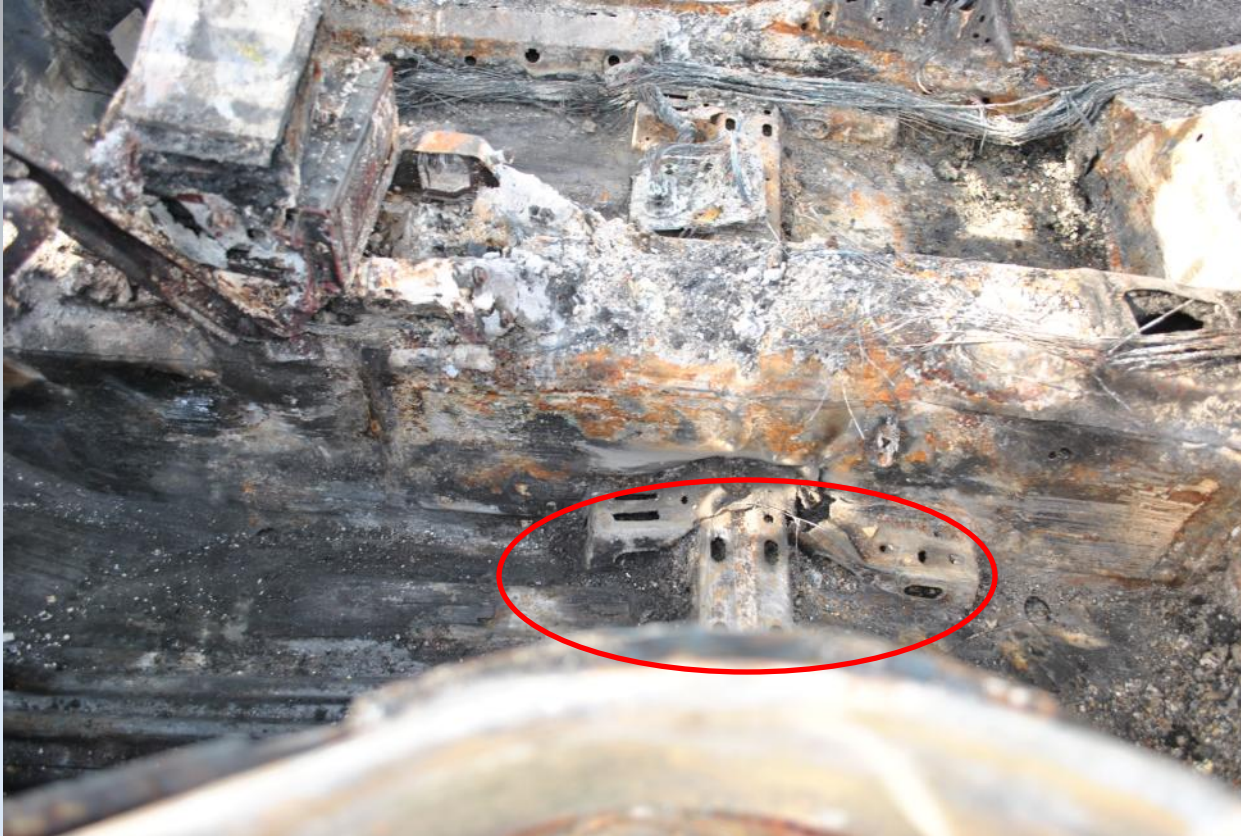
Cross-member Intrusion Into Battery Compartment

- The battery and cooling system were damaged during the crash test
- Conductive liquid coolant leaked inside the battery compartment
- The monitoring electronics for the battery were exposed to the conductive coolant (rollover test)
- Fire initiated in the Volt 23 days after testing as a result of the damage and exposure.
- The fire was initiated and sustained by the stored energy in the battery.

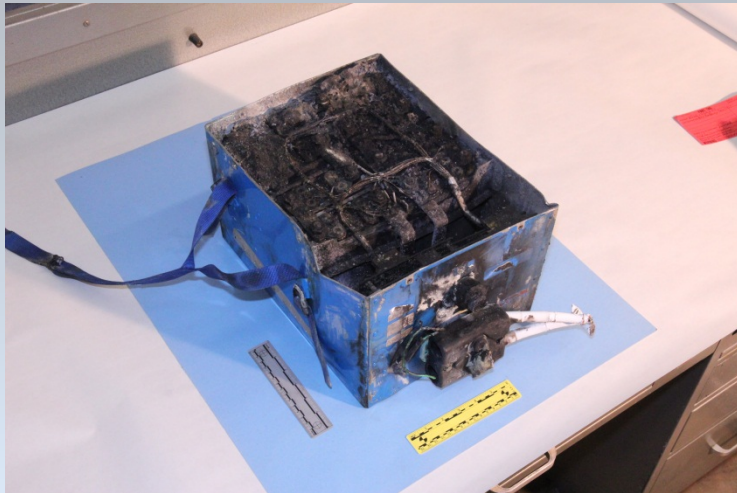
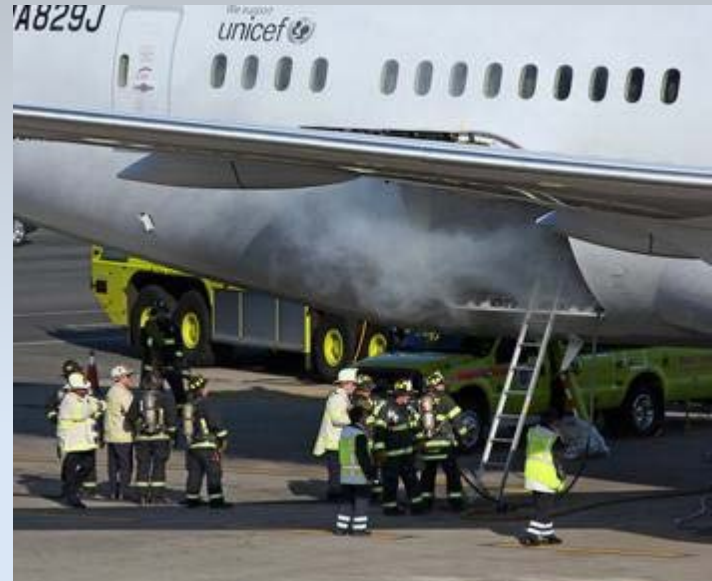
Incident Overview

- APU battery pack suffered a thermal event with release of smoke and gasses on a JAL 787 while on the ground at Logan Airport in Boston, MA

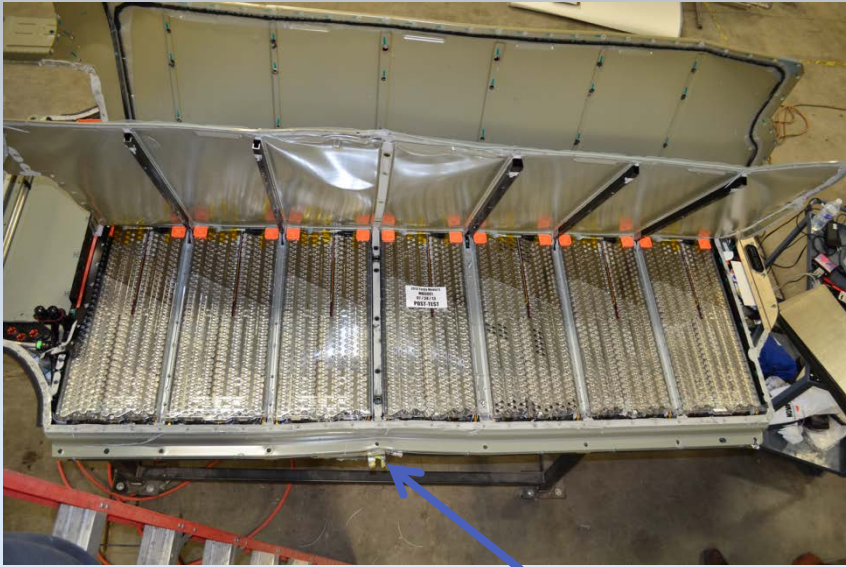
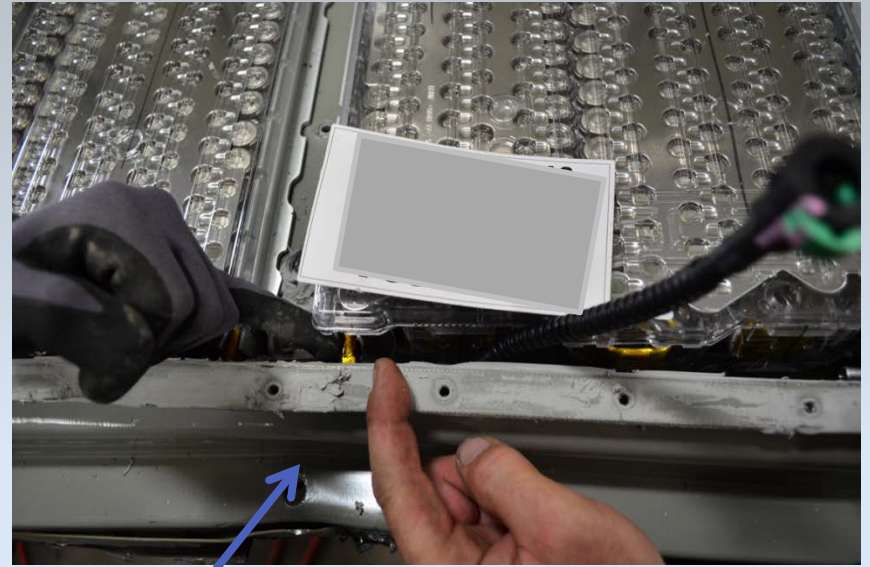
Example of a Post-Crash Battery Pack Inspection

- Mechanical crush/structural integrity of the battery pack
 - No battery cell damage was observed
- Electrical Isolation
 - Isolation was maintained
- Battery monitoring
 - Utilizes manufacturer support to monitor battery
 - No standard measurement solution available currently
- Battery health assessment
 - Based on physical (visual) inspection and prolonged post-test observation
 - Research would identify performance metrics that could be measured using better tools to evaluate the battery post-crash
