Analysis of REESS fire during vibration test

Bohyun Moon

2023. 06. 26

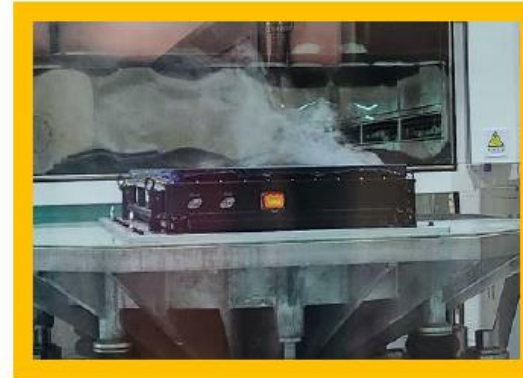
Fatigue accumulation due to vertical vibration

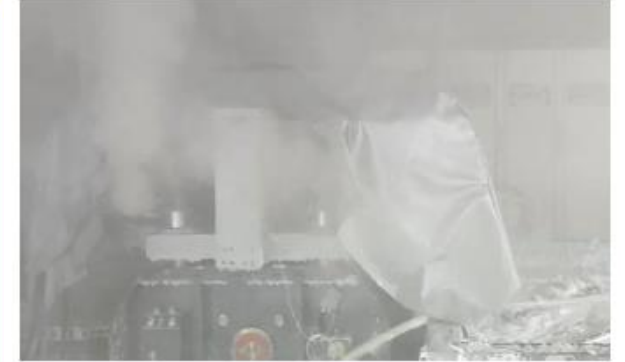
Vulnerable part of module retention bracket has broken

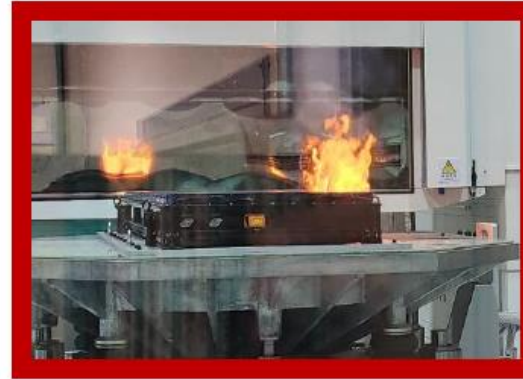
Removed modules are constantly exposed to up and down shocks

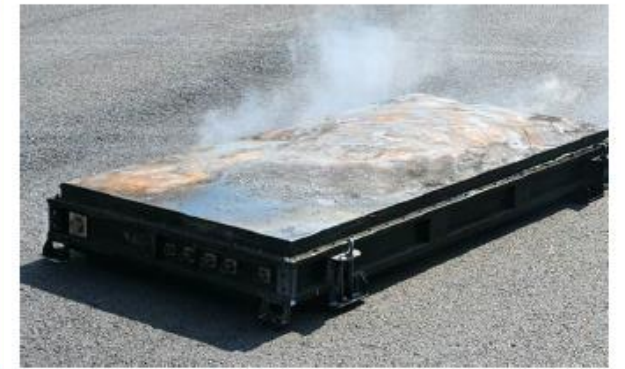
Accumulated damage to modules causes TR
