Transport Canada / Transports Canada

# **COMMERCIAL VEHICLES AND VULNERABLE ROAD USERS**

**ASFCA DATA SUMMARY 2004-2014**

2015-12-15

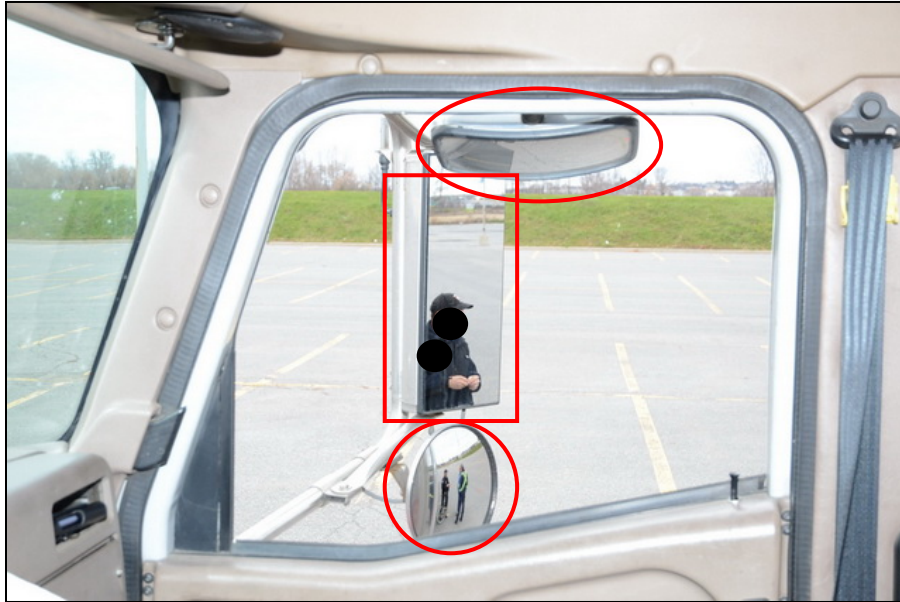
**Figure 1: Passenger Side Mirrors on a Tractor**

All vehicles were equipped with exterior rear view planar mirrors on each side of the vehicle, as specified in CMVSS 111 for vehicles, other than school buses, with a GVWR over 4536 kg (section 27). However, additional mirrors were nearly always installed by the truck operators, or owners, to improve the driver's field of view. Circular convex mirrors near the planar mirrors, fender or hood-mounted circular convex mirrors, and a look-down rectangular convex mirror over the passenger door window were the common type of mirrors installed (see Figures 1 & 2). In fact, 95% of the vehicles had additional mirrors installed. It should be noted that external mirrors often block a driver's direct field of view and create blind spots.

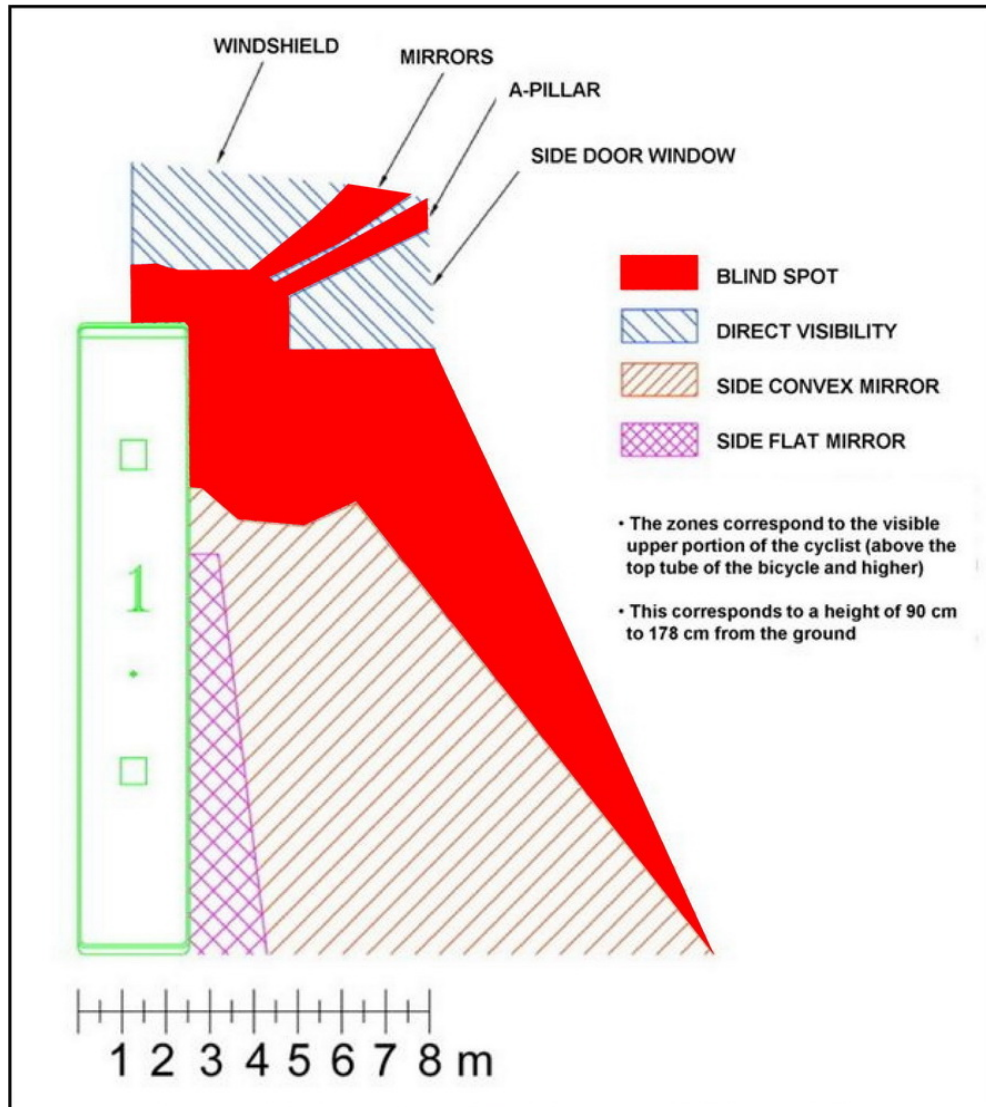
Figure 3: Field of View for 2008 Prevost X3-45 Coach Bus

There are significant blind spots around commercial vehicles as a result of both the physical size of the vehicle, and the higher seating position of the driver. Both characteristics impair the driver's field of view, particularly in front of the vehicle and extending to the sides adjacent to the frontal zone. The vehicle hood, the A and B-pillars of the cab, the trailer and the exterior mirrors, all create blind spot zones for the operator. A number of recent cases contain an analysis of the case vehicle visibility zones. An example is shown in Figure 3.

The vehicle involved was a three-axle highway coach bus (cab forward design). The bus was equipped with planar mirrors and smaller convex mirrors mounted to both front pillars. The visibility zones for this bus were mapped and are shown in Figure 3. The bus was not carrying passengers at the time of the incident.

The northbound bus slowed to make a right turn on the east/west road. At the same time, a teenage male on a bicycle was travelling north on the sidewalk adjacent to the travel lane of the bus. The bus turned in front of the cyclist and the cyclist struck the side of the bus ahead of the rear axles, fell to the ground, and was run over by the two rear axles and dragged 9 m. It was noted that bus had a side height from the ground, between the front and rear axles, of only 280 mm. The driver reported that he never noticed the cyclist on the sidewalk.

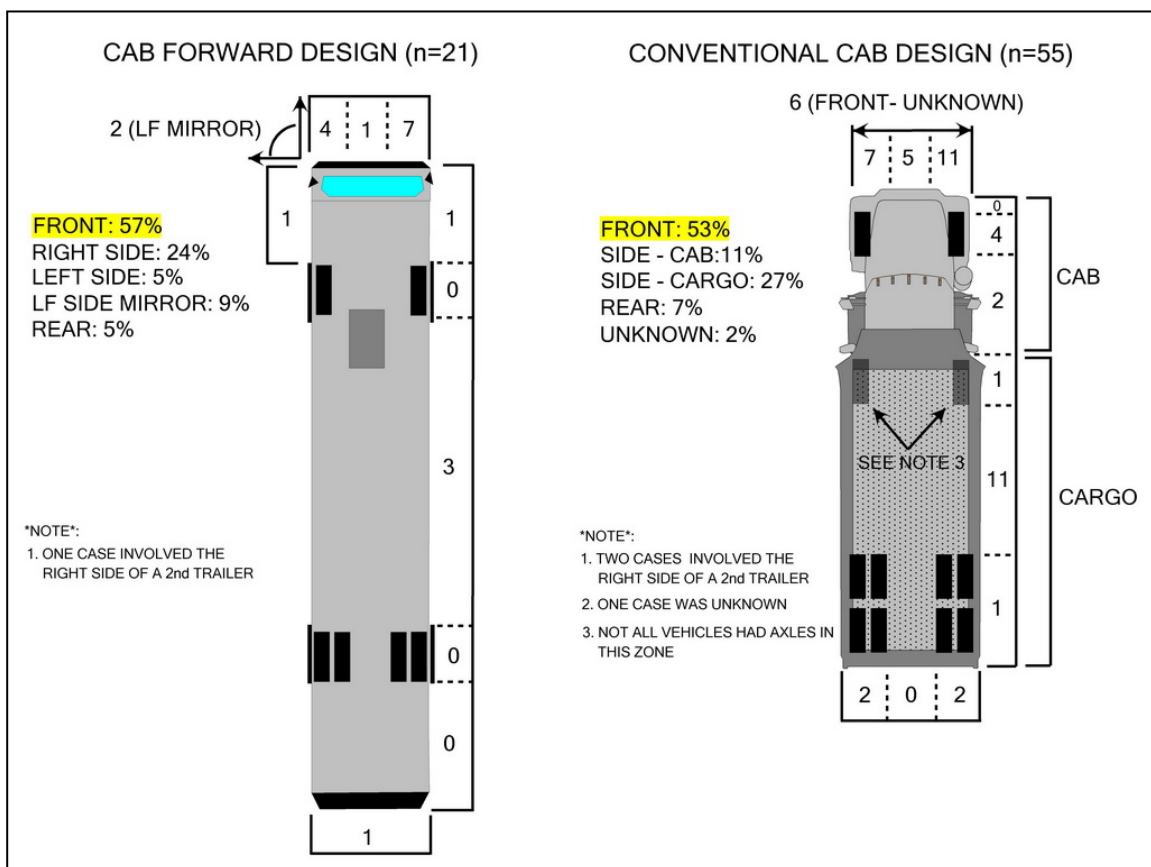
**Figure 4: Location of VRU at Impact**

A more detailed breakdown of the VRU location with respect to a generic vehicle design is shown in Figure 4. The majority of VRUs were located in the frontal plane of the vehicle at impact and there was no significant difference between cab designs. In 68% of the frontal impacts, the vehicle was either heading straight, or turning left or right, from a stopped position. A further 17% of vehicles were turning left or right at speed, which is typically a low speed manoeuvre in an urban environment.
