EVS GTR IWG #14

Evaluation of traction battery safety under Vehicle immersed accident

Video clips for Failed water immersion test

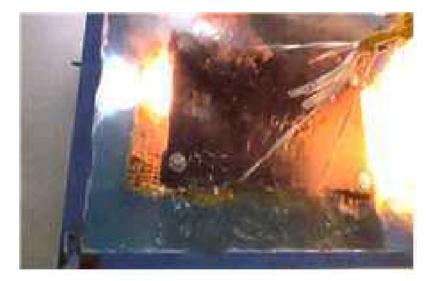
1

Ignition and explosion immediately after immersion

Insufficient for Distance through insulation (DTI) in High voltage battery

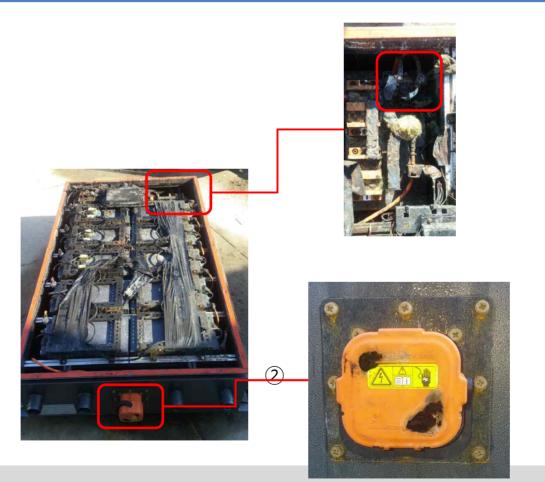
2

Arcing occurs at power outlet immediately after immersion (relay open) Continuous arcing at Safety plug (Disconnected switch)

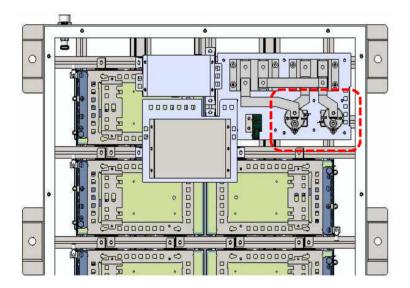
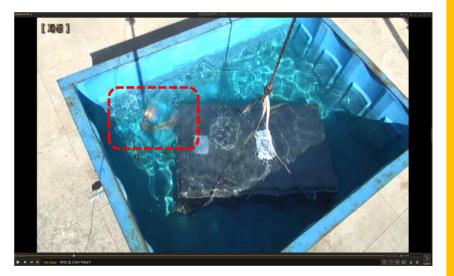
2

Arcing occurs at power outlet immediately after immersion (relay open) Continuous arcing at Safety plug (Disconnected switch)

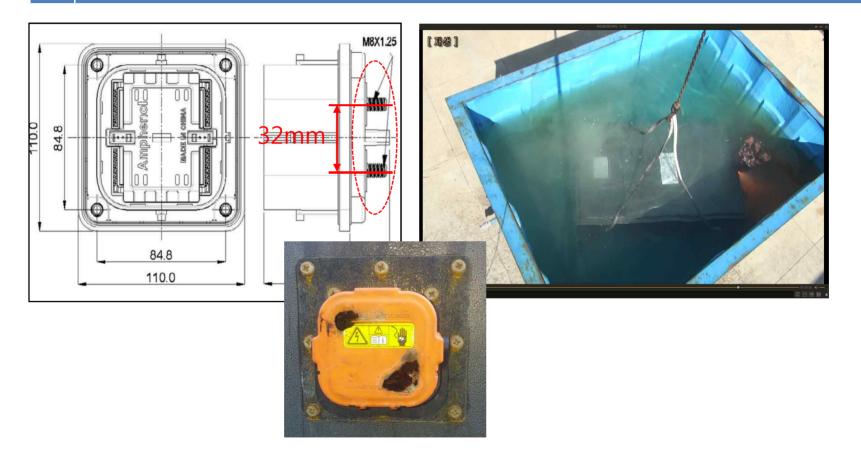
2

Arcing occurs at power outlet immediately after immersion (relay open) Continuous arcing at Safety plug (Disconnected switch)
