Necessity of Bus Rollover Test

Oct. 17-19, 2017

Kwon Sinwook

(KATRI / Korea)

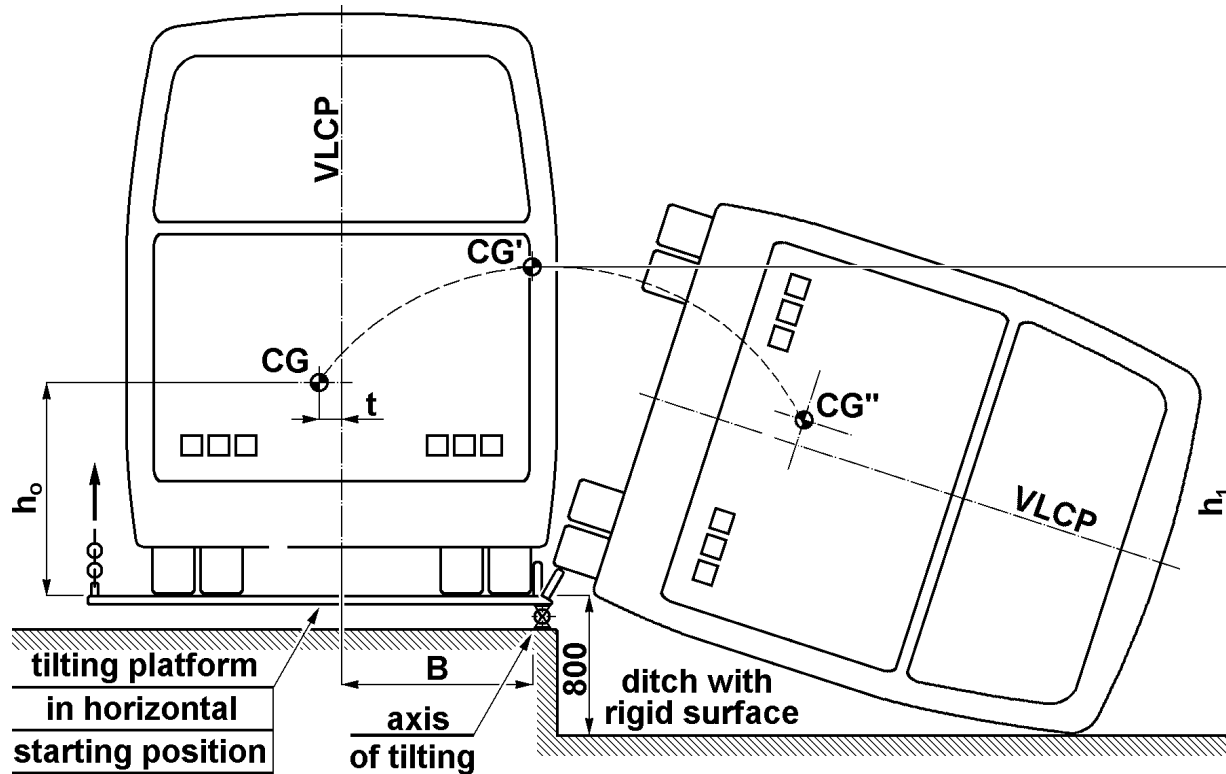
3. Bus rolover test (1/4)

- 6 CNG storages (924 liter): pressure 210kPa, filled with nitrogen 60% and helium 40%
- Place a test vehicle on the platform above 800 mm from the ground tilting less than 0.087rad/sec

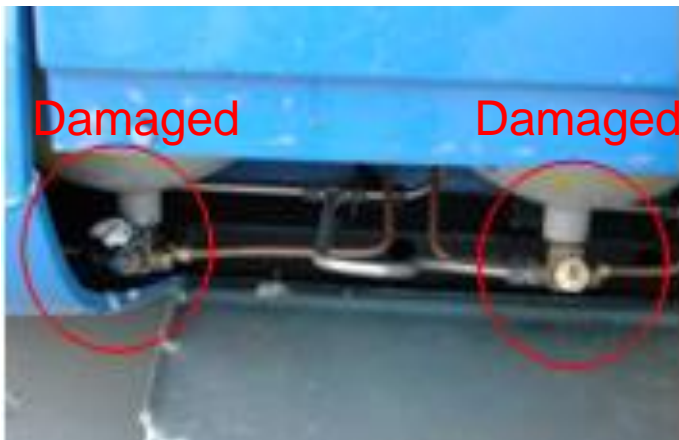
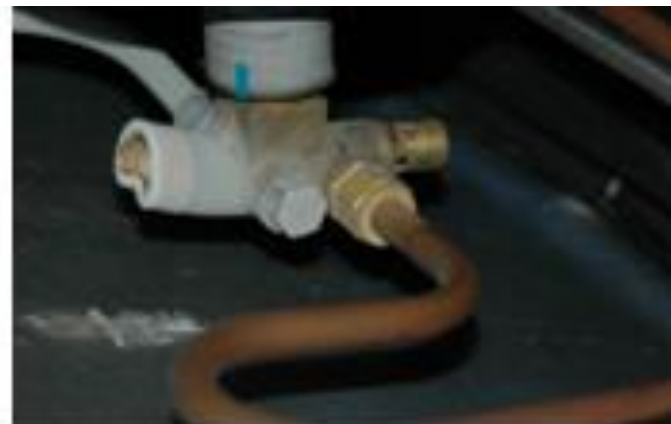
Closed view of valves

- ❑ Strength of superstructure: Satisfied (Rollover at 40 degree)
- ❑ Analysis of fuel system integrity
 - Gas leakage from broken valves due to the impact
 - Leakage amount by pressure drop in the high pressure portion exceeded the fuel leakage limit of UN GTR 13 (118NL per minute)

- ❑ Bus rollover test result
 - Mass gas leakage was occurred through the broken valves due to the impact
- ❑ Buses with fuel storages in the roof have possibility of gas leakage after rollover
- ❑ Need to consider bus rollover test in GTR No.13 Ph.2
- ❑ Considerations with test method
 - Body acceleration is very high (more than 40g based on simulation result)
 - Korea is planning to further research on this issue
