# GIDAS accident analysis pole side impact with CV's

# Overview

Source: GIDAS-Database , status 1st July 2010

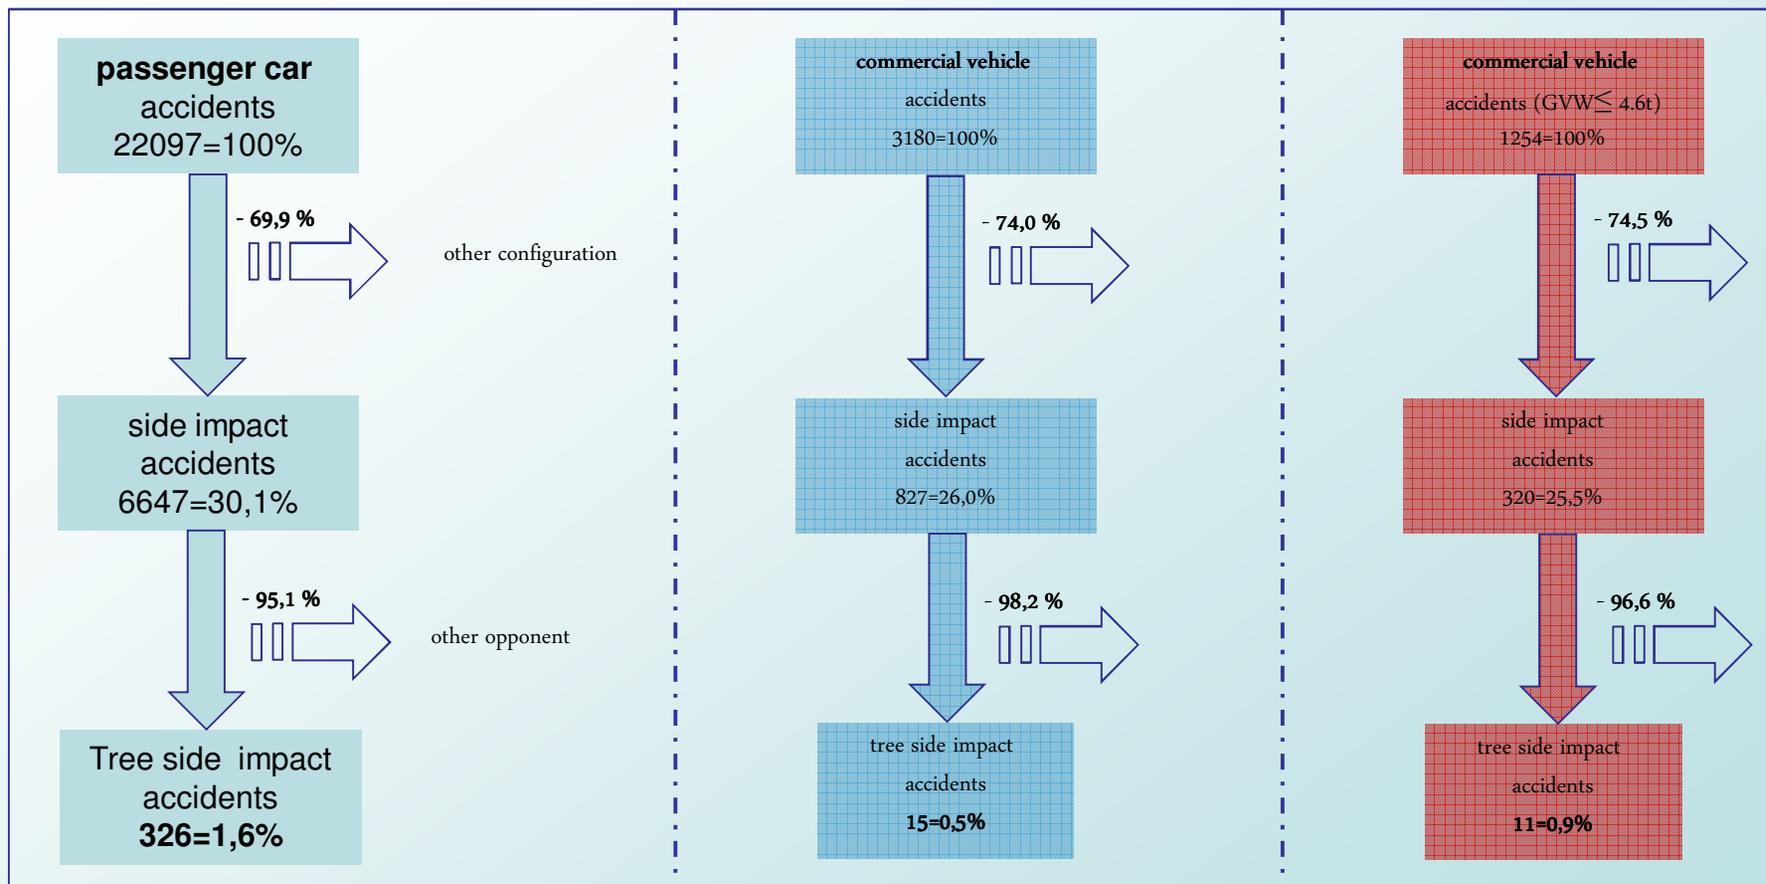
# Overall significance

Comparatively, far more often pole side impact accidents occur with passenger cars (1,6 %) than commercial vehicles (between 0,5% and 0,9%).

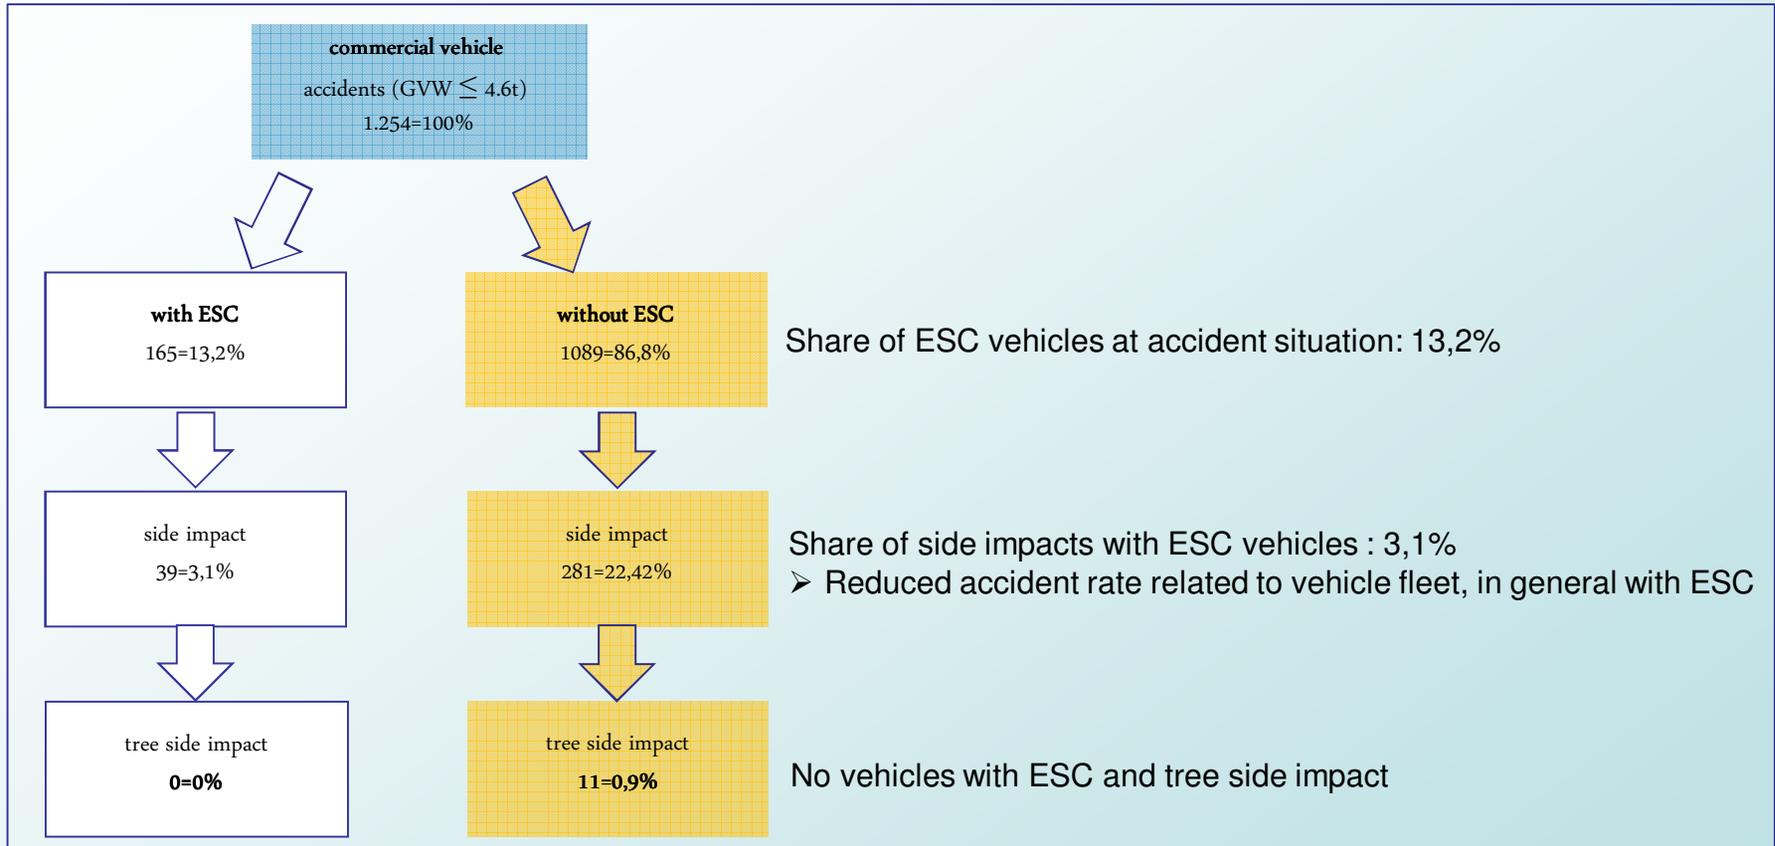
# ESC influence on accidentology

None of the eleven vans involved in pole side accidents were equipped with ESC

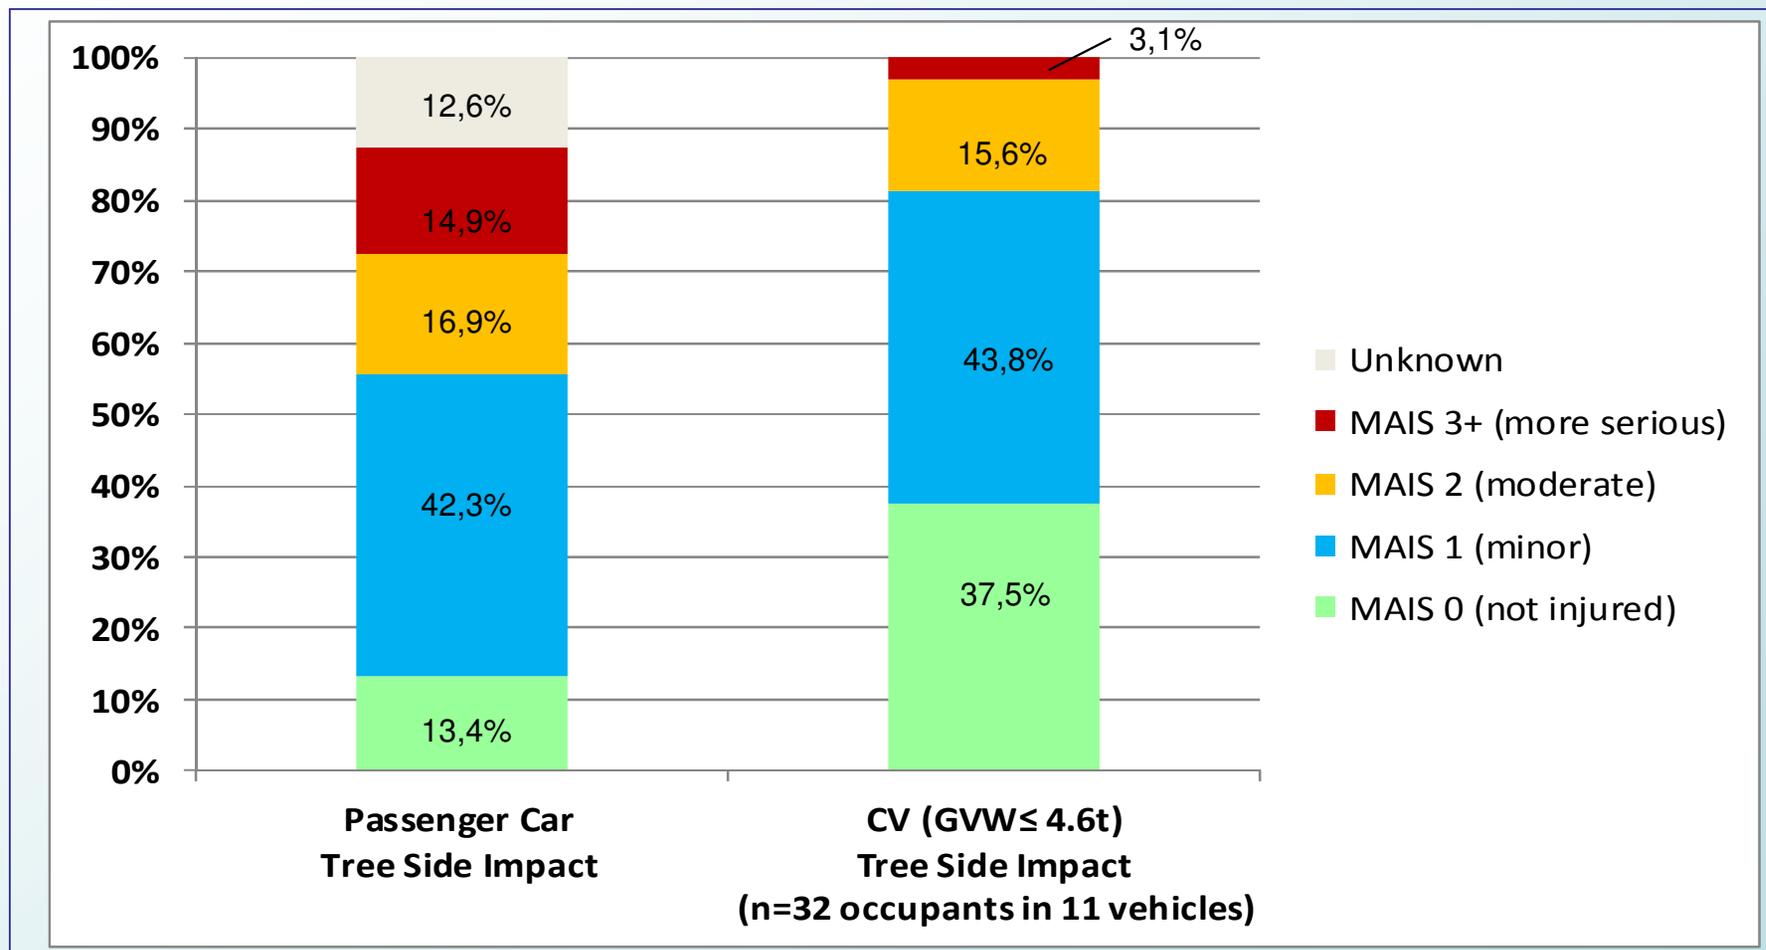
# Commercial vehicles $\leq 4.6t$ and cars: Occupant injury severity distribution

**Conclusion: Only one accident occurred resulting in a serious injured. The occupant was seated in the rear, left of a commercial vehicle. (was belted)**

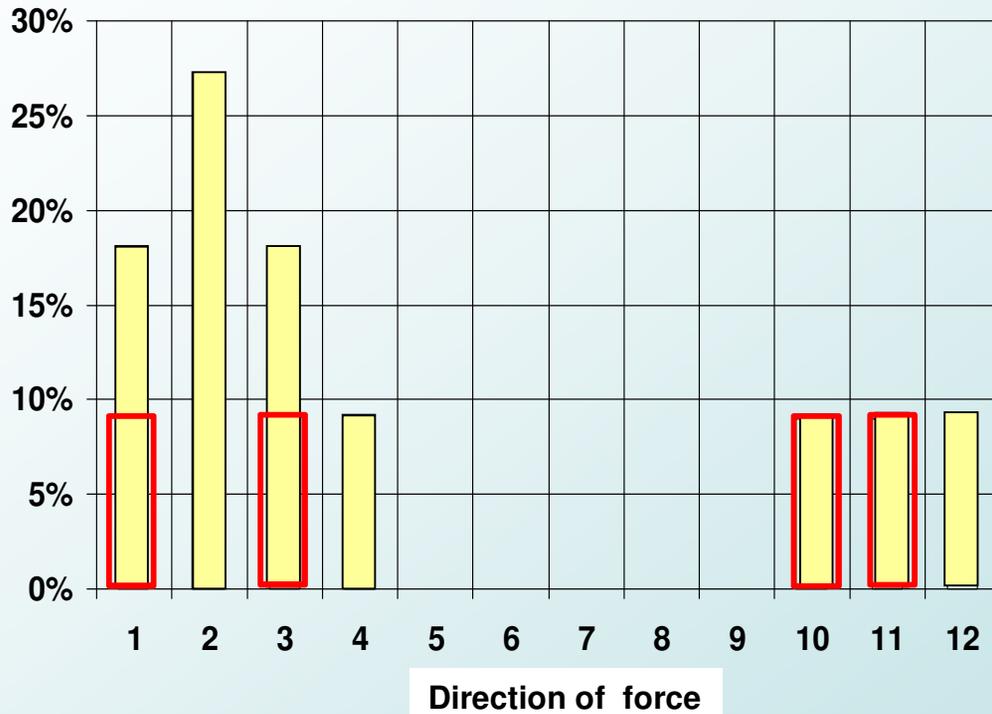
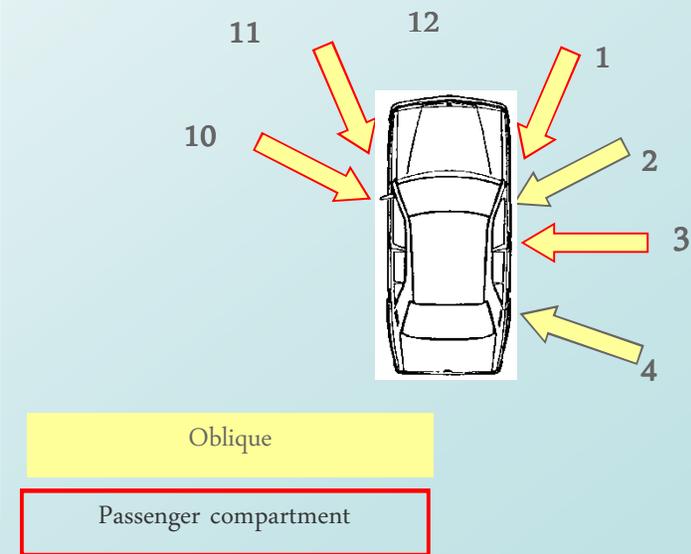
## Side impact distribution at passenger compartment

- 25,5% of all accidents are side impacts (source: GIDAS database)
- 11 accidents with pole/ tree side impact (0,9%)
- Only 4 pole side impacts occur in the passenger compartment

- Oblique direction for 3 pole side impacts and one pure lateral side impact.

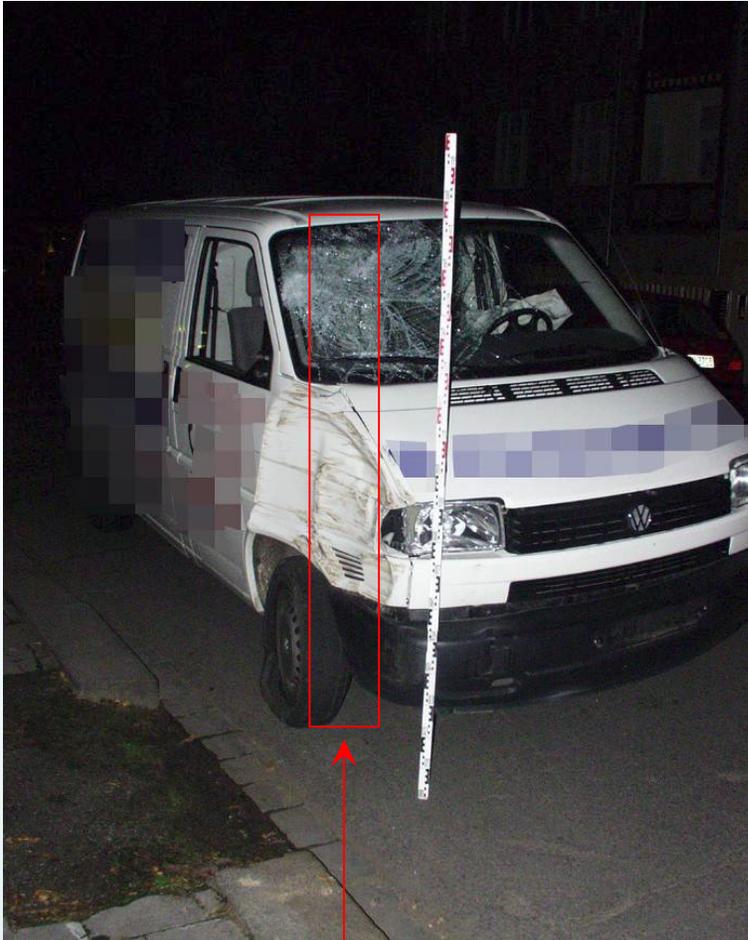
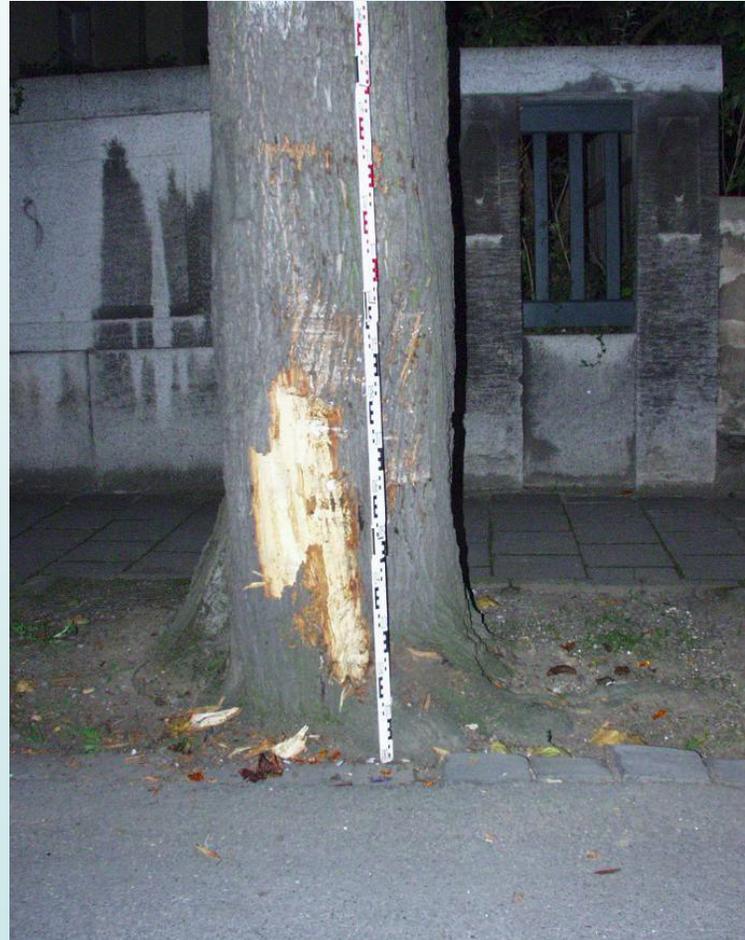
# Example no. 1010618

## Frontal corner struck tree

VDI1=12

EES=10 km/h

Overlap=5%

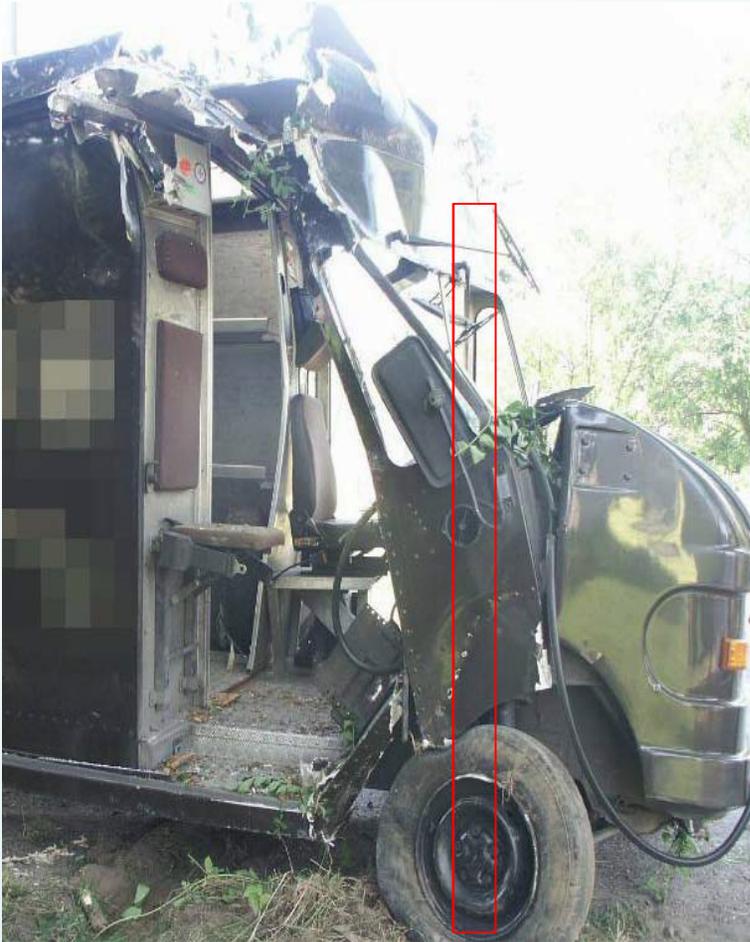
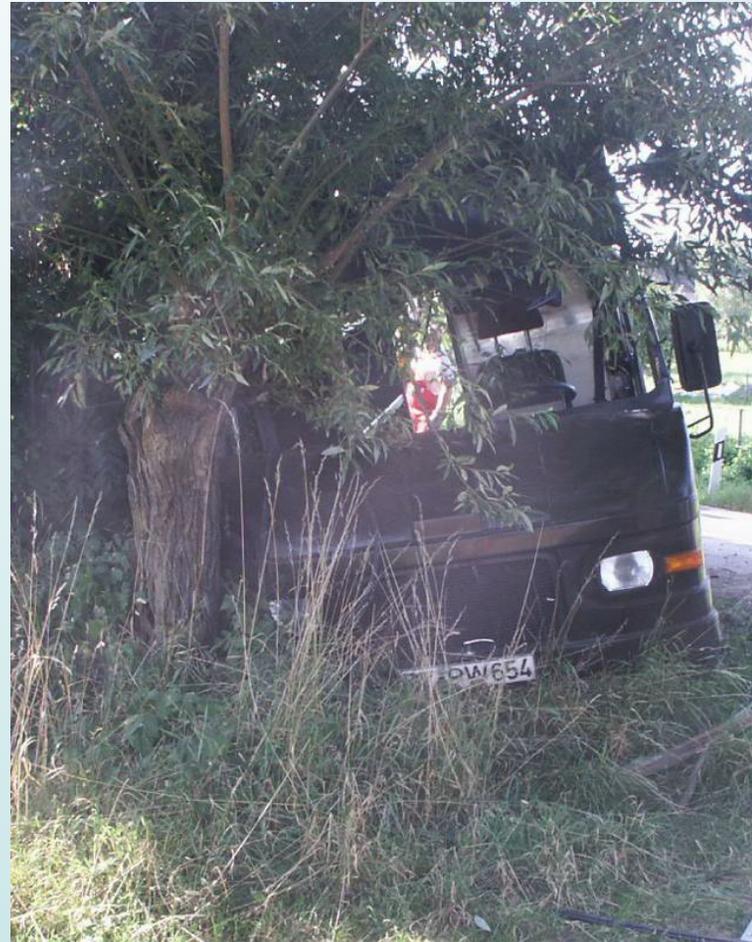
# Example no. 1030485

## Frontal corner struck tree

VDI1=2

EES=15 km/h

Overlap=10%

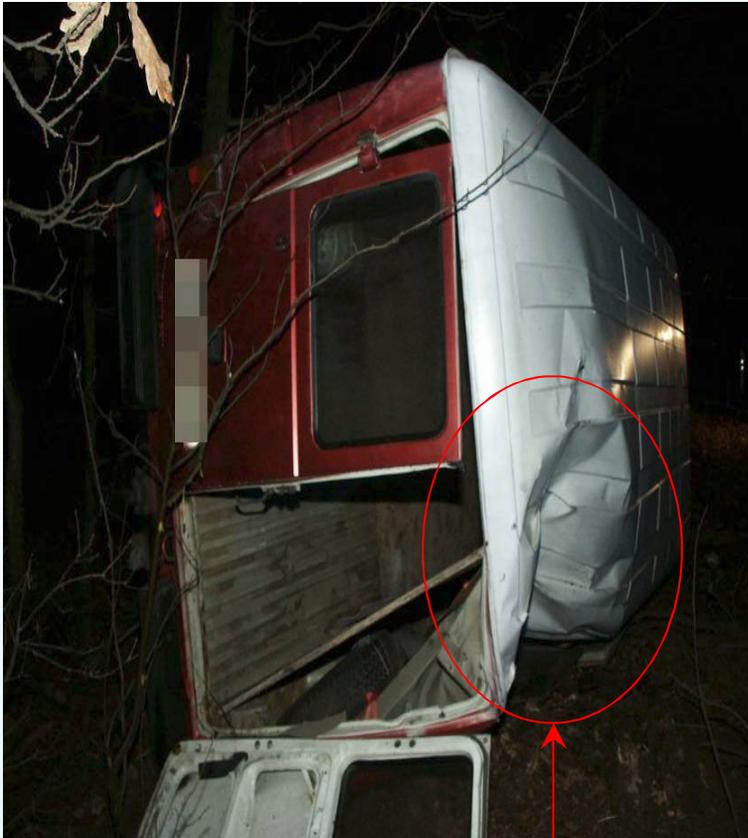
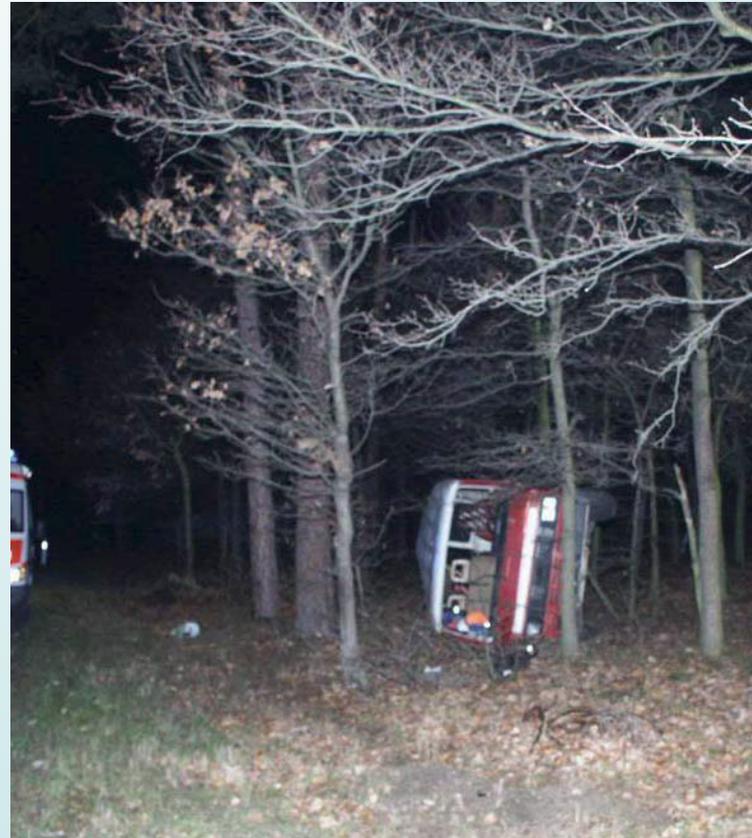
# Example no. 1030762

## Lateral rear against a tree

VDI1=4

EES=20 km/h

Overlap=10%

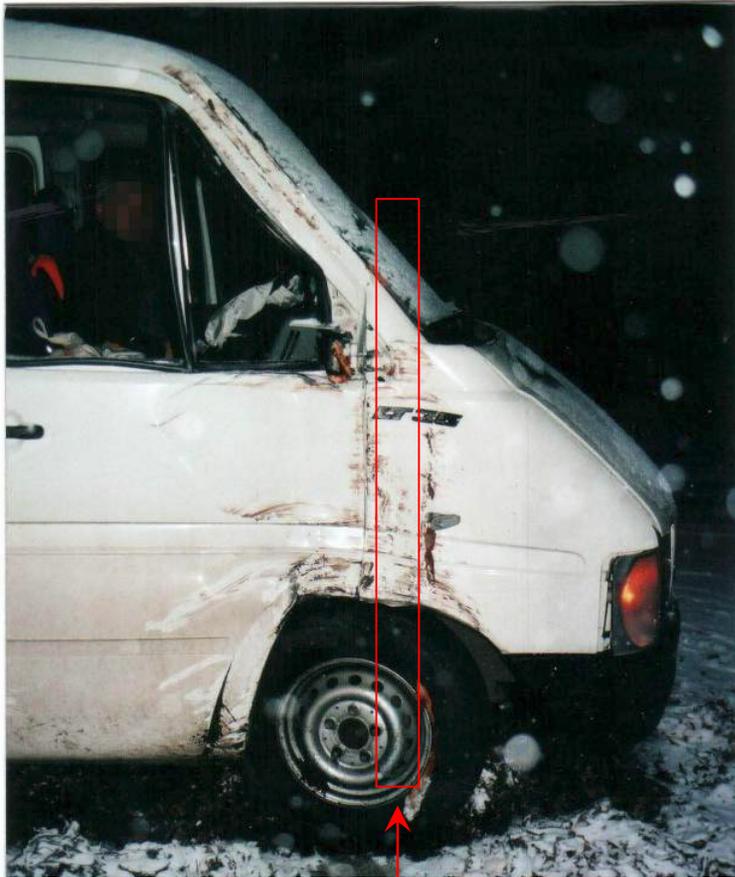
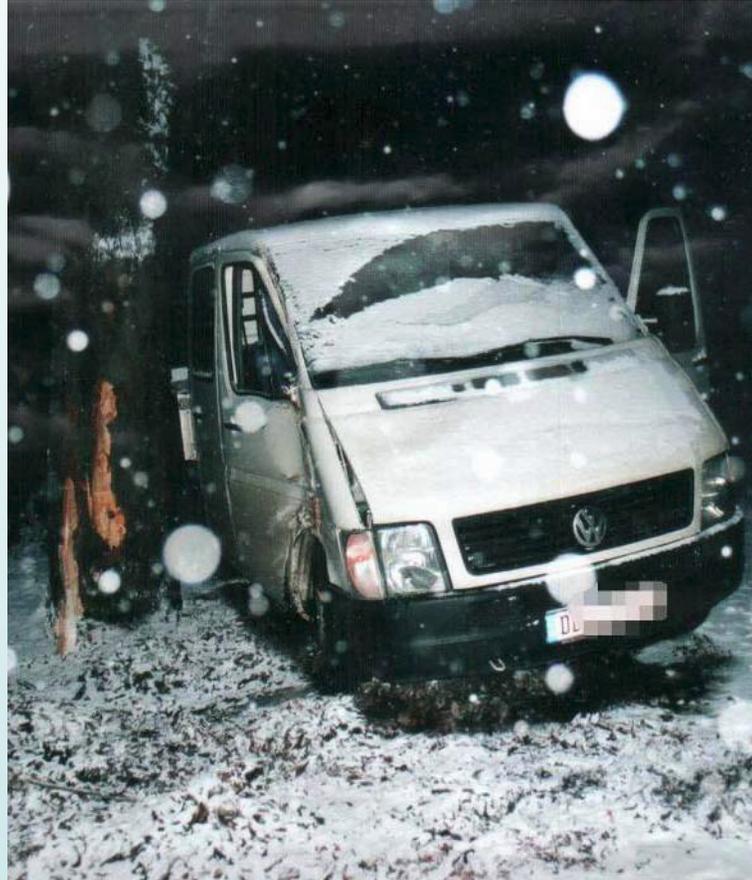
# Example no. 1050964

## Front corner against tree

VDI1=2

EES=18 km/h

Overlap=15%

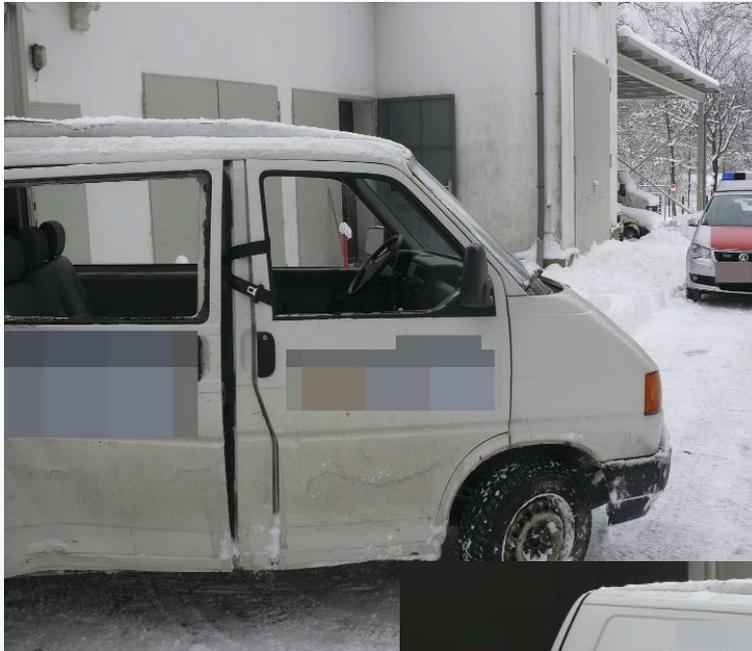
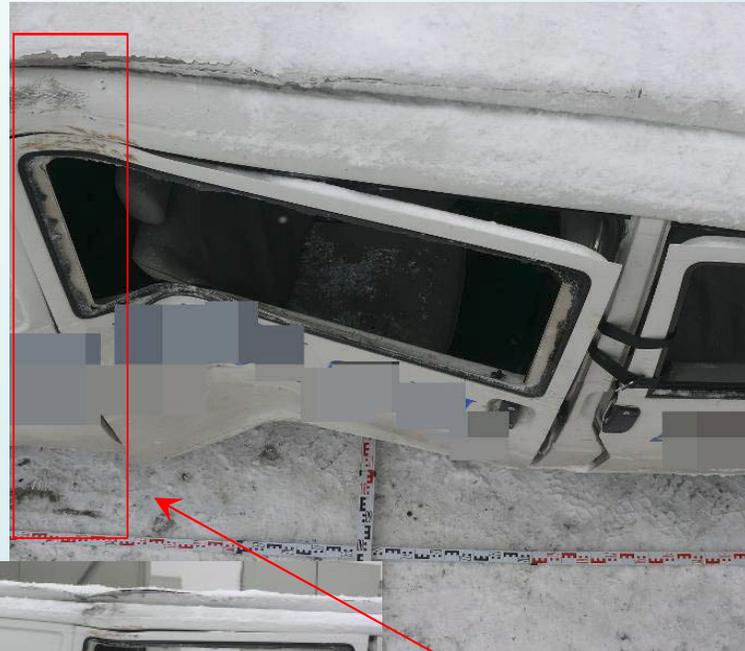
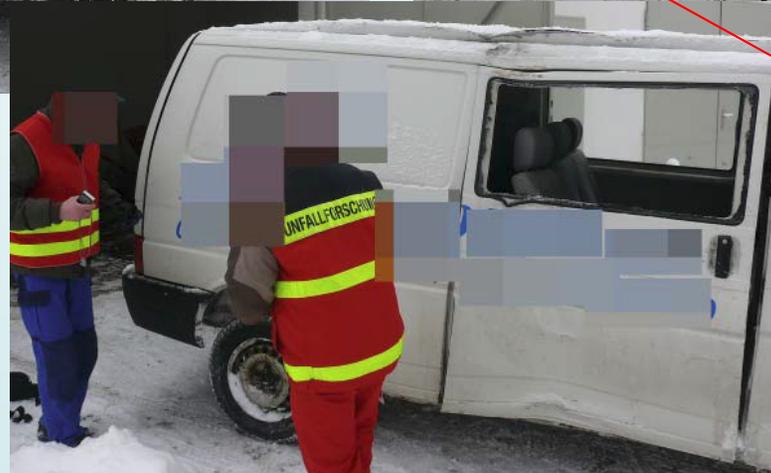
# Example no. 1090087

## Lateral centre/middle against pole

VDI1=3

EES=18 km/h

Overlap=14%

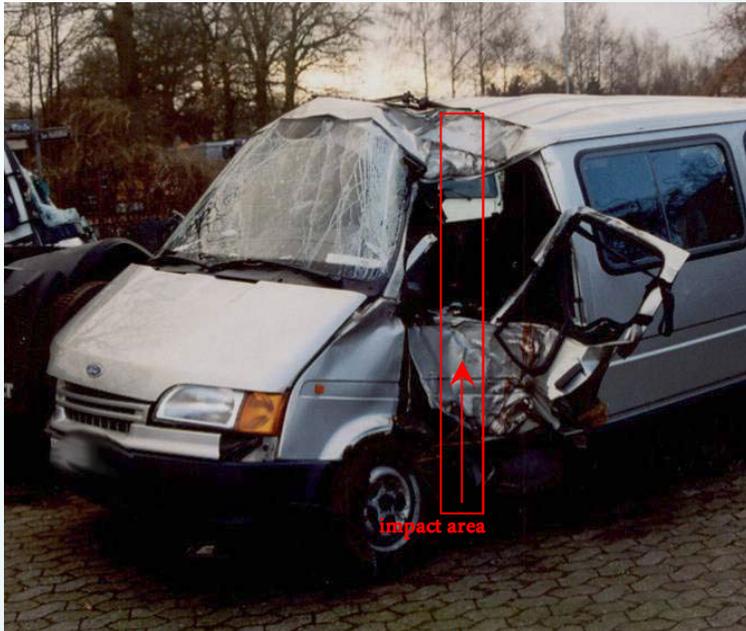
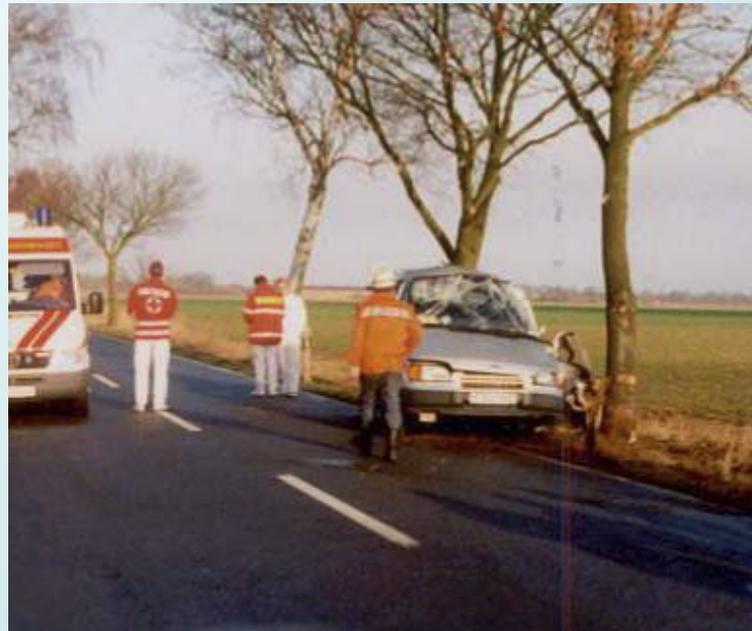
# Example no. 30000111

## Lateral against tree

VDI1=10

EES=34 km/h

Overlap=8%

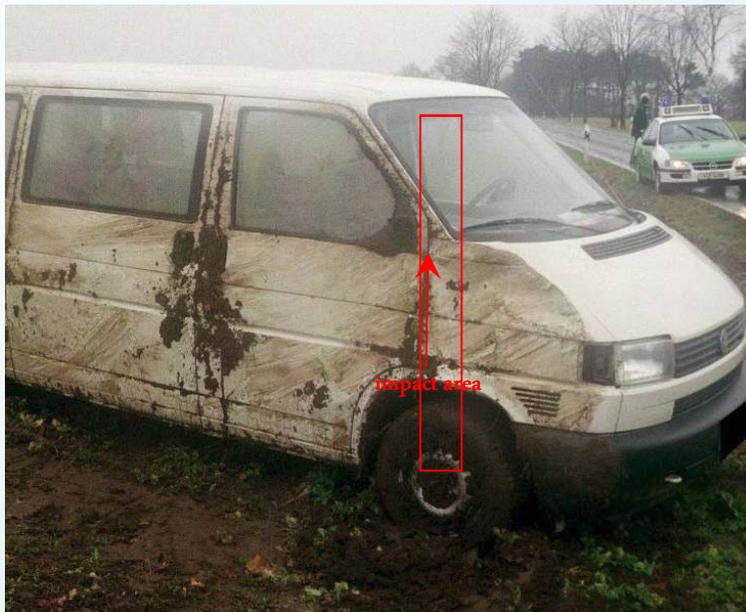
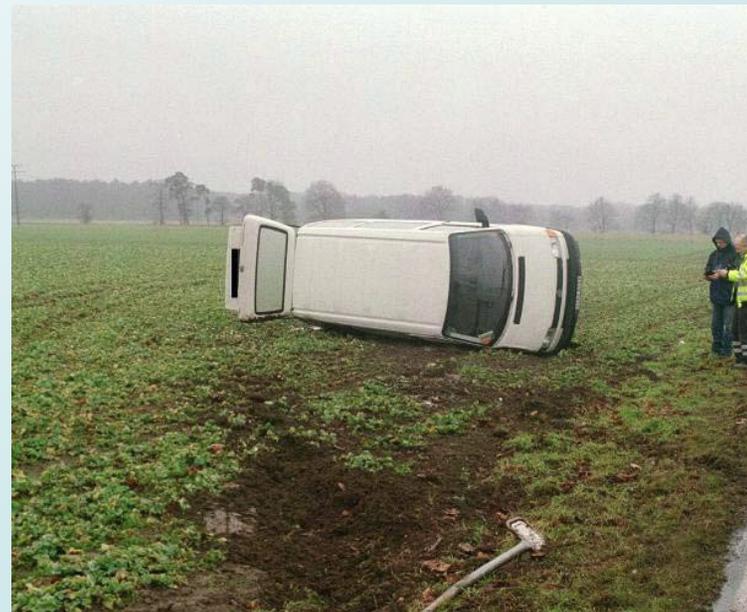
# Example no. 30030039

## Lateral against a pole

VDI1=2

EES=3 km/h

Overlap=1%

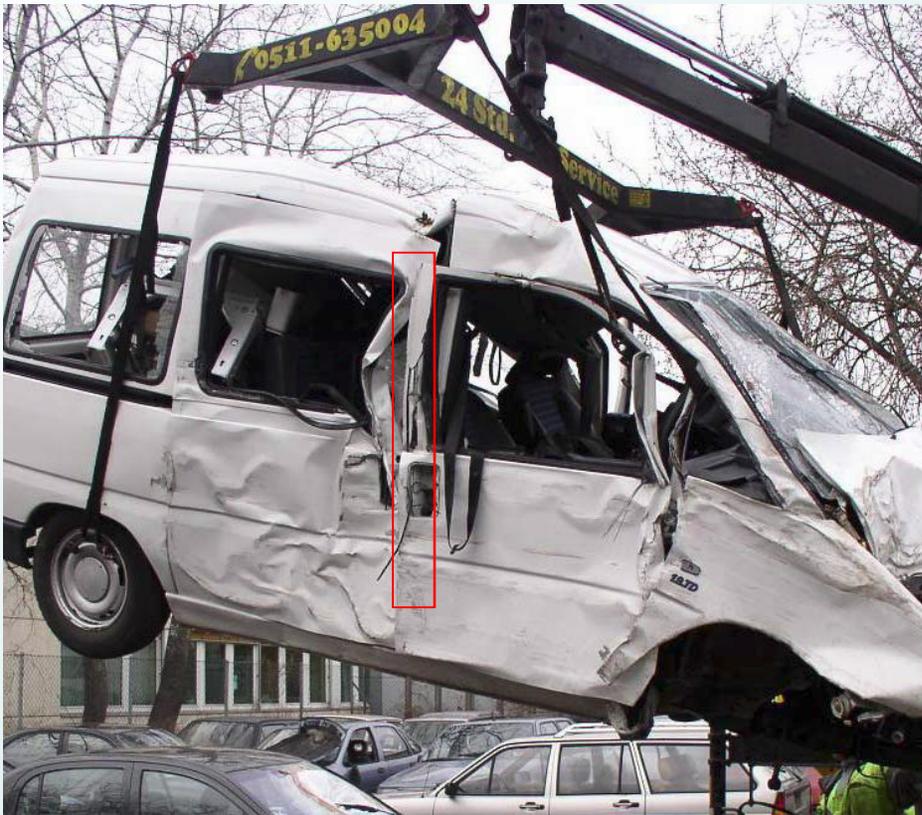
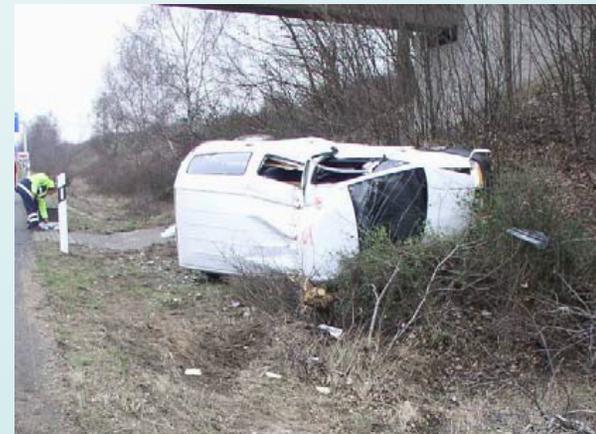
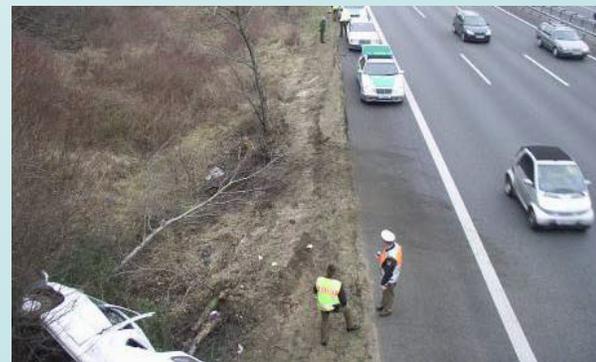
# Example no. 30040047

## Frontal against tree, then lateral against trees

VDI1=1

EES=25 km/h

Overlap=5%

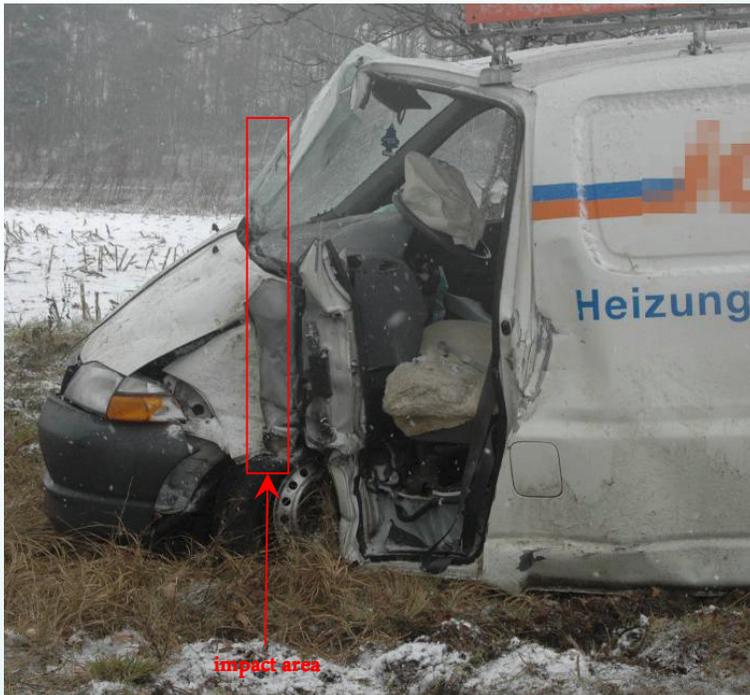
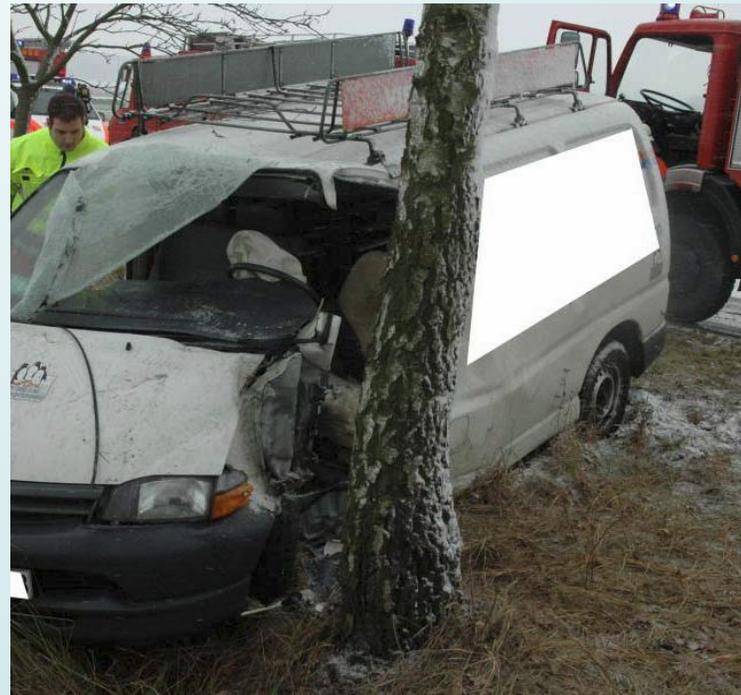
# Example no. 30040957

## Lateral against tree

VDI1=11

EES=32 km/h

Overlap=7%

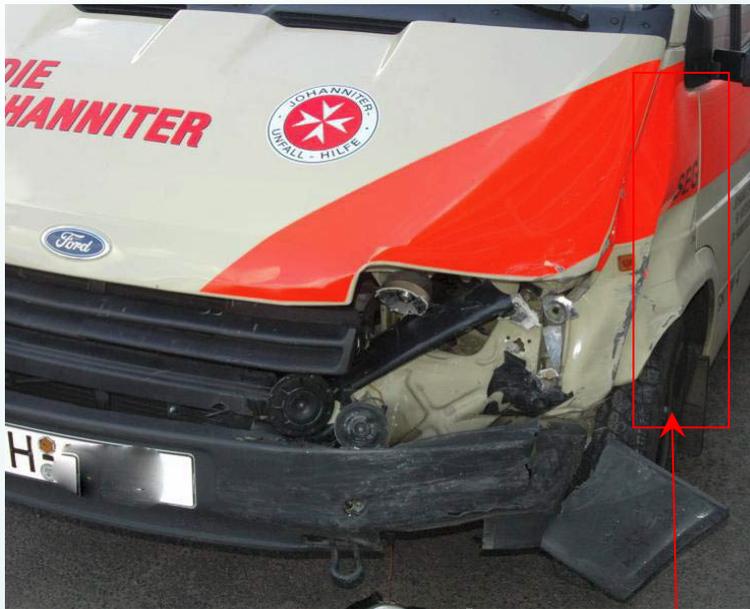
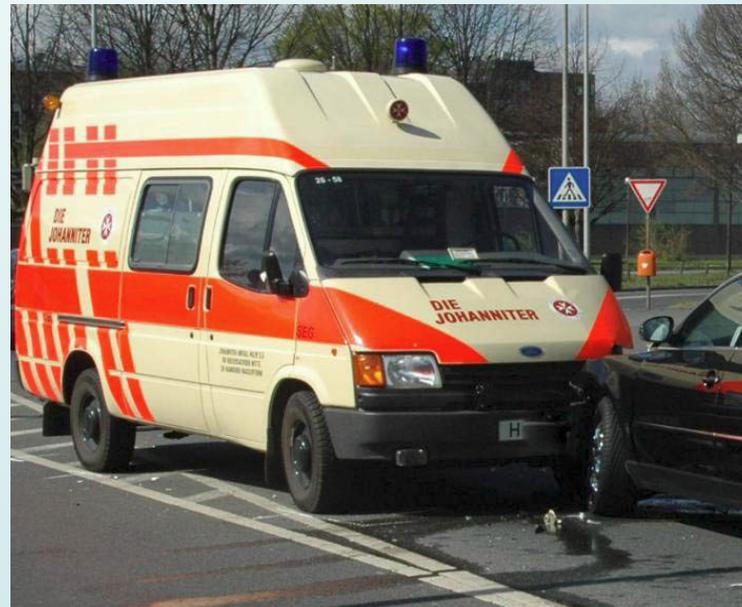
# Example no. 30070272

## Frontal corner against pole

VDI1=1

EES=1 km/h

Overlap=1%
