Asbjørn Hagerupsen
Senior principal engineer
Directorate of Public Roads Norway

GRSF task-force on the behaviour of M2 & M3 general construction in case of Fire Event (BMFE),

Our assessment of suggestions for improvement as shown on page 19 DOK- BMFE-1-05e

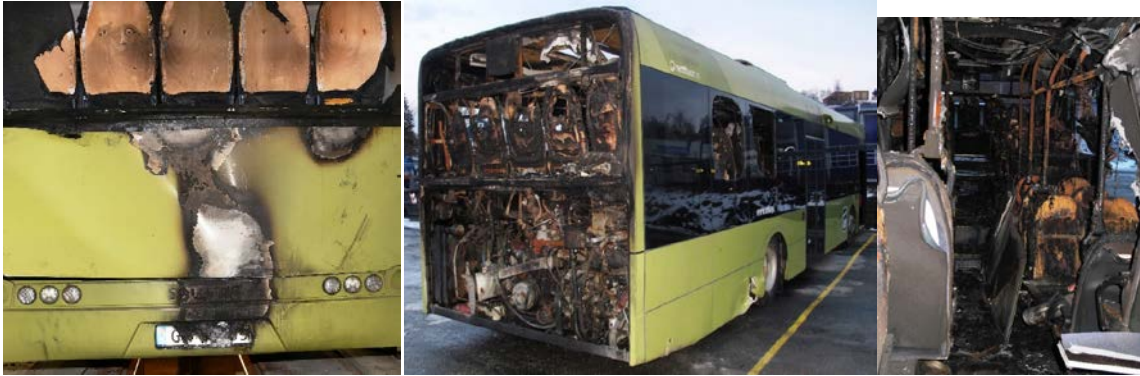
Two very similar fires with gas-powered (CNG) buses occurred in Trondheim (Norway) in November and December 2016.

- Both fires probably started in the LED lights that illuminated the rear licence plate of the buses.
- Investigation of the used LED-lights revealed cracks that were not compatible with normal impact of fastening, or normal use.

- The lights have most likely had cracks that did not prevent moisture intrusion into the lights.
- Moisture with subsequent irradiation in circuit board components in LED light is therefore a probable source of ignition in both fires.

- The investigation also showed that the fuses in the electrical system were too large in relation to the light manufacturer's recommendations for the license plate lights. Thus, the fuses were not an effective barrier to fire in the event of faults in single components.

- Furthermore, the sound reducing material used in the two buses were not compatible with good fire resistance, and it contributed to the fire in both cases. It is likely to assume that both fires would be fully developed fires, without fire rescue from the fire department, even with internal fire extinguishing system triggered and the use of handheld extinguisher.
