***ROAD ACCIDENT OCCURRED ON 02/28/1996.
COACH BURSTS INTO FLAMES IN BAILÉN
(SPAIN) Chapter 08.
COACH EVACUATION DRILLS.***

***INSIA (UNIVERSITY INSTITUTE FOR
AUTOMOBILE RESEARCH)***

December, 1996

COACH EVACUATION DRILLS

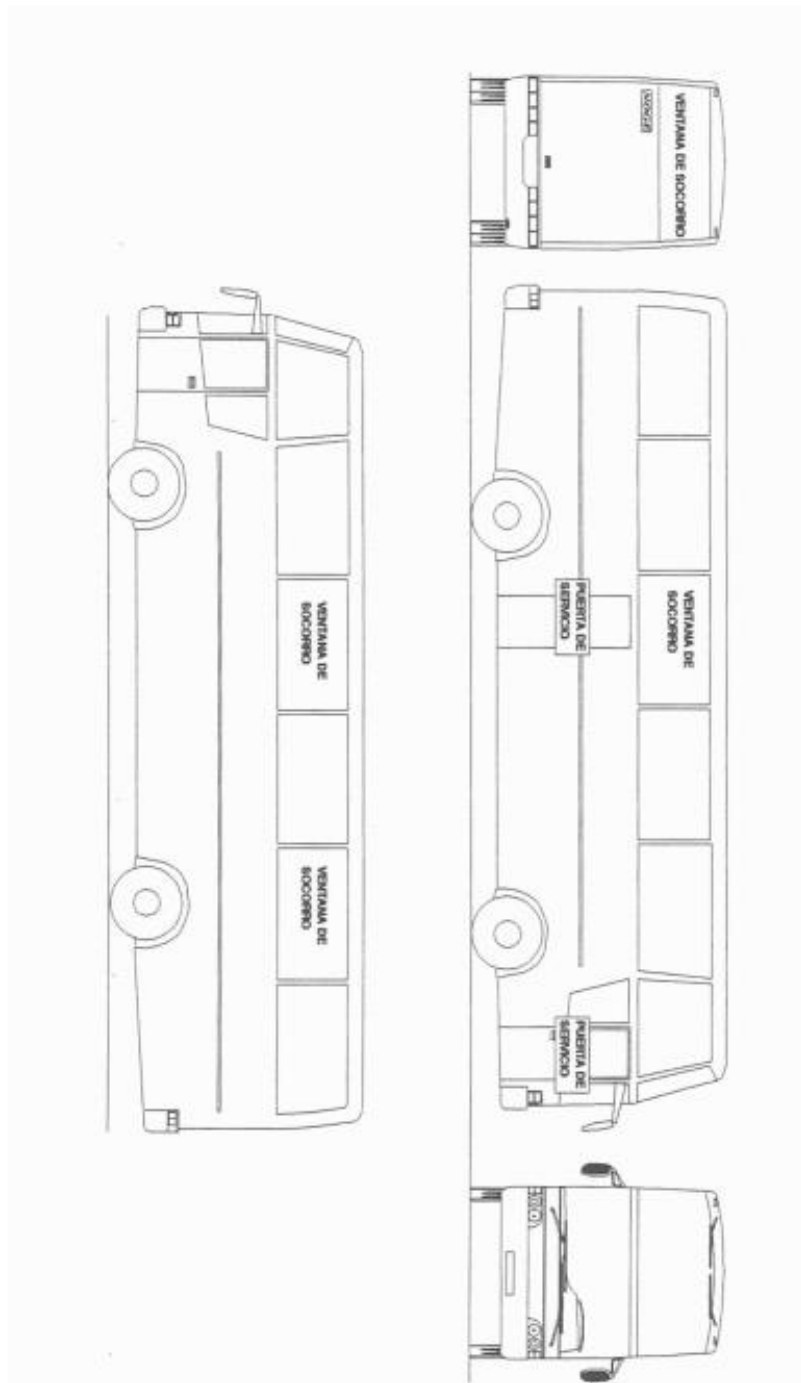
Figure 1: Location of exits on the bus

The coach vehicle has nine exits. Regulation 36.02 prescribes a minimum number of six departures in Class II vehicles with more than 35 seats, so that this vehicle comfortably meets this specification.

The distribution of these exits in the vehicle are shown in Figure 1, these exits presented the characteristics described below.

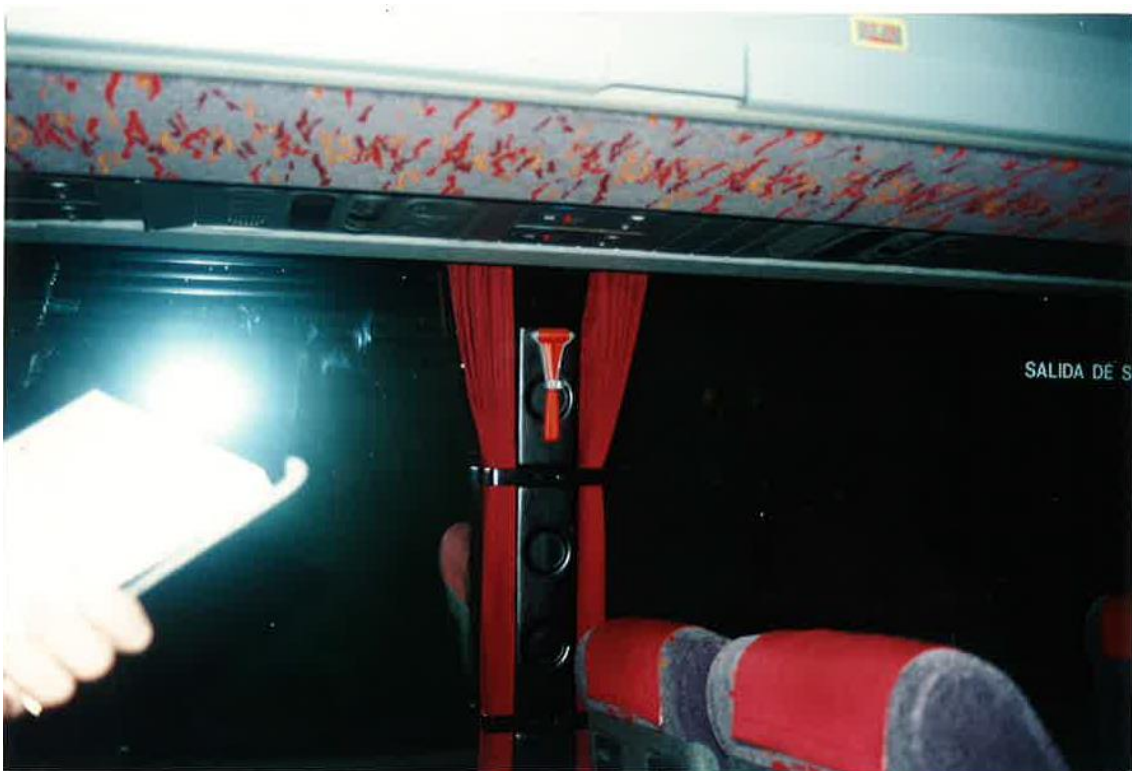
Figure 2: Photograph of hammer in an identical vehicle to the damaged one.

Next to each emergency window, a hammer should be provided to break the glass for easy identification and accessibility, which means a total of four hammers.

The following illustration (Figure 2) shows the location of one of these hammers. This photograph has been taken on a vehicle identical to the damaged vehicle.

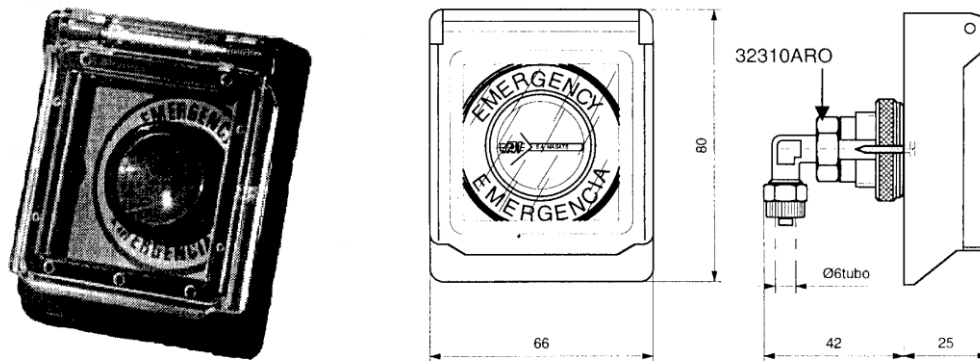
Figure 8: Internal control of emergency opening of service doors.

According to this specification, the damaged internal controls of the vehicle are inadmissible since they are located at a height of less than 1320 mm above the first step.

It is noteworthy that these controls inside the passenger compartment are not equipped with any type of emergency lighting, so their location is very difficult in the case of a failure of the inner illumination.

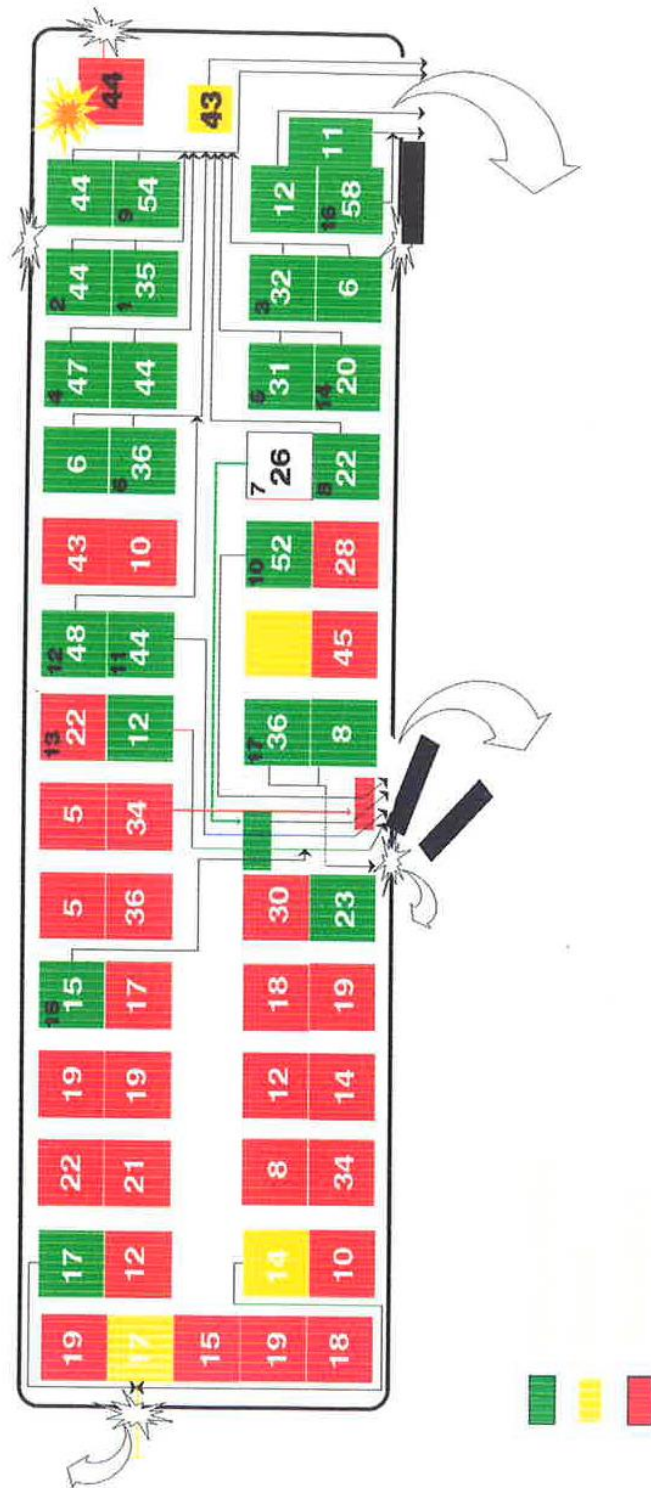
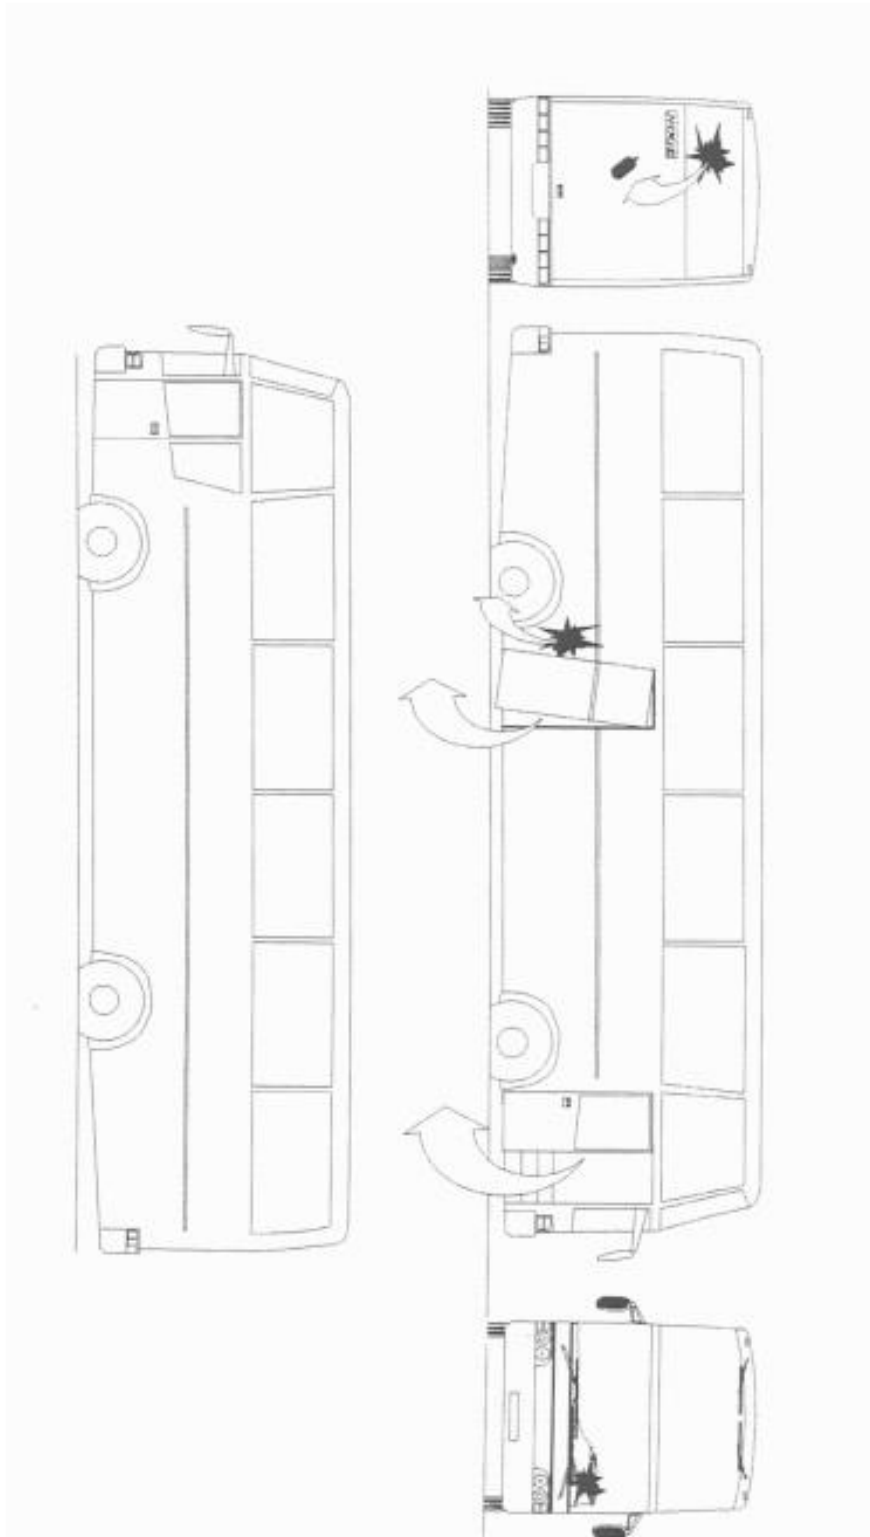
Figure 21: Exits used in the evacuation of the damaged vehicle. Plan view.

Finally, the possible starting point of the fire is indicated, as well as the points of location of destroyed areas to get out of the vehicle (glass, side panels), represented by a star. An exception should be noted in the case of the red star positioned on the front windshield, corresponding to the breakage of this windshield by the driver, which was projected after the collision. The graph on

The possible gap is shown in Figure 21 and Figure 22. However, it seems unlikely the exit of passengers by it. It is possible that, in the low visibility conditions described, this lateral gap was confused with the exit hole left by the rear door.

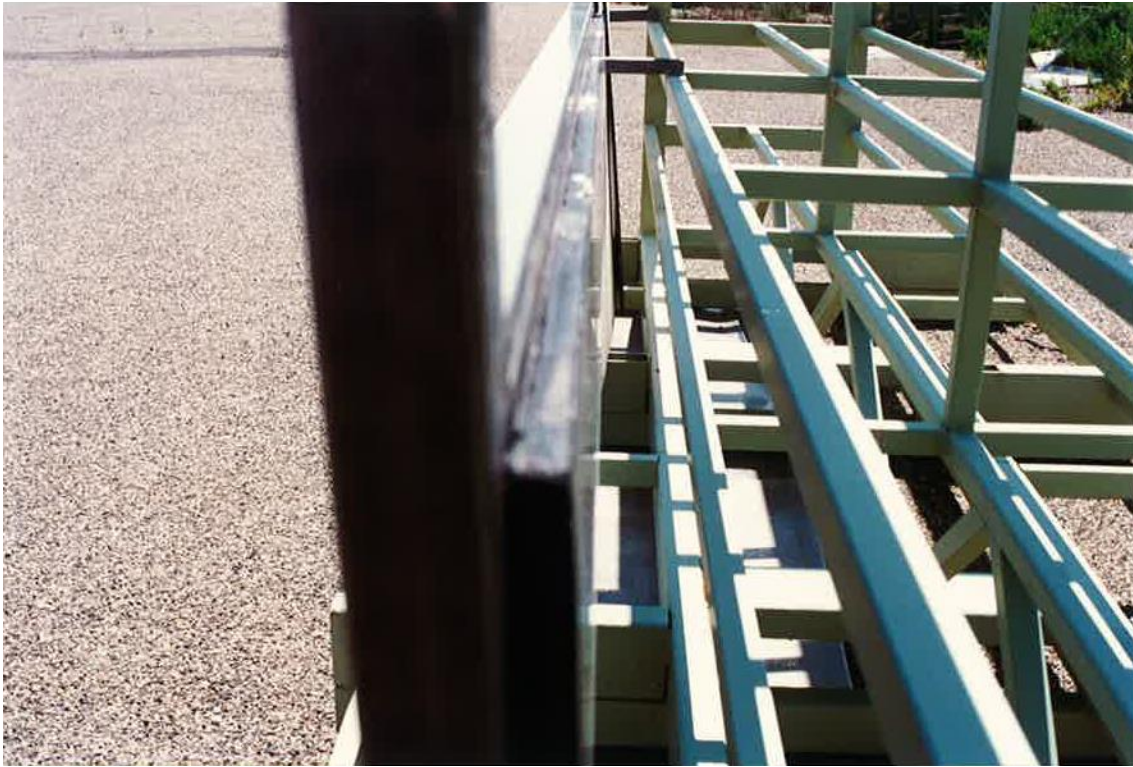
Figure 23: Adhesive fixing glass windows to the frame. Glass breaking tests.

2. The way of placing the glass on the frame must be identical to that used on the injured coach. These glasses are glued to the frame, a remarkable fact given that the fixing material used absorbs part of the impact energy. This fixation is shown in the following photograph (Figure 23).

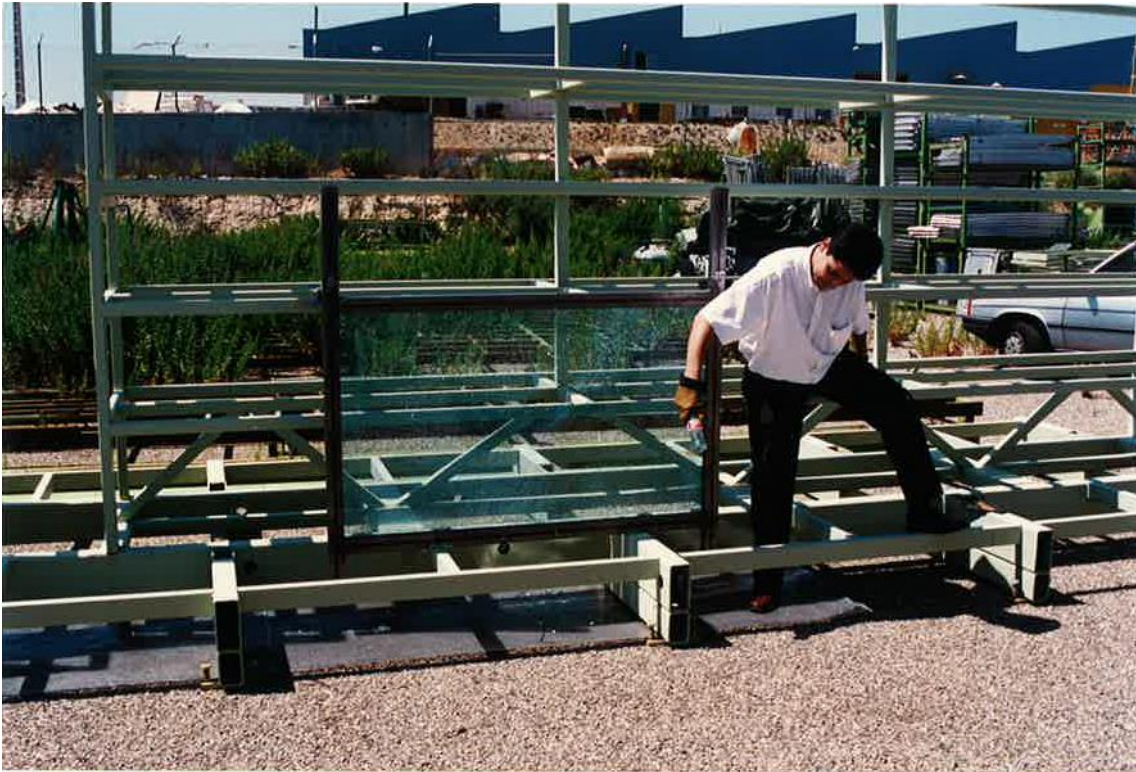
Figure 25: Simple moon break with bottle.

- The glass bottle is supported by the upper neck, using the lower seat of the same as an impact element. This end easily provokes the breaking of the moon, as seen in the photograph shown below (Figure 25).

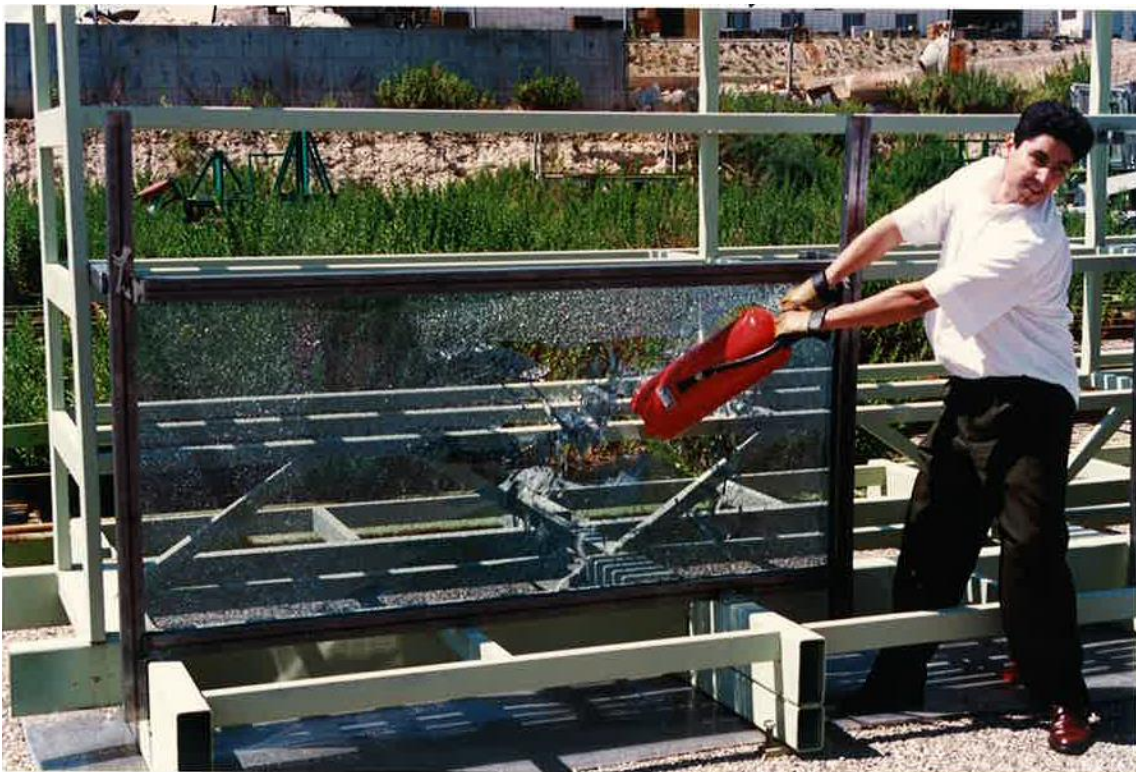
Figure 26: Simple moon break with fire extinguisher.

- Finally, the fire extinguisher, given its high weight, destroys the glass, generating an appreciable gap by penetration. This essay is presented in the following photograph (Figure 26).
