# Panorama Sunroof Glass

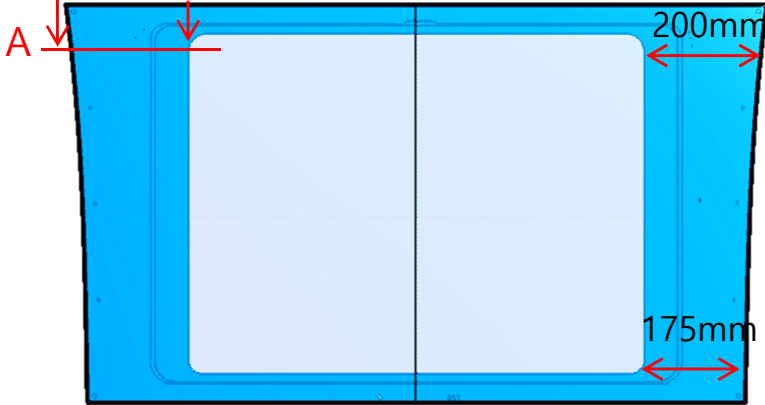
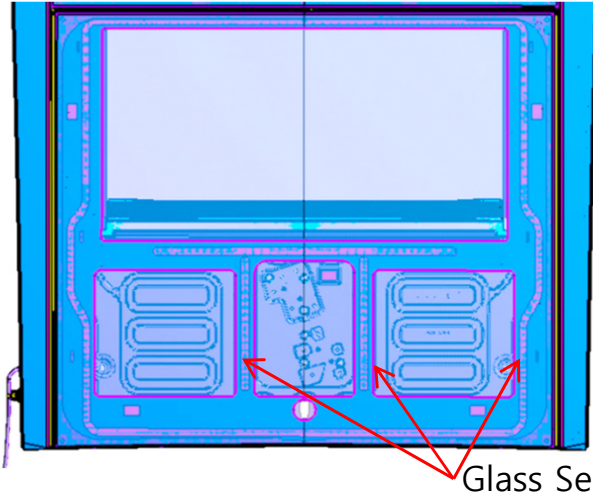
Item	Front Glass	Rear Glass
Geometry

Problem	<p>- For the non side-molding glass, the elimination of ceramic coated area allow the sunlight penetration in PU area, and glass could be broken off.</p>

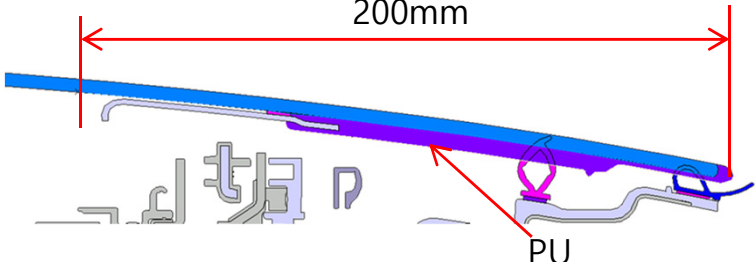
<p>- Glass sealers are applied to prevent the booming and rattle noise near the motor mounting part, the ceramic coated areas are need to protect the sealer from the sunlight.</p>
