Flex PLI: Detailed Review of Drawing Package and Itemized Check against Master Leg Impactor SN03

**7th Meeting of Informal Group GTR9 Phase 2
July 3rd, 2013**

Dirk-Uwe Gehring
BGS Böhme & Gehring GmbH

Oliver Zander
Bundesanstalt für Straßenwesen

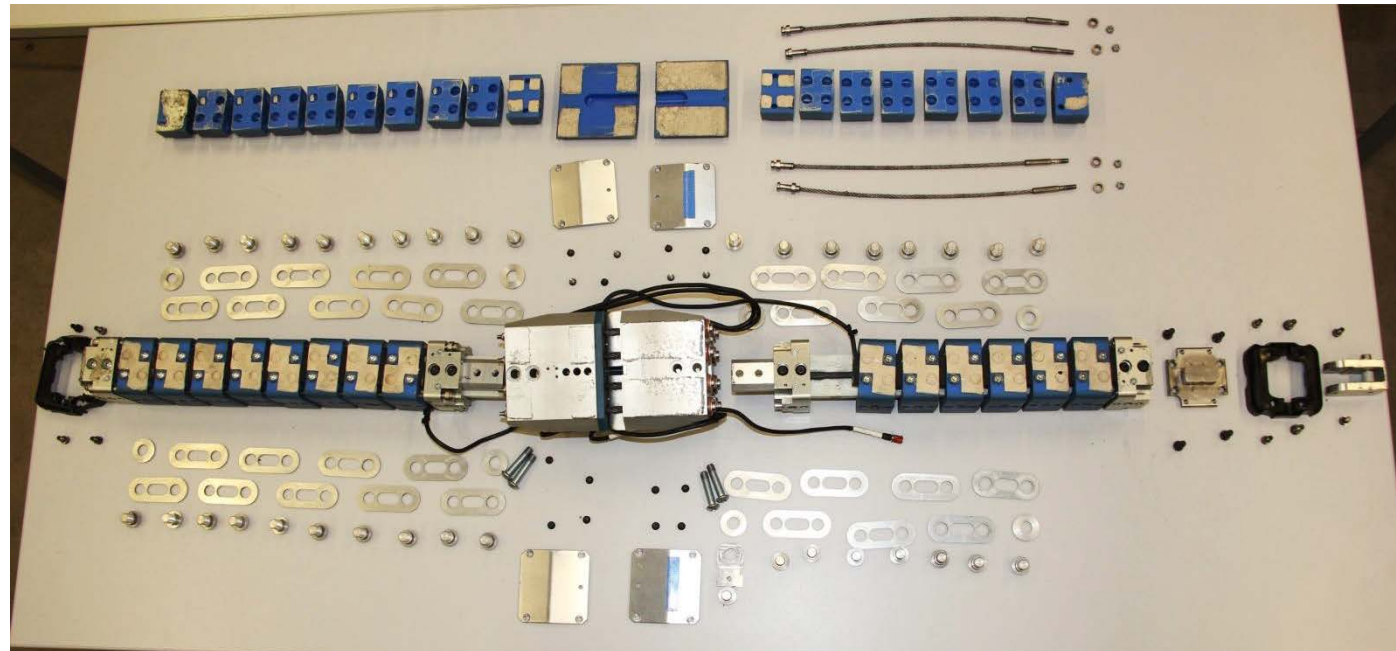
Partly
disassembled
impactor:

- Impactor preparation (SN03):
 - Inverse certification test
 - Pendulum certification test
 - Complete impactor disassembly

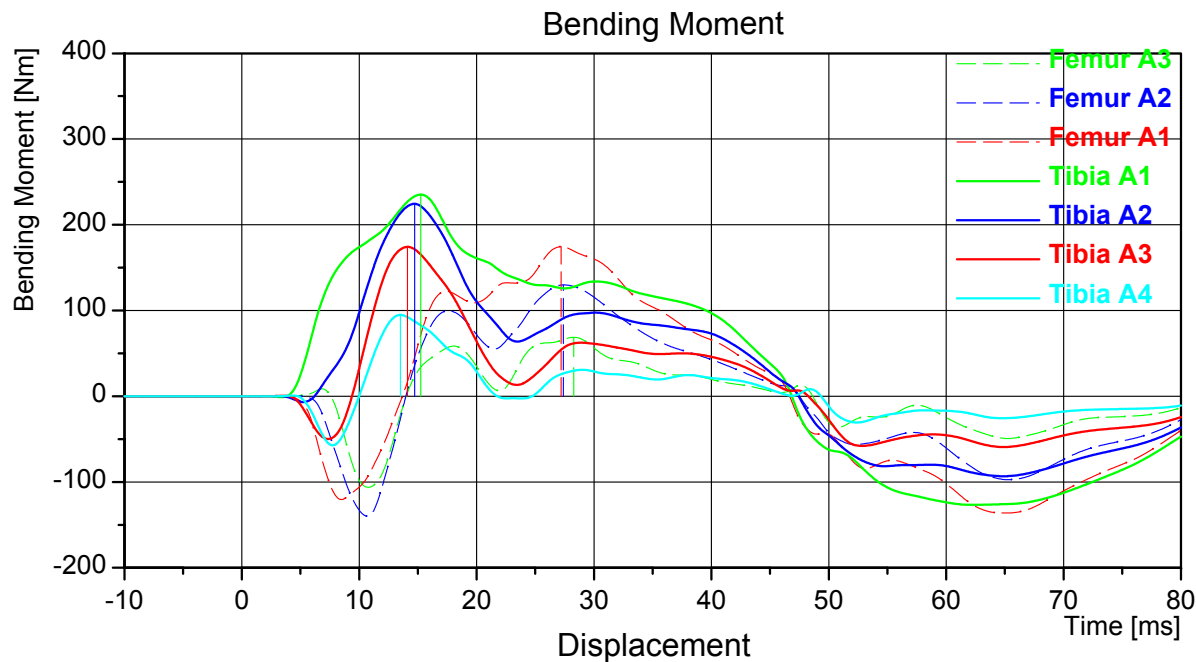
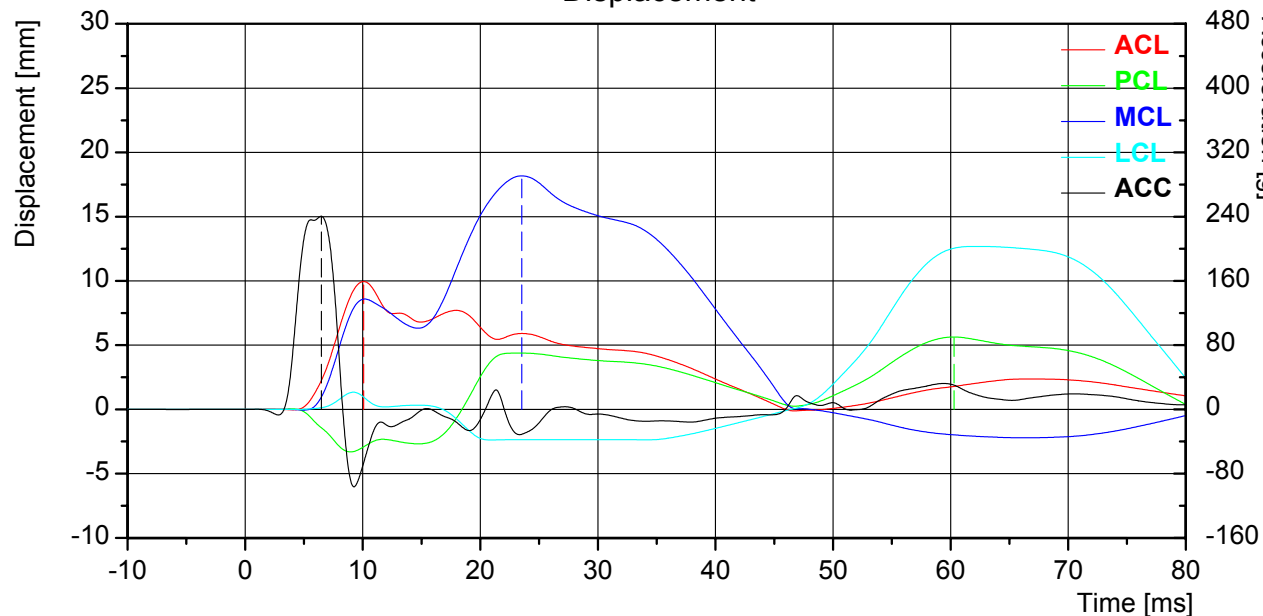
SN03 : Calib-SN03-1212-I

Impactor : SN03
Test No. : Calib-SN03-1212-I
Date : 07.12.2012
Customer :

Stabilised temperature : 20.3 °C

Impact Velocity : 11.06 m/s

Component	Maximum Bending Moment [Nm]	Time [ms]
CFC 180		
Femur A3	68.8 Nm	28.3 ms
Femur A2	129.9 Nm	27.4 ms
Femur A1	174.5 Nm	27.2 ms
Tibia A1	235.2 Nm	15.2 ms
Tibia A2	224.4 Nm	14.7 ms
Tibia A3	174.3 Nm	14.1 ms
Tibia A4	94.9 Nm	13.5 ms

Component	Maximum Displacement [mm]	Time [ms]
CFC 180		
ACL	10.0 mm	10.1 ms
PCL	4.4 mm	23.3 ms
MCL	18.2 mm	23.5 ms
LCL	13.8 mm	353.2 ms

Component	Maximum Acceleration [g]	Time [ms]
CFC 180		
ACC	240.4 g	6.5 ms

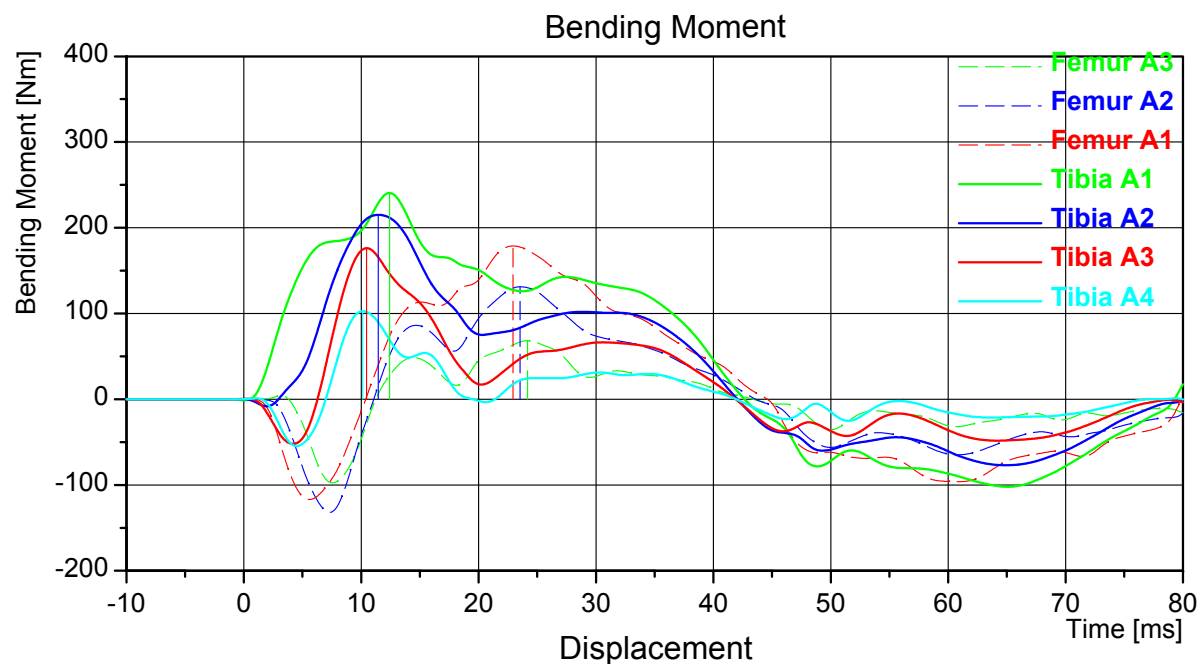
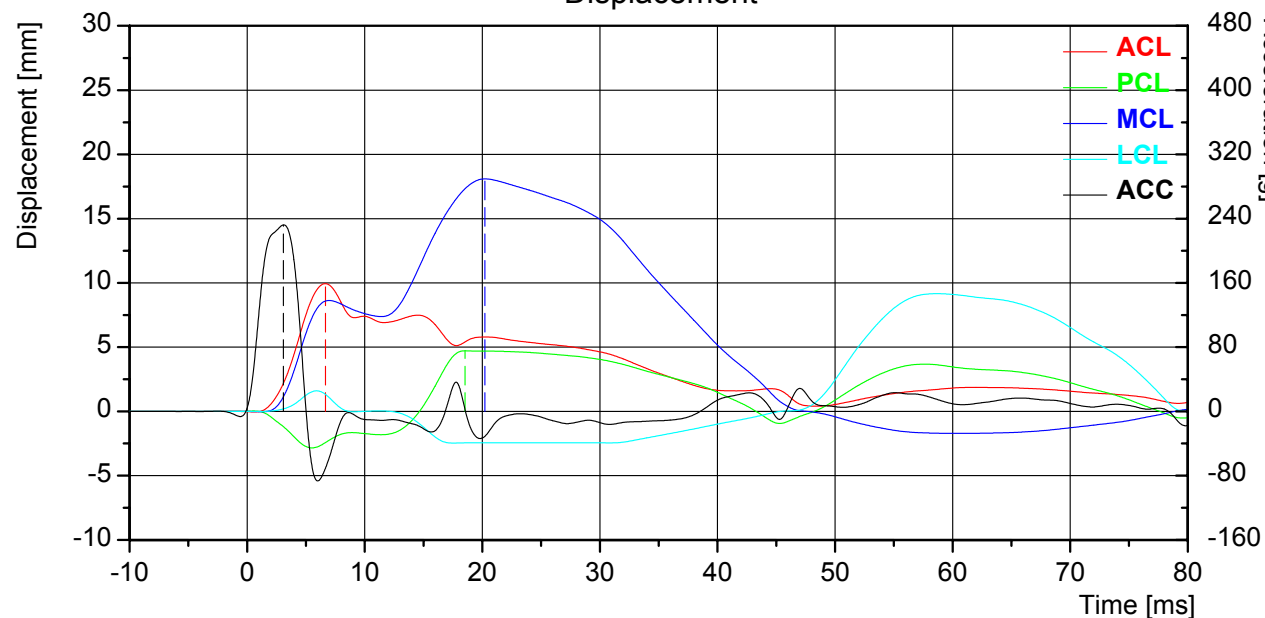
Flex GTR SN03 : Calib-SN03-0713-I

Impactor : Flex GTR SN03
Test No. : Calib-SN03-0713-I
Date : 01.07.2013
Customer : BAST

Stabilised temperature : 21.5 °C

Impact Velocity : 10.95 m/s

Component	Maximum Bending Moment [Nm]	Time [ms]
CFC 180		
Femur A3	68.3 Nm	24.2 ms
Femur A2	131.2 Nm	23.5 ms
Femur A1	178.8 Nm	22.9 ms
Tibia A1	240.6 Nm	12.4 ms
Tibia A2	215.1 Nm	11.5 ms
Tibia A3	176.2 Nm	10.5 ms
Tibia A4	102.6 Nm	10.1 ms

Component	Maximum Displacement [mm]	Time [ms]
CFC 180		
ACL	9.9 mm	6.7 ms
PCL	4.7 mm	18.5 ms
MCL	18.1 mm	20.2 ms
LCL	9.1 mm	58.3 ms

Component	Maximum Acceleration [g]	Time [ms]
CFC 180		
ACC	232.3 g	3.1 ms

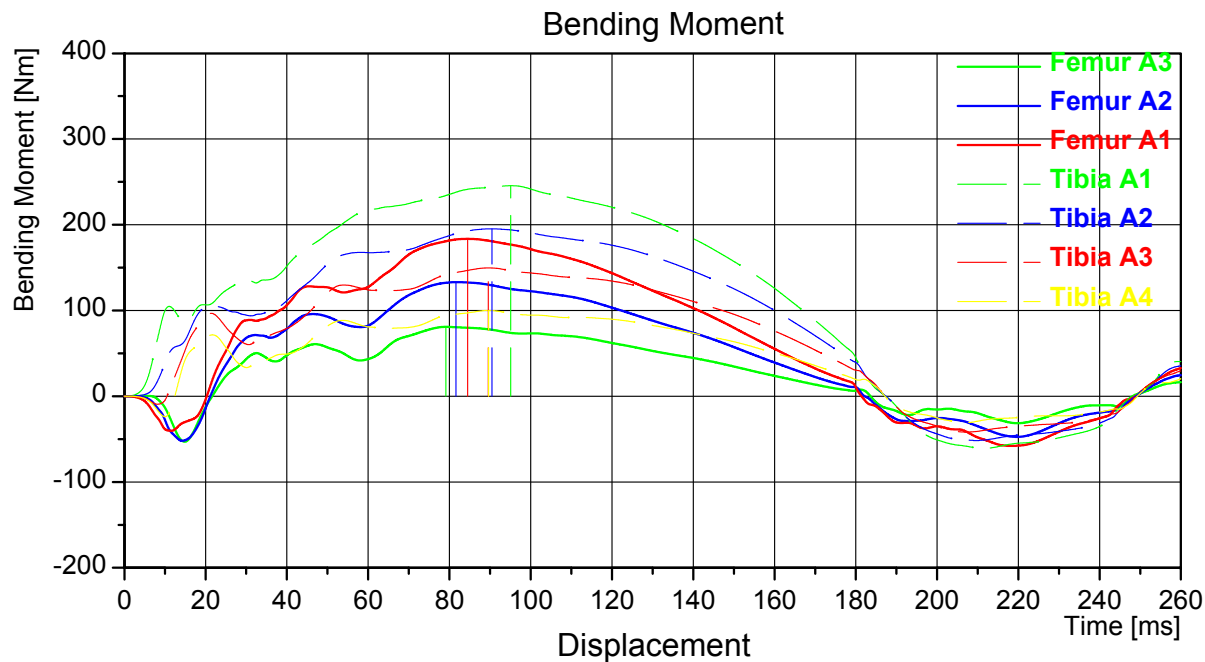
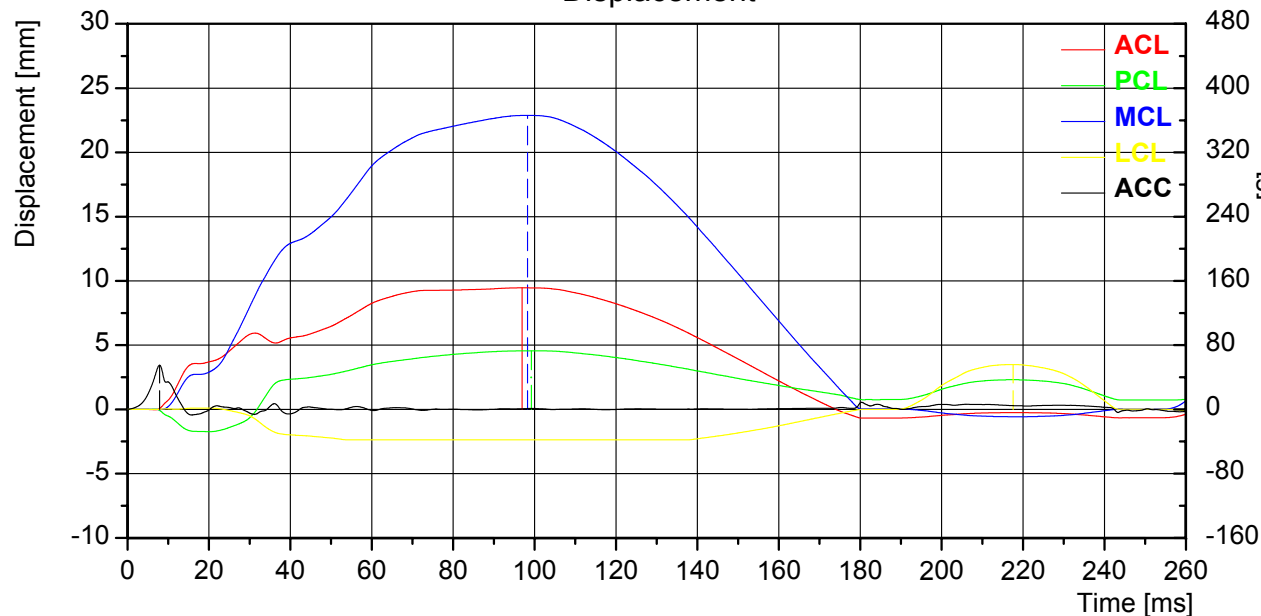
SN03 : Calib-SN03-1212-P

Impactor : SN03
Test No. : Calib-SN03-1212-P
Date : 07.12.2012
Customer :

Stabilised temperature : 20.1 °C

Component	Maximum Bending Moment [Nm]	Time [ms]
CFC 180		
Femur A3	81.0 Nm	79.1 ms
Femur A2	133.1 Nm	81.6 ms
Femur A1	183.6 Nm	84.5 ms
Tibia A1	245.6 Nm	95.1 ms
Tibia A2	195.2 Nm	90.4 ms
Tibia A3	149.8 Nm	89.6 ms
Tibia A4	100.1 Nm	89.6 ms

Component	Maximum Displacement [mm]	Time [ms]
CFC 180		
ACL	9.5 mm	97.0 ms
PCL	4.6 mm	99.2 ms
MCL	22.9 mm	98.3 ms
LCL	3.5 mm	217.6 ms

Component	Maximum Acceleration [g]	Time [ms]
CFC 180		
ACC	55.1 g	7.9 ms

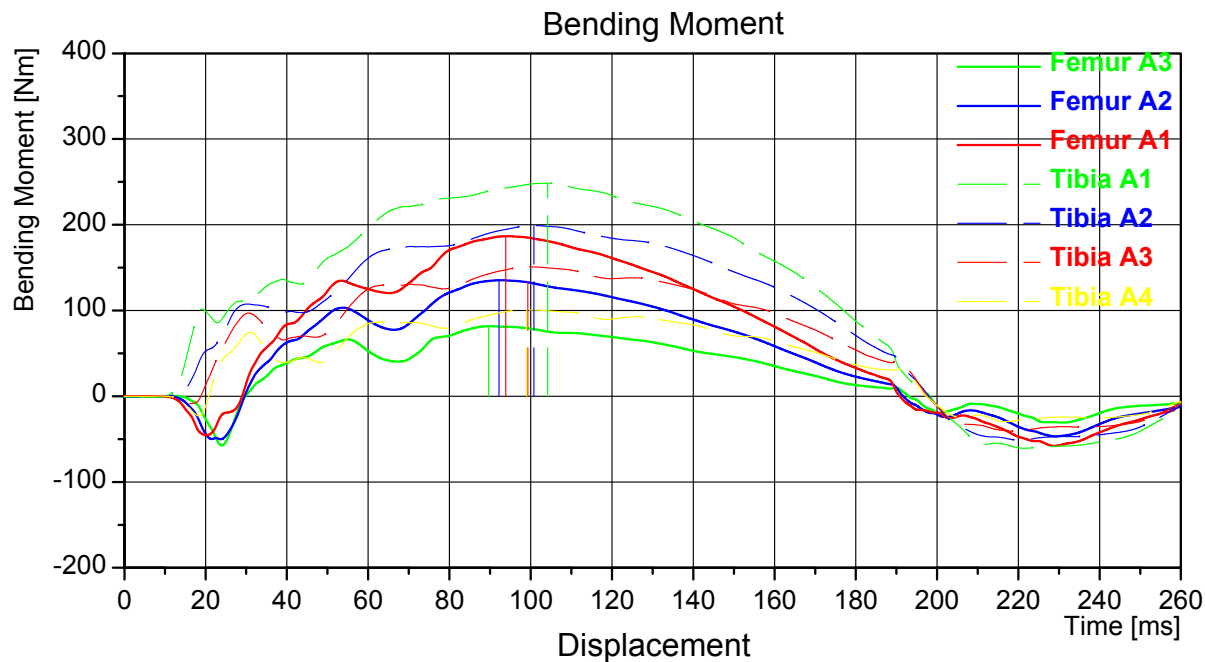
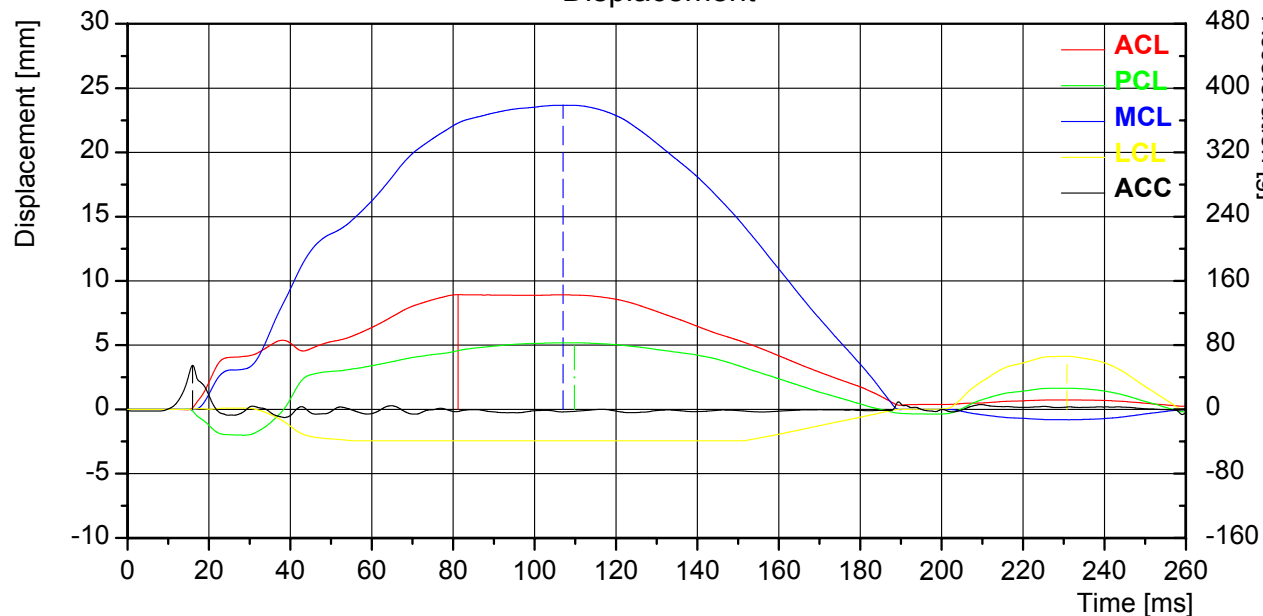
Flex GTR SN03 : Calib-SN03-0713-P

Impactor : Flex GTR SN03
Test No. : Calib-SN03-0713-P
Date : 01.07.2013
Customer : BAST

Stabilised temperature : 21.4 °C

Component	Maximum Bending Moment [Nm]	Time [ms]
CFC 180		
Femur A3	81.7 Nm	89.6 ms
Femur A2	135.2 Nm	92.2 ms
Femur A1	186.6 Nm	93.8 ms
Tibia A1	248.6 Nm	104.2 ms
Tibia A2	199.0 Nm	100.8 ms
Tibia A3	151.0 Nm	99.3 ms
Tibia A4	100.8 Nm	99.0 ms

Component	Maximum Displacement [mm]	Time [ms]
CFC 180		
ACL	8.9 mm	81.2 ms
PCL	5.2 mm	109.8 ms
MCL	23.7 mm	107.0 ms
LCL	4.1 mm	230.8 ms

Component	Maximum Acceleration [g]	Time [ms]
CFC 180		
ACC	54.9 g	16.0 ms
