# Evaluation of GTR No. 20 Test Procedures

Submission to IWG for GTR 20

April 2021 –IWG #21

MGA Research Corporation

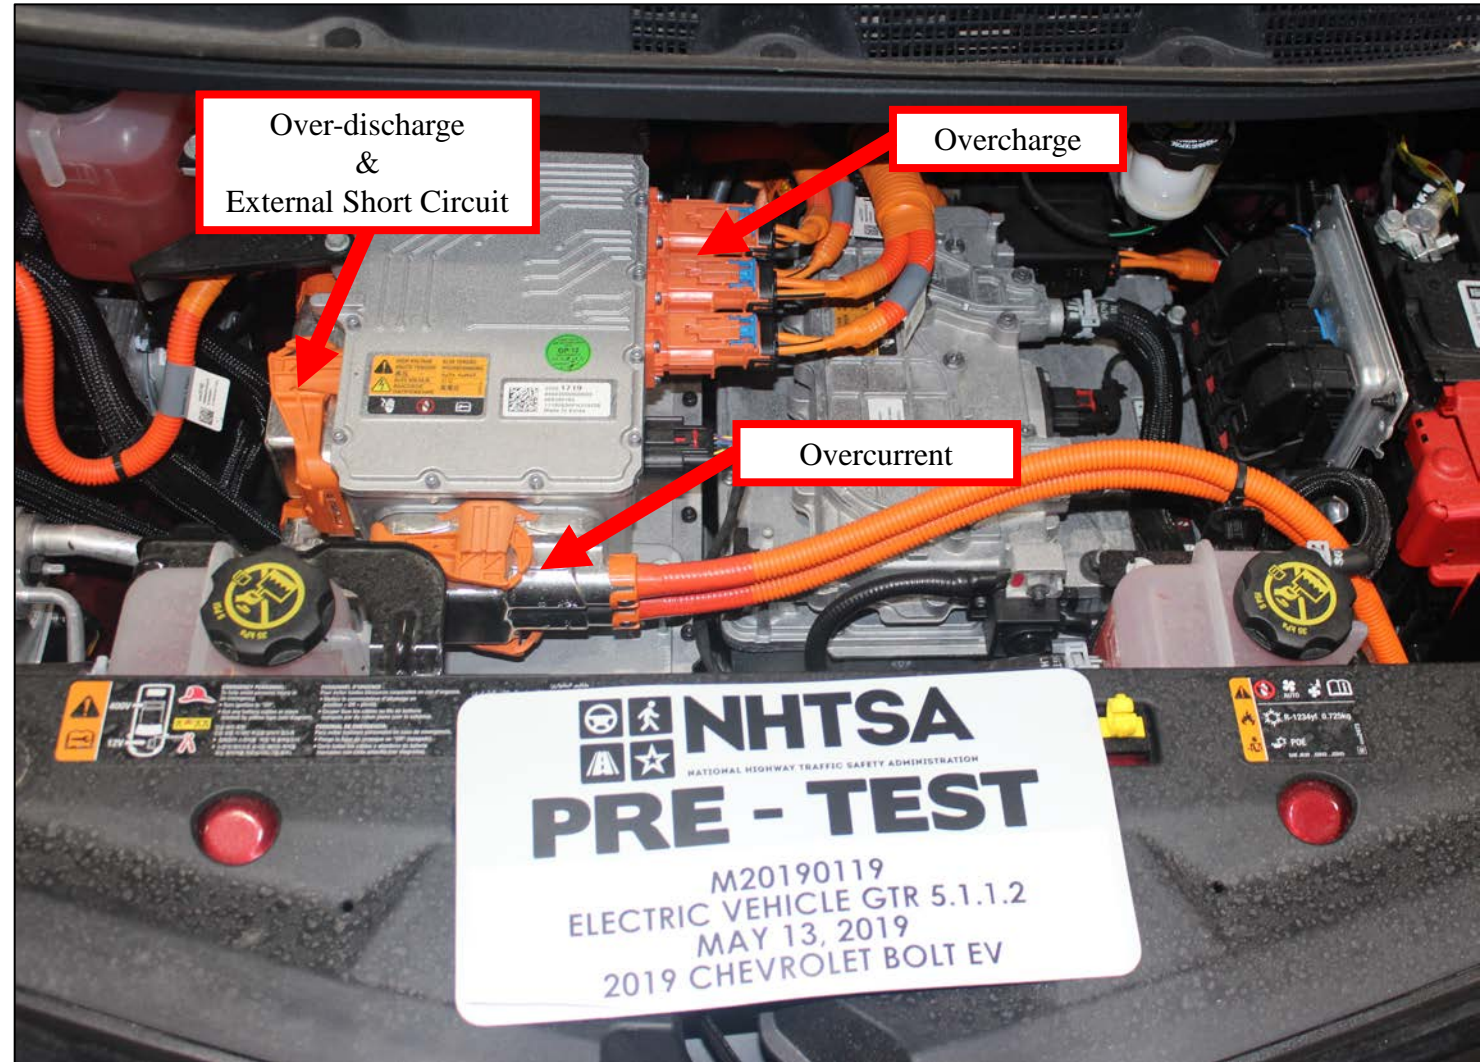
# Chevrolet Bolt Breakout Harness

- General Motors provided harnesses and instructions for installing at each location.
  - Qty 2 breakout harness
  - Qty 3 connection locations
- Isolation measurements conducted with a separate harness.

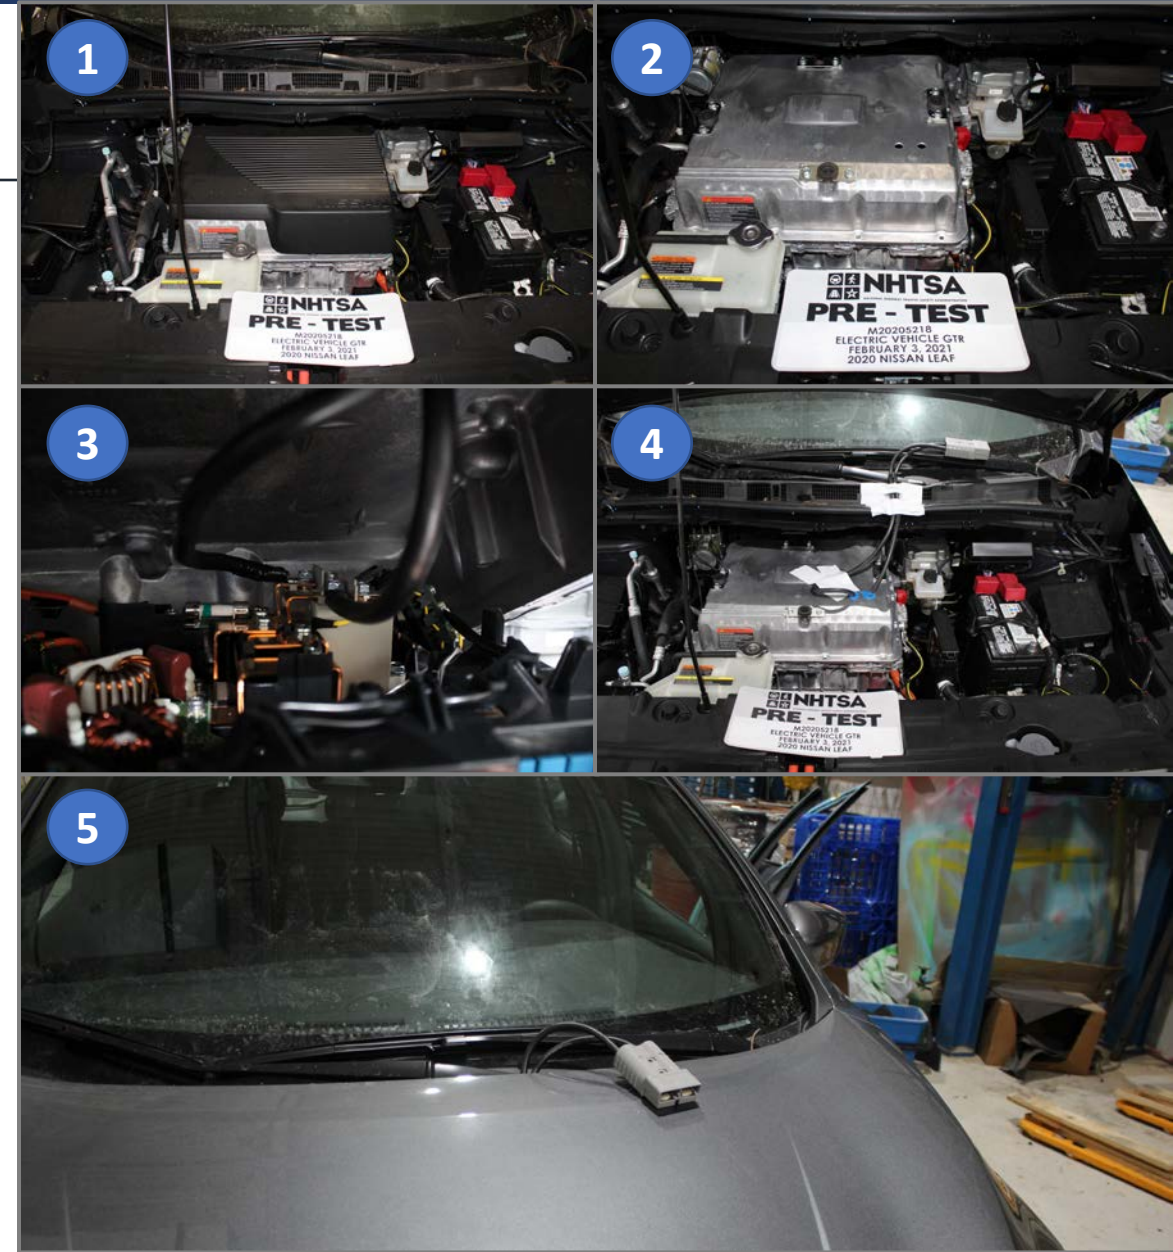
# Nissan Leaf Breakout Harness

- Nissan breakout harness connected to high voltage bus in PDM
  - Single harness and connection location used for all testing.
- Isolation measurements conducted with a separate harness.

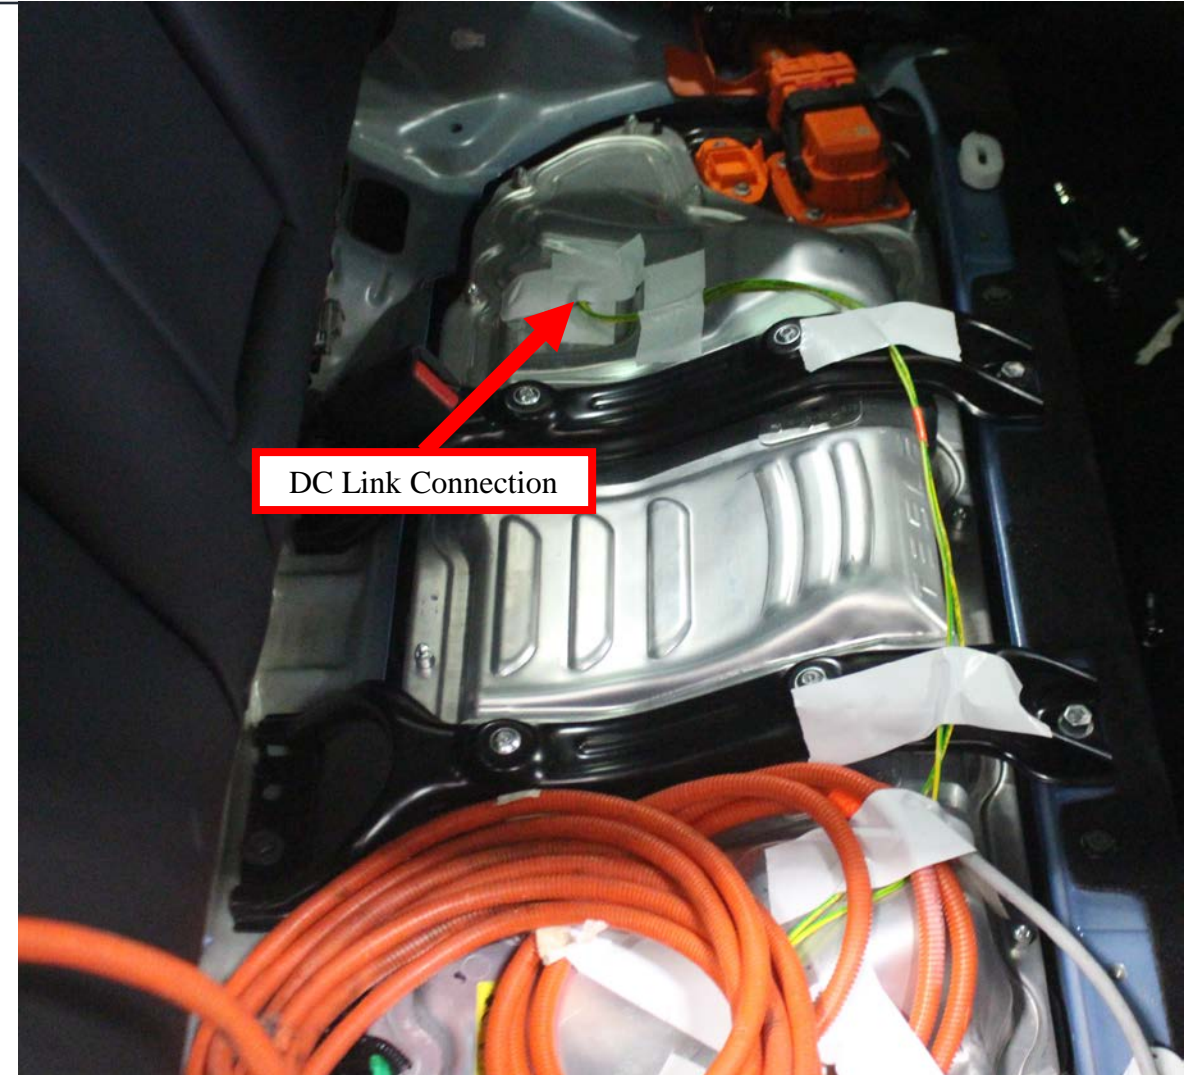
# Tesla Model 3 Breakout Harness

- Tesla breakout harness connected to DC Link Connection following instructions provided.
  - Single connection location used for all testing.
  - Harness wire gauge increased for external short circuit test.
- GTR harness connection same as isolation measurement connection

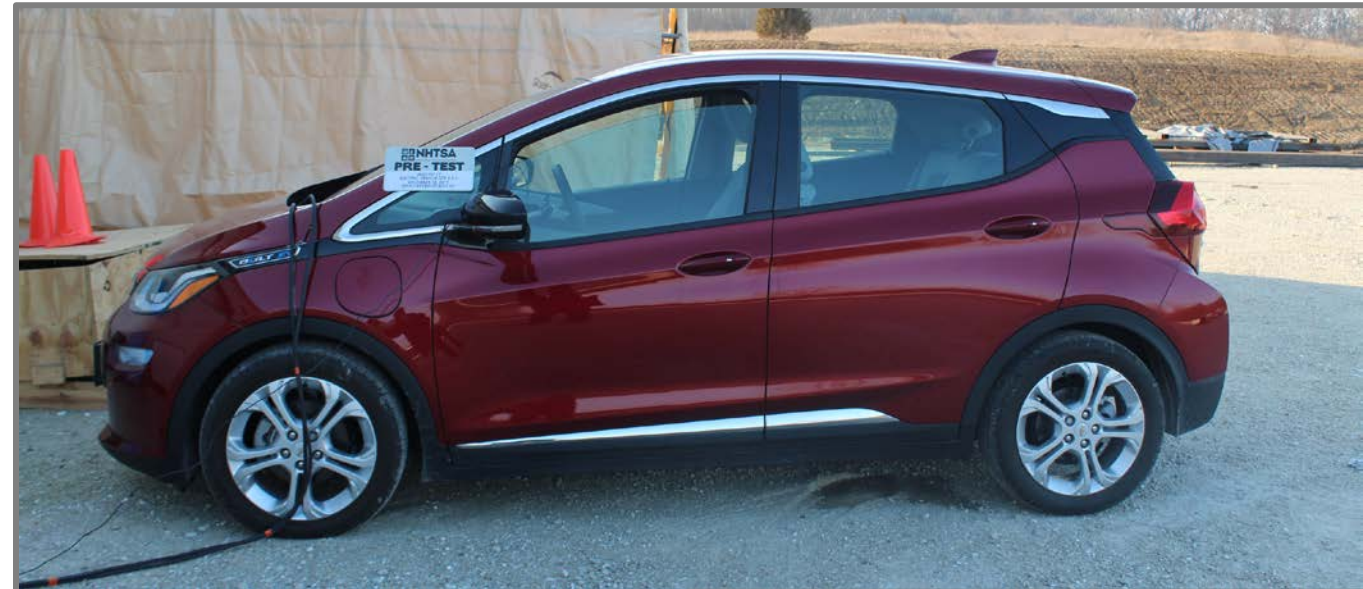
## 5.4.5 External short circuit protection

- Vehicle based test conducted with an external short test machine connected to the breakout harness.
- All three vehicles required repair after short circuit test
  - Chevrolet Bolt successfully repaired by dealership.
  - Nissan Leaf and Tesla Model 3 repairs in progress.

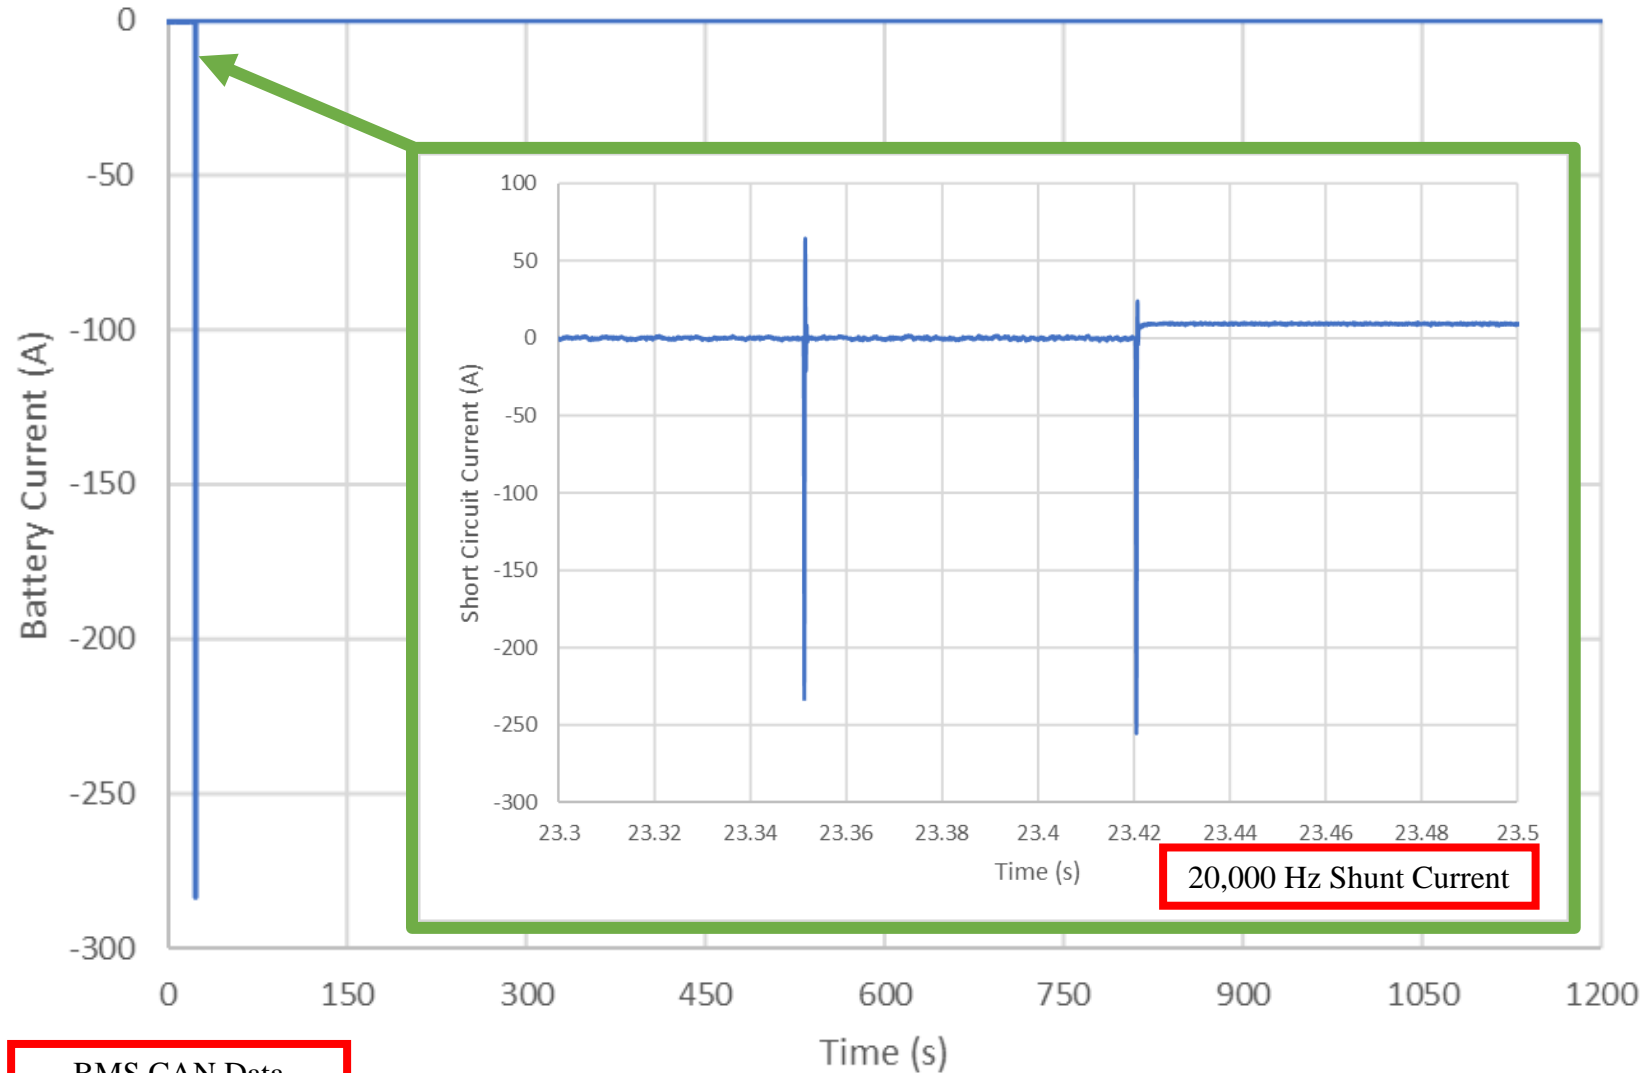
- During repair of the vehicle it was determined that the fuse on the manual disconnect level was blown and a relay contactor was shorted.

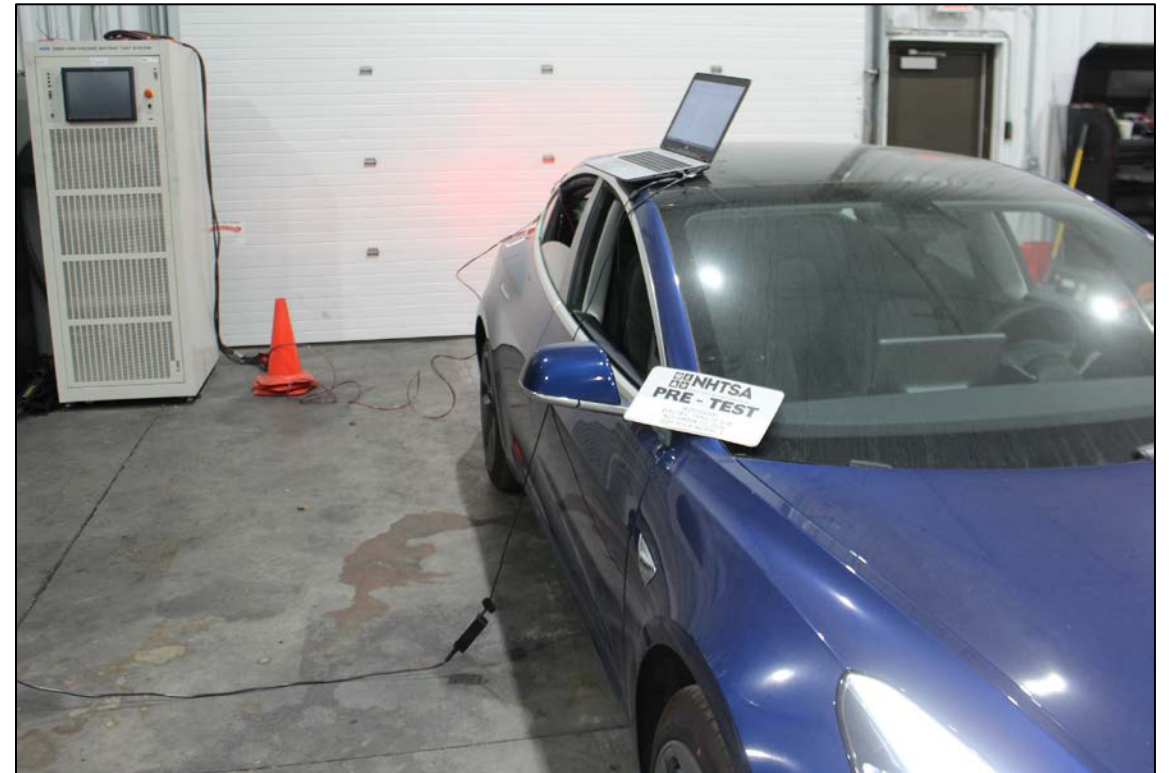
## 5.4.6 Overcharge protection

- Breakout harness and NHR 9300 Battery Test System used in conjunction with OEM Level 1 charger to perform the test in all cases.
- Vehicle REESS SOC adjusted to 95% prior to testing to reduce overall test duration.
- REESS high voltage connection to breakout harness opened for all three vehicles.

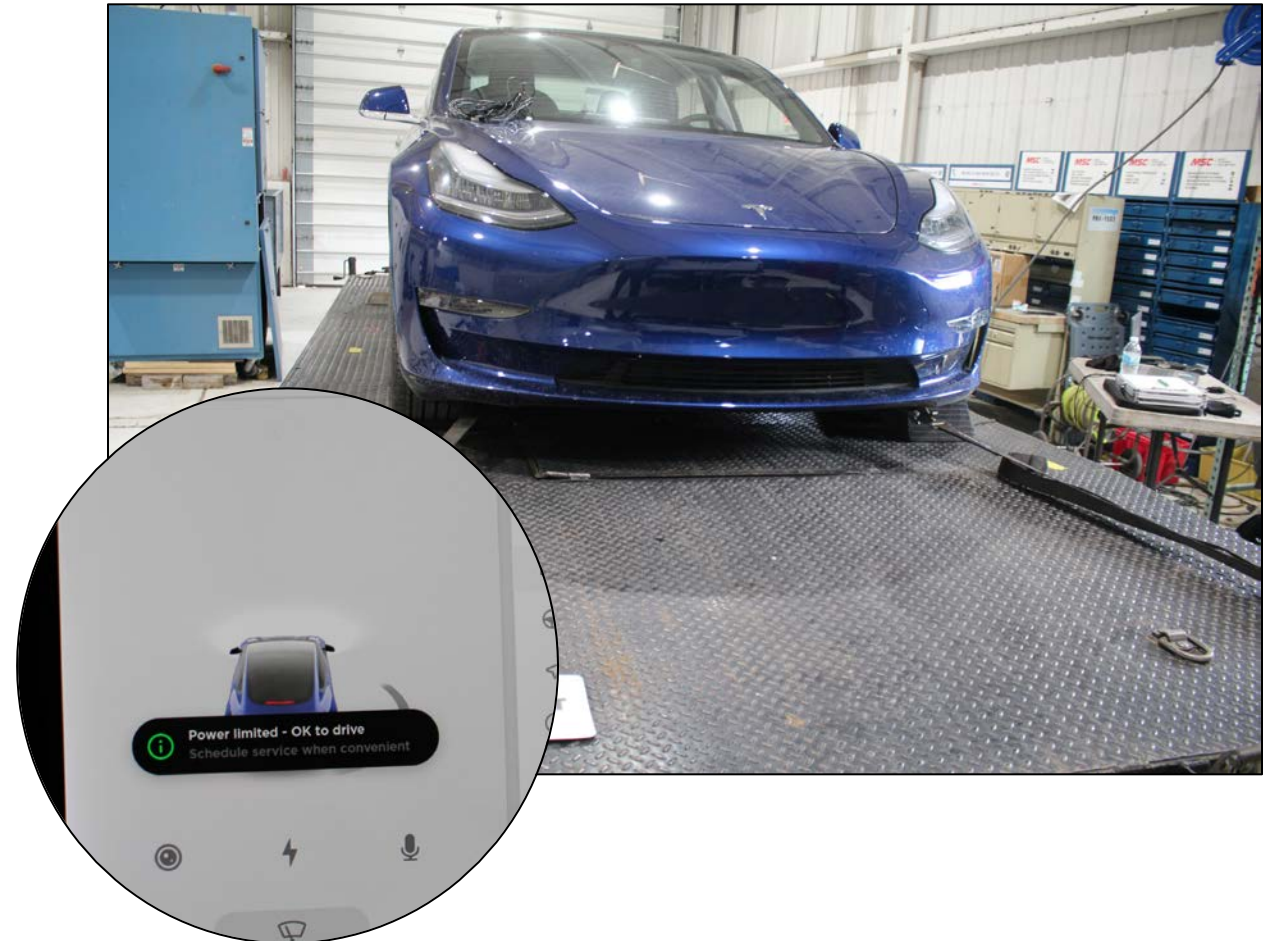
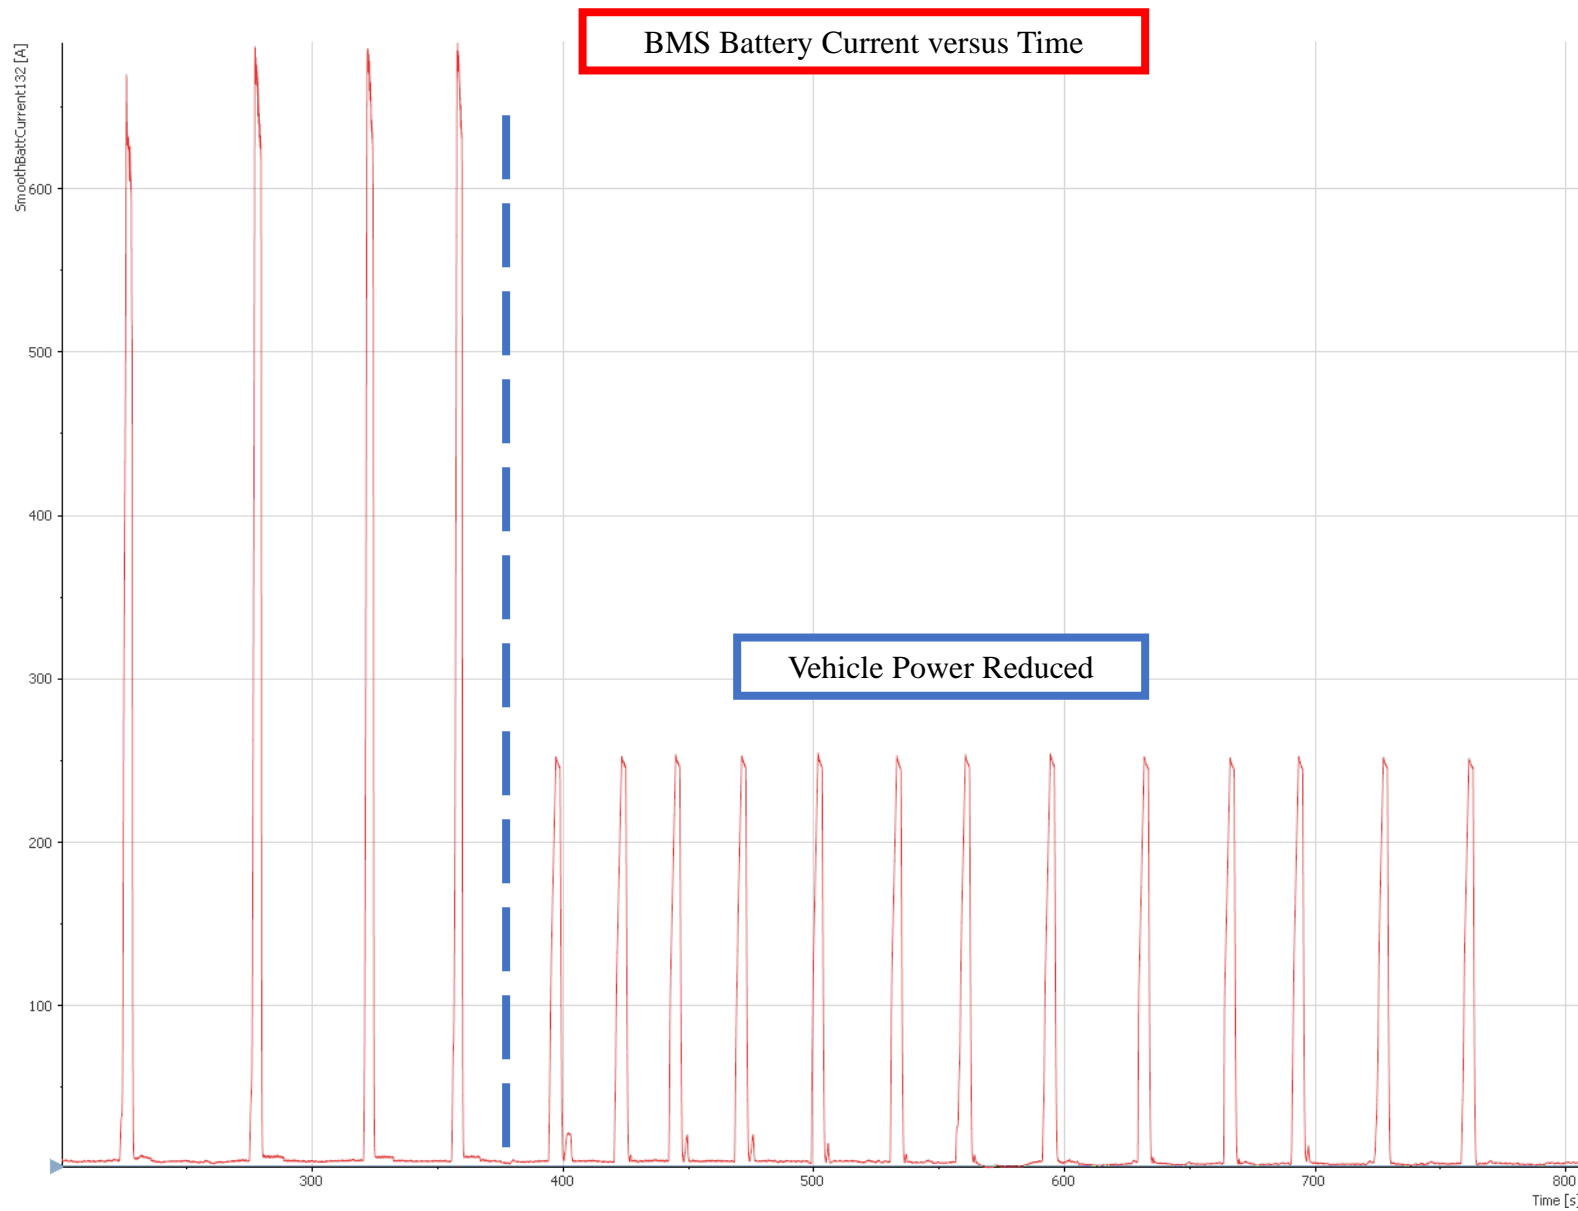
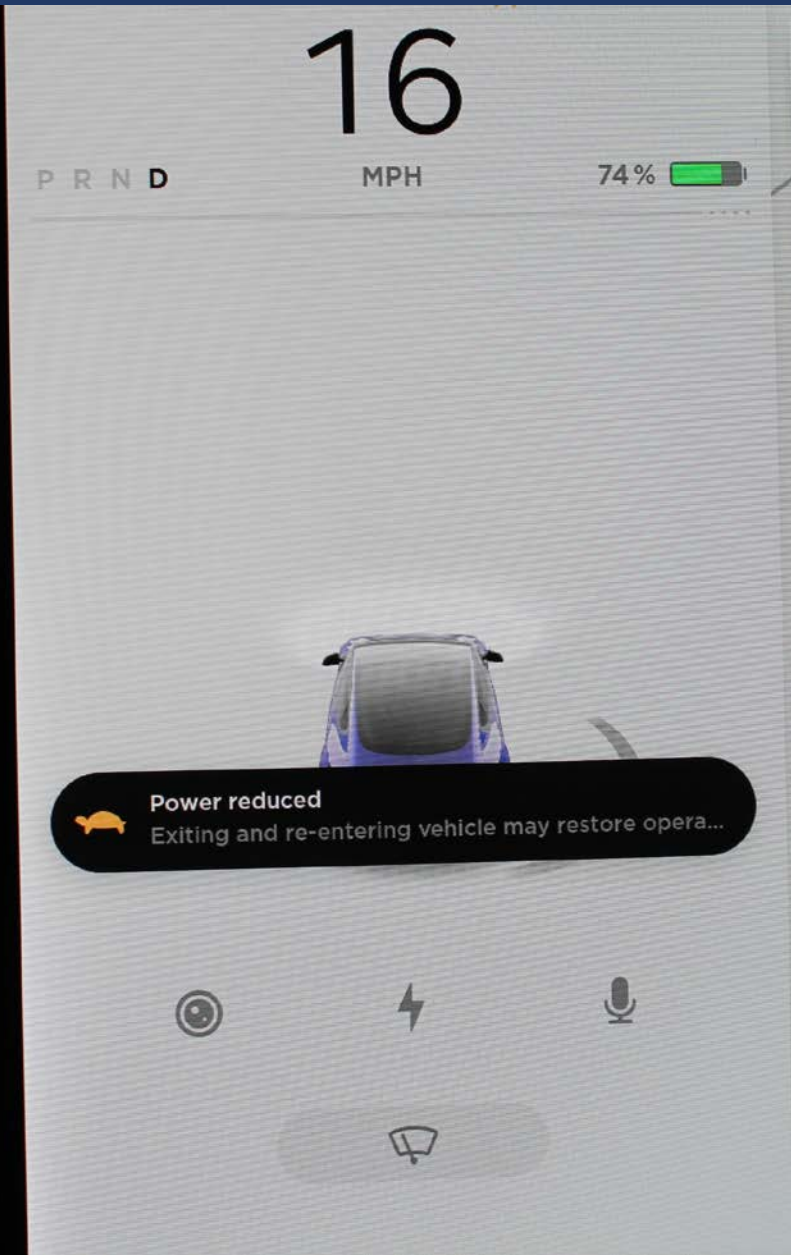
## 5.4.8 Over-temperature protection

- Vehicle was conditioned prior to installation on chassis dynamometer.
- Electric vehicle may need to be placed into a special driving mode to enable operation on the dynamometer.
  - Tesla Model 3 required disabling front anti-lock brake system.

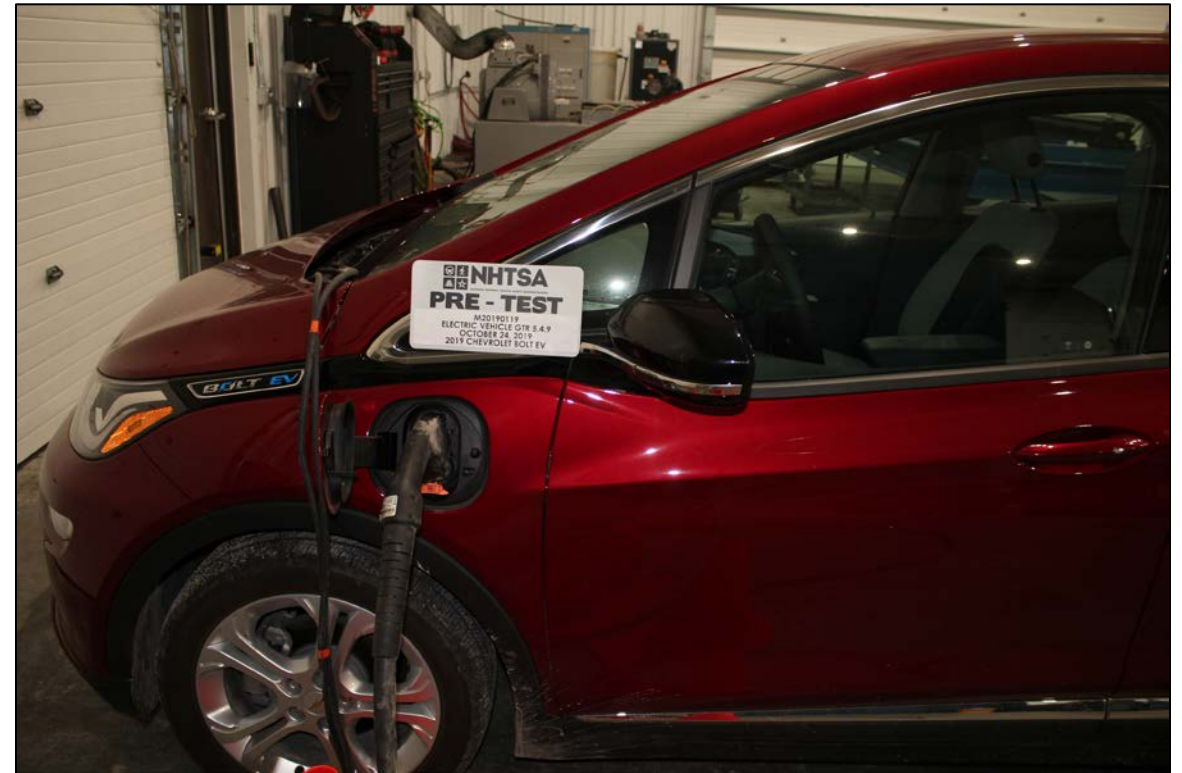
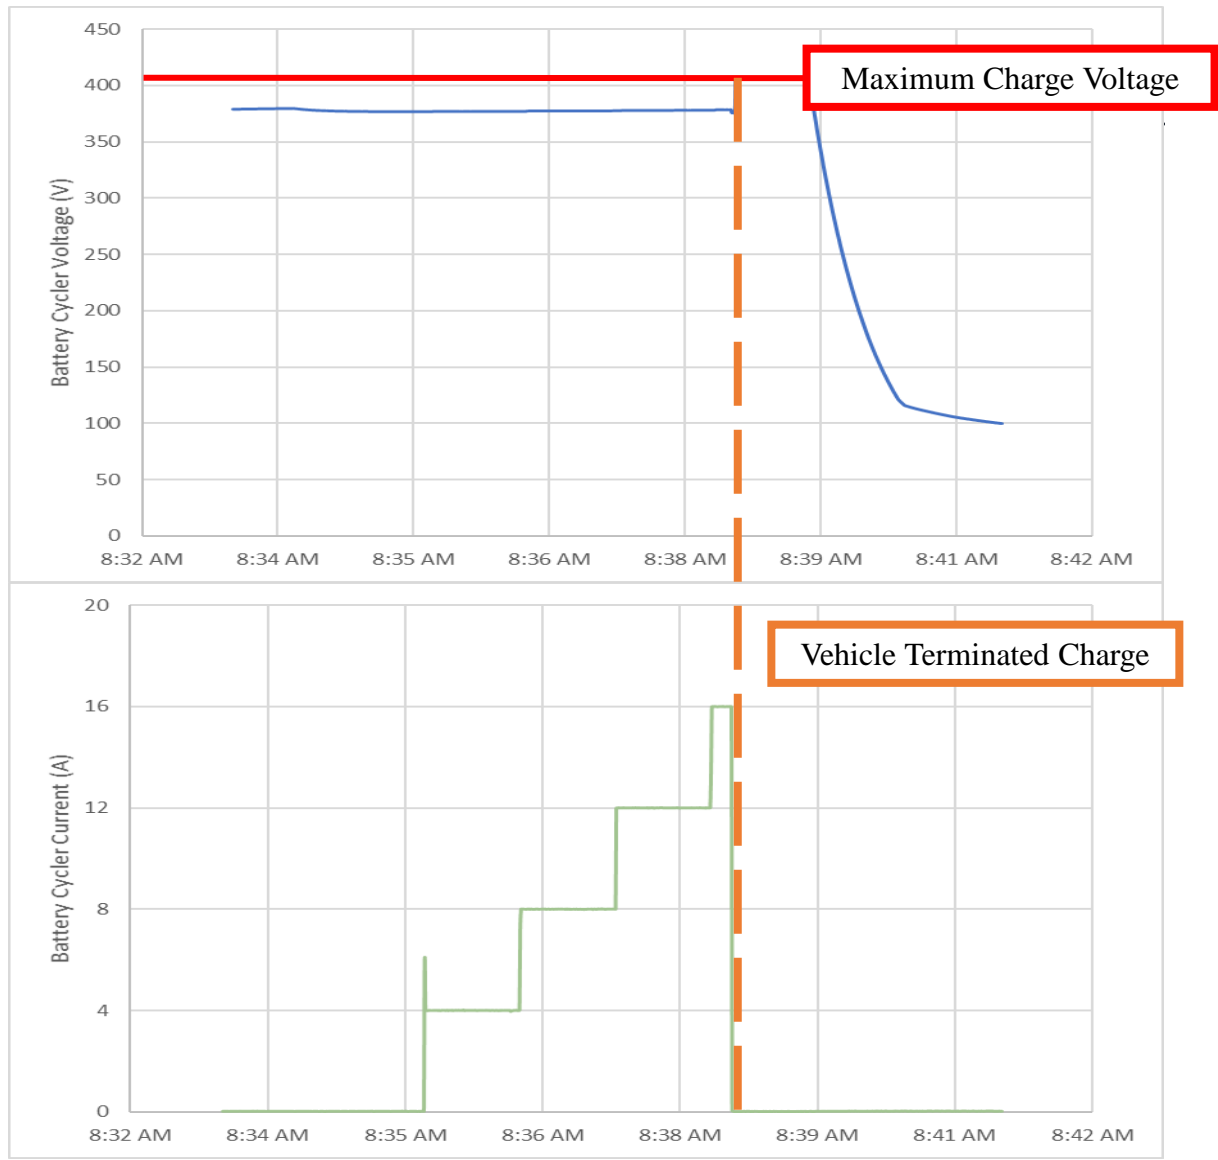
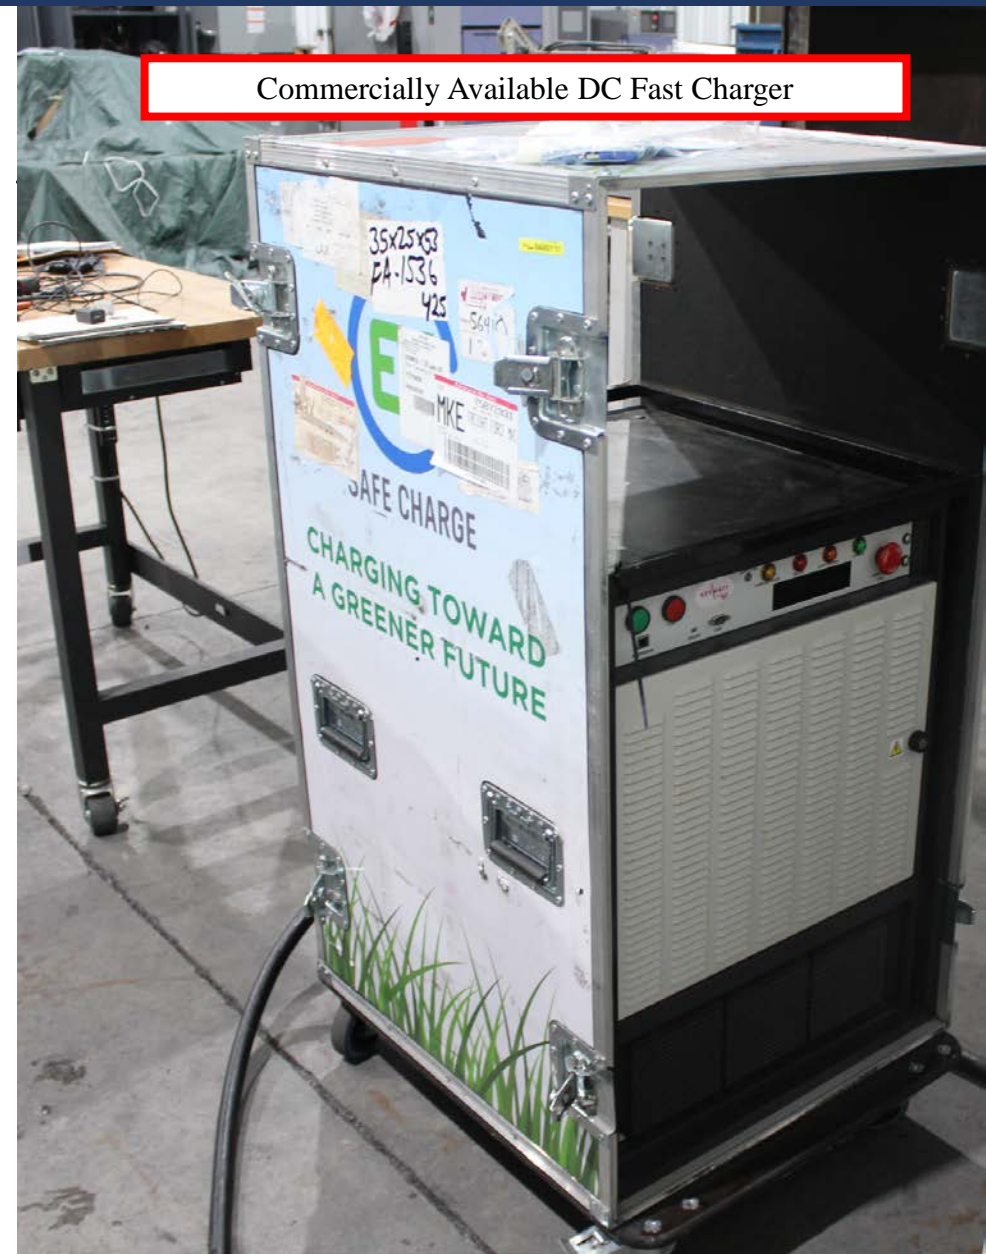
## 5.4.9 Overcurrent protection

- DC Fast Charger connected to vehicle in parallel with NHR 9300 Battery Test System.
  - Battery Test System supplied overcurrent after DC Fast Charge connection established.
  - Grounding loop can cause isolation errors with DC Fast Charge connection.
