IWG Safer Transport of Children in Buses and Coaches

Fifth meeting 28/01/2021

CRS installation in buses & coaches

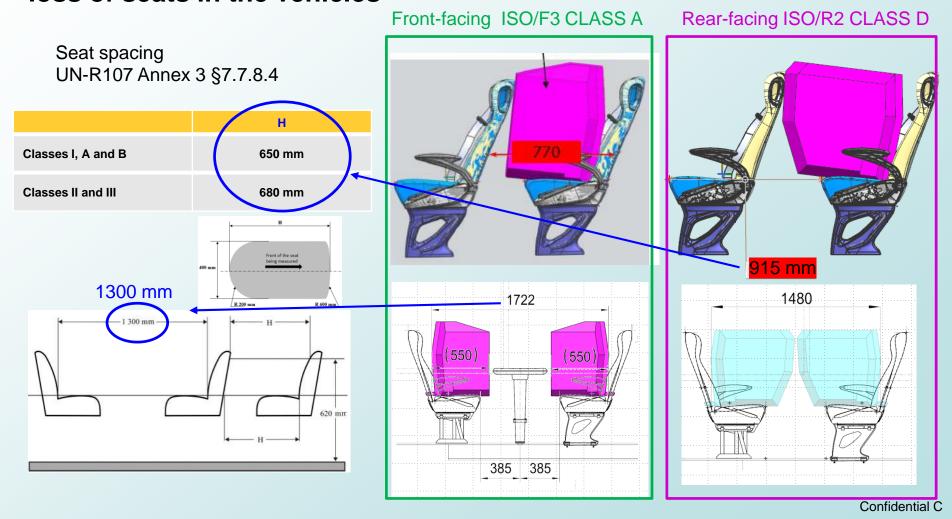
1) Seat dimensions and spacing

Using UN R 129-CRS would lead to larger seat spacing and a significant loss of seats in the vehicles

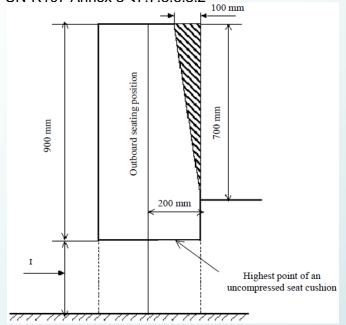
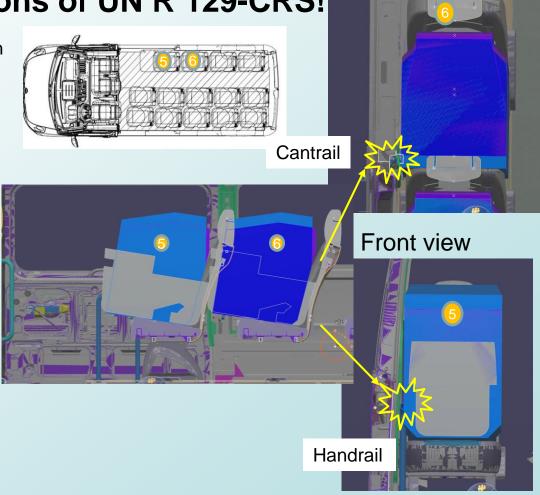
Permitted intrusion above a seating position UN-R107 Annex 3 §7.7.8.6.3.2

Permitted intrusions acc. to UN R 107 are in conflict with the dimensions of UN R 129-CRS!

I (mm)

400 to 500 (for Classes A, B, I and II min 350 mm at wheel arches and engine compartment(s))

Top view

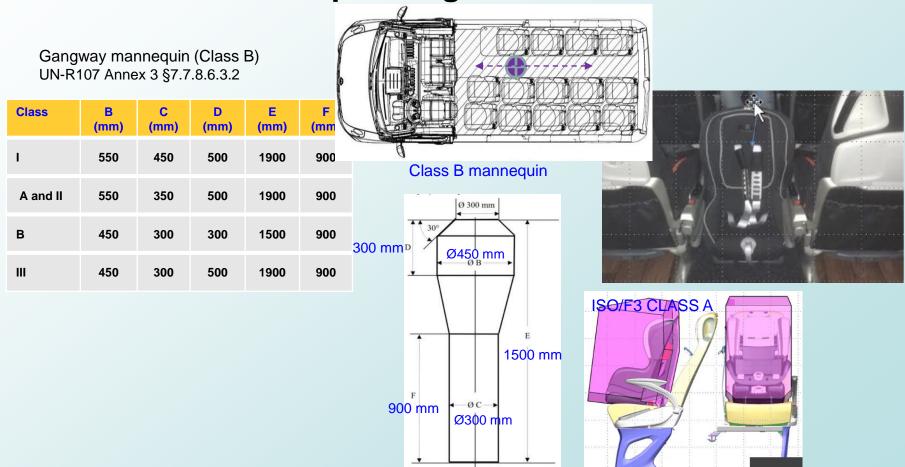
Influence on interior arrangements of buses 2) Access to the vehicle seats

UN R 107 Gangway dimensions do not permit to move the CRS to the individual passenger seats!

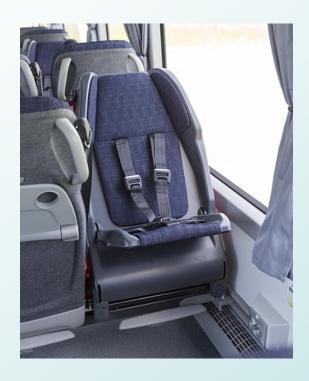
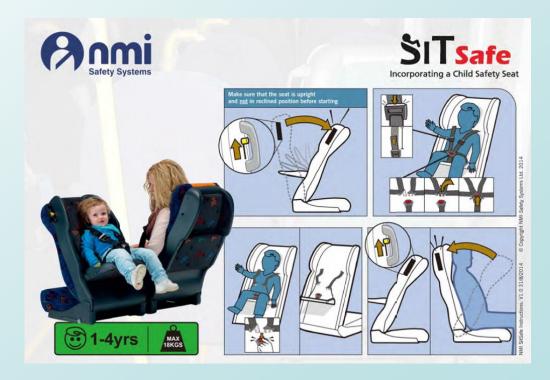
5) In-vehicle child seats

CRS-bus approval shall follow prescriptions on UN R 80 – basis, shall be technology neutral and not focused on existing R 129-CRS

Eg: SiTSafe as a solution for option in Nordic bus procurement requirements « At least 2 child seats for 3 years of age (UN-R44) »

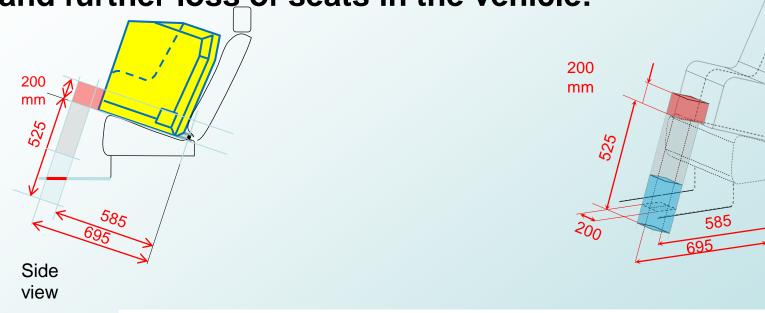
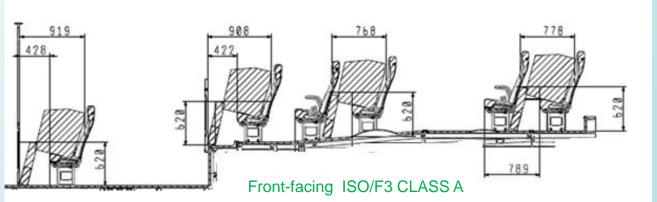
6) Support leg volume assessment

Support leg might lead to further increase of seat spacing

and further loss of seats in the vehicle!
