# Interim report of vehicle performance investigation for VtP

AEBS-HDV-05

30<sup>th</sup> June 2021

- The performance of AEBS Vehicle to Pedestrian was investigated by the actual vehicle test.
- The vehicles of two categories (N2, N3) were tested.
- The tests were carried out in accordance with R152 (AEBS tests for M1/N1).
- Test speed was 10, 15, 20, 25, 30, 35, (40, 50, 60) km/h.

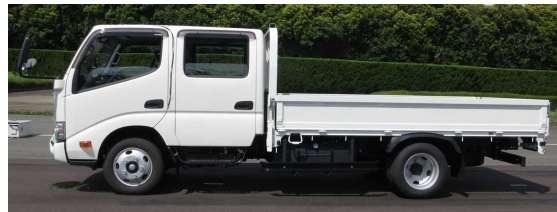
N2 (Hydraulic brake)

Weight of vehicles	Unladen	Laden
N2 (Hydraulic brake)	2930 kg	5030 kg
N3 (Air brake)	10905 kg	—— *1

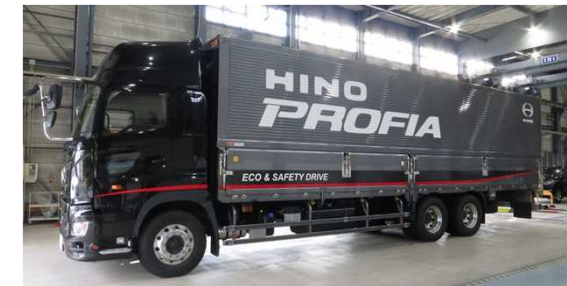
N3 (Air brake)

\*1 The test of Laden condition of N3 was omitted, because the loads to make the vehicle laden condition (almost 25000kg) could not be prepared.

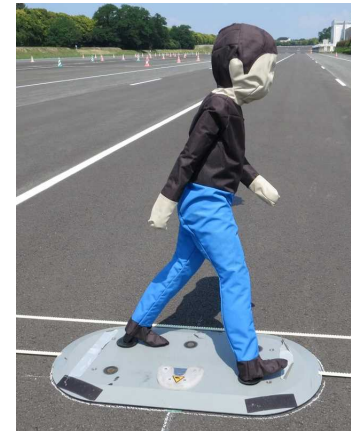
ISO 19206-2:2018  
(Child)

As well as R152, a child soft target in accordance with ISO 19206-2 was used. Additionally, an adult soft target in accordance with ISO 19206-2 was used in the particular test speed.

Non-articulated (fixed legs) soft targets were used, because there was concern of bigger damage of legs of the soft targets by collisions with large truck.

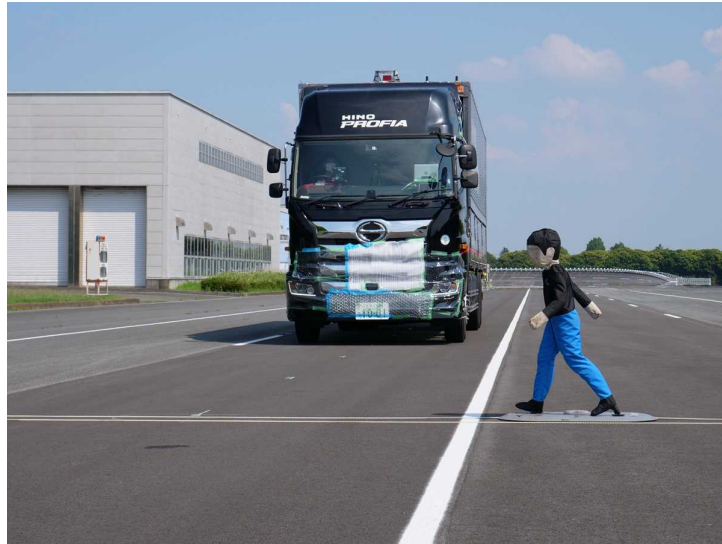
N3(Air), Crossing (child)

Testing scenario	Moving speed	Collision offset
Stationary (Child)	0 km/h	50 %
Crossing (Child)	5 km/h	50 %
Stationary (Adult)	0 km/h	50 %
Crossing (Adult)	5 km/h	50 %

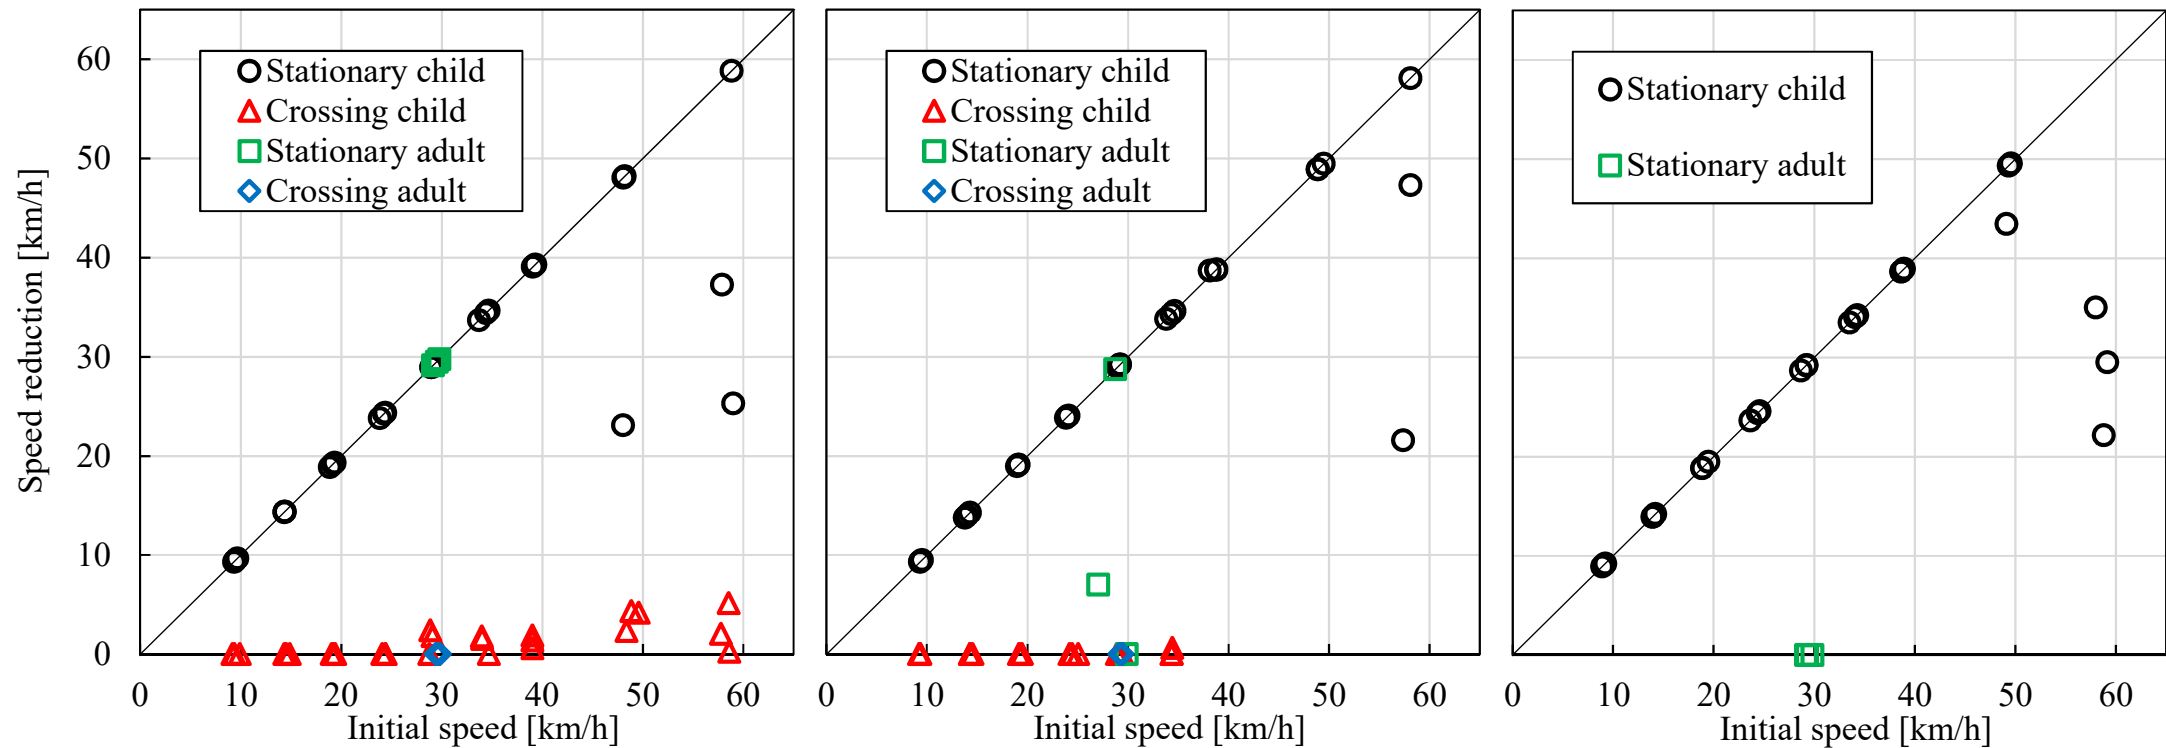
N3 (Air) Unladen

N2(Hydraulic) Unladen \*2

N2(Hydraulic) Laden \*3

Initial speed means actual vehicle speed, and it was defined as below.

- In the case that emergency braking was observed : Vehicle speed at when deceleration exceeds  $0.3 \text{ m/s}^2$ .
- In the case that emergency braking was not observed : Vehicle speed at TTC 4 s.

\*2 In N2 Unladen condition, tests of initial speed of 40 km/h or higher of crossing pedestrian scenario were omitted, because no emergency braking was observed below 35 km/h.

\*3 In N2 Laden condition, only the tests of stationary scenario were performed, because no emergency braking was observed in the tests of crossing scenario in Unladen conditions.

- In testing the performance of HDVs in avoiding collisions with stationary pedestrians, the vehicles managed to avoid the collision when running at a speed of 10km/h to 60km/h (failing in some cases though).
- In testing the performance of N3 vehicles in avoiding collisions with pedestrians crossing the road, they could not avoid the collision when running at a speed of 30 to 60km/h, but the activation of the alarm and the emergency brake was confirmed.

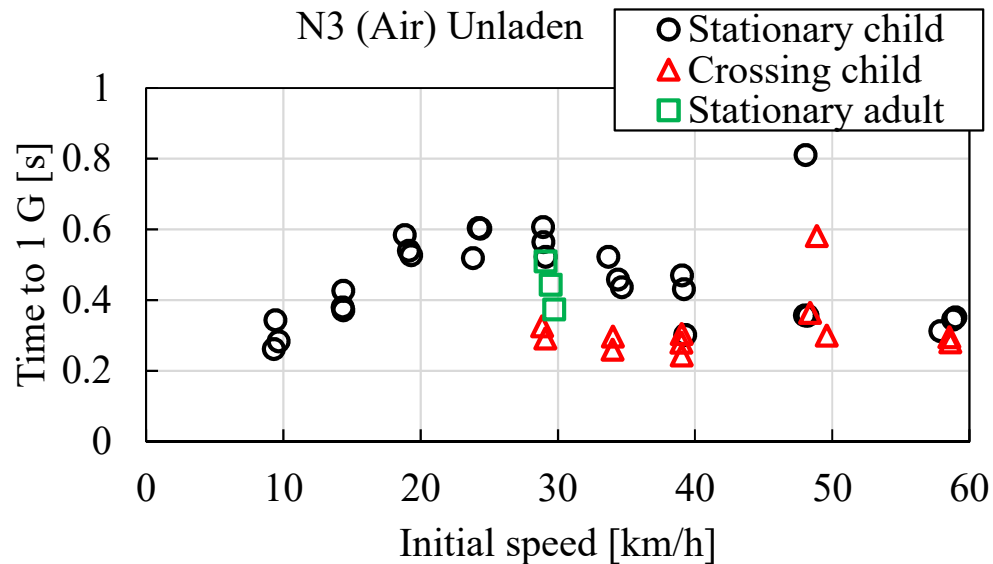
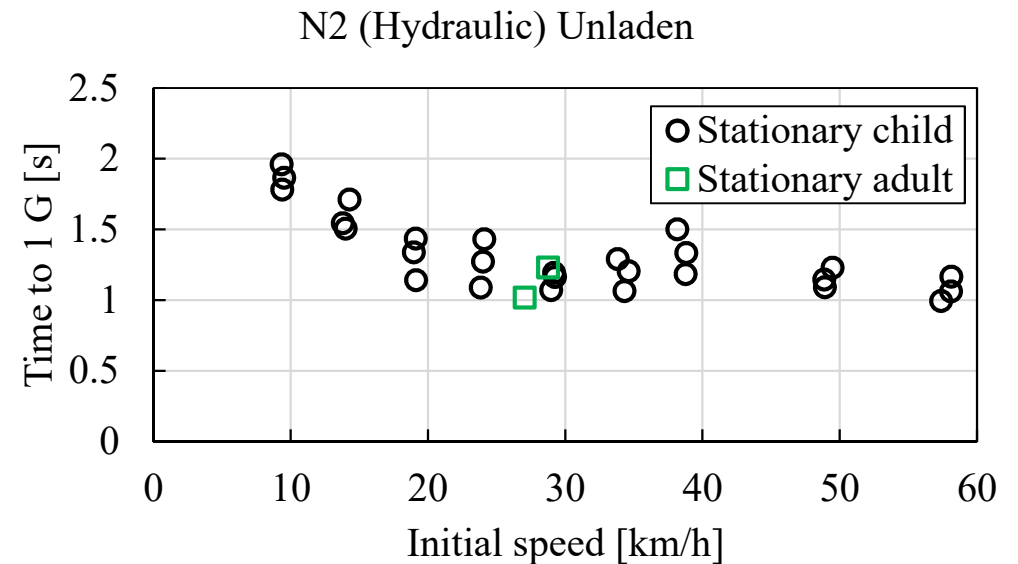
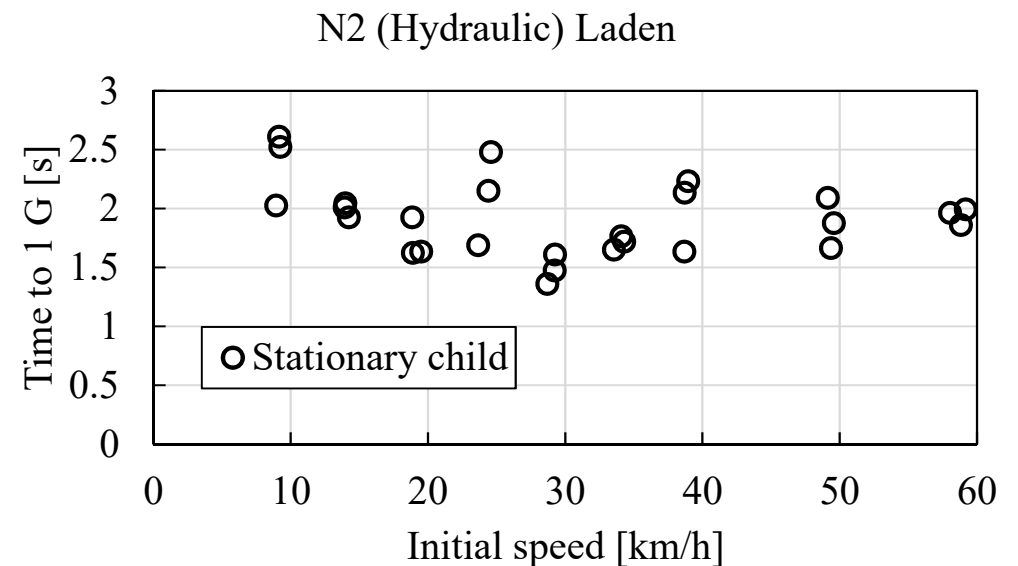
Only data in the case when deceleration by emergency braking was significantly observed was shown in the figure.

Time to 1G was measured from time series data of deceleration by the following method.  
N3 Air brake : From the timing of deceleration 0.3 m/s<sup>2</sup> to the first peak value  
N2 Hydraulic brake : From the timing of deceleration 0.3 m/s<sup>2</sup> to the first linear area

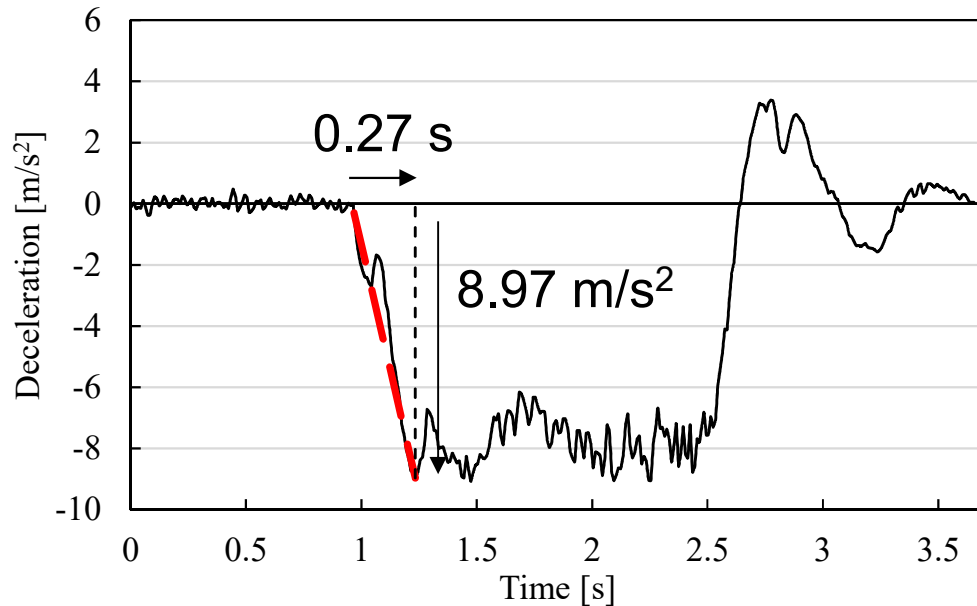
N3(Unladen), Stationary child,  
test speed 40km/h

0.27 s to 8.97 m/s<sup>2</sup>  
→ 0.30 s to 9.8 m/s<sup>2</sup>

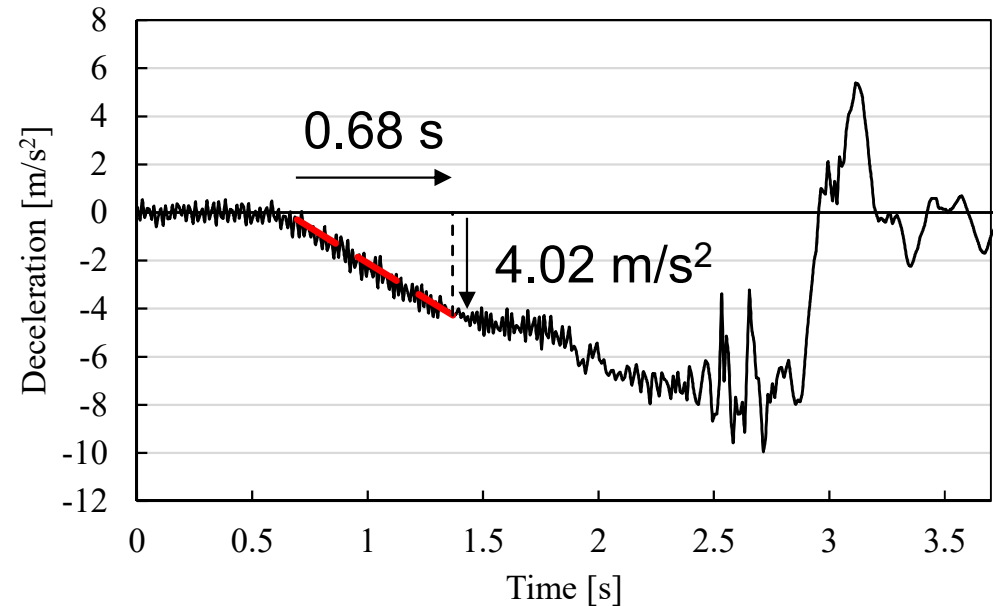
N2(Laden), Stationary child,  
test speed 40km/h

0.68 s to 4.02 m/s<sup>2</sup>  
→ 1.67 s to 9.8 m/s<sup>2</sup>

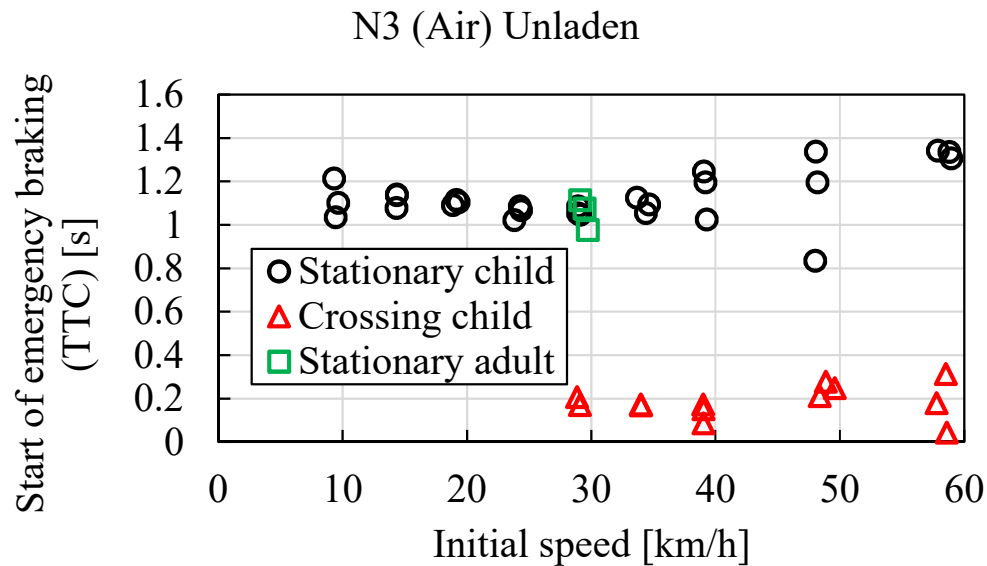
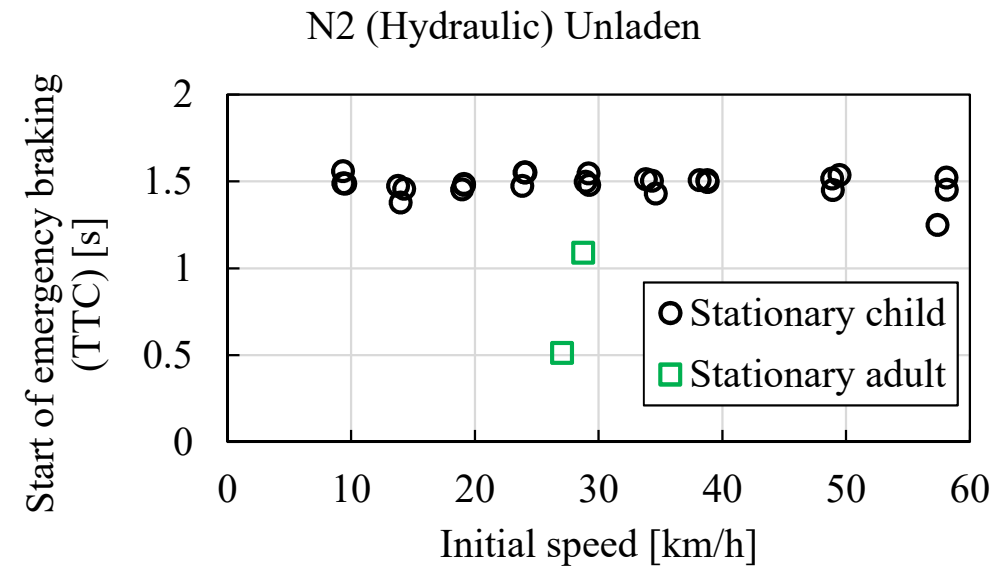
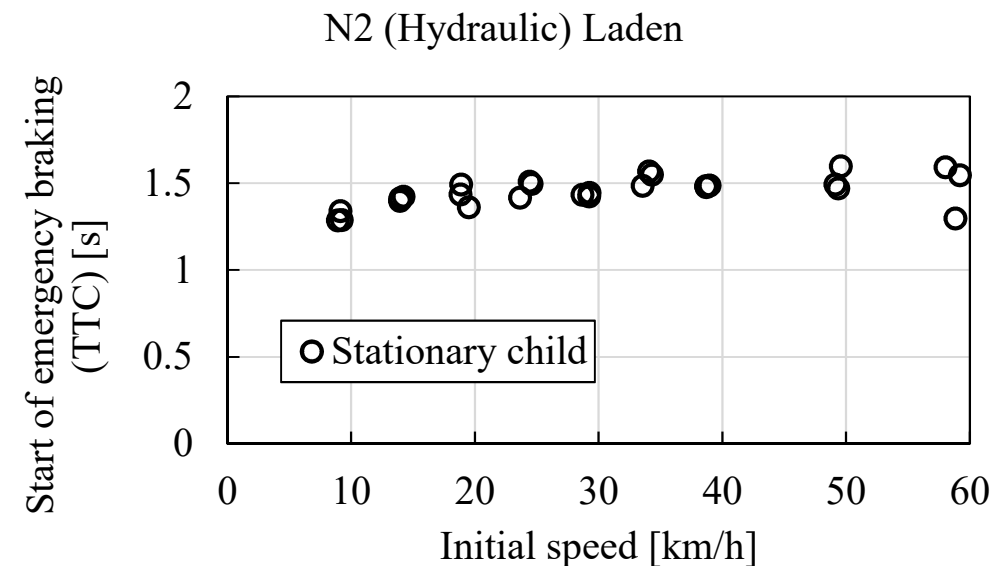
# Test Result : Start of emergency braking (TTC)

Only data in the case when deceleration by emergency braking was significantly observed was shown in the figure.

AEBS activation timing :  
Timing at when deceleration exceeds  $0.3 \text{ m/s}^2$ .

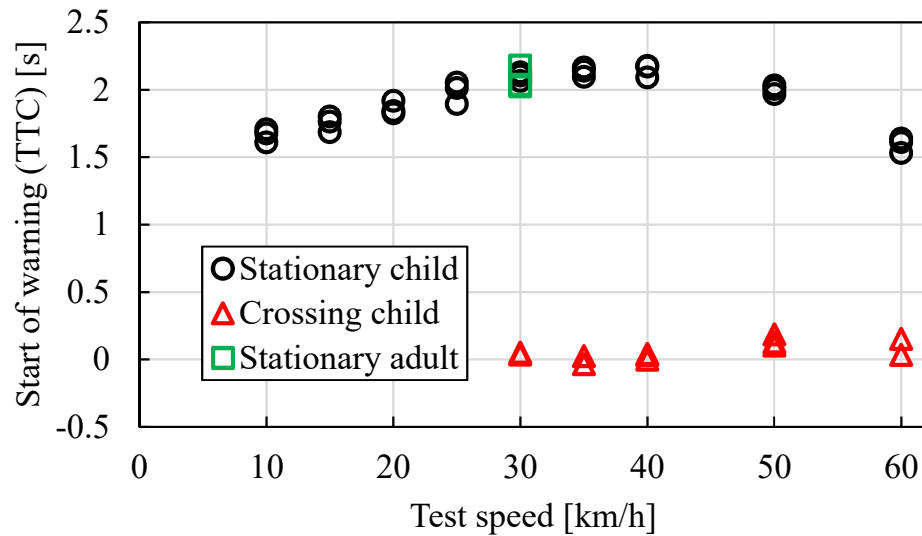
### N3 (Air) Unladen

# Test Result : Start of warning (TTC)

Test speed:  
It is defined as the speed of test condition, and distinguished from the Initial Speed.
