Vehicle Level Thermal Runaway Test: Parked Conditions

EVS 23 – GTR

Parking Mode Test Validation - Test Setup

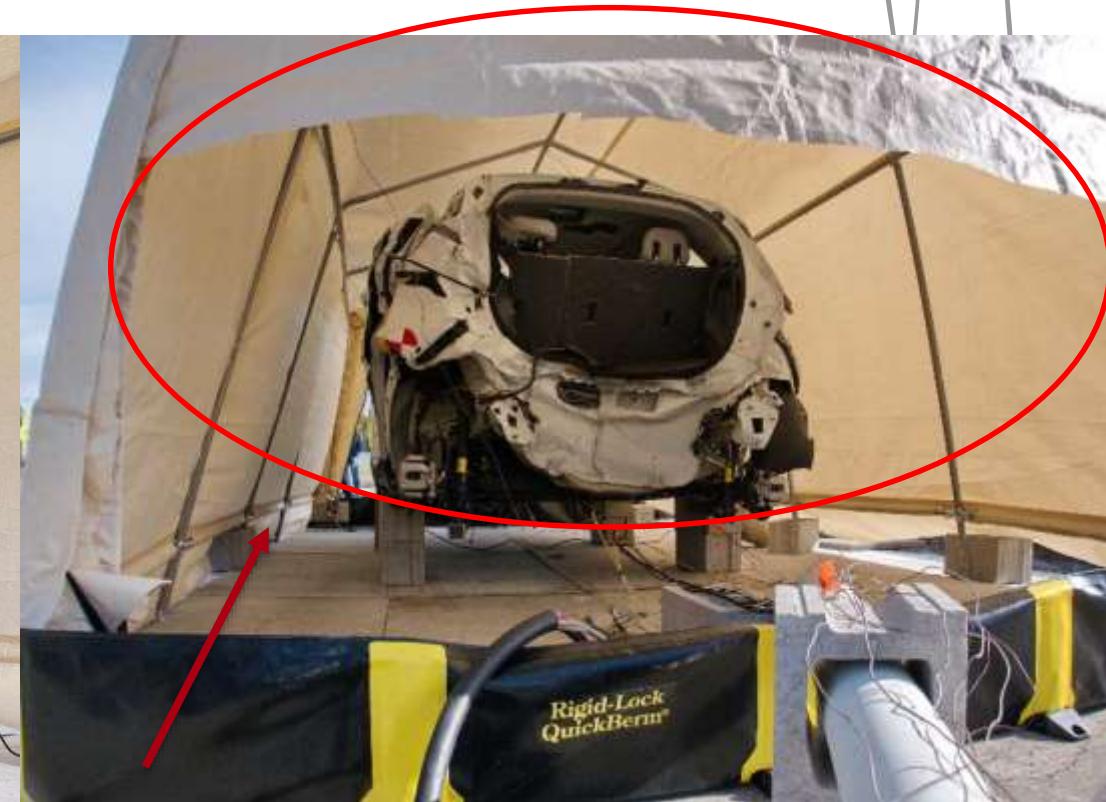
Parking Mode Test Setup - 3

To investigate a garage scenario, a fabric tent shelter was installed around the DUT.

Multi gas analyzer

12V charger removed,
hood closed
prior to test

Shelter had opening at front and back to permit some airflow in/out of the shelter

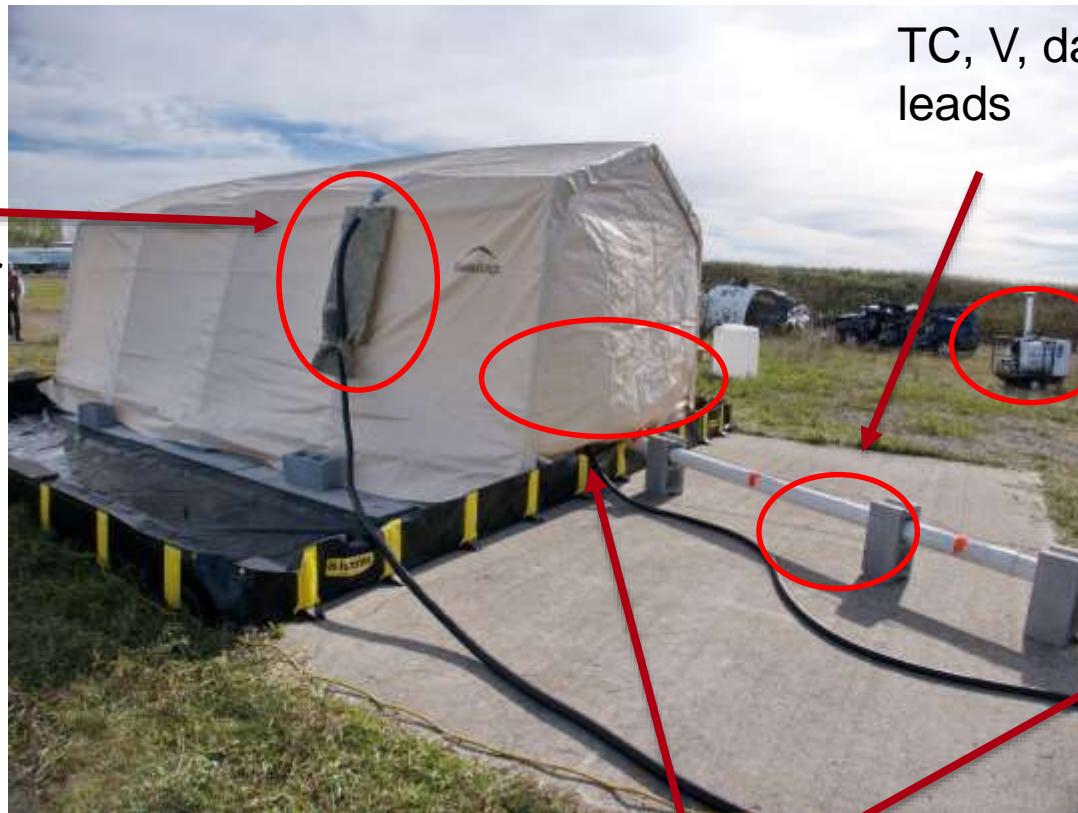
Parking Mode Test Setup - 4

Collection
of gas at
top of
shelter for
FTIR gas
analysis

Opening created in shelter
(front and back) prior to
test to permit gas flow

TC, V, data
leads

Heater for maintaining battery
temperature overnight

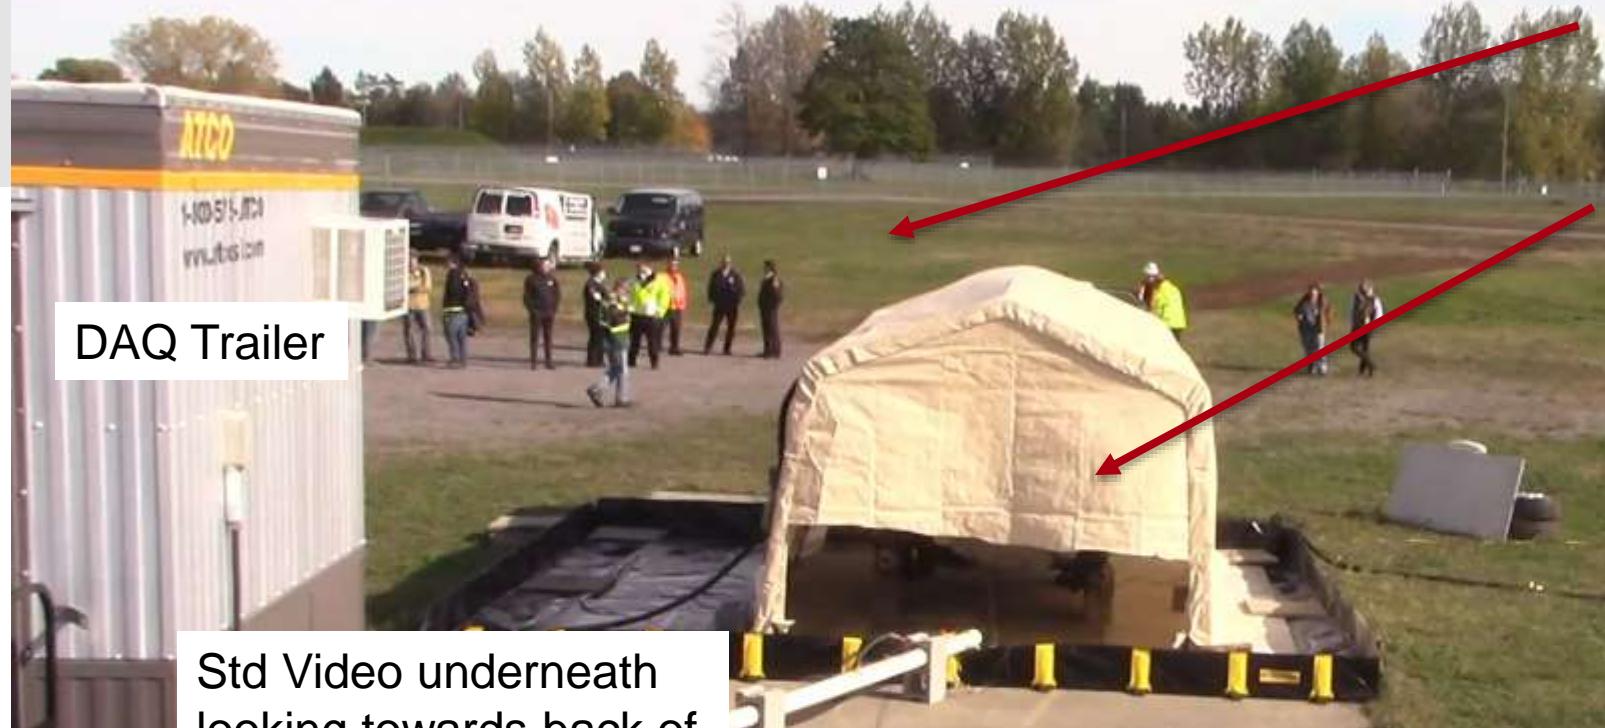
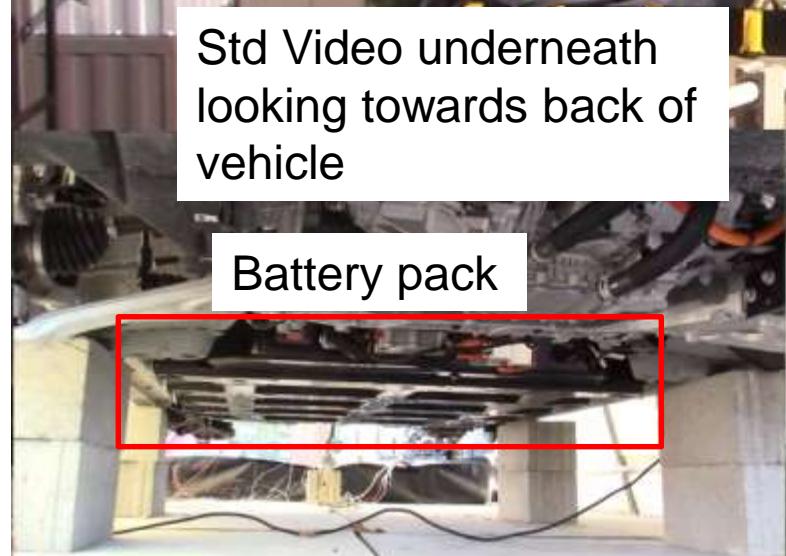
Event Log

- 00:00 Video and Heating Starts
- 00:25 First audible Thermal Runaway with visible white smoke released
- 00:37 Smoke visible in cabin**
- 01:06 + release of pressure/gas in waves; visible in IR camera and sound
- 01:58 FTIR gas analysis reveals increase in several gas emissions (spikes)
- 03:07 White smoke begins to intensify
- 04:30 Significant heat release from pack visible in IR camera (potential rupture?), smoke begins to darken and intensify further, FTIR is oversaturated and is shut down
- 05:45 FTIR sampling line removed, smoke darkened with intense release from tent
- 08:49 deflagration, tent consumed, first visible flame
- 12:22 Water applied

After ~9 min of smoke release, a deflagration followed by a significant vehicle fire occurred. The fire engulfed the complete vehicle immediately and consumed the tent structure.
