Safer Transport of Children in Buses and Coaches STCBC

M3, class II/III vehicle check with CRS-envelopes B2 and R2
Consequences for seat spacing and interior layout of vehicles

Test vehicles: Setra S 517 HDH (single deck); Setra S 531 DT (double deck)

Michael Becker, Daimler Buses, 24.01.2022

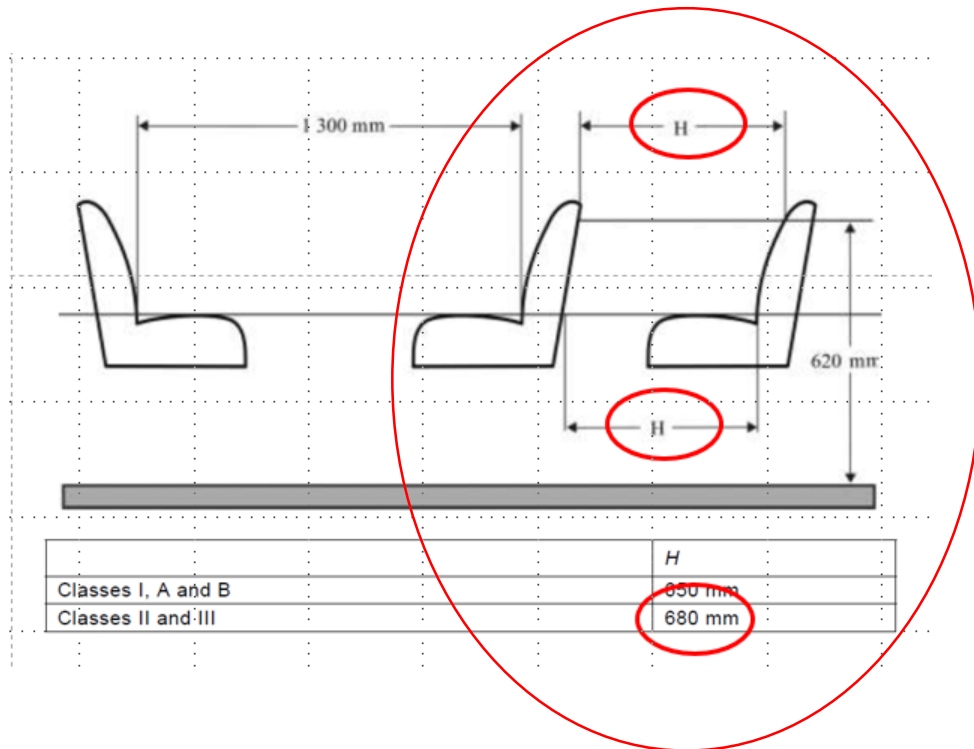
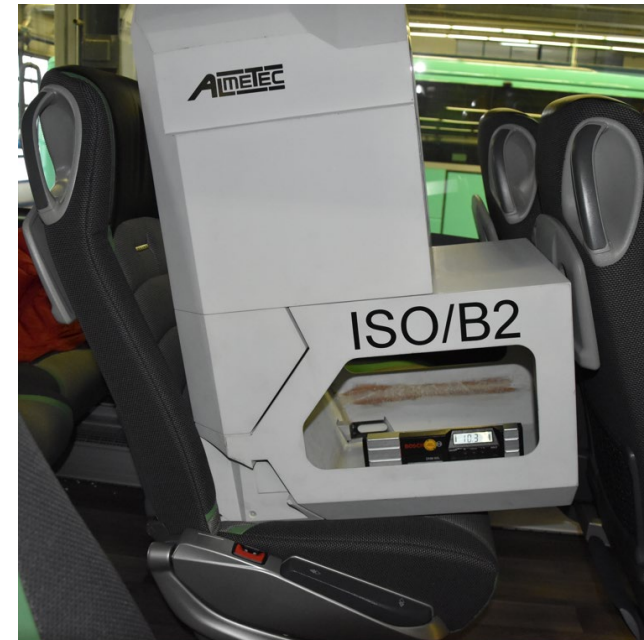
1. Check of seat spacing H with ISO/B2
(see UN R 107, annex 3, para. 7.7.8.4 and annex 4, figure 12A)

Fitting of ISO/B2 with 680 mm seat spacing possible

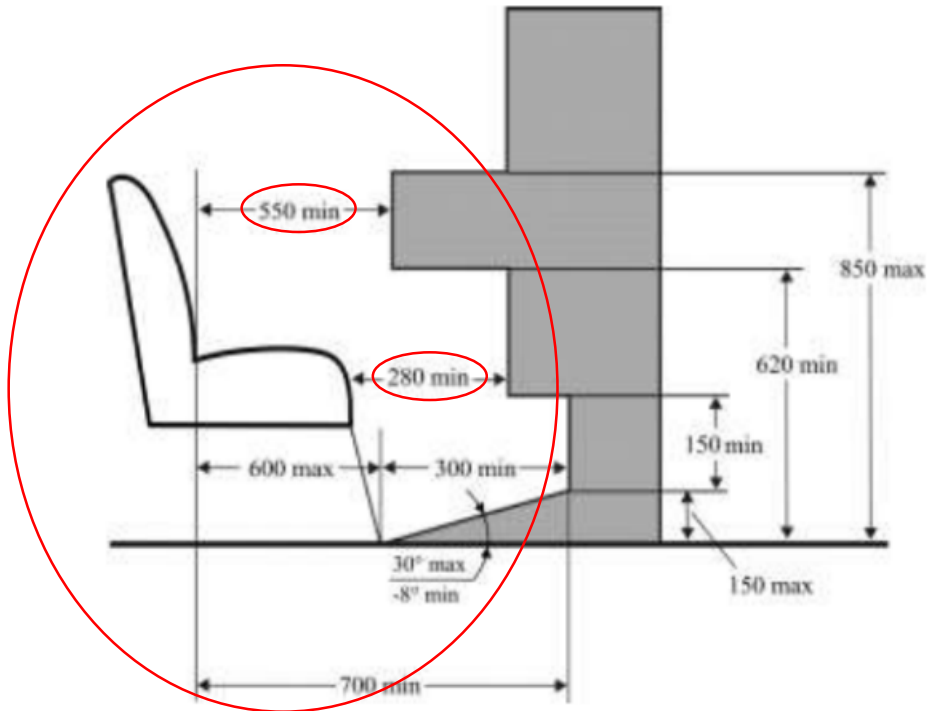
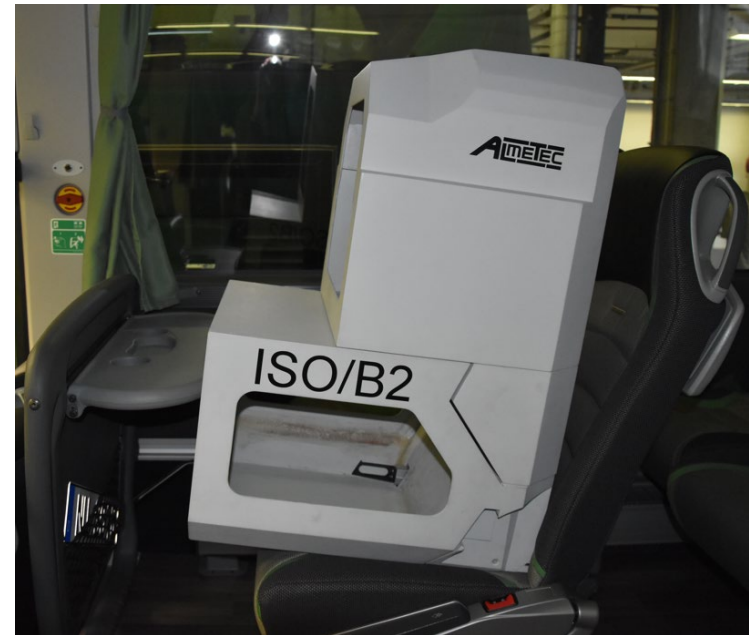
2. Check of required seat distance of 550 mm and 280 mm with ISO/B2
(see UN R 107, annex 3, para. 7.7.8.5.1 and annex 4, figure 13)

Fitting of ISO/B2 needs further 70-80 mm in addition to the required min. distance between seat and partition

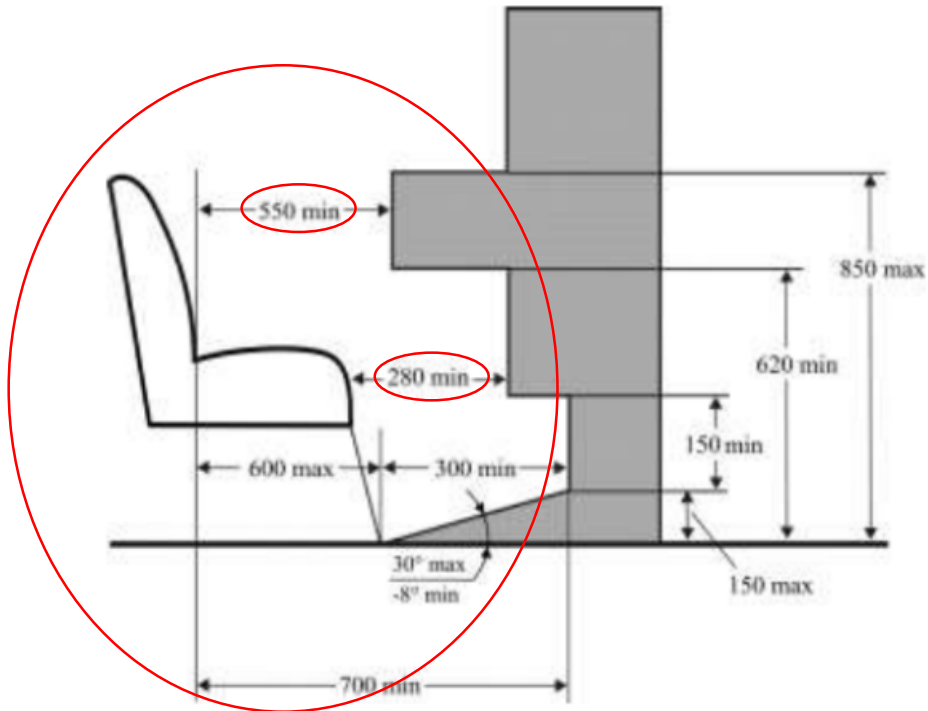
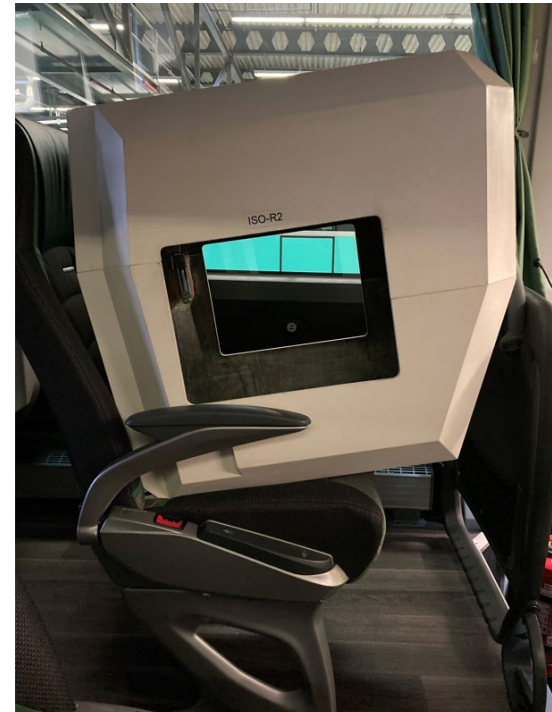
3. Check of required seat distance of 550 mm and 280 mm with ISO/R2
(see UN R 107, annex 3, para. 7.7.8.5.1 and annex 4, figure 13)

Fitting of ISO/R2 needs further 120-130 mm in addition to the required min. distance between seat and partition

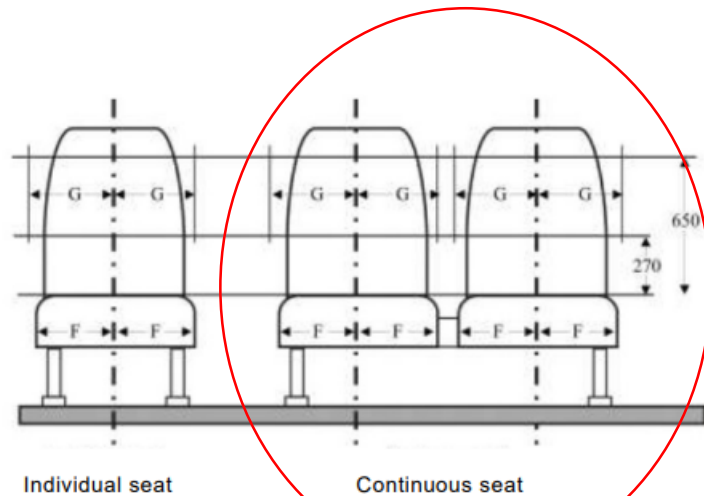
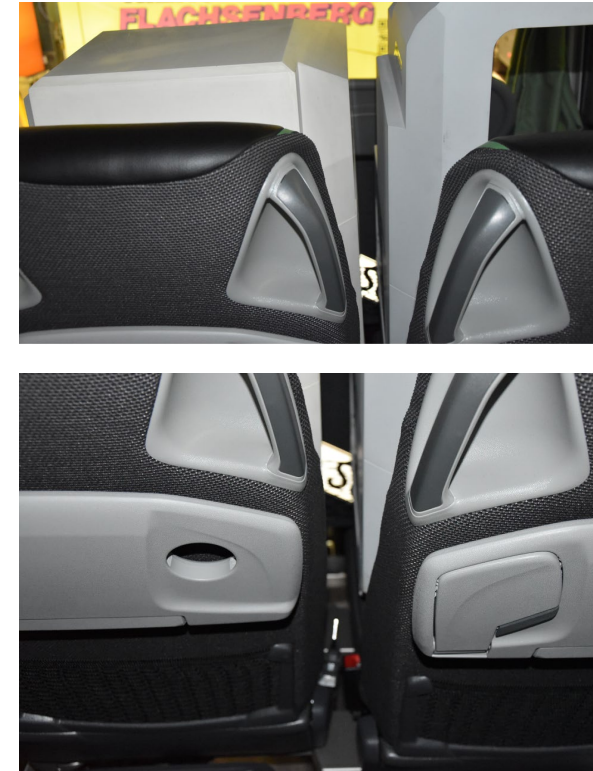
4. Check if required seat dimensions allow for 2 ISO/B2 side by side
(see UN R 107, annex 3, para. 7.7.8.1 and annex 4, figure 9)

F (mm) min	G (mm) minimum	
	Continuous seats	Individual seats
200*	225	250

Fitting of 2 ISO/B2 side by side leads to very little space between the 2 enveloppes. It is questionable, if space is sufficient to reach belt/buckle

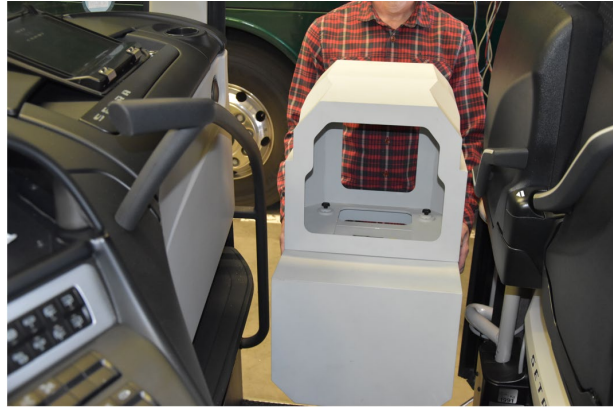
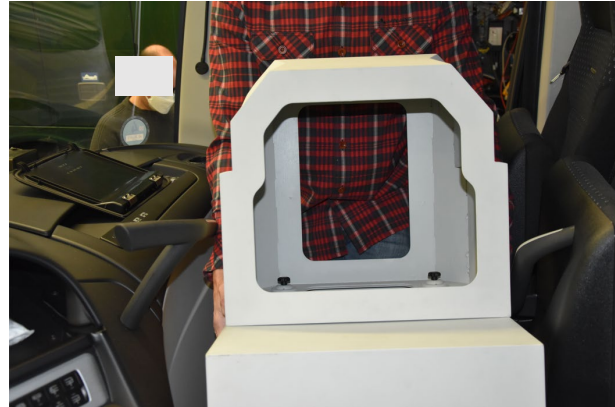
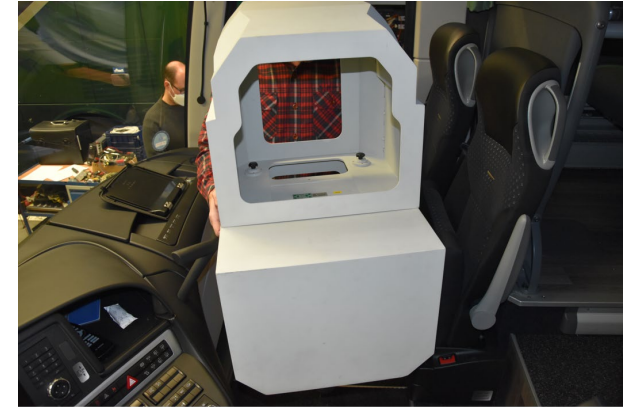
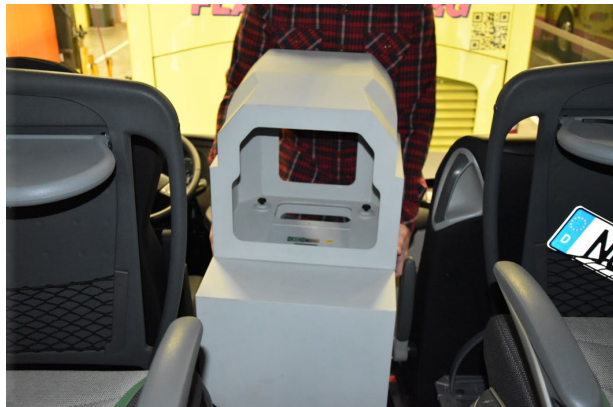
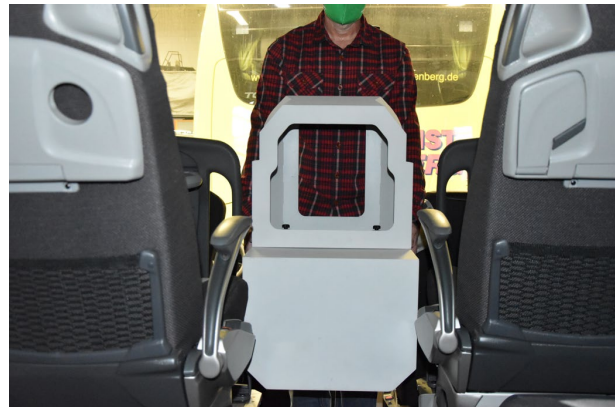
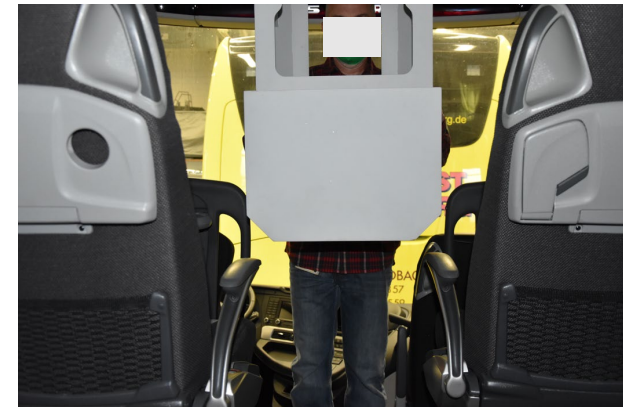
5. Check if ISO/B2 can be moved from outside the vehicle to the seating places
(see UN R 107, annex 3, para. 7.7.1/7.7.5)

Moving ISO/B2 from outside the vehicle to the seating places is possible but very challenging because of narrow gangways and entrance passages

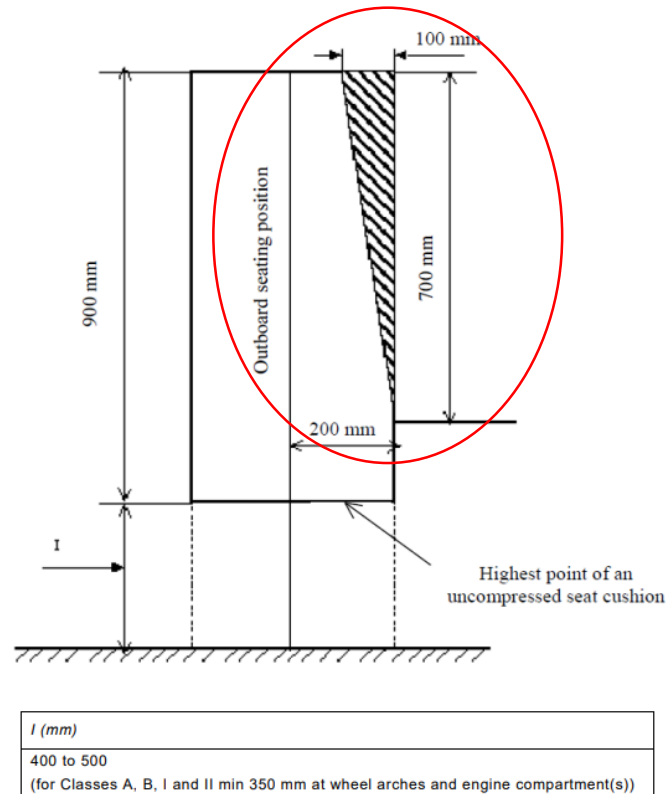
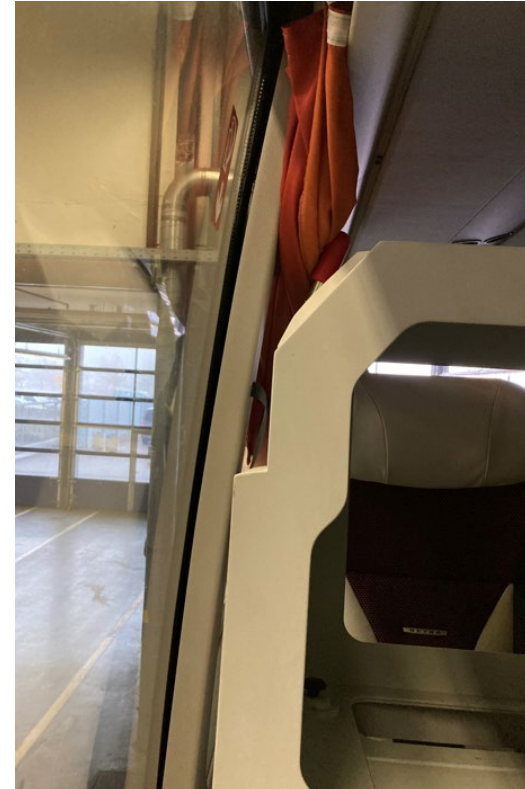
6. Check if ISO/R2 in the outboard seating position collides with window pillar cover or similar interior parts (see UN R 107, annex 3, para. 7.7.8.6.3.2 and annex 4, figure 15)

Collision of ISO/B2 with window pillar and glass-breaking-device on the upper deck of a class II/III-double-deck vehicle

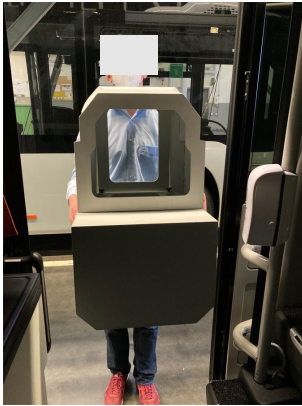
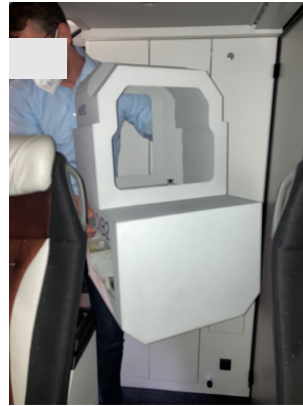
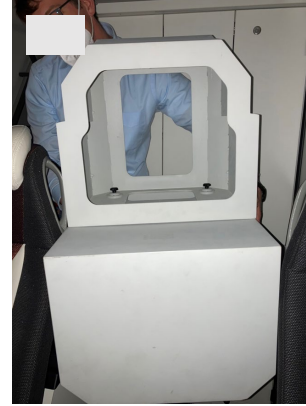
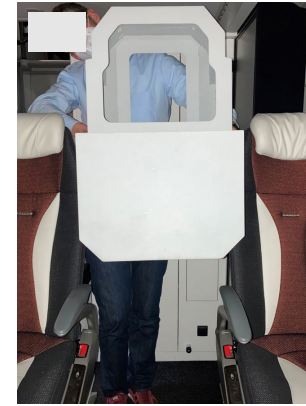
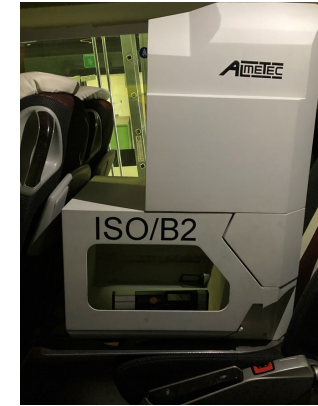
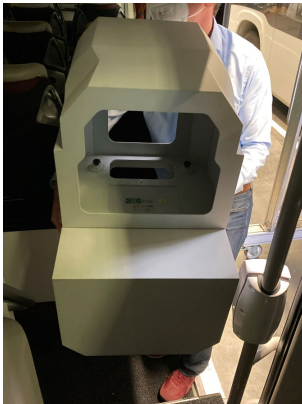
7. Check if ISO/B2 can be moved from outside the vehicle to the seating places
(see UN R 107, annex 3, para. 7.7.1/7.7.5)

Moving ISO/B2 from outside the vehicle to the seating places is possible but very challenging because of narrow gangways and narrow stepwell

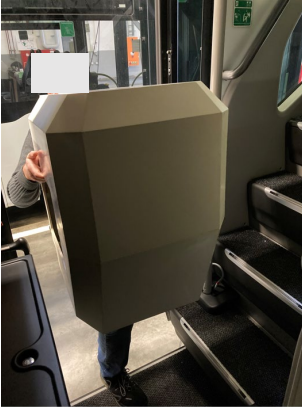
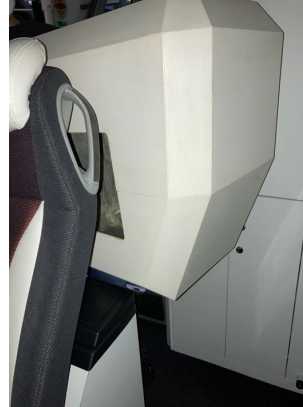
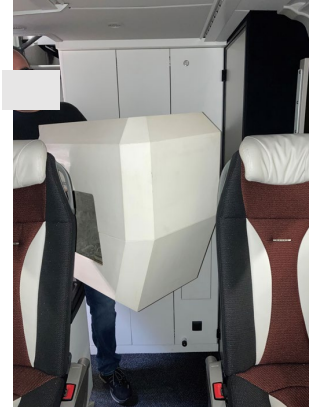
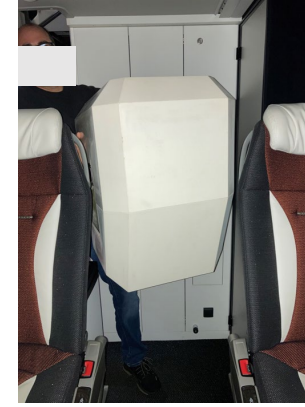
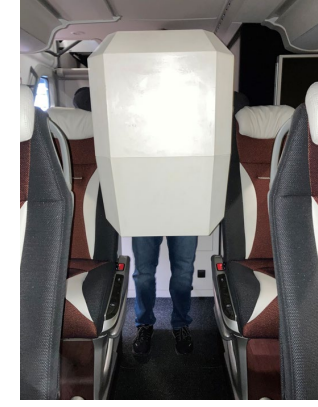
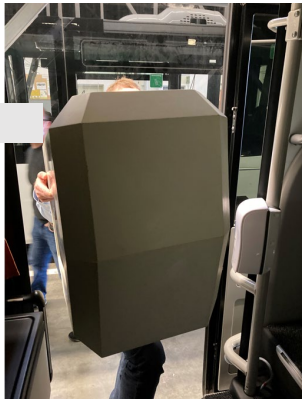
8. Check if ISO/R2 can be moved from outside the vehicle to the seating places
(see UN R 107, annex 3, para. 7.7.1/7.7.5)

Moving ISO/R2 from outside the vehicle to the seating places is possible but very challenging because of narrow gangways and narrow stepwell
