IGPG: Task Force ‚Wipertest‘ – On-road tests (Subgroup 1)

Investigation of windshields with standard laminated glass

On-road tests: windshield in laminated glass - safeguarding Daimler E-Klasse

On-road tests PC windshields with AS4700: safeguarding BMW 3er

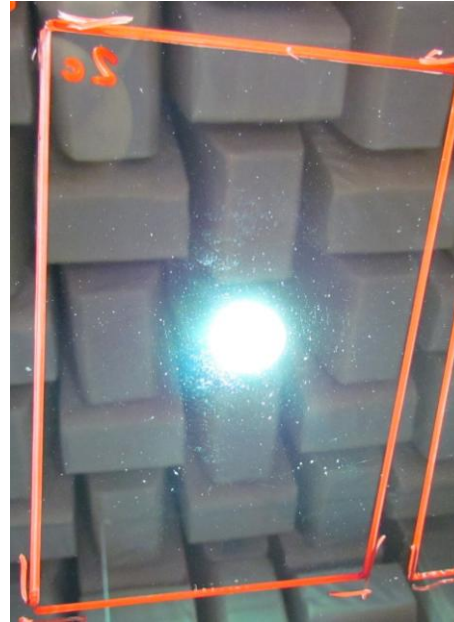
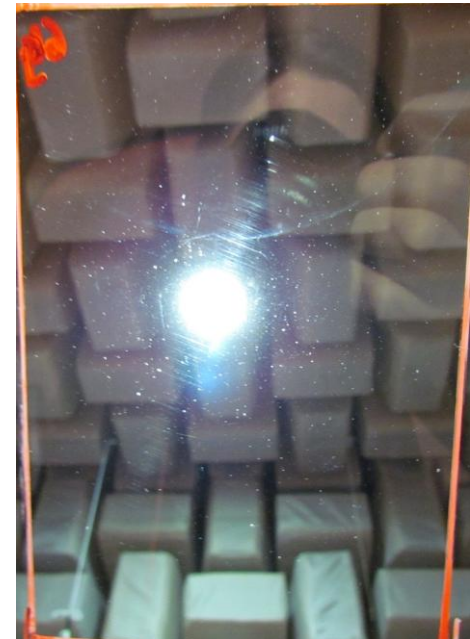
Impacts

e.g. by stones, sand

Deterioration by wiper

e.g. scratches, reversal points

Scratches,

e.g. by ice scratcher

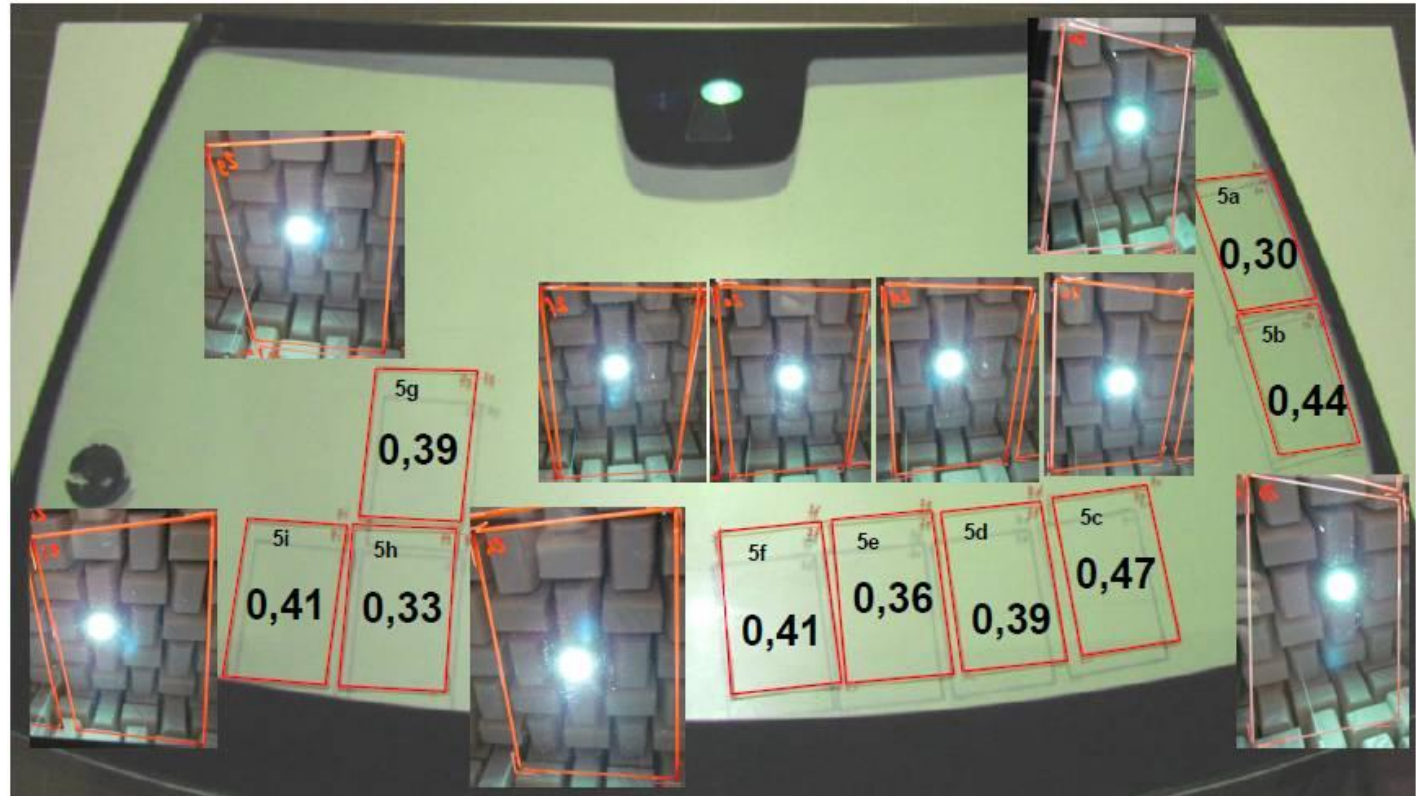
Dauerlaufwindschutzscheibe
Mercedes E-Klasse
164.514 km Raff-DL

Red Marked Areas on the windshield with visible deterioration, measured Haze-values

- ▶ duration:
approx. 12 month
- ▶ mileage:
approx. 164500 km
- ▶ wiper cycles:
some
not counted
- ▶ Haze values:
average 0,4 %

Only impacts

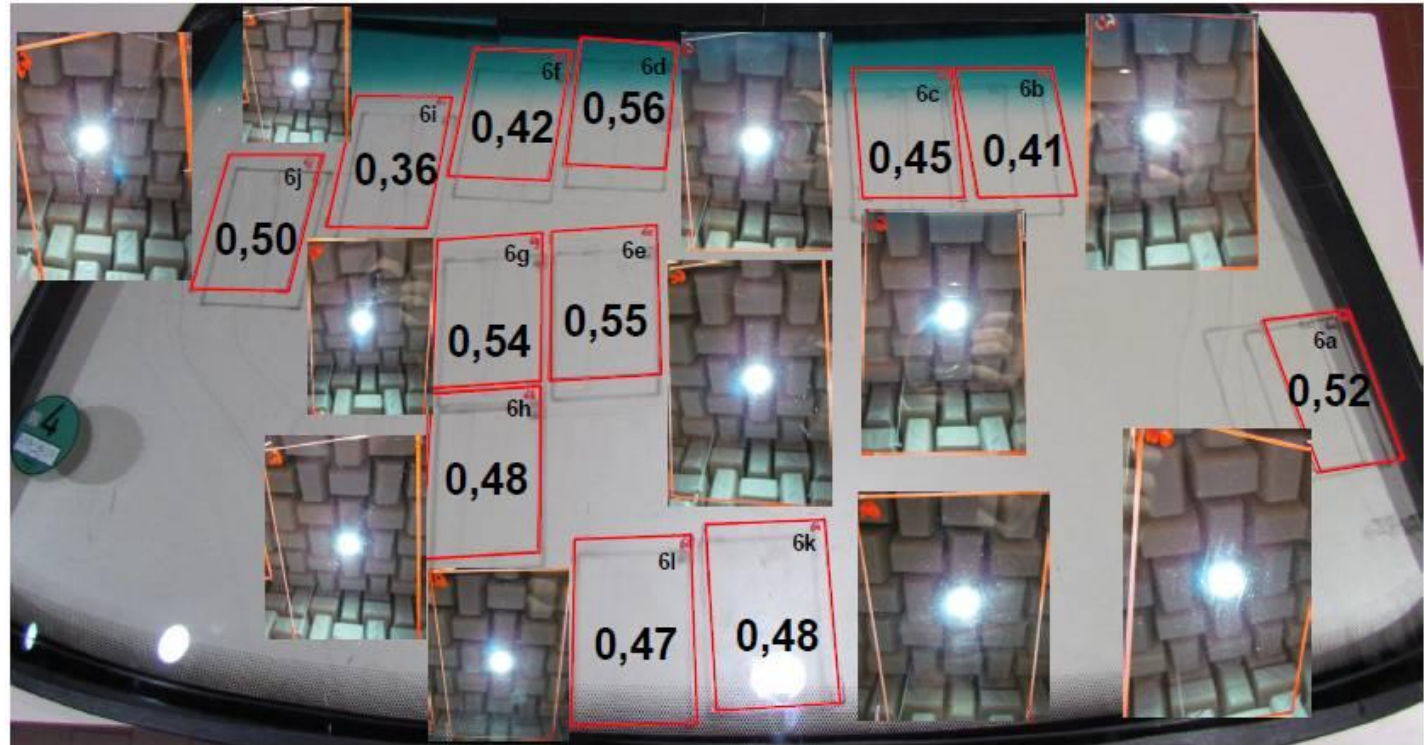
Red Marked Areas on the windshield with visible deterioration, measured Haze-values

- ▶ duration:
approx. 22 years
- ▶ mileage:
approx. 325100 km
- ▶ wiper cycles:
enough
not counted
- ▶ Haze values:
average 0,48 %

Mostly impacts, also wiper deterioration, scratches

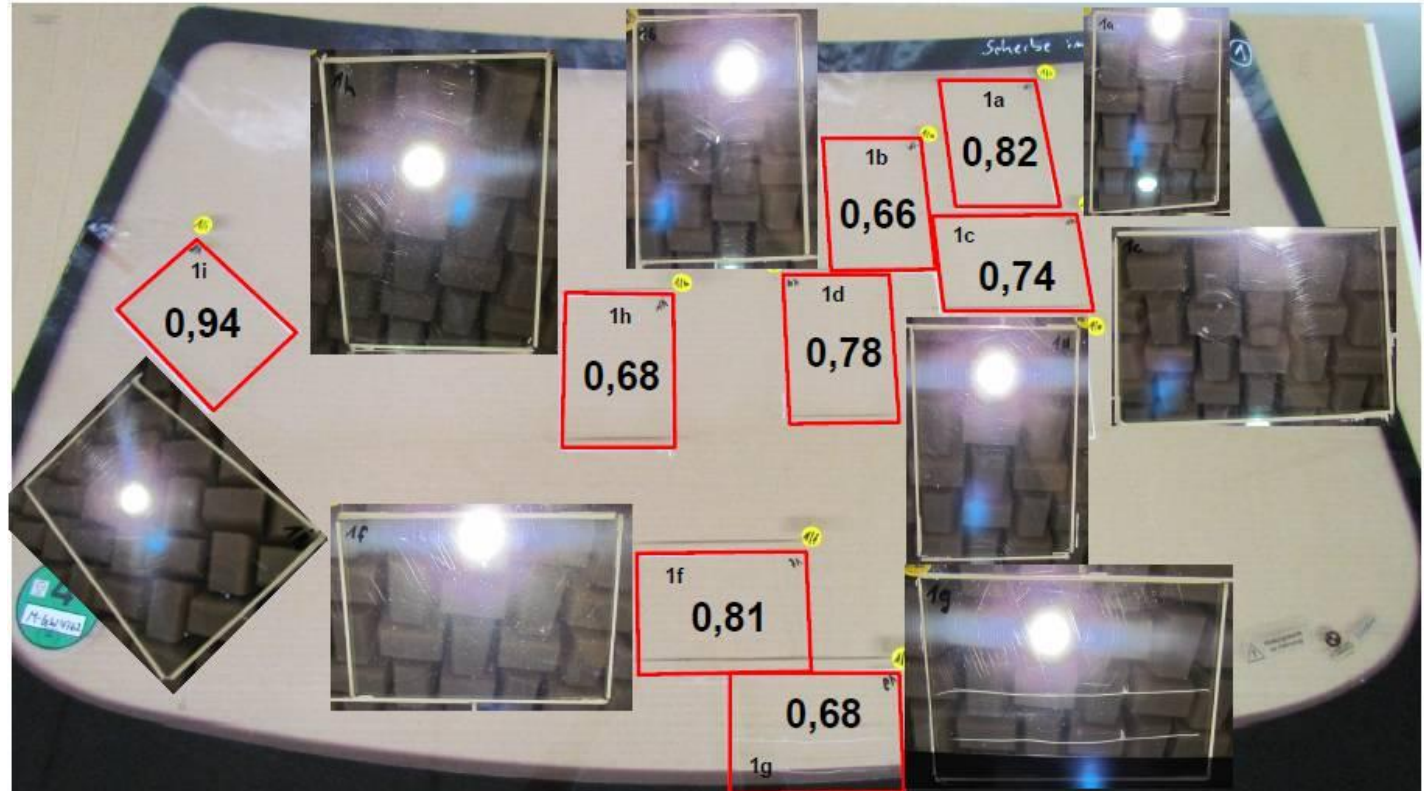
Red Marked Areas on the windshield with visible deterioration, measured Haze-values

- ▶ duration:
approx. 2 month
- ▶ mileage:
approx. 30000 km
- ▶ wiper cycles:
not much
no counter
- ▶ Haze values:
average 0,76 %

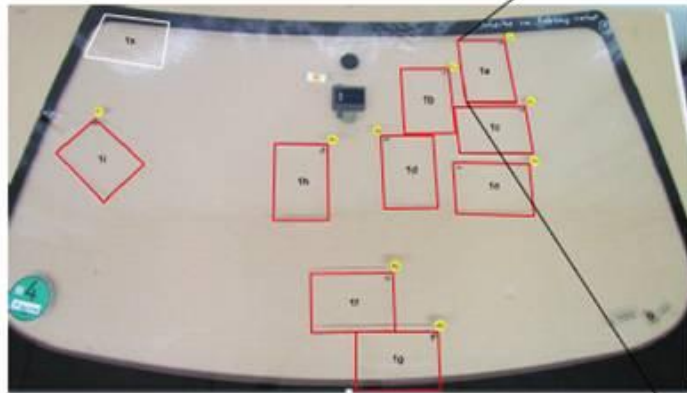
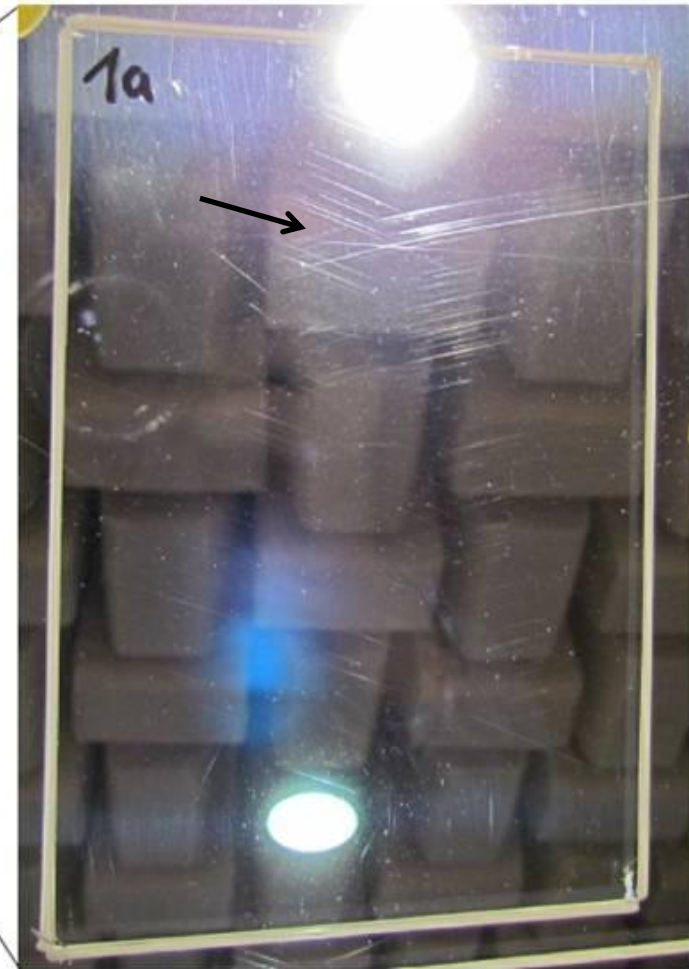
Deterioration of sample 1a:
double wiped area

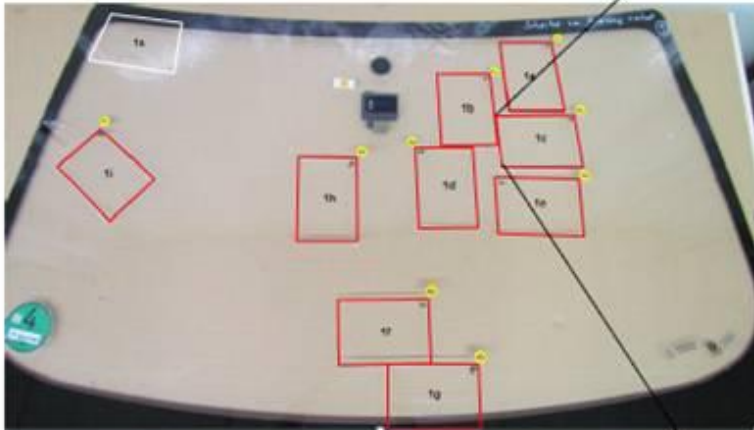
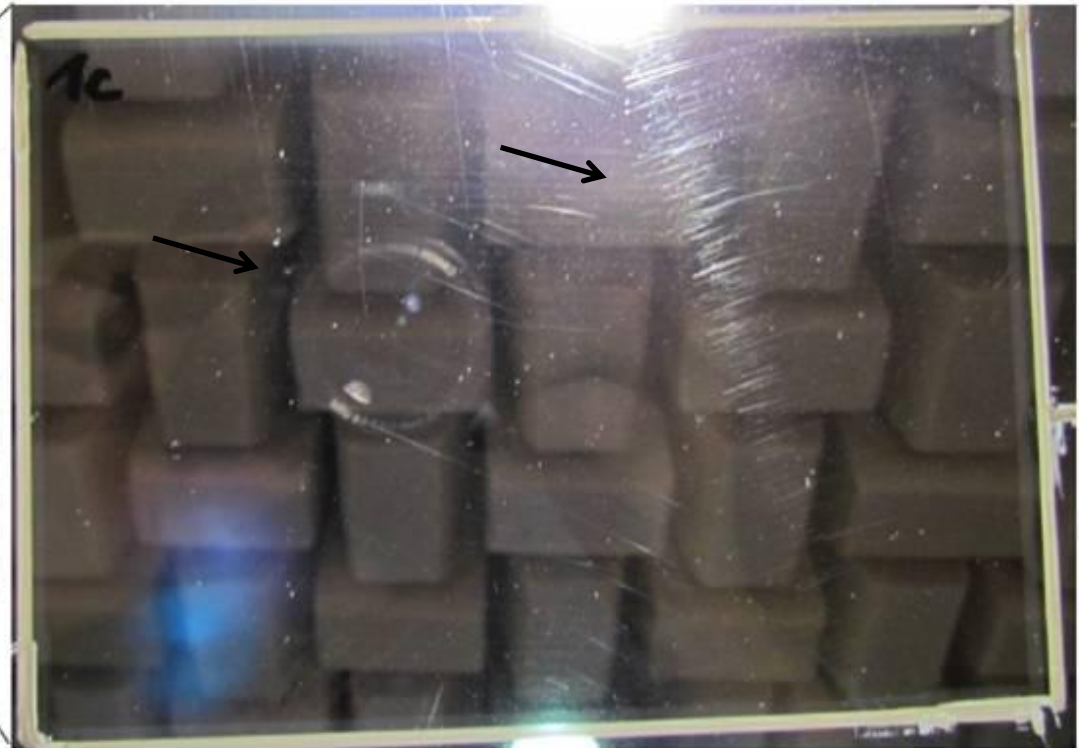
Deterioration of sample 1c:

- by wiper
- stone impacts visible

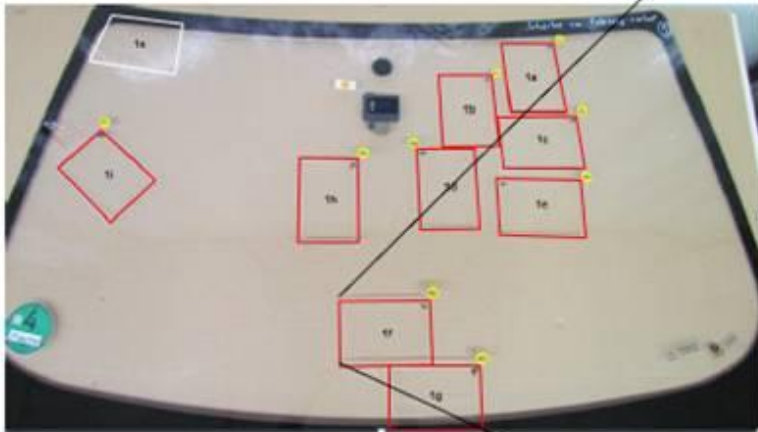
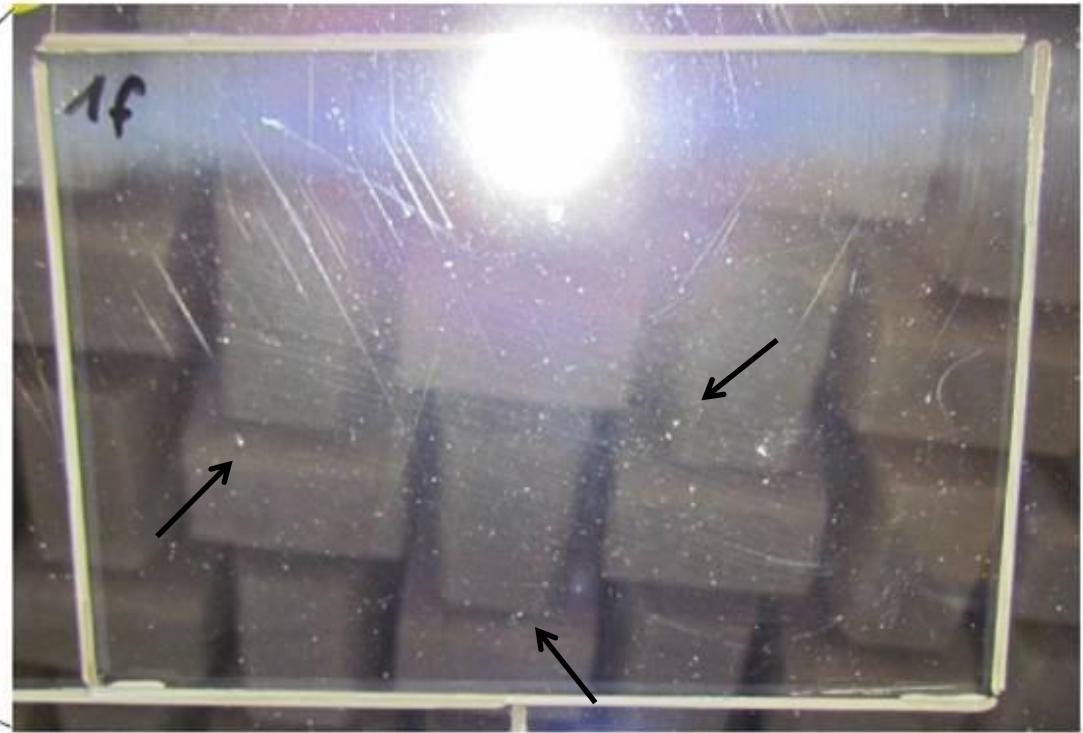
Detrioration of sample 1f:
mostly by stone impacts

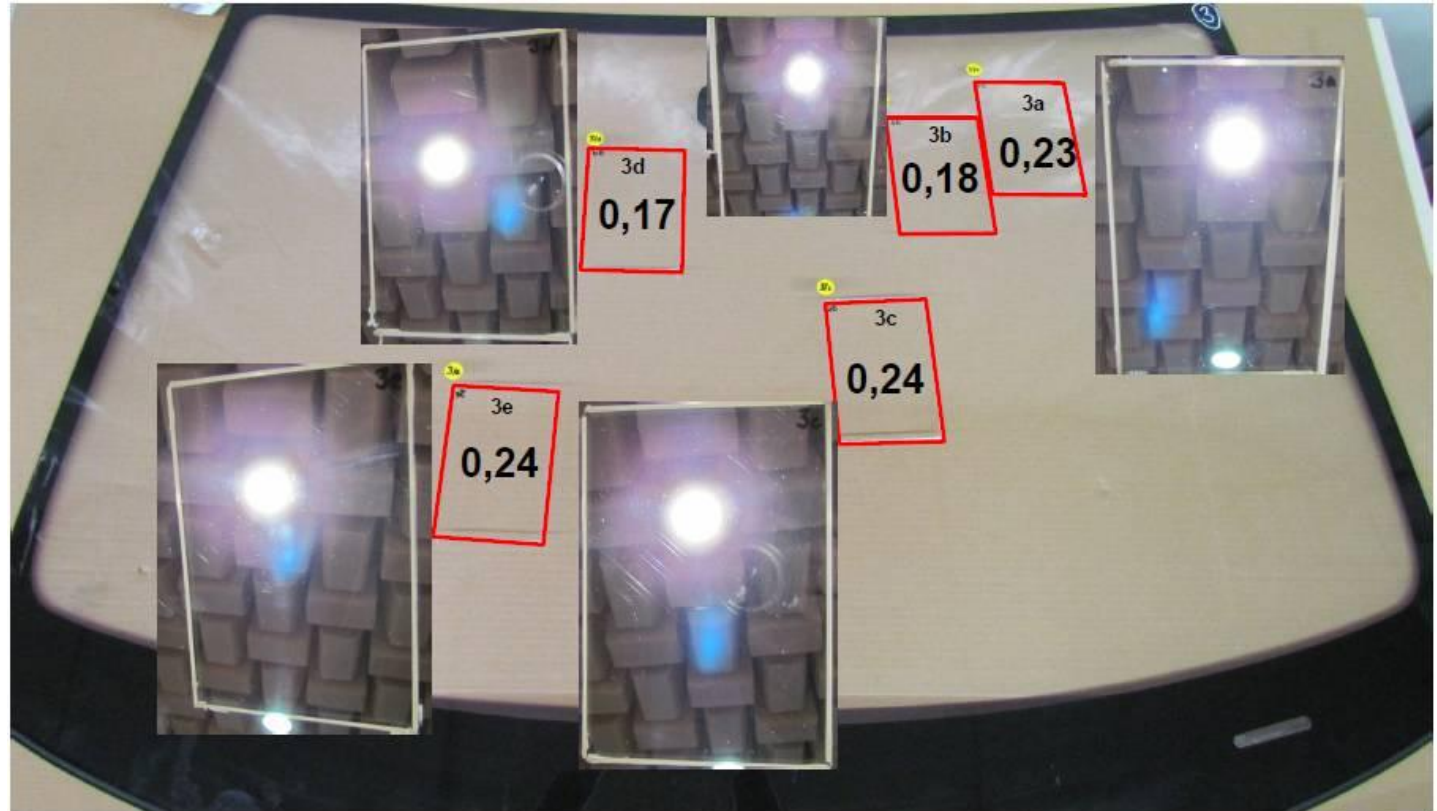
Red Marked Areas on the windshield with visible deterioration, measured Haze-values

- ▶ duration:
approx. 3 month
- ▶ mileage:
approx. 10000 km
- ▶ wiper cycles:
52000
- ▶ Haze values:
average 0,21 %

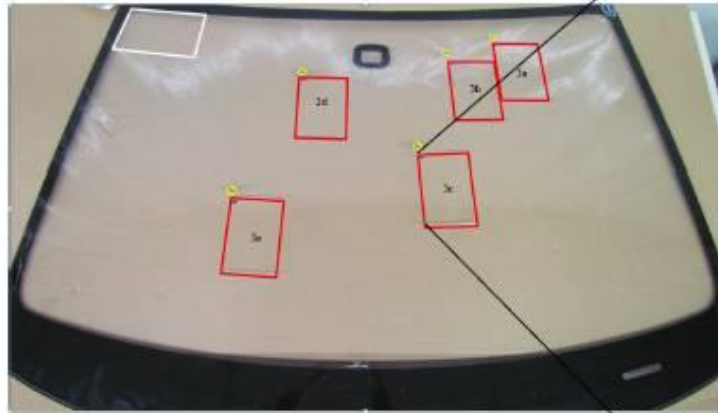
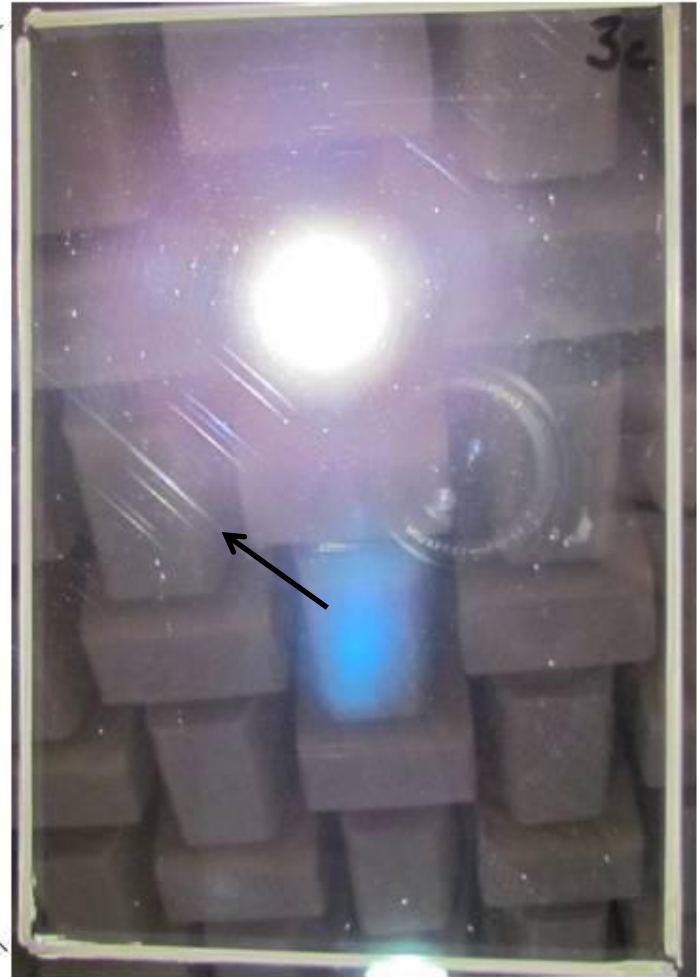
Deterioration of sample 3c:
by wiper

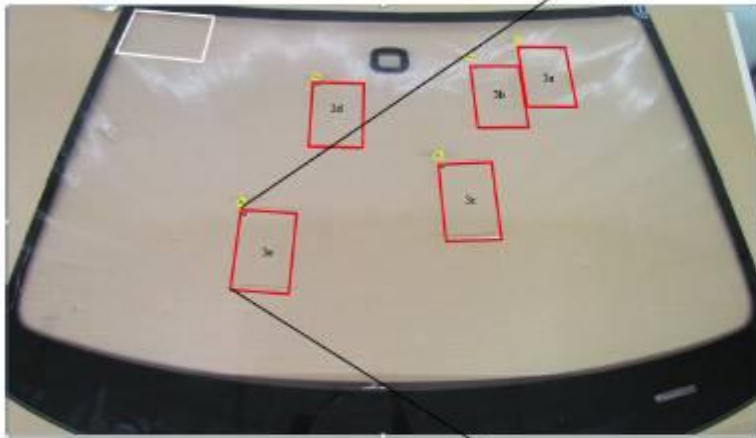
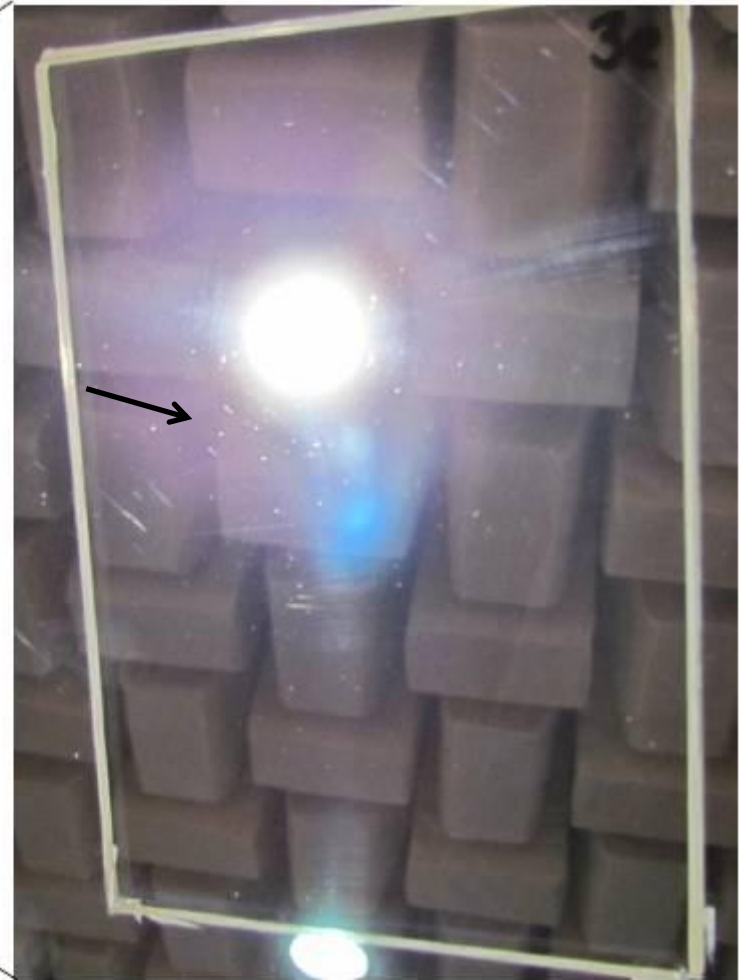
Detrioration of sample 3e:
mostly by stone impacts

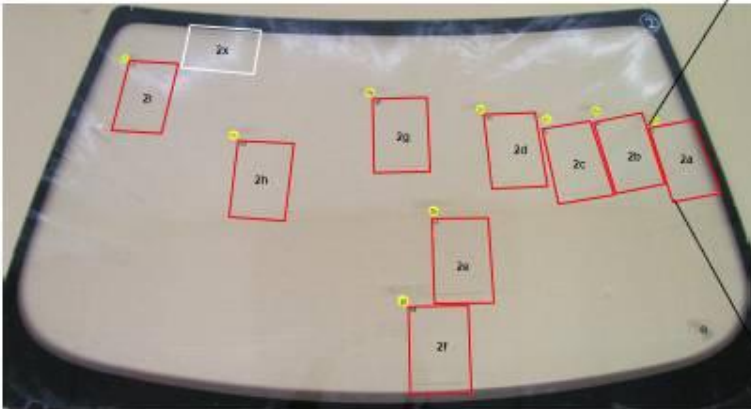
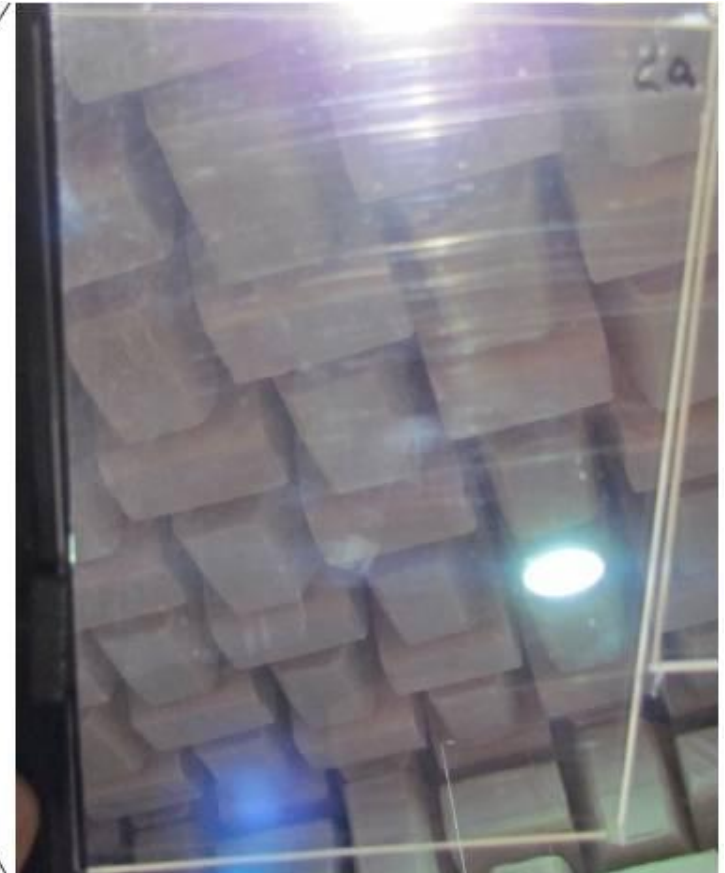
Windshield: PC with AS4700

- ▶ BMW 3er
- ▶ wiper approval equipment
- ▶ 1,5 Mio cycles (without sand):
no visible deterioration
- ▶ 100 cycles with sand
manual distribution on the windshield

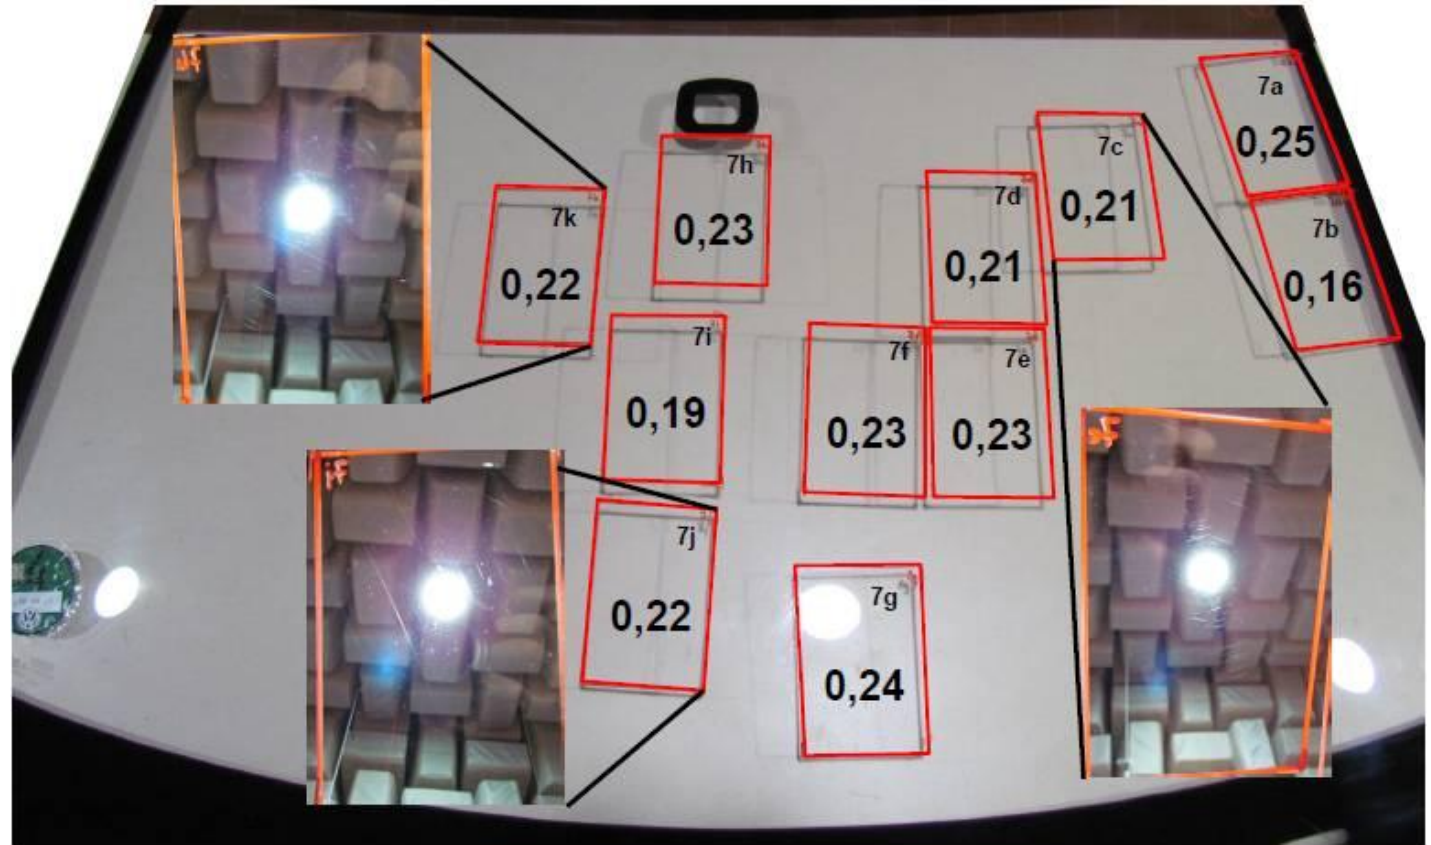
Red Marked Areas on the windshield with visible deterioration, measured Haze-values

- ▶ duration:
approx. 9 month
- ▶ mileage:
approx. 8200 km
- ▶ wiper cycles:
3021
- ▶ Haze values:
average 0,21 %

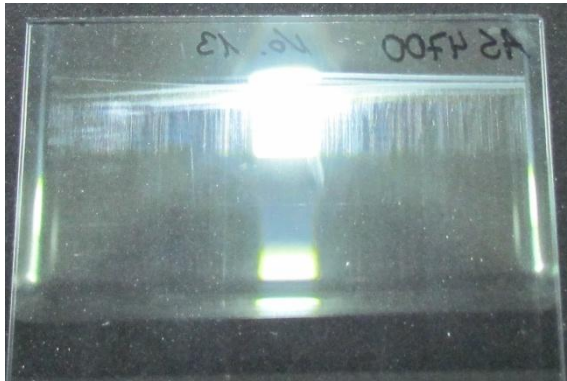
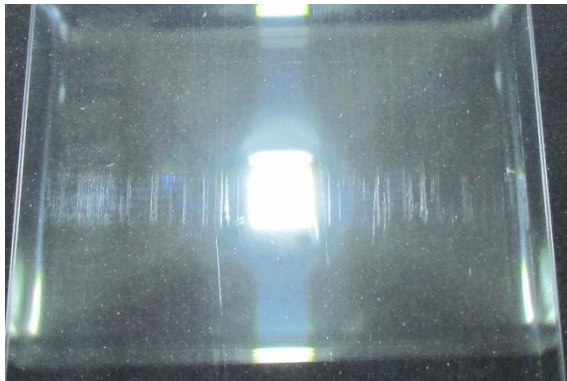
Comparison wiper test and on-road test: similar deterioration

Samples from wiper test

AS4700: 10000 cycles

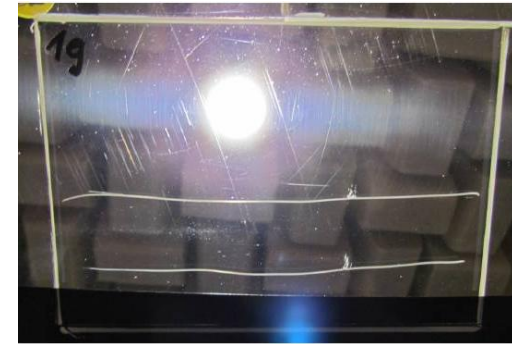
Samples of the windshield from on-road test

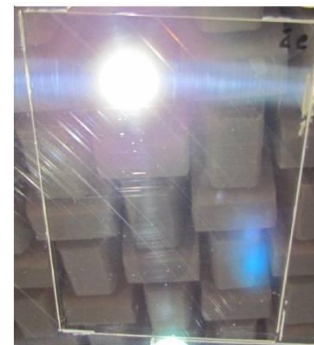
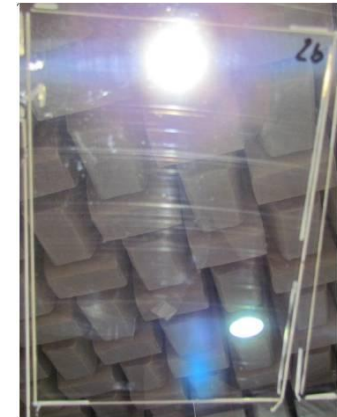
Samples of the windshield from wiper test

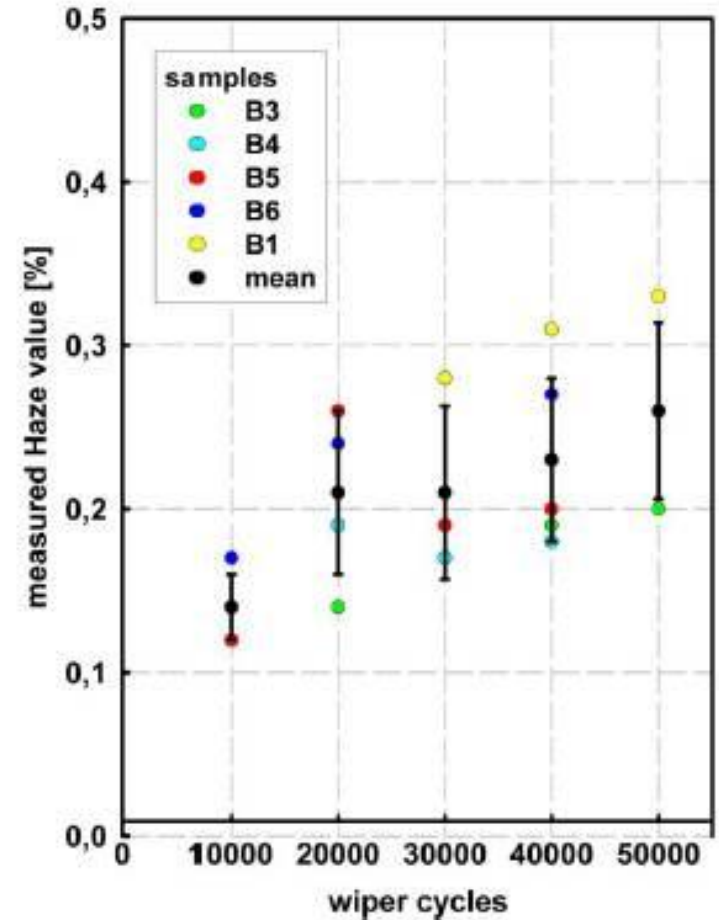
Results wiper test: Haze values of different materials after wiper cycles

Laminated glass (VSG)

cycles	measured Haze [%]							
	samples						mean	standard deviation
	B3	B4	B5	B6	B1	B2		
10000	0,12		0,12	0,17		0,14	0,02	
20000	0,14	0,19	0,26	0,24		0,21	0,05	
30000	0,17	0,17	0,19	0,28	0,28	0,15	0,053	
40000	0,19	0,18	0,2	0,27	0,31	0,24	0,05	
50000	0,2				0,33	0,24	0,054

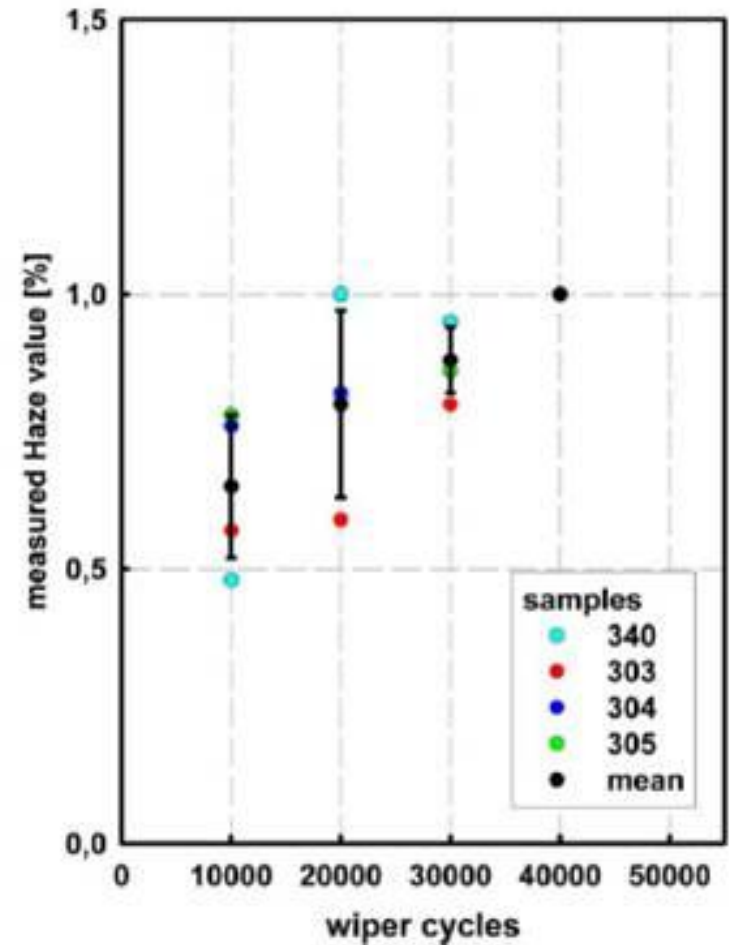
Results wiper test: Haze values of different materials after wiper cycles

PMMA coated

cycles	measured Haze [%]					
	samples				mean	standard deviation
	340	303	304	305		
10000	0,48	0,57	0,76	0,78	0,65	0,13
20000	1	0,59	0,82		0,8	0,17
30000	0,95	0,8		0,86	0,88	0,06
40000	1				1	
50000

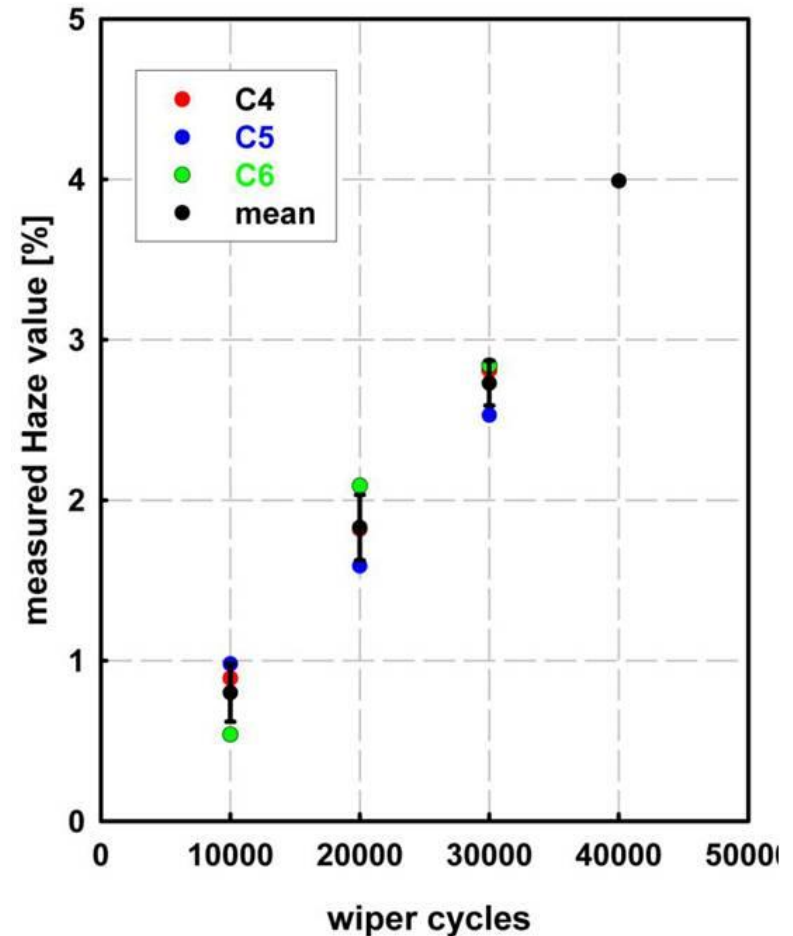
Results wiper test: Haze values of different materials after wiper cycles

PC coated with AS4700

cycles	measured Haze [%]				
	samples			mean	standard deviation
	C4	C5	C6		
10000	0,89	0,98	0,54	0,8	0,18
20000	1,82	1,59	2,09	1,83	0,204
30000	2,81	2,53	2,84	2,73	0,14
40000		3,99		3,99	0
50000

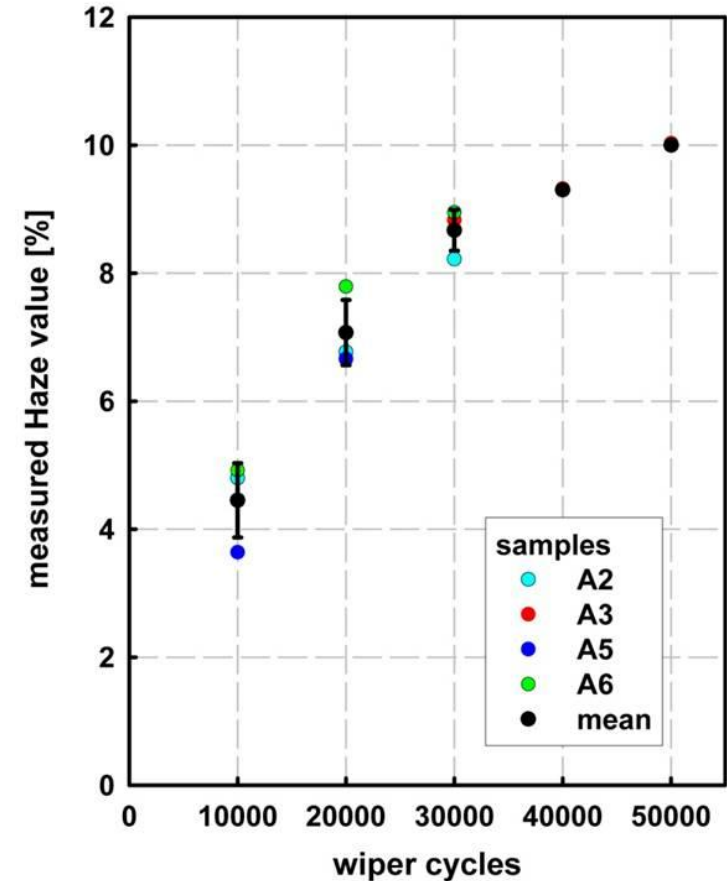
Results wiper test: Haze values of different materials after wiper cycles

PC coated with UVHC3000

cycles	measured Haze [%]					
	samples				mean	standard deviation
	A2	A3	A5	A6		
10000	4,8		3,64	4,92	4,45	0,58
20000	6,77		6,66	7,79	7,07	0,51
30000	8,22	8,83		8,95	8,67	0,32
40000		9,32			9,3	0
50000		10,03			10	0

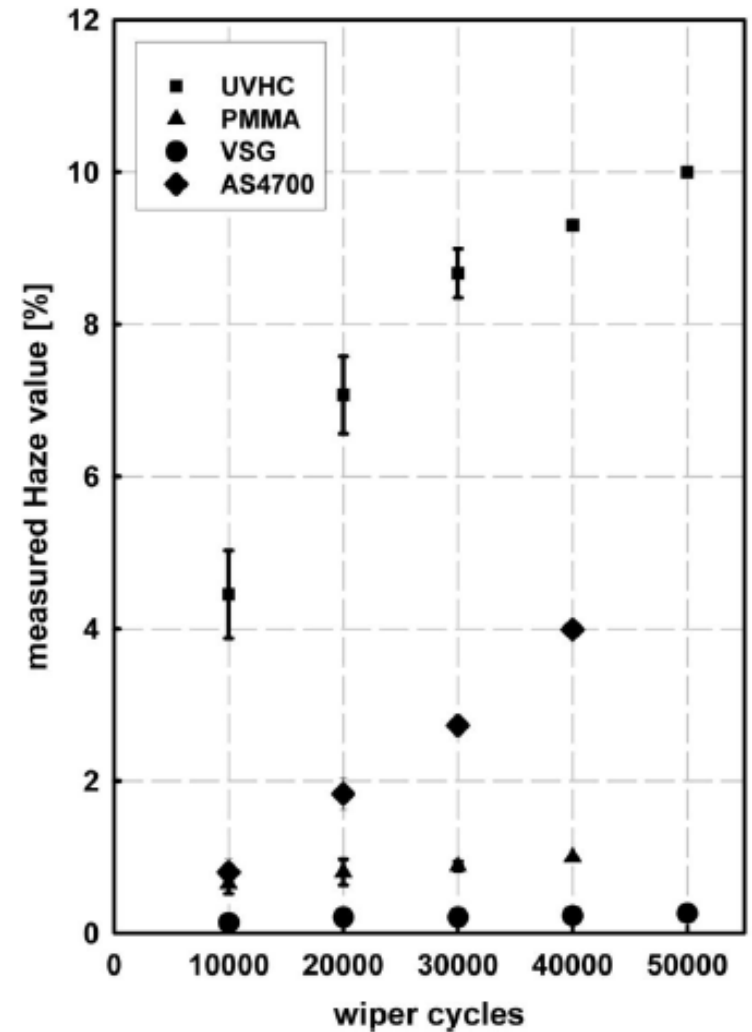
Results wiper test: Haze values of different materials after wiper cycles

All tested materials

- ▶ Proposal for the regulation document: Wiper test with current test condition (base of the obtained results)
min. 3 test samples
wiper cycles: 50000
criterium: $\leq 0,5$ % Haze
