# **46<sup>th</sup> DETA IWG Session**

## **Unique Identifier**

March 2<sup>nd</sup>, 2023

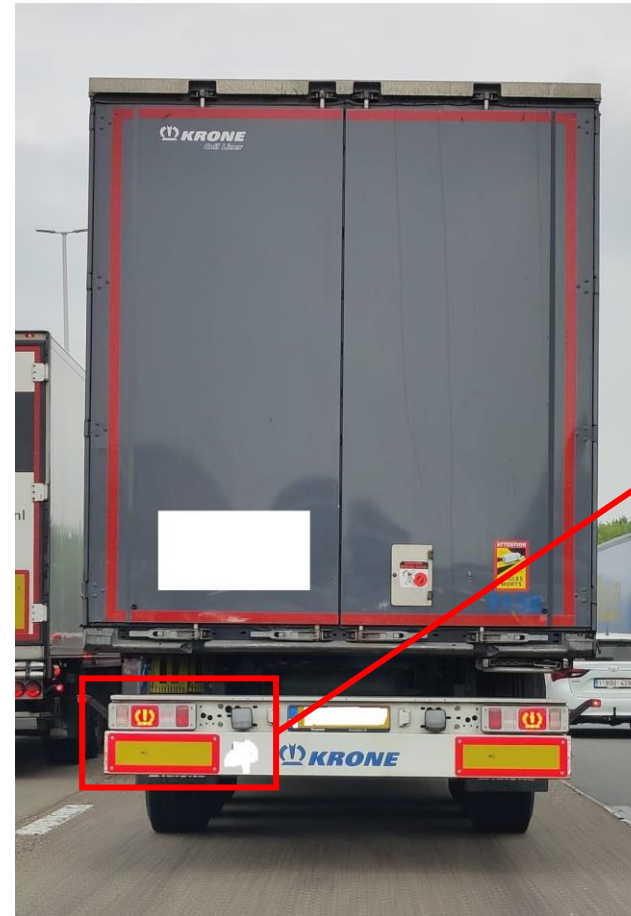
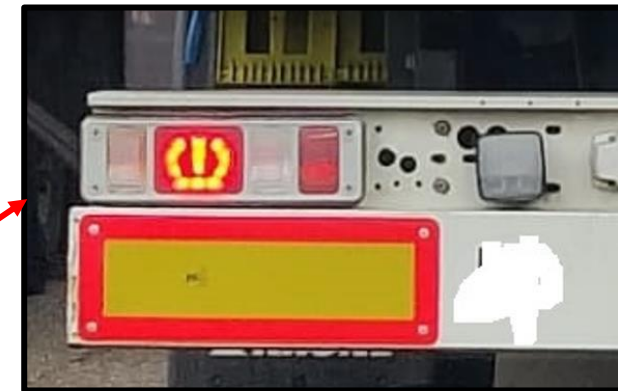
**UI, as conceived today, obliges to download a PDF to check whether this semitrailer has a triangular retroreflective device (IIIB)**

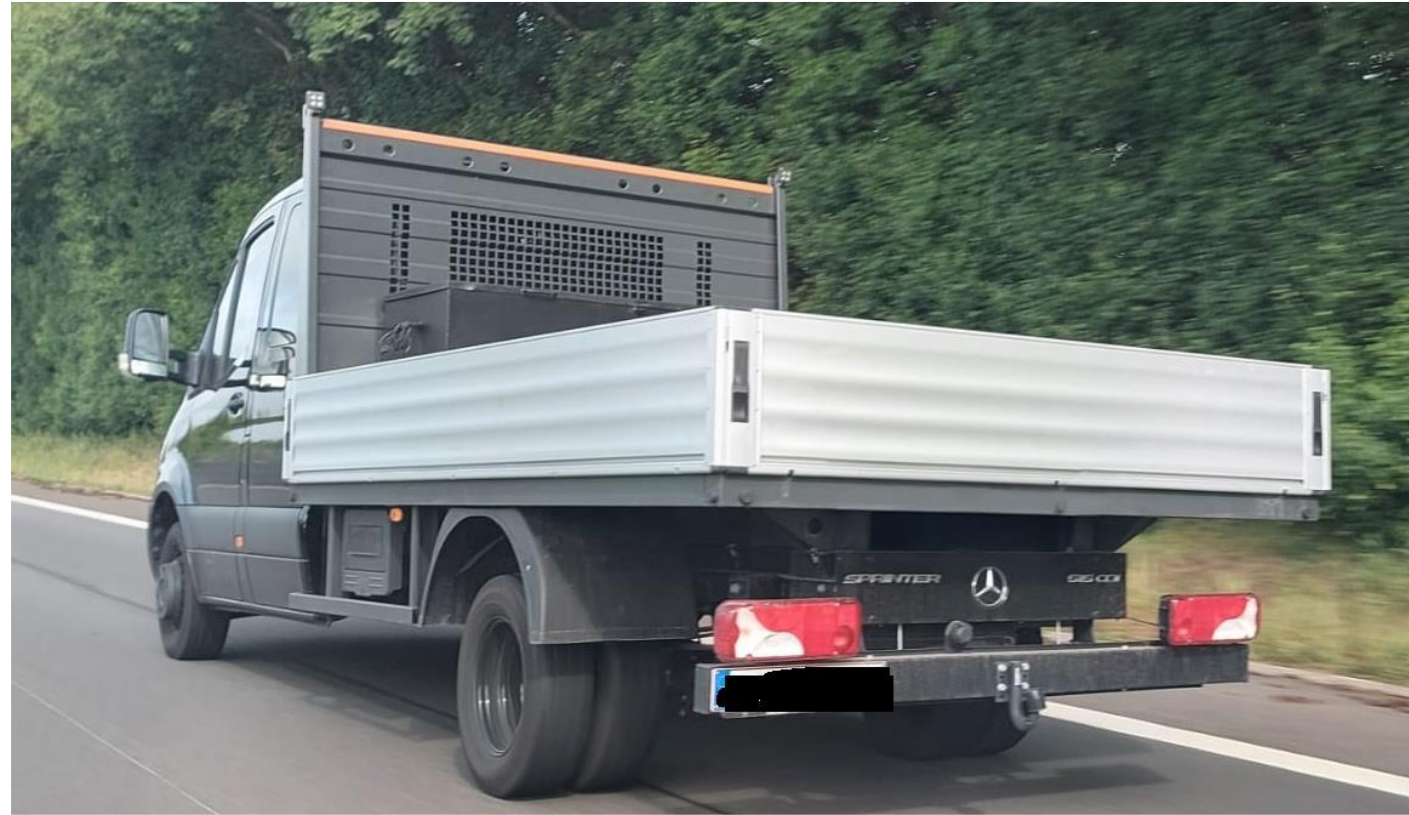
**UI, as conceived today, obliges to download a PDF to check whether this truck has a side marker lamp (SM1) incorporated in the rear group of lamps**

**The 1997 Agreement and Directive 2014/45/EU require to check the presence of the devices shown in the examples.**

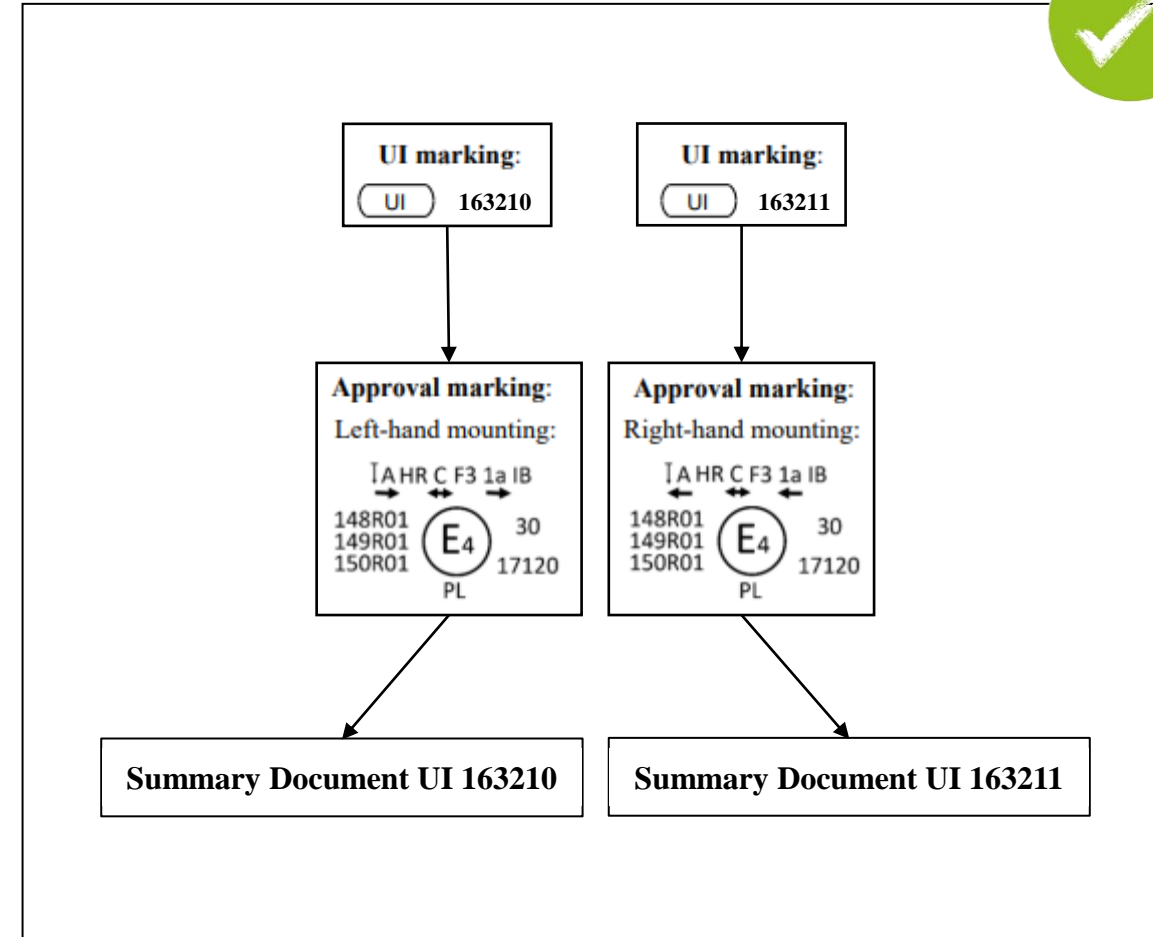
## Example of a summary document

The following is given merely as an example and any other arrangements in accordance with Annex 9 to this Regulation is acceptable.

<p><b>Summary Document UI 163210</b></p> <p><b>UI marking:</b>  </p> <p><b>Approval marking:</b></p> <p>Left-hand mounting:      Right-hand mounting:</p> <p style="text-align: center;"> </p> <p style="text-align: center;"> </p> <p><b>Restrictions to the use and/or installation of the device:</b></p> <p>Maximum installation height of the front position lamp (A) is 750 mm</p> <p style="text-align: right;">page 1 of 2</p>	<p><b>Summary Document UI 163210</b></p> <p><b>Additional information, if any:</b></p> <p>This device, with a plastic outer lens (PL), contains the functions driving-beam (HR), passing-beam (C), front fog lamp of Class F3 (F3), front direction indicator of category 1a (1a), reflex reflector of Class IB (IB) and a front position lamp (A) with reduced light distribution (as indicated by the vertical arrow).</p> <p>The driving-beam provides a maximum intensity between 123,625 and 145,125 candelas (as indicated by the number 30). The passing-beam fulfils the requirements for right-hand traffic and left-hand traffic (as indicated by the double headed arrow).</p> <p>Due to the photometric restrictions for the front position lamp and the front direction indicator the arrow below the symbols (A, 1a) shall be directed outwards from the vehicle.</p> <p style="text-align: right;">page 2 of 2</p>
