Pedal Misapplication Cases from EDR Perspective

Korea Automobile Testing & Research Institute (KATRI)

Special Accident Investigation Office

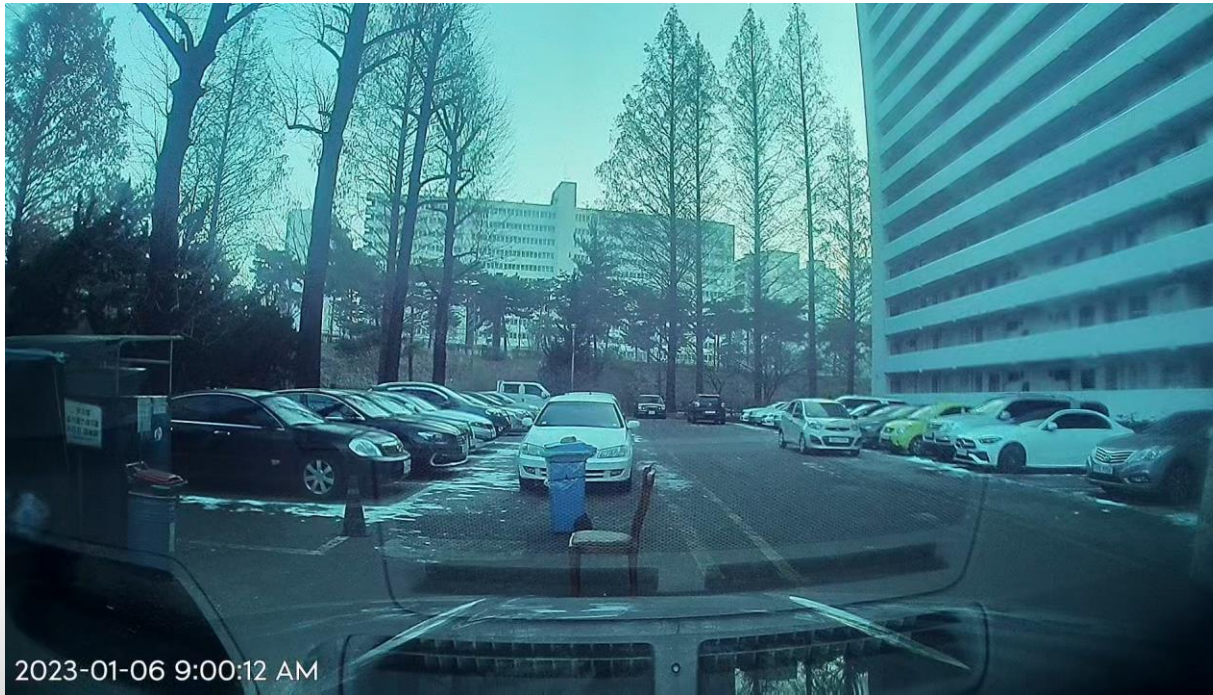
- ☑ Collisions with vehicles and trees in front of the parking lot due to unintended acceleration
- ☑ The driver claims that the vehicle suddenly accelerated with loud engine noise while stopping
- ☑ On the EDR record, APS is 99% and the brake pedal is not pressed

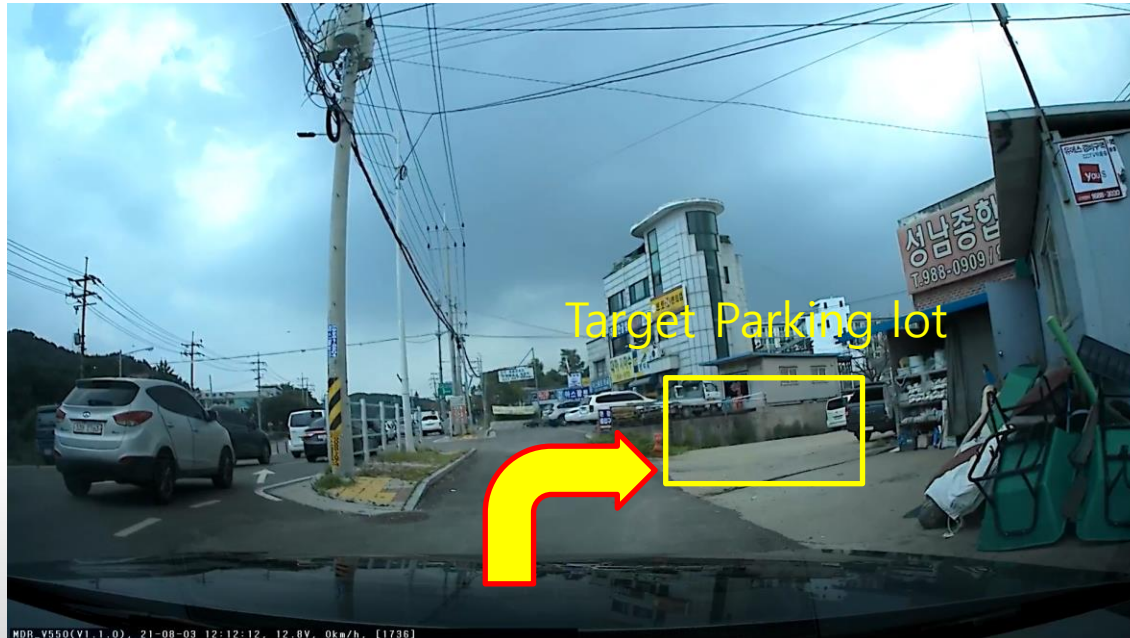
- ☑ The driver was trying to park the vehicle in a parking lot on the right.
- ☑ But, the driver claims that the brake pedal was operated but the vehicle suddenly accelerated without braking
- ☑ According to the EDR and Video analysis, the driver entered the parking lot with the right steering and operated the accelerator pedal

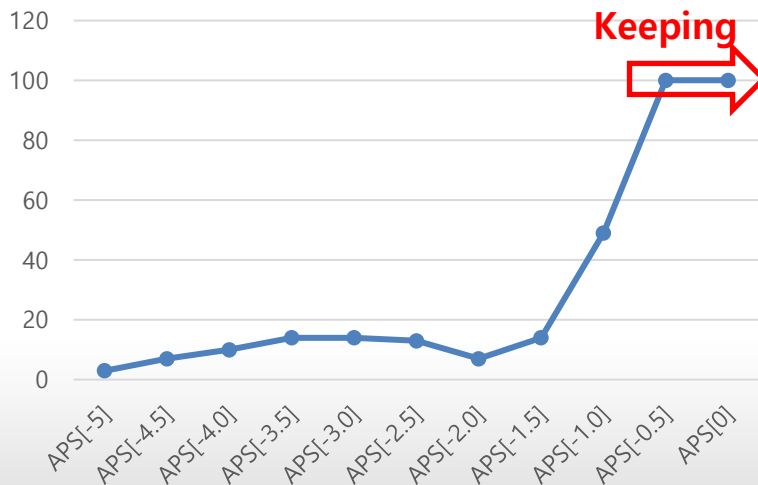
- ☑ There are two types of APS records in the EDR for pedal misapplication
- ☑ (Type 1: **Keeping**) Driver presses the accelerator pedal continuously and keeps it pressed at full throttle
- ☑ (Type 2 : **Pumping**) Repeated pedal misapplication causes the gas pedal to pump, and the pumping speed tends to increase after the initial pedal misapplication.

Type 1: Press the pedal all the way down.

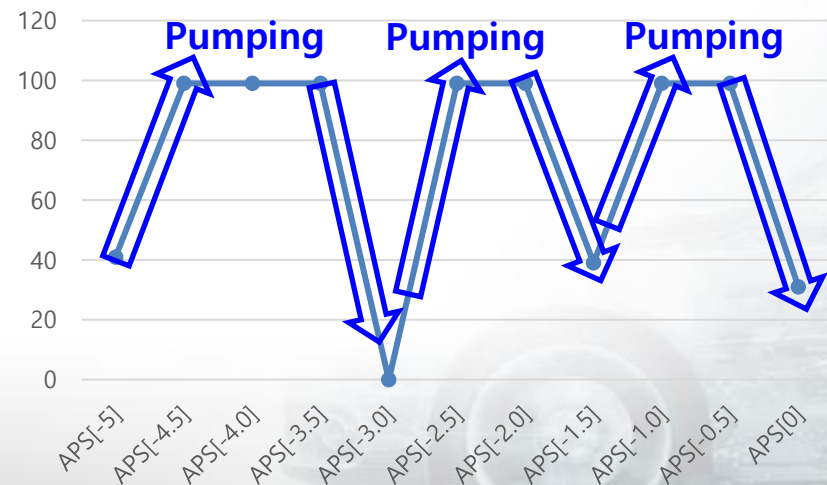
Type 2: Pumping the gas pedal

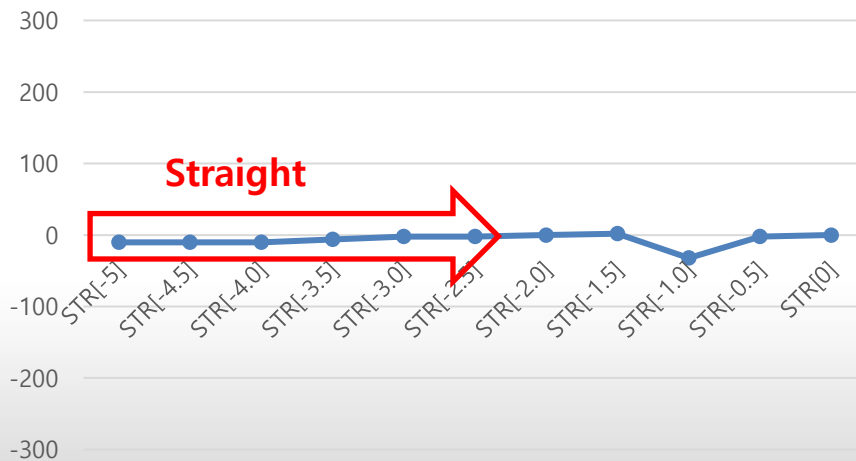
- ☑ There are two situations of steering records in the EDR for pedal misapplication
- ☑ (Situation 1: Straight) Steering angle changed below ± 45 degrees between 5 seconds and 2.5 seconds before the accident
- ☑ (Situation 2: Turning) Steering angle change exceeded ± 45 degrees between 5 seconds and 2.5 seconds before the accident.

Situation 1: Straight

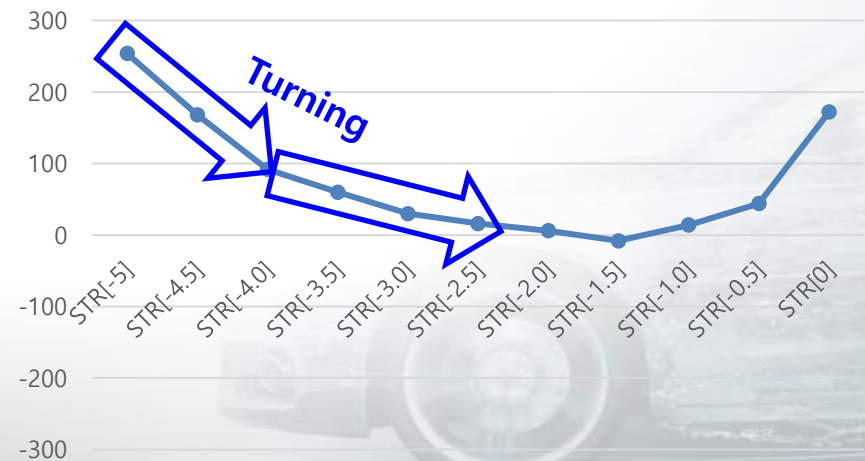
Situation 2: Turning

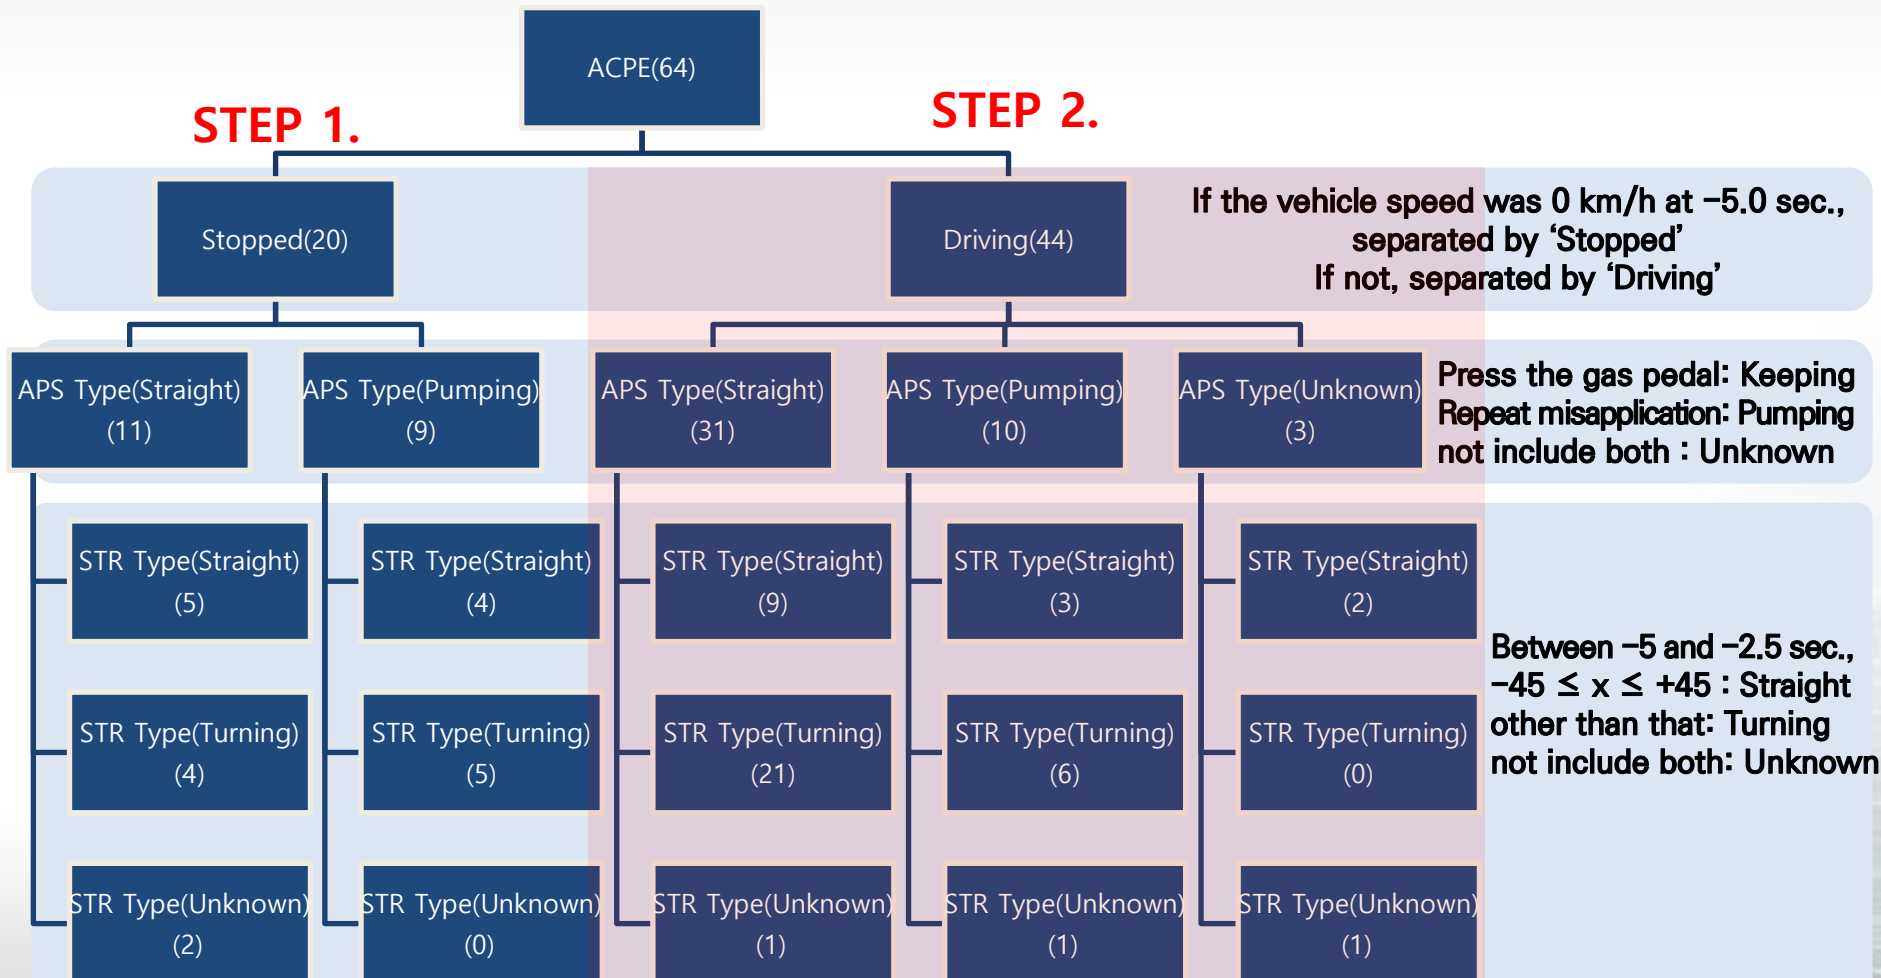
EDR Data Analysis

- ☑ Analyzed data from 64 accidents and confirmed that 44 (68%) occurred(in driving mode).
- ☑ In 42 cases (66%), the gas pedal was kept after the pedal misapplication, but in 20 cases (31%), it was pumping the gas pedal.
- ☑ there were more accidents in which the gas pedal misapplication while driving in a turn, with 23 cases (36%) in a straight line and 36 cases (56%) in a turn.
- ☑ The maximum speed of accidents caused by pedal misapplication during a stop was 44km/h, but the maximum speed of accidents caused by pedal misapplication while driving was 73km/h.
- ☑ In Step 2, it is necessary to consider pedal misapplication in situations that require deceleration while driving, such as parking, entering a building, or entering a curve.
