Investigation of ACPE performance tested by creeping procedure

National Traffic Safety and Environment Laboratory

Purpose of the investigation

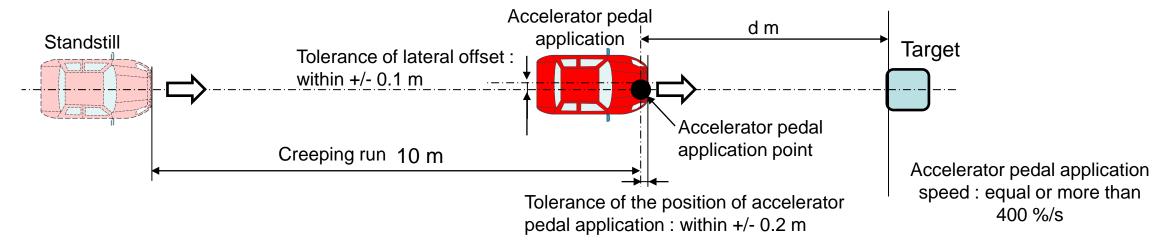
- The driver released brake pedal. And the vehicle runs 10 m with creeping speed.
- The driver applies accelerator pedal at the accelerator pedal application point which is fixed. The reason why the distance of creeping run and the position of accelerator pedal application are fixed is in order to minimize the deviation of the distance as much as possible between the position of accelerator pedal application and the target.
- Both the steering control and accelerator pedal were operated within the tolerances by a professional driver.

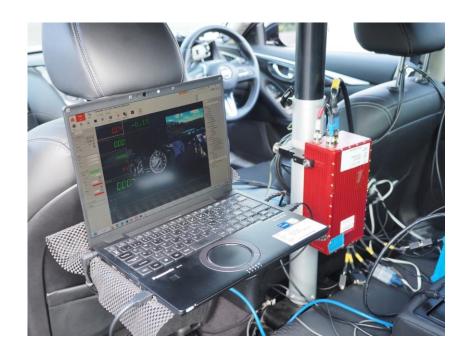
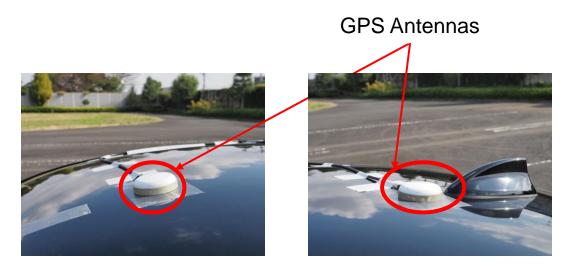
- Longitudinal and lateral position of the vehicle and velocity of the vehicle were measured accurately by RTK GPS (OxTS RT-range).
- Accelerator pedal position was measured by recording the change of voltage.

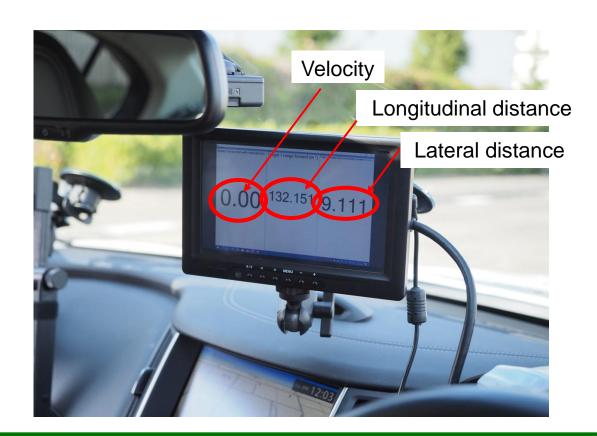
• Through the monitor on the dashboard, velocity, longitudinal distance and lateral distance of the vehicle were provided to the driver in real time as the guidance in order to drive within the tolerances.

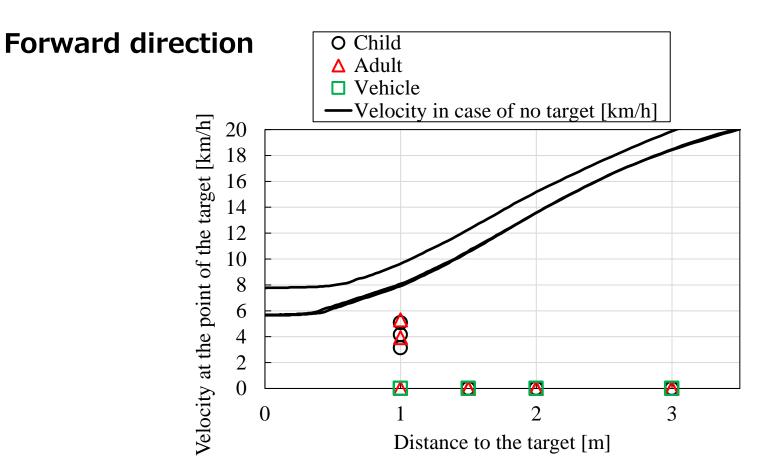
Experimental result (Velocity at the point of the target)

- In case of the vehicle target, acceleration was controlled and the vehicle was stopped by brake control in all the distance conditions.
- In case of the adult target and the child target, acceleration was controlled in 1 m condition, and the vehicle was stopped by brake control after acceleration control in the condition of 1.5 m, 2 m and 3 m conditions.
- In case of "no target", about 2 km/h deviation of velocity among 3 trials was observed.

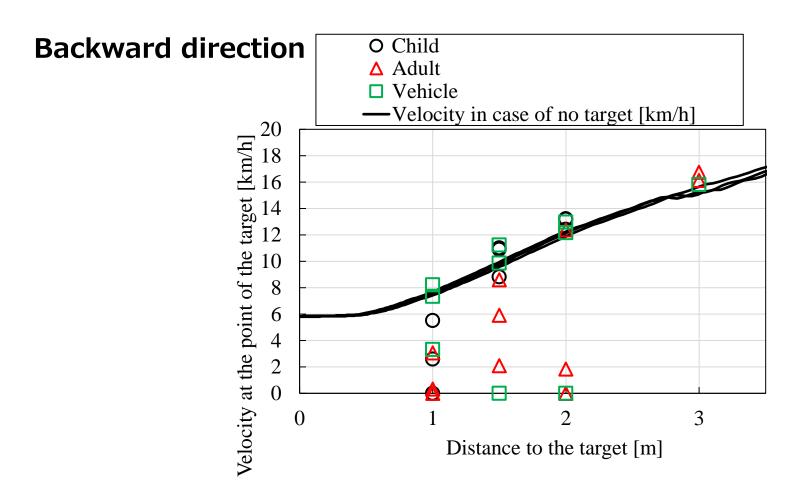
Experimental result (Velocity at the point of the target)

The cases in which no acceleration control were observed were seen regardless the of the targets and the distances.

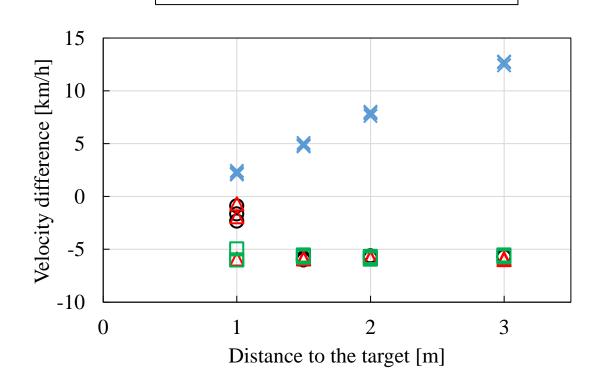
Forward direction

Experimental result (Velocity difference*)

- In all of the targets, velocity difference is below 0 km/h in each distance condition (acceleration control was activated).
- Even if the case of "no target" condition (without acceleration control), the velocity differences with velocity at the point of accelerator pedal application was less than 8 km/h in 1 m, 1.5 m and 2 m.

*Velocity difference = (Velocity at the point of target) – (Velocity at the point of accelerator pedal application)

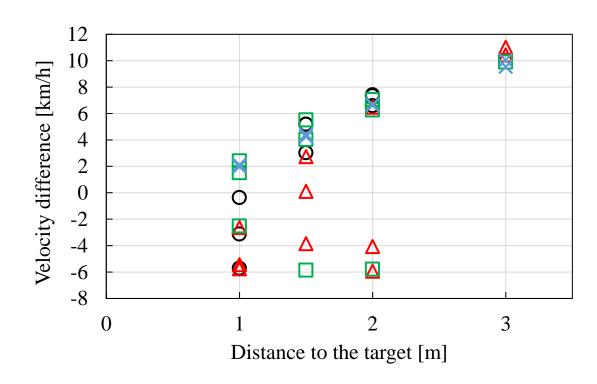
Backward direction

Experimental result (Velocity difference*)

- In all of the targets, such cases in which acceleration control was not activated were observed. On the other hand, such cases in which acceleration control was activated were observed except 3 m.
- Even if the case of "no target" condition (without acceleration control), the velocity differences with velocity at the point of accelerator pedal application was less than 8 km/h in 1 m, 1.5 m and 2 m (similar to forward direction).

*Velocity difference = (Velocity at the point of target) – (Velocity at the point of accelerator pedal application)

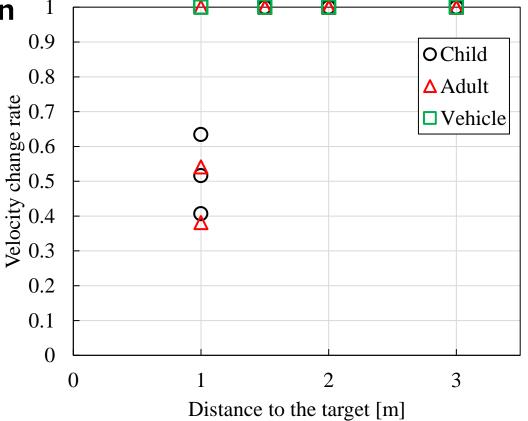
Forward direction

Experimental result (Velocity change rate*)

- In all of the targets, velocity difference is from 0.4 to 1.0.
- In all of the target, velocity change rate was 1.0 (the vehicle was stopped by braking control) in 1.5 m, 2m, and 3m.

(velocity at the point of target with "no target") – (velocity at the target point with a target)

*Velocity change rate = (velocity at the point of target with "no target")

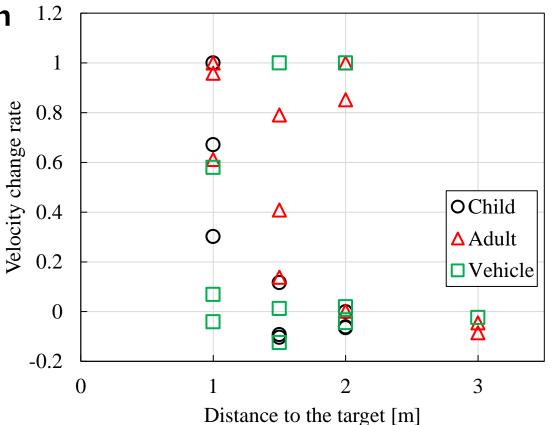
Backward direction

Experimental result (Velocity change rate*)

- Data of velocity change rate in 1 m, 1.5 m and 2 m is distributed in wider range compared to forward direction.
- In case of the child target, velocity change rate was equal to or below 0 in 1.5 m and 2 m (Experiment was skipped in 3 m).
- In 3 m, velocity change rate was equal to or below 0 in both cases of the vehicle and adult targets.

(velocity at the point of target with "no target") - (velocity at the target point with a target)

(velocity at the point of target with "no target")

*Velocity change rate =

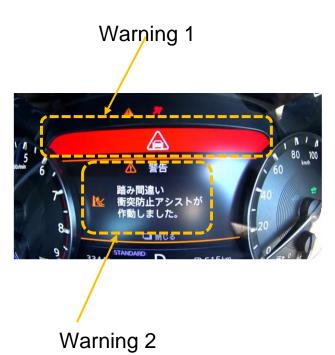
Definition of the words in the figures

Warning 1: The warning which inform the driver that emergency braking control function is being activated. This warning is shown, either when emergency braking control of AEBS or low speed emergency braking control of ACPE is activated.

Warning 2: The warning which inform the driver that ACPE is being activated. This warning is specified for ACPE.

Td(100%): The time of accelerator pedal application from 0% to reaching 100% [s]

Vp(0-100%): Accelerator pedal application speed [%/s]

De: Error of distance at the point of accelerator pedal application [m]

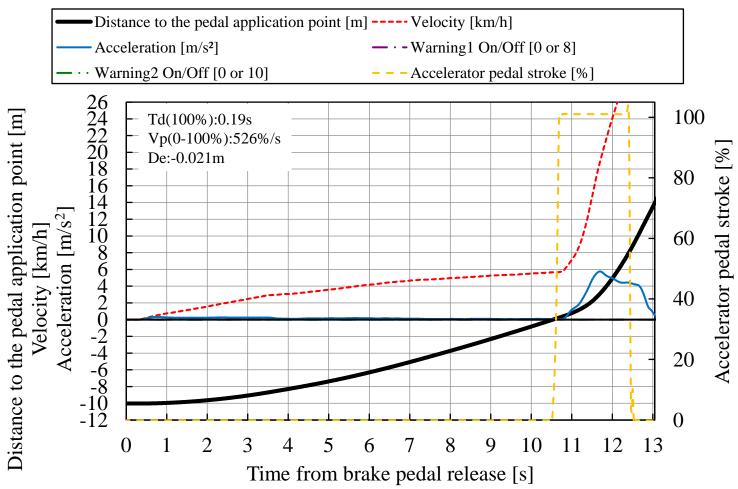
Maximum acceleration of the vehicle was approximately 6 m/s² in the condition of "no target".

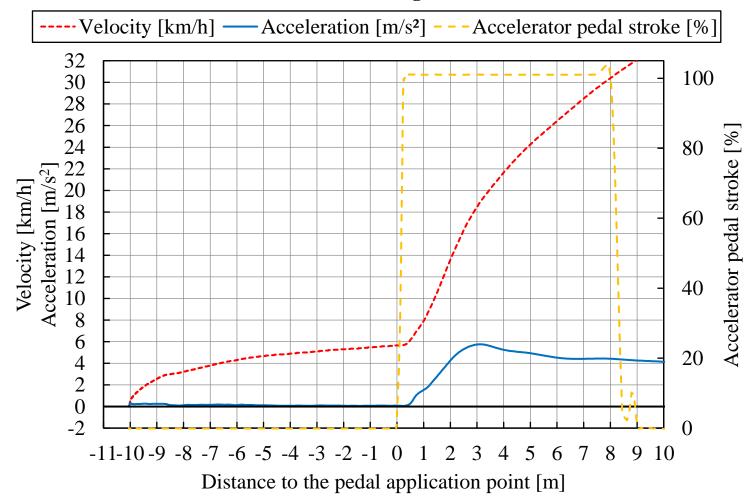
Forward___NoTarget___No.1

Velocity of the vehicle was approximately 6 km/h just when the vehicle reached the accelerator pedal application point, however velocity was not steady value (gradual acceleration was ongoing).

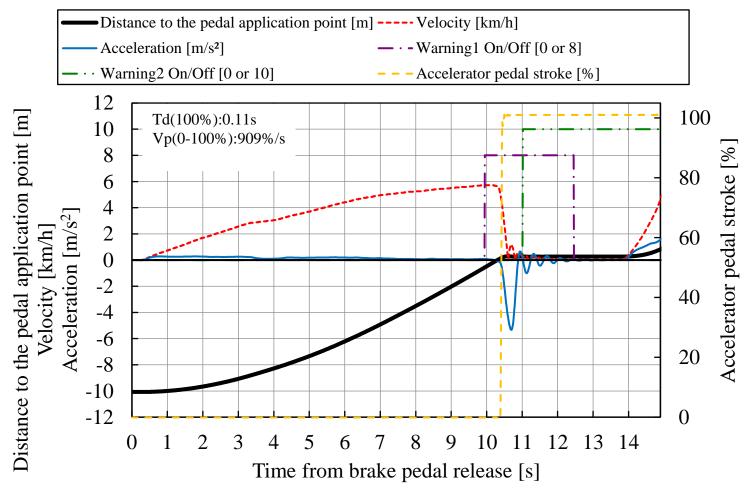
- Acceleration control was continued for more than 2 s.
- The vehicle was decelerated and completely stopped.
- It is difficult to distinguish whether braking control was carried out by AEBS or ACPE, because the warning 1 was begun just before the start of accelerator pedal application.

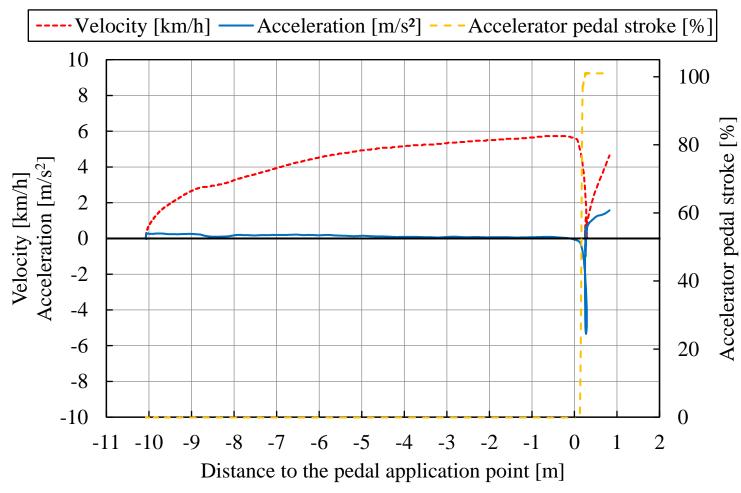
Collision with the target was avoided by braking control.

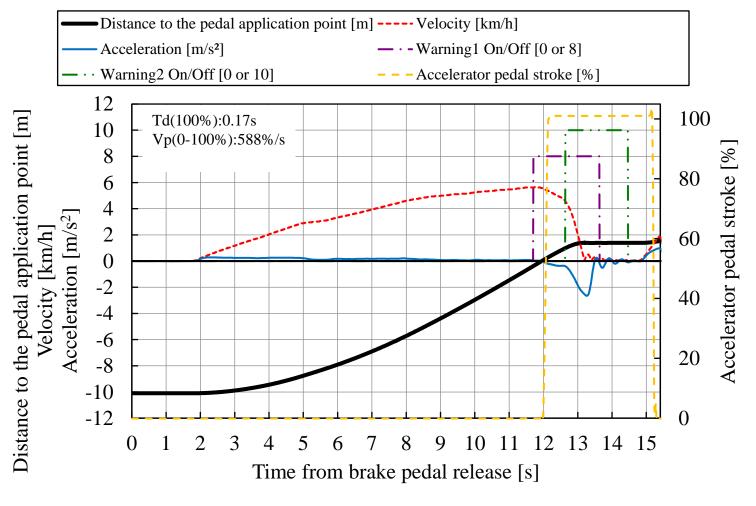
Forward__Vehicle_1.5m_No.1

- Acceleration control was continued for more than 2 s.
- The vehicle was decelerated and completely stopped.
- It is difficult to distinguish whether braking control was carried out by AEBS or ACPE, because the warning 1 was begun just before the start of accelerator pedal application.

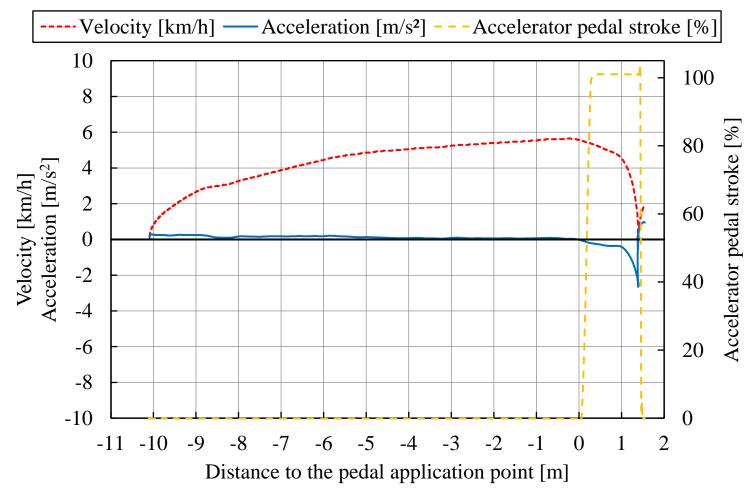
Forward__Vehicle_1.5m_No.1

Collision with the target was avoided by braking control.

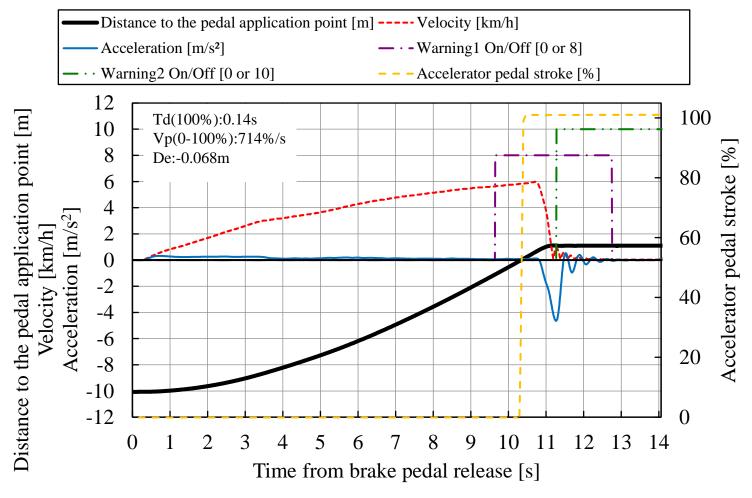
- Acceleration control was continued for more than 2 s.
- The vehicle was decelerated and completely stopped.
- It is difficult to distinguish whether braking control was carried out by AEBS or ACPE, because the warning 1 was begun just before the start of accelerator pedal application.

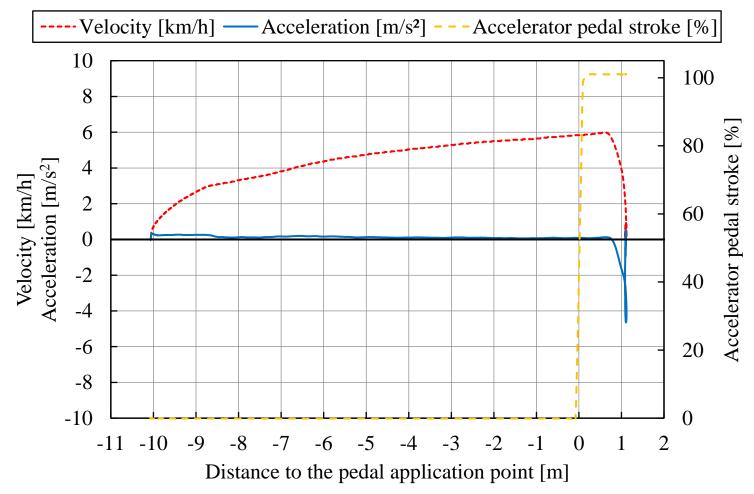
The vehicle was completely stopped by braking control, but slightly collided with the target (collision speed was approximately 4 km/h).

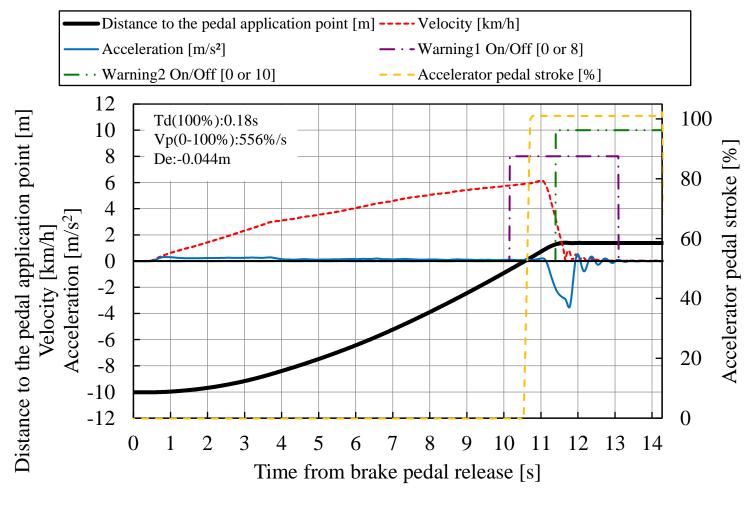
- Acceleration control was continued for more than 2 s.
- The vehicle was decelerated and completely stopped.
- It is difficult to distinguish whether braking control was carried out by AEBS or ACPE, because the warning 1 was begun just before the start of accelerator pedal application.

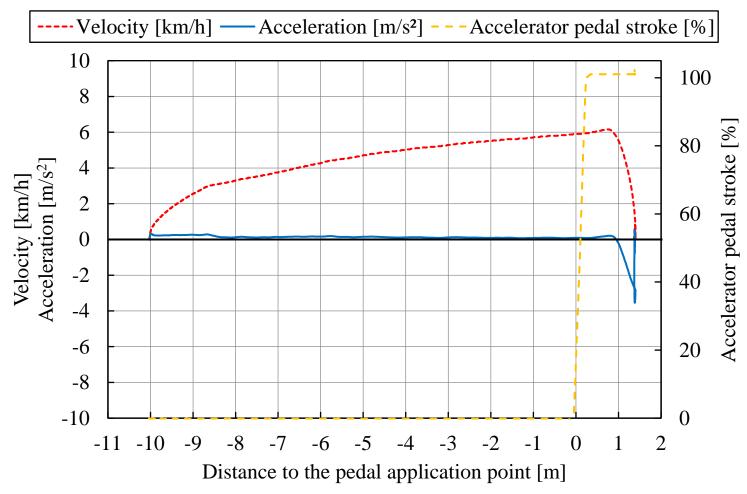
Collision with the target was avoided by braking control.

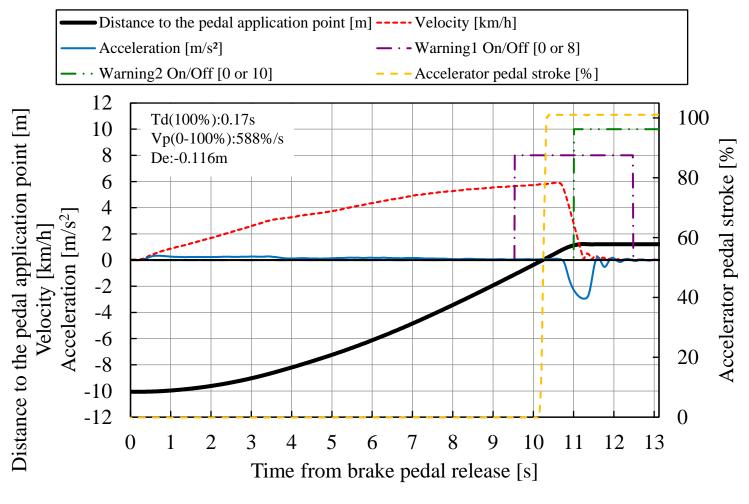
- Acceleration control was continued for more than 2 s.
- The vehicle was decelerated and completely stopped.
- It is difficult to distinguish whether braking control was carried out by AEBS or ACPE, because the warning 1 was begun just before the start of accelerator pedal application.

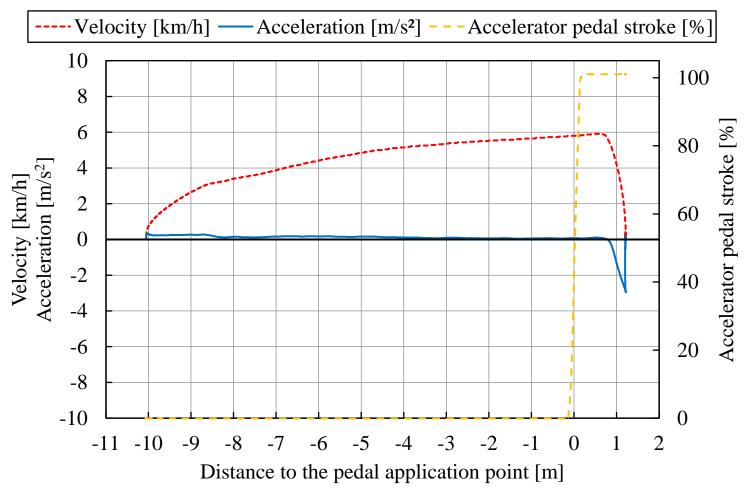
The vehicle was completely stopped by braking control, but slightly collided with the target (collision speed was approximately 4 km/h).

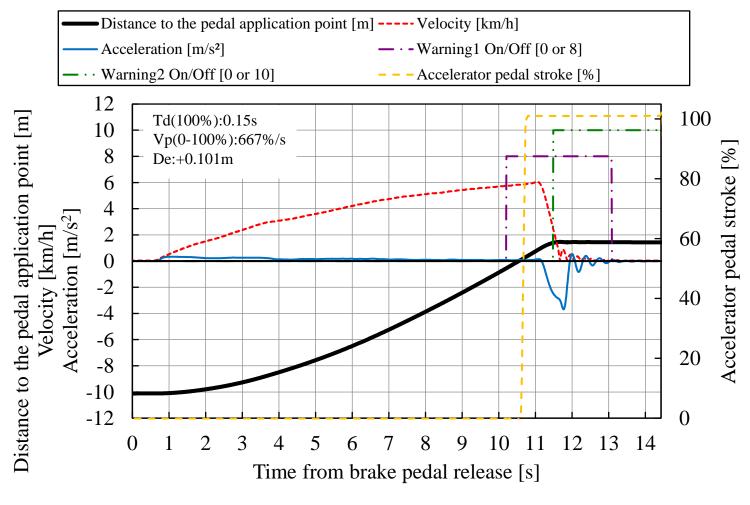
- Acceleration control was continued for more than 2 s.
- The vehicle was decelerated and completely stopped.
- It is difficult to distinguish whether braking control was carried out by AEBS or ACPE, because the warning 1 was begun just before the start of accelerator pedal application.

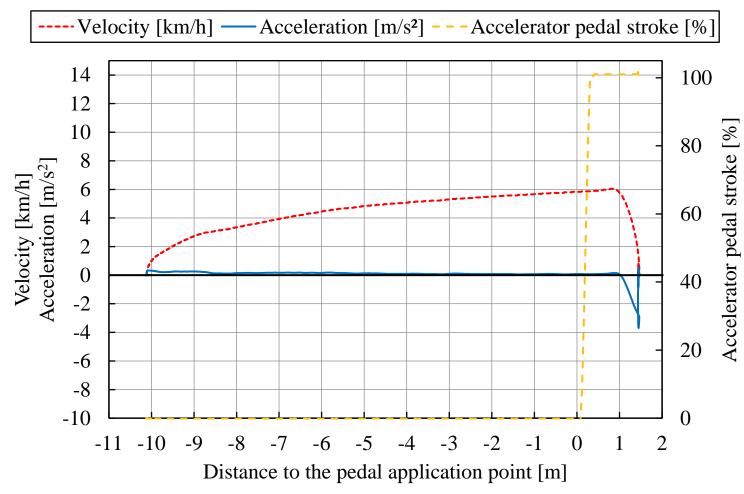
Collision with the target was avoided by braking control.

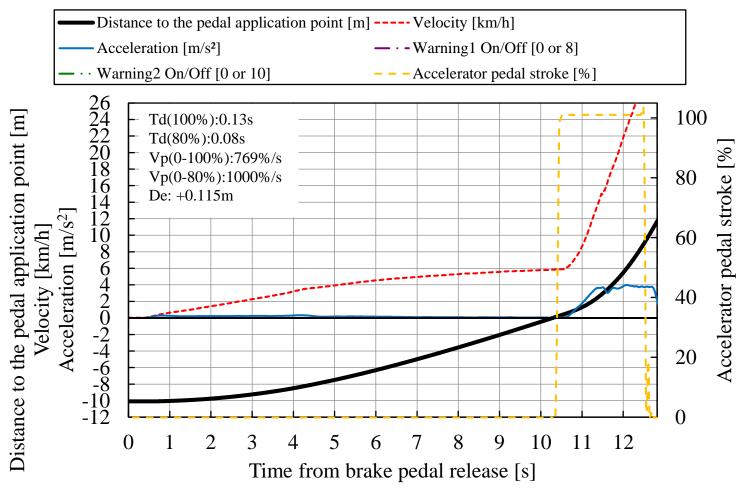
Maximum acceleration of the vehicle was approximately 4 m/s² in the condition of "no target".

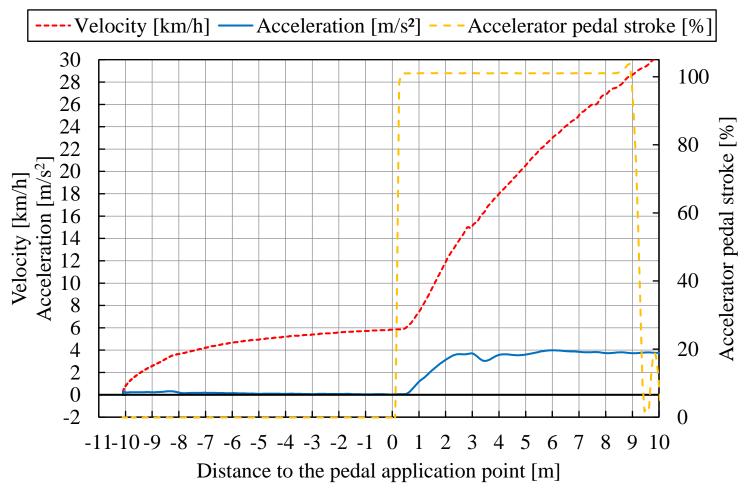
Velocity of the vehicle was approximately 6 km/h just when the vehicle reached the accelerator pedal application point, however velocity was not steady value (gentle acceleration was ongoing). It was same tendency as forward direction.

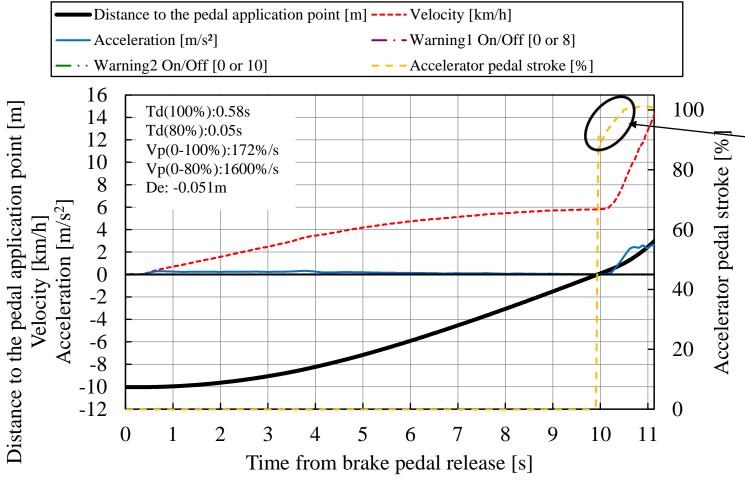
Backward_Vehicle_1m__No.2

- Both warning 1 and warning 2 were not shown, and acceleration control was not observed.
- Accelerator pedal could not be applied 100% stroke with the speed of 400%/s due to the change of reaction force of the pedal.

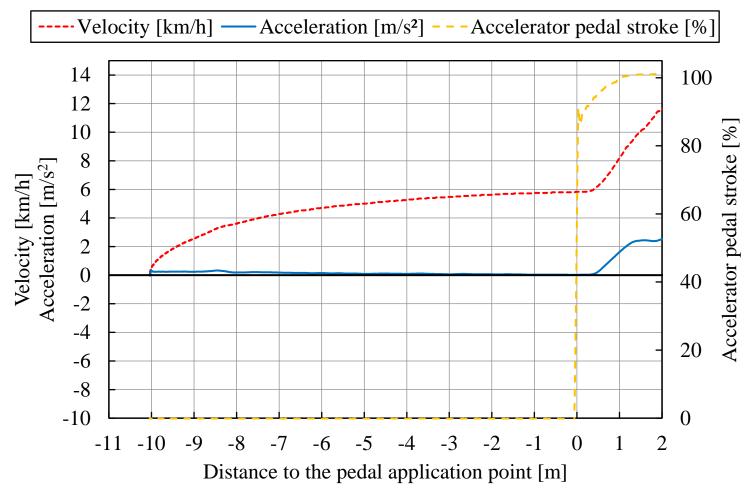
Backward_Vehicle_1m__No.2

Collision speed was approximately 8 km/h.

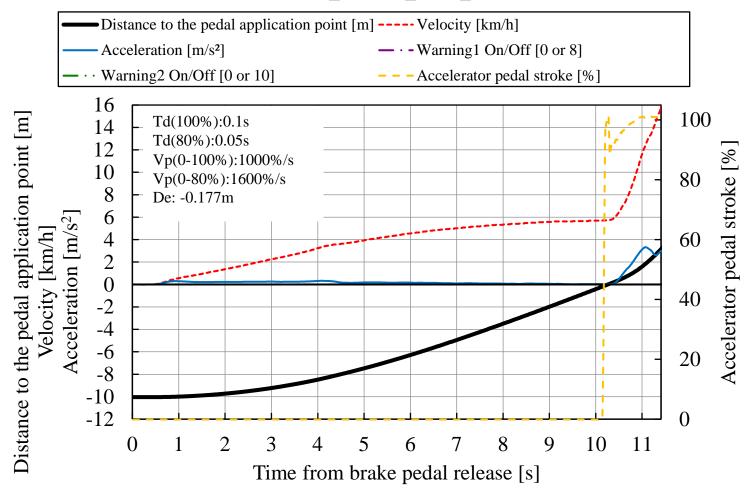
Backward_Vehicle_1.5m_No.1

Both warning 1 and warning 2 were not shown, and acceleration control was not observed.

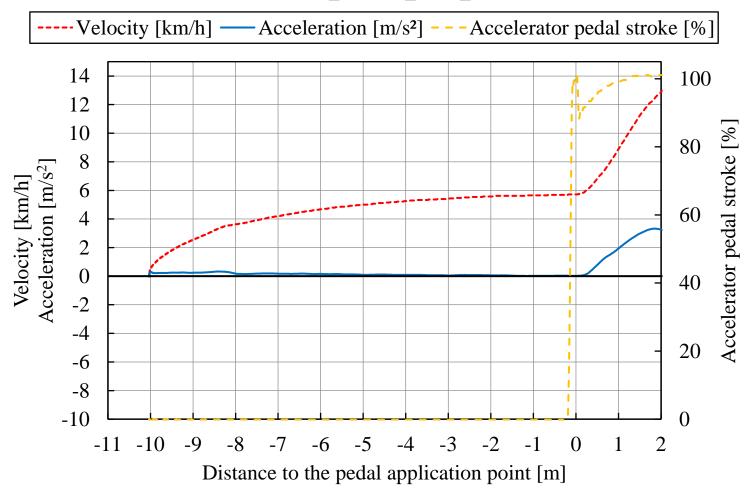
Backward_Vehicle_1.5m_No.1

Collision speed was approximately 11 km/h.

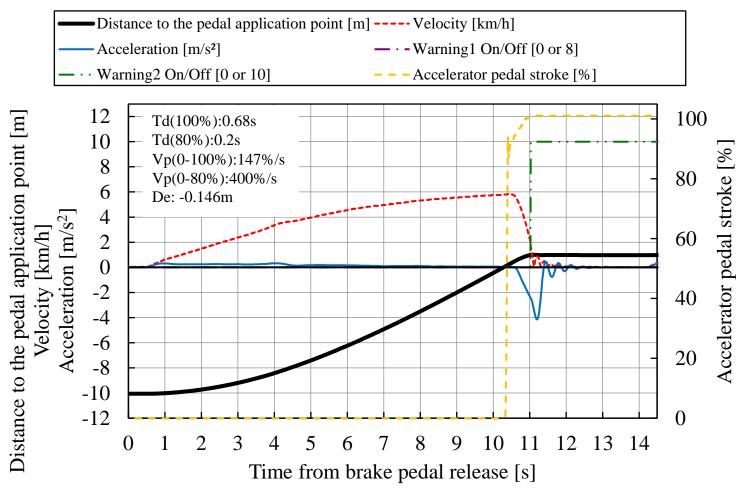
- Acceleration control was continued for more than 2 s.
- The vehicle was decelerated and completely stopped.
- In this case, it is considered that braking control was carried out by ACPE, because this vehicle doesn't have AEBS function for backward direction.

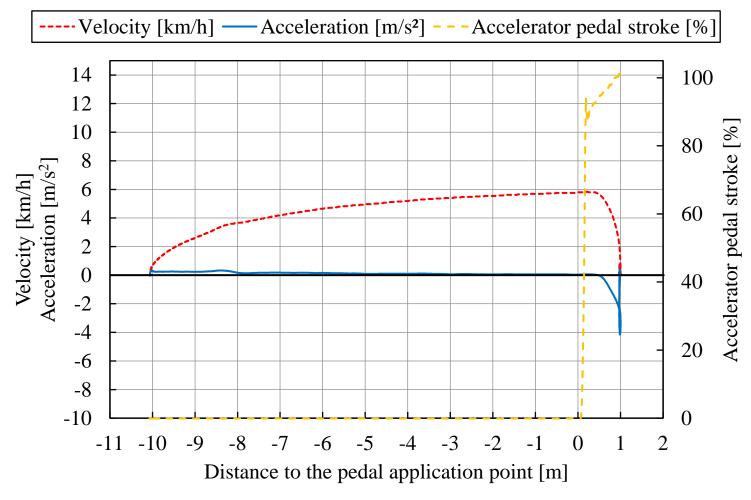
Collision with the target was avoided by braking control.

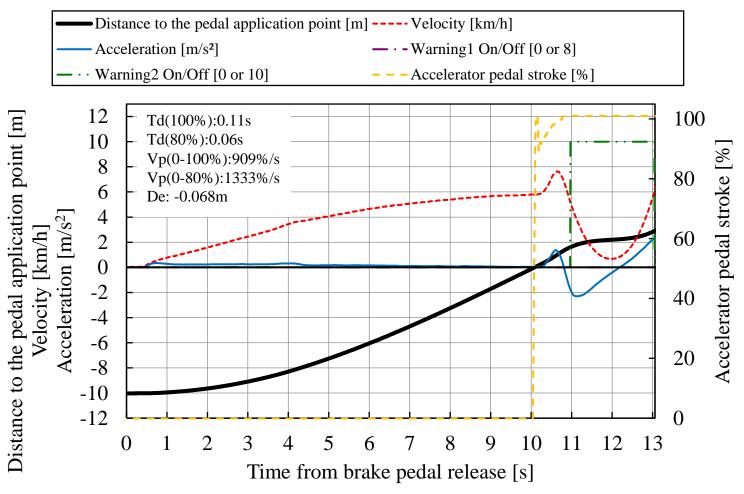
Backward_Adult___1.5m_No.2

- Both acceleration control was continued for more than 2 s.
- The vehicle was decelerated, but braking control was finished just before the vehicle was completely stopped.
- In this case, it is considered that braking control was carried out by ACPE, because this vehicle doesn't have AEBS function for backward direction.

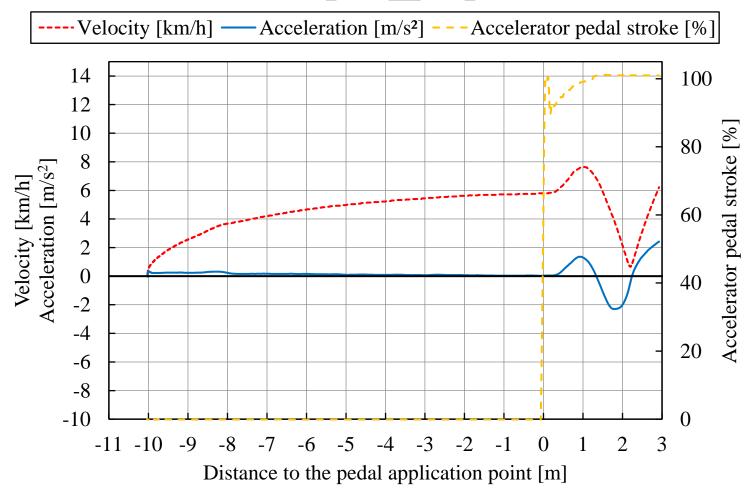
Backward_Adult___1.5m_No.2

- Collision speed was approximately 6 km/h.
- The vehicle accelerated just after the collision with the target. It is estimated that the vehicle could not detect the target any more after the adult pedestrian target fell over.

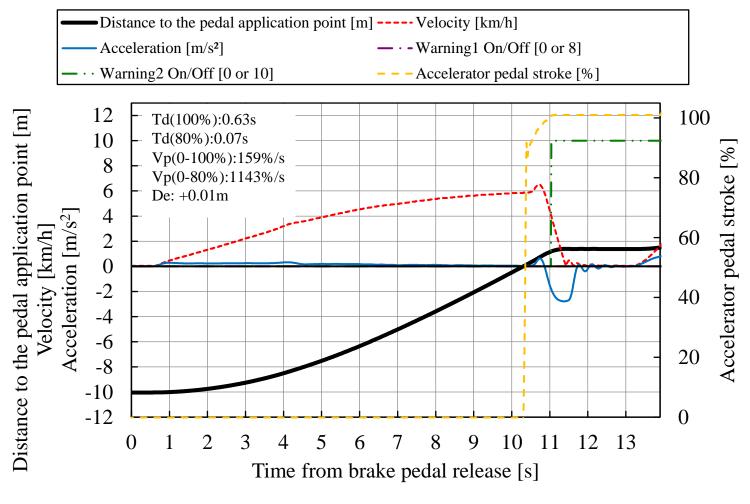
- Acceleration control was continued for more than 2 s.
- The vehicle was decelerated and completely stopped.
- In this case, it is considered that braking control was carried out by ACPE, because this vehicle doesn't have AEBS function for backward direction.

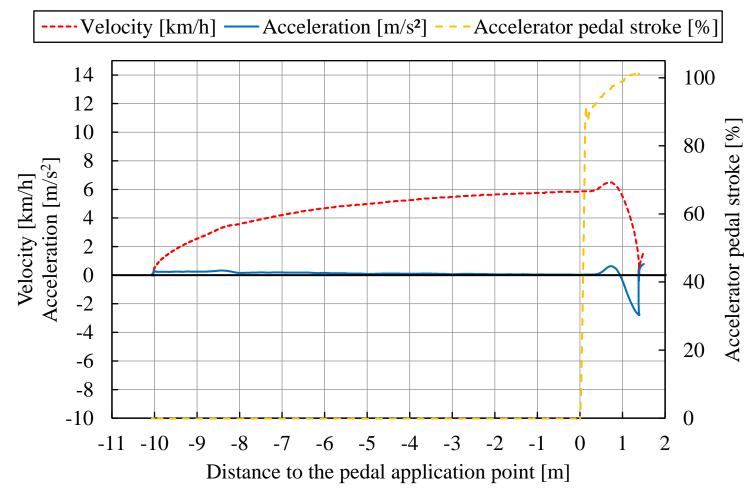
Collision speed was approximately 5.5 km/h.

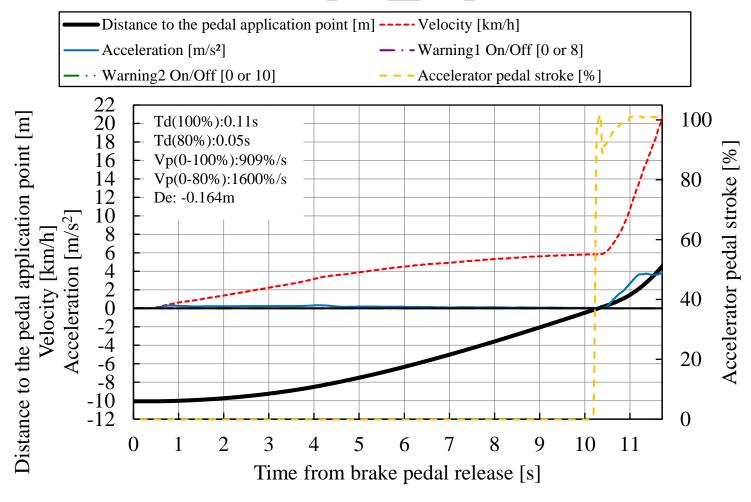
Backward_Child___1.5m_No.1

Both warning 1 and warning 2 were not shown, and acceleration control was not observed.

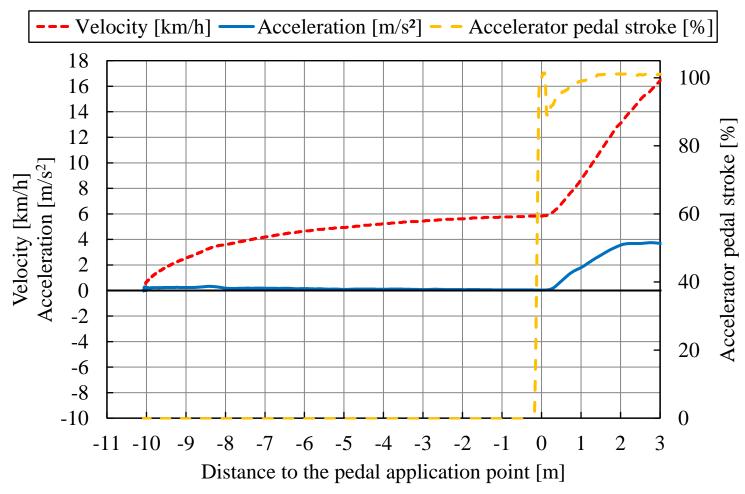
Collision speed was approximately 11 km/h.

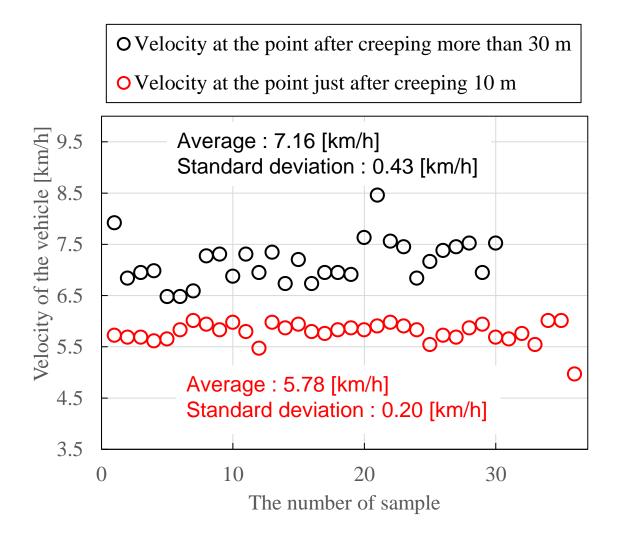
Experimental result (data plot of creeping velocity)

- Difference of average value is approximately 1.4 km/h.
- Standard deviation of creeping velocity after the vehicle ran more than 30 m is larger than that at the point of just after creeping 10 m.
- It is considered that the creeping distance or the creeping time should be considered carefully, if the creeping procedure is applied as the ACPE test.
