Investigation of another vehicle performance by creeping procedure

National Traffic Safety and Environment Laboratory

Purpose of this report

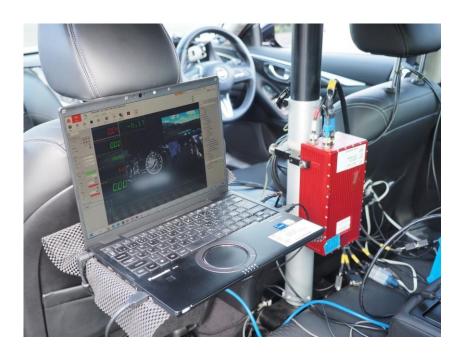
- Longitudinal and lateral position of the vehicle and velocity of the vehicle were measured accurately by RTK GPS (OxTS RT-range).
- Accelerator pedal position was measured by recording the change of voltage.

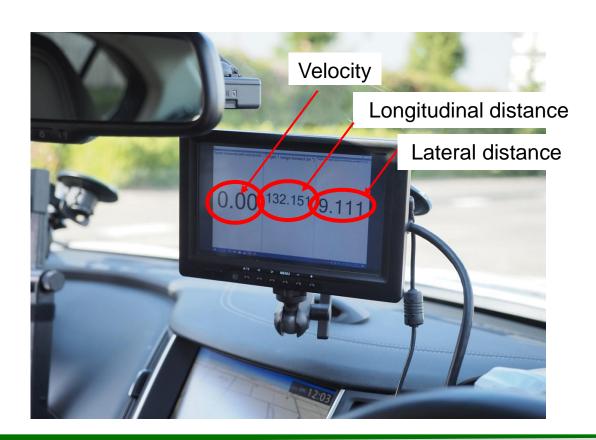
• Through the monitor on the dashboard, velocity, longitudinal distance and lateral distance of the vehicle were provided to the driver in real time as the guidance in order to drive within the tolerances.
