## Injury Risk of Lower Leg outside of 30° Tangent-Area

Alexandra Fries, I/EK-551; Thomas Schenk, I/GG-32;

# Agenda

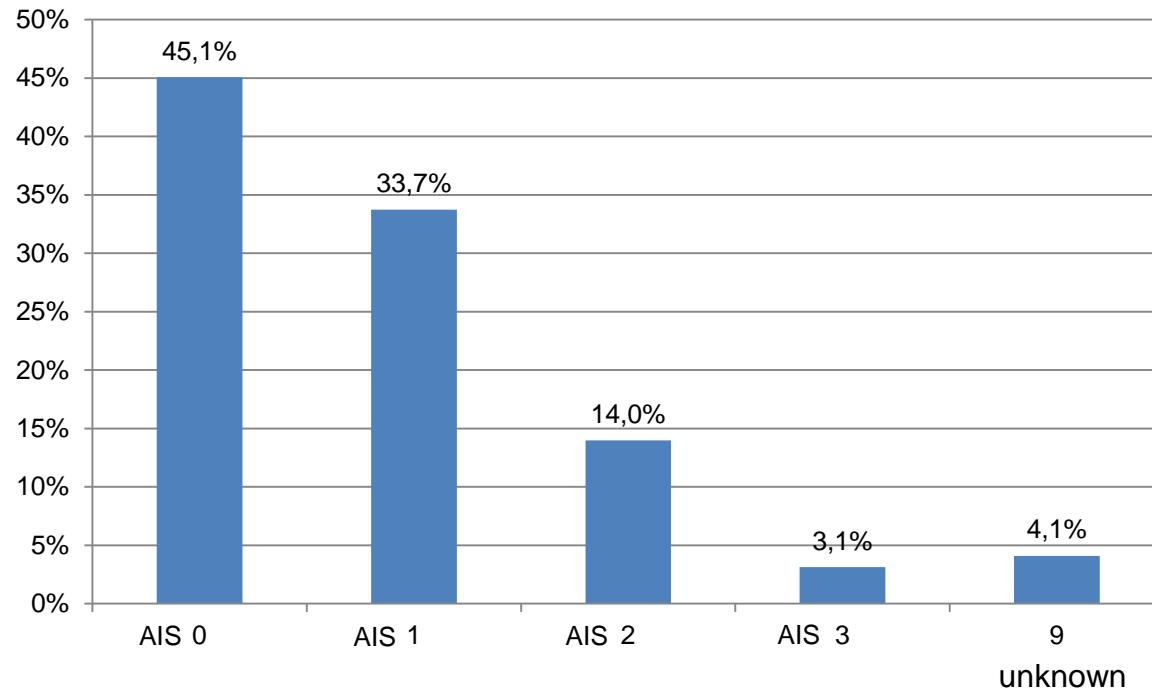
- ▶ 2002-2013: 415 frontal pedestrian accidents (total)
- ▶ Distribution of AISUSKNIE
  - ▶ Maximum severity of AISUSKNIE = 3

- ▶ The large majority of cases ( $\approx 79\%$ ) show no injury or slight injuries

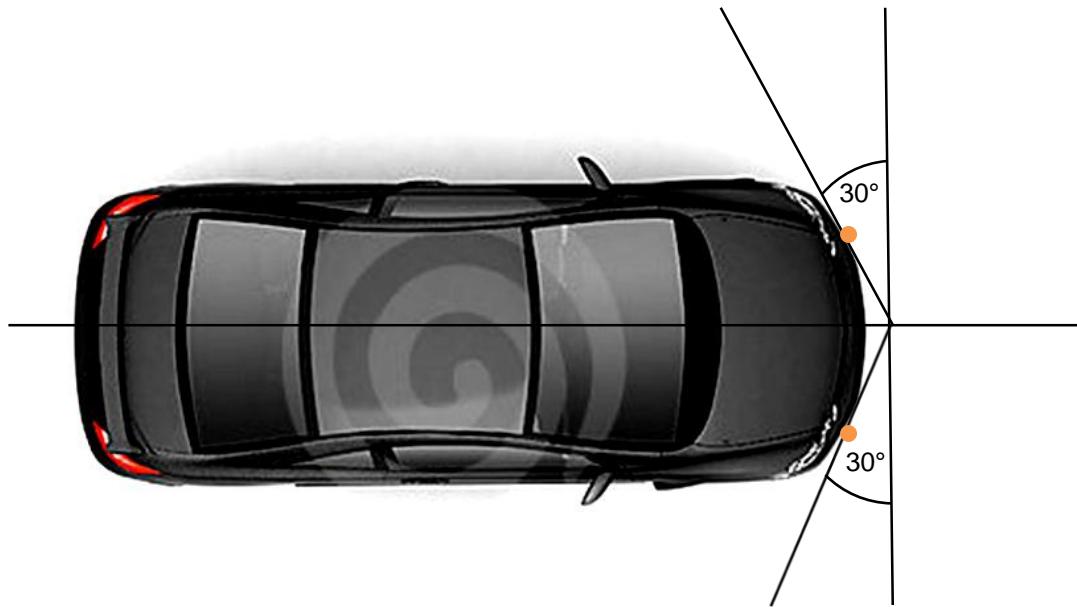
- ▶ 30° tangent at front end of the car

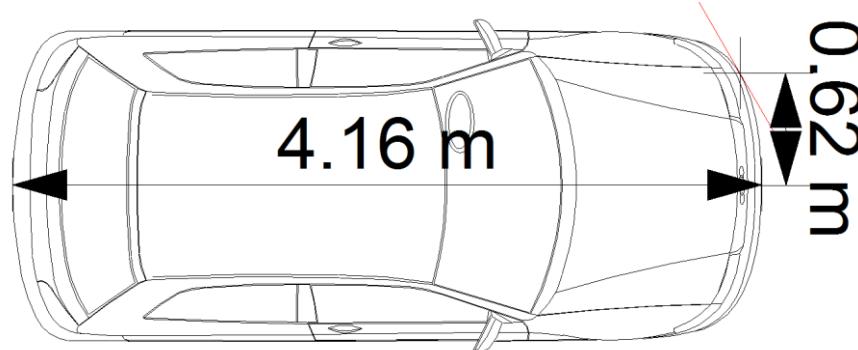
- ▶ Source: Geometric models available for the accident reconstruction software
  - ▶ High degree of detail, accuracy of determination  $\pm 10$  mm
- ▶ Example AUDI A3

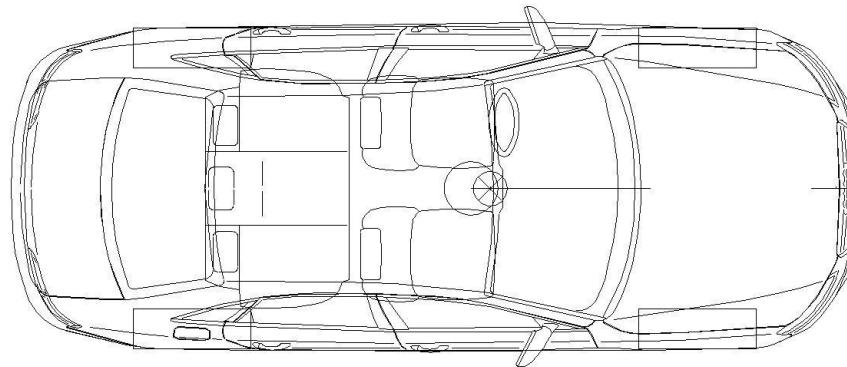
- ▶ Example AUDI A4

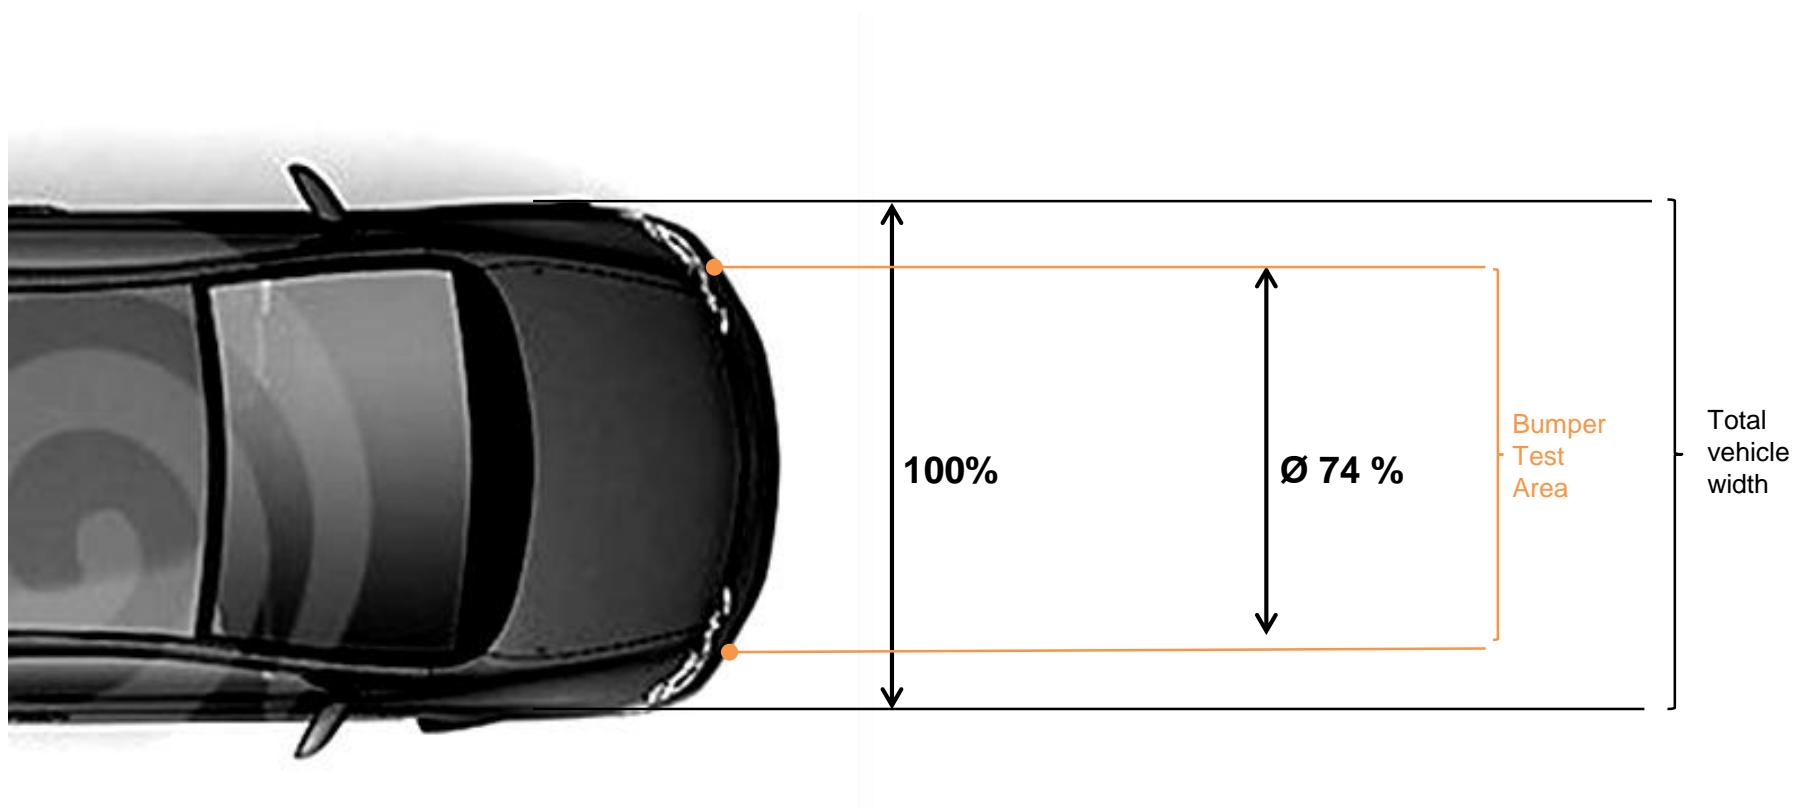
- ▶ Average size of the BTA: 74% of vehicle width

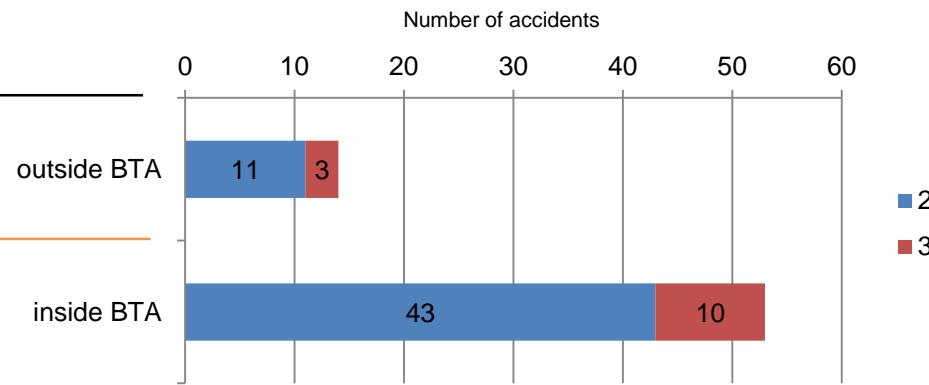
- ▶ Absolute distribution of all accidents

- ▶ A trend to lower frequency of severe accidents in the outer area can be seen in relation to the test area

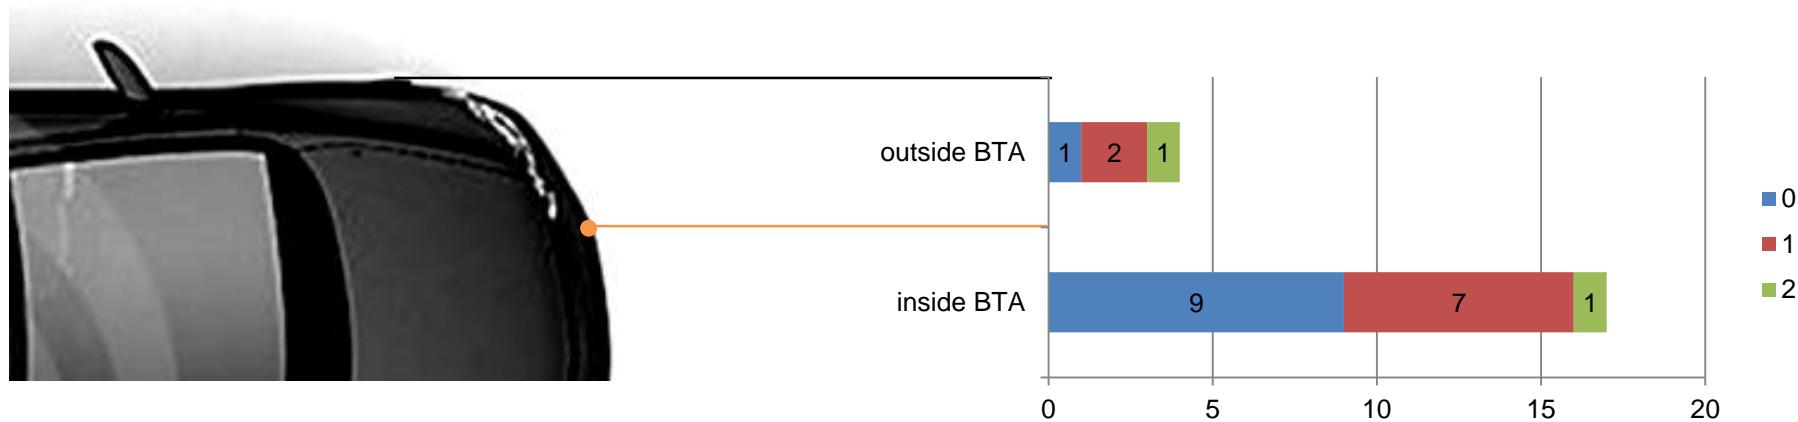
- ▶ Contact point outside BTA: 4 accidents
- ▶ Contact point inside BTA: 17 accidents

- ▶ No severe injuries (AISKNIEUS) can be found in GIDAS outside the currently defined bumper test area for modern cars with a market launch after 2006
