47<sup>th</sup> Meeting Informal Group on Child Restraint Systems
Booster Vehicle Seat Fixture Development

14<sup>th</sup> October2014 Farid Bendjellal

## Current Booster Fixture – N1083

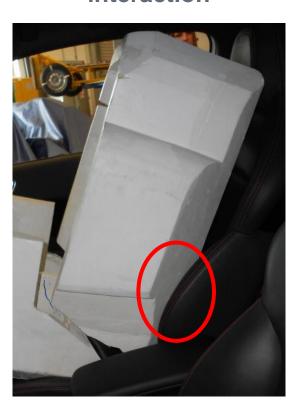
3 – Seat-rear interaction

Is this critical?

May prevent ISOFIX latching

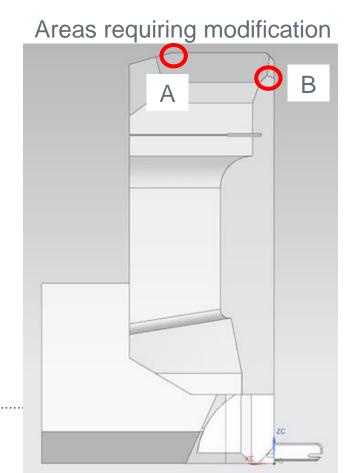
Vehicle	Attachment	Position	Issue	Comment
Audi A1	Belt	Outer	C-Pillar	Significance – Minor No angle change (1.5°) Amount to remove ≈ 5mm

2 interactions with C-pillar / roof

# Proposed modification areas A1 C-Pillar interaction Space Star C-Pillar interaction Zafira door interaction

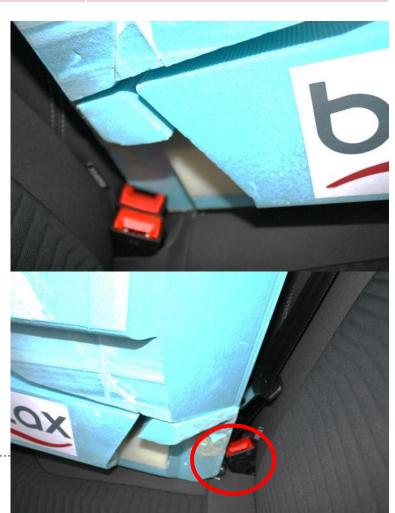
Vehicle	Attachment	Position	Issue	Comment
Ford Fiesta	Belt	Middle	Buckling	Significance – Critical for centre seat only

- Fixture does not fit in rear centre position
- Not possible to buckle
- Width between buckles less than 280mm (ISOFIX centre width)
- Therefore impossible to fit if fixture has ISOFIX connectors

Vehicle	Attachment	Position	Issue	Comment
Audi A1	ISO Belt	Outer Outer	No Latch C-Pillar	Propose modification
Ford Fiesta	Belt	Middle	Buckling	Position not suitable
Mitsubishi Space Star	ISO	Outer	C-Pillar	Propose modification
Vauxhall Adam	ISO	Outer	C-Pillar	Fixture fits
Vauxhall Zafira	Belt/ISO	Outer	Door	Propose modification

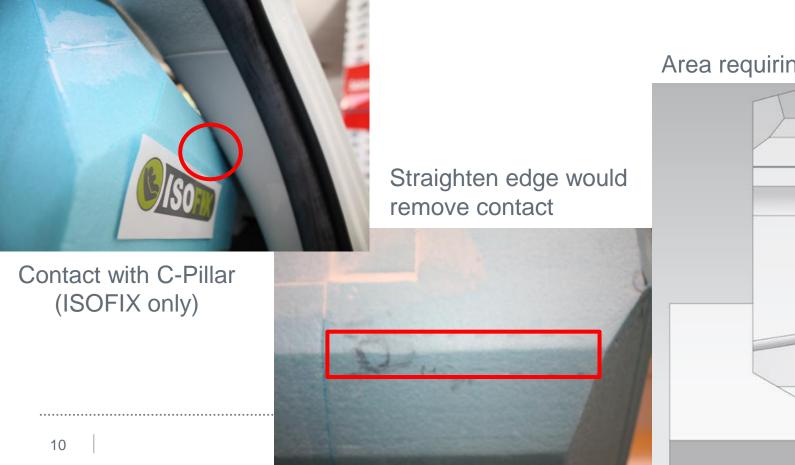
Area requiring modification

Vehicle	Attachment	Position	Issue	Comment
Mitsubishi Space Star / Mirage	ISO	Outer	C-Pillar	Significance – Minor No angle change (1°) Amount to remove ≈ 5mm

Space Star C-Pillar interaction

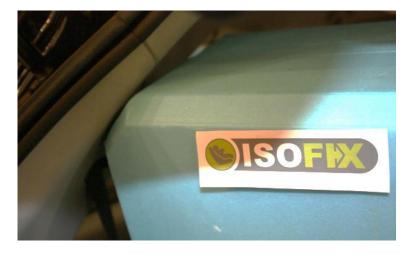
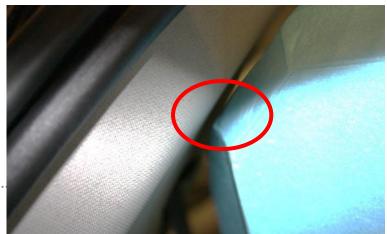
Vehicle	Attachment	Position	Issue	Comment
Vauxhall Adam	ISO	Outer	C-Pillar	No interaction Action – None

- No interaction found
- Gap between C-Pillar and fixture using ISOFIX
- Conclusion: Fixture fits

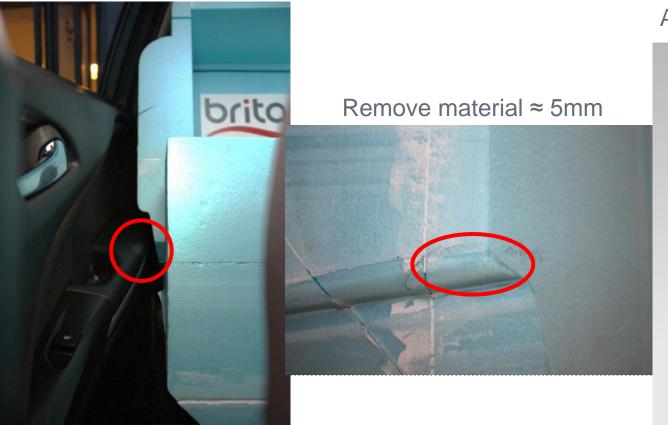
Area requiring modification

Vehicle	Attachment	Position	Issue	Comment
Vauxhall Zafira Tourer	Belt/ISO	Outer	Door	Significance – Minor No angle change (1°) Amount to remove ≈ 5mm

Very small contact with door

#### Zafira door interaction

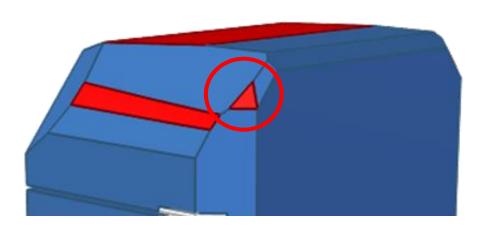
A1 C-Pillar/roof interaction

Existing intersect
