Informal document WP.29-162-15 (162nd WP.29, 11-14 March 2014, agenda item 8.5)

Recall System & Latest Issue in Korea

(Defect investigation on panoramic sunroof)

KOREA, MOLIT (Ministry of Land, Infrastructure and Transport)

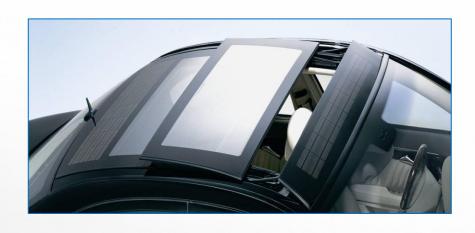
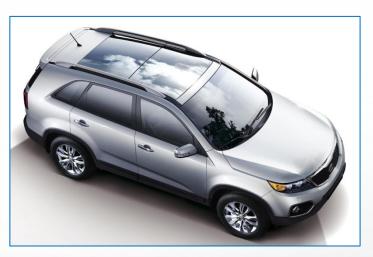
- Sharp increase in consumer complaints of panoramic sunroof
 - 2011: 2 cases
 - 2013: 33 cases (5 cases of imported models)
- Details of consumer complaints
 - Sudden shattering of panoramic sunroof while driving the car with the driver unaware
 - Driver may suffer abrasions due to shattered glass and encounter risk of secondary accidents
