Overall Review of CPA

(CPA : Ceramic Printed Area)

MOLIT

KATRI

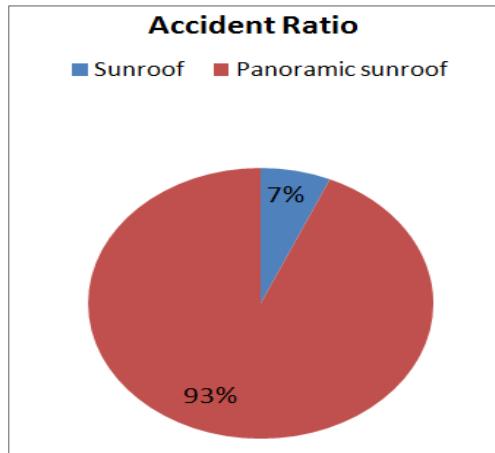
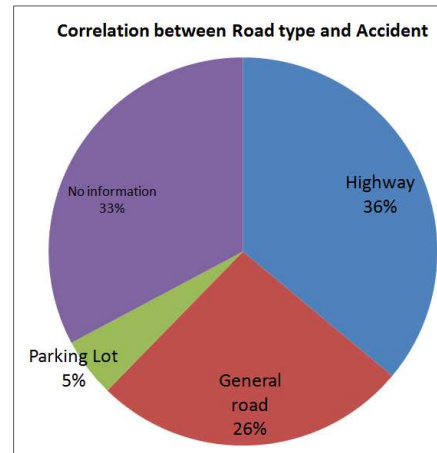
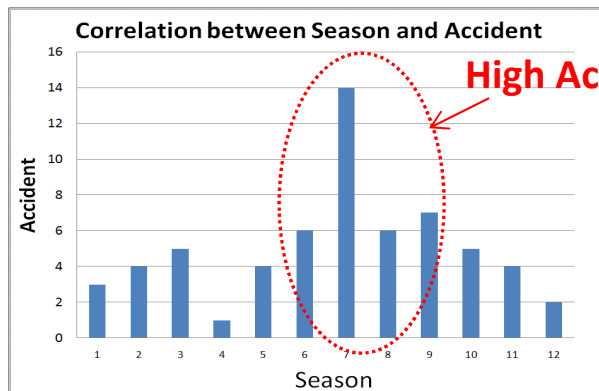
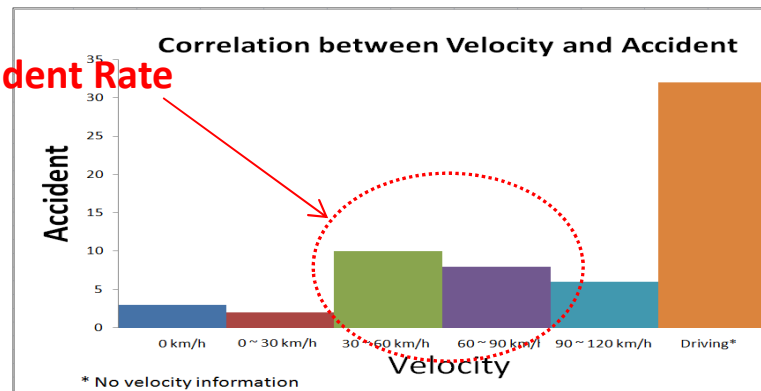
- The number of consumer defect complaints : **61** (2010~2015. 7)

- Most defect complaints due to glass breakage seem to be placed on panoramic sunroof of a large glass size.
- In terms of season, the glass breakage rate is high from June to September, of which temperature is high..

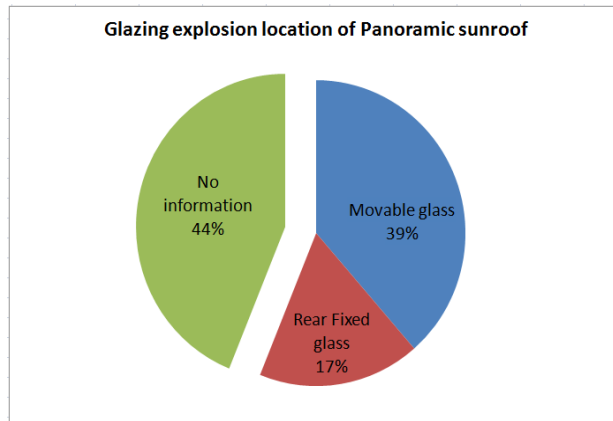
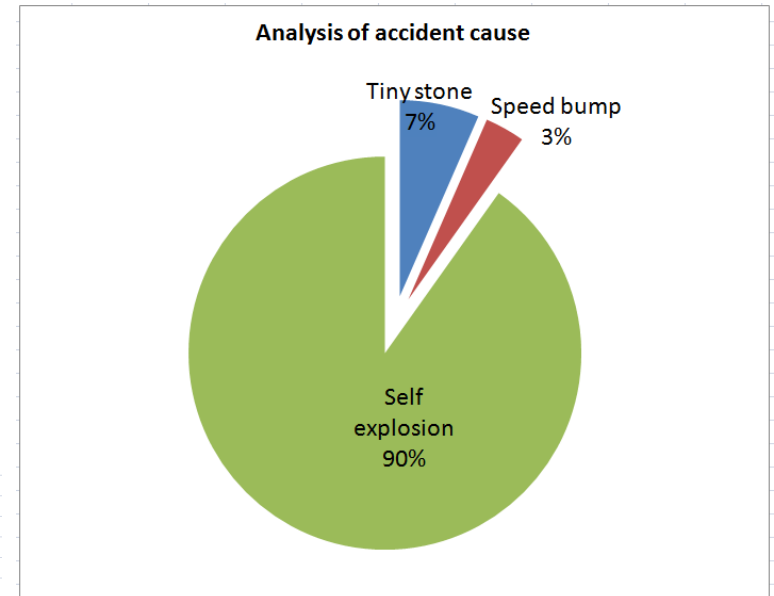
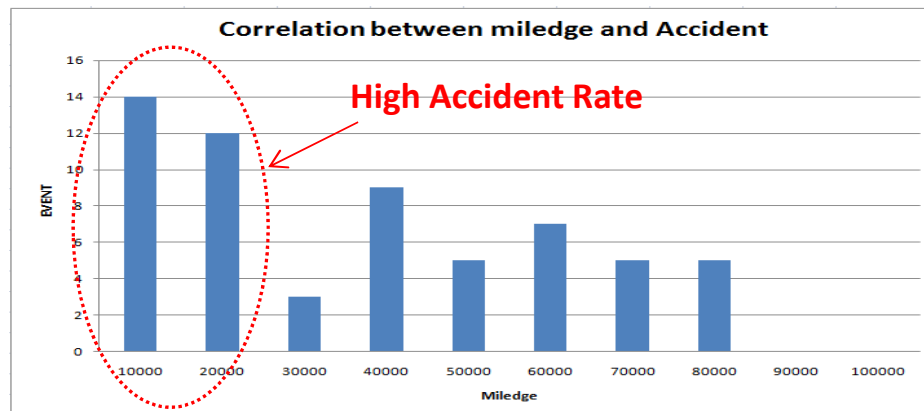
- **Status of Consumer defect complaints in Korea**
 - **Analysis of Consumer defect complaints**

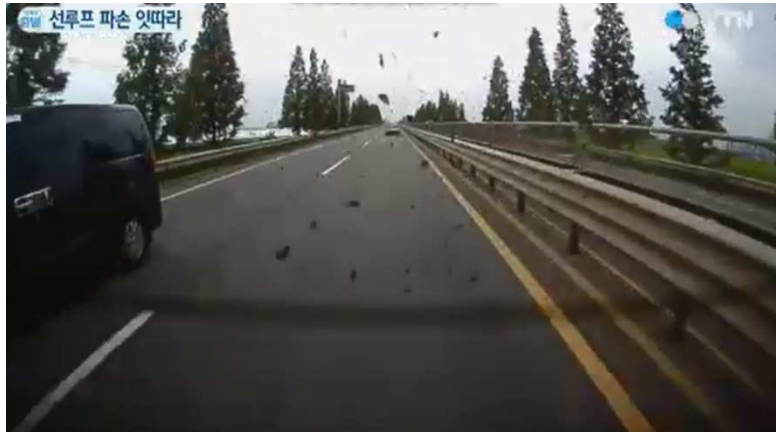
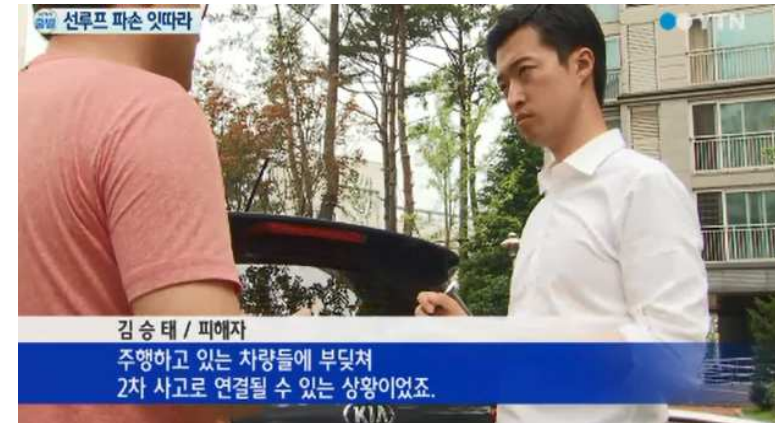
- Report about breakage of PSG (YTN, 14 July 2014)

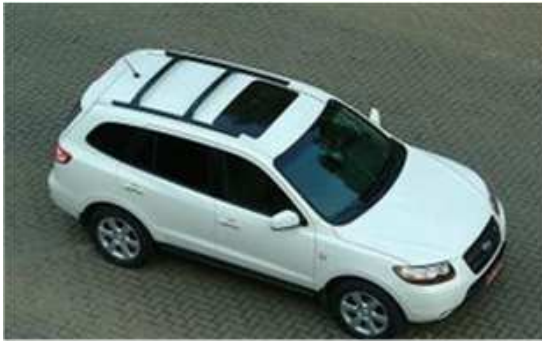
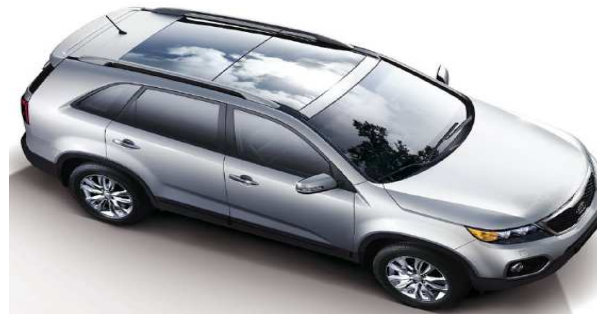
- Toughened glass of sunroof (including panoramic sunroof) mounting on the vehicles sold in 2015 Korea market from the Korea vehicle manufacturer

: Sunroof : 20 models,

Panoramic sunroof : 21 models

- Panoramic sunroof of Top-loading type is placed on about 95% of panoramic sunroof models mounting on vehicles and about 99% of sales volume in Korea

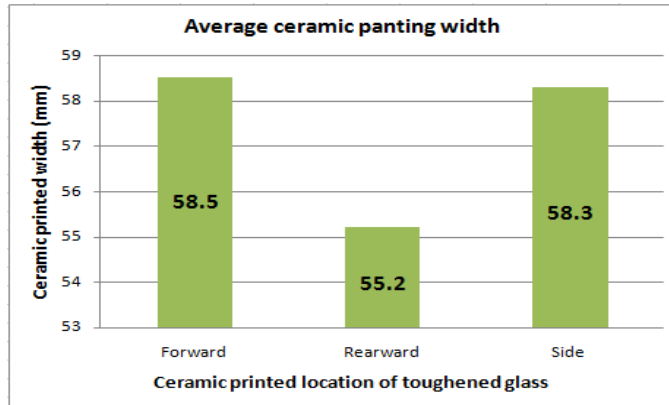
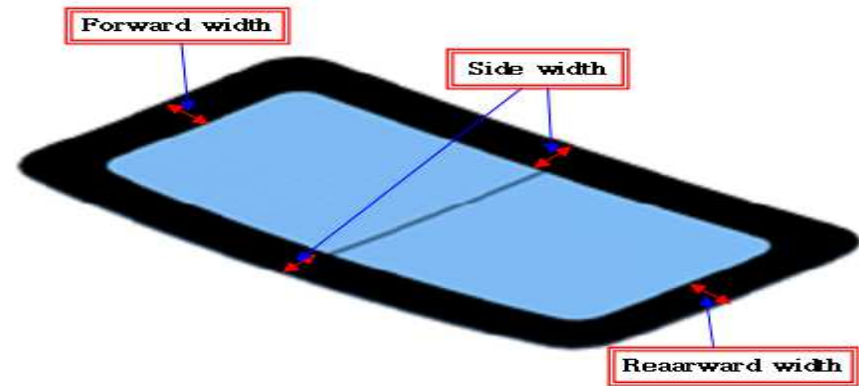
- Average width of CPA at each location in sunroof glazing (20 models)

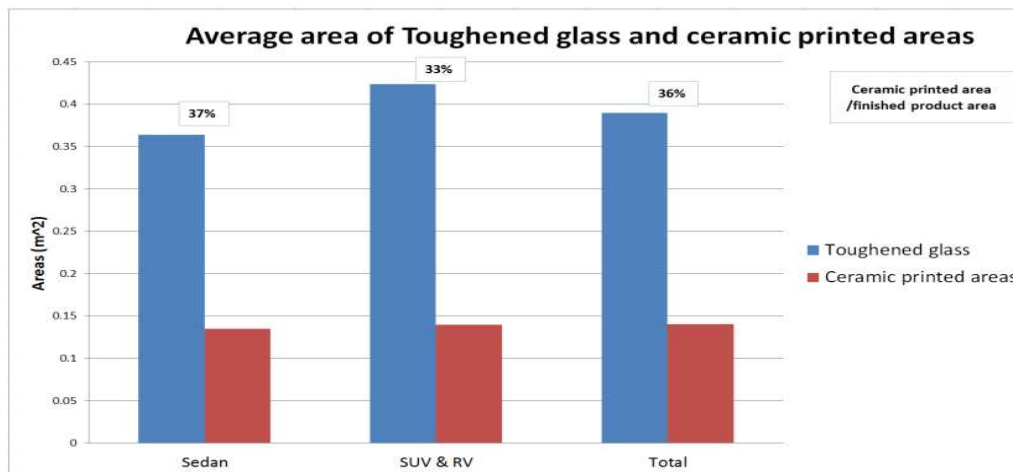
- Size and proportion of CPA sunroof glazing depending on vehicle type

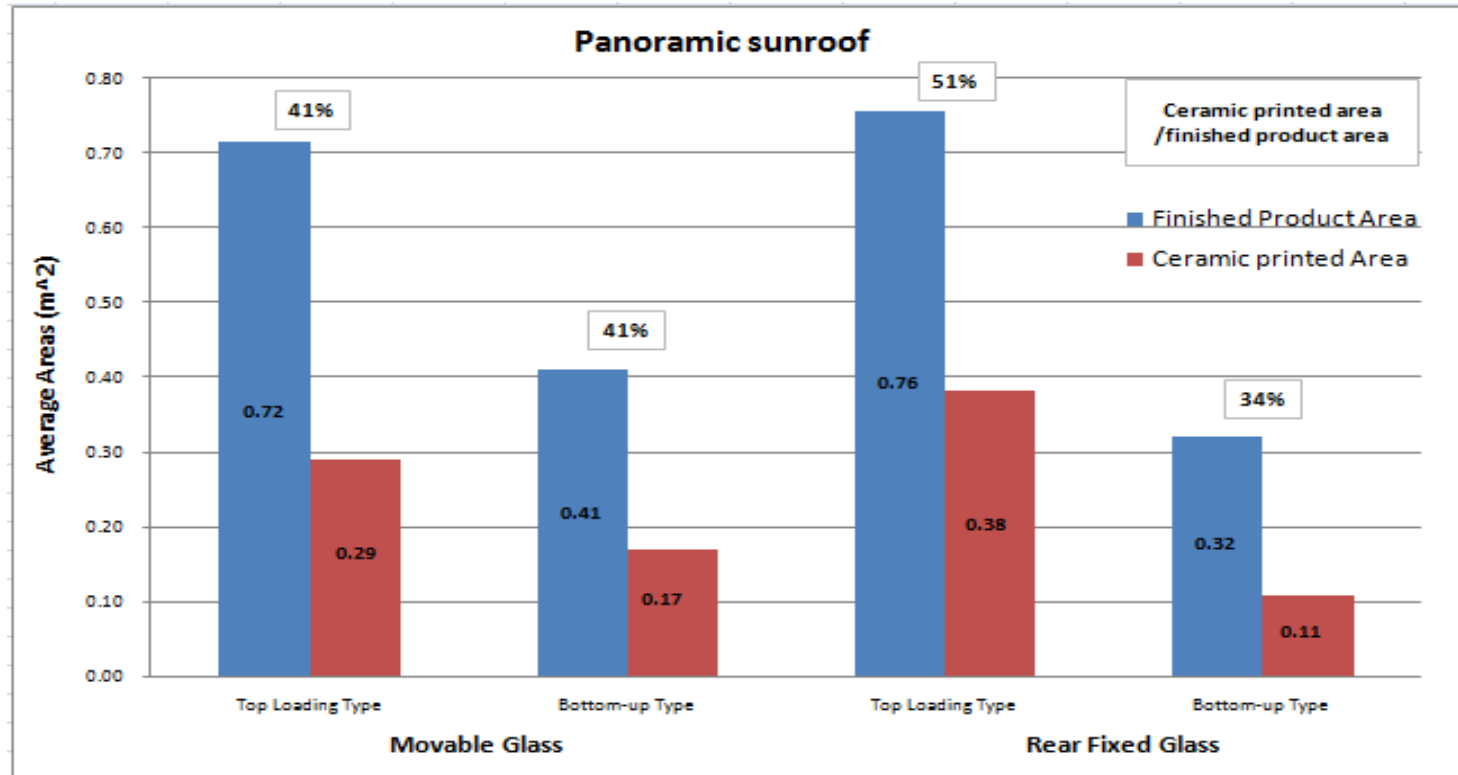
- Survey of Ceramic Printed Area(CPA) in PSG
 - Proportion of CPA as a type of PSG (21 models)

- ✓ The top-loading type seems larger toughened glass sizes and ceramic printed applicable areas compared to bottom-up type.
- ✓ **In particular, unlike bottom-up type, top-loading type has wider area of rear fixed glass and ceramic print applicable area**

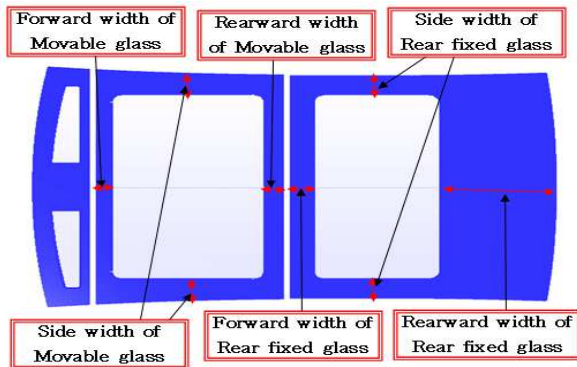
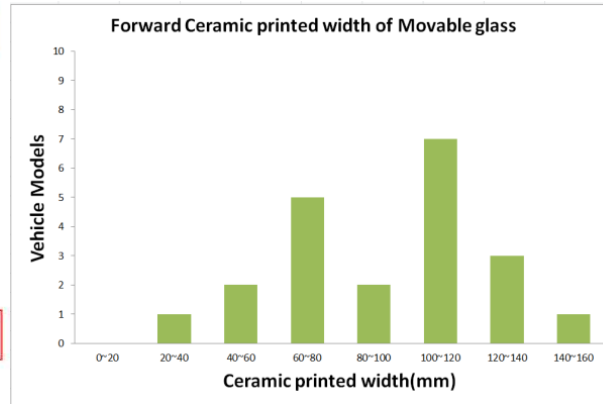
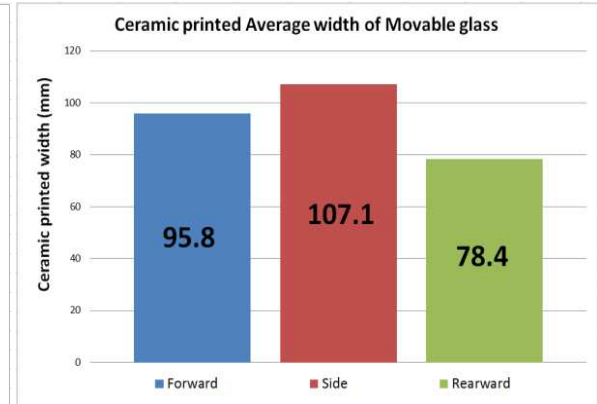
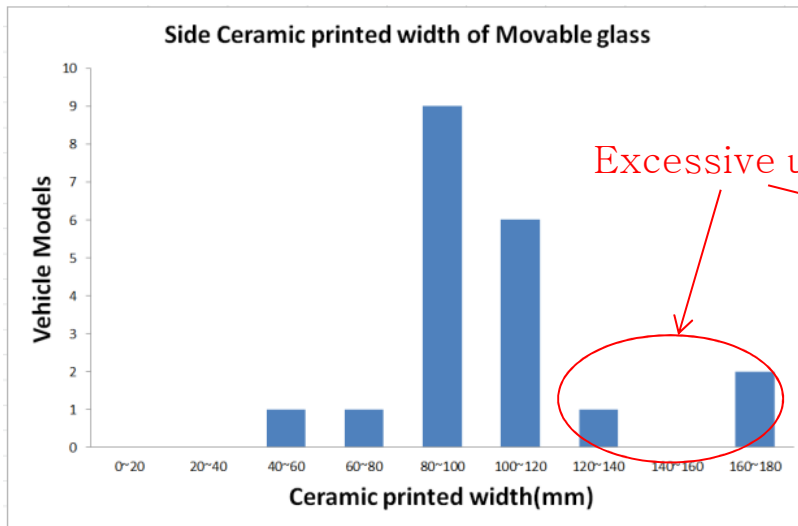
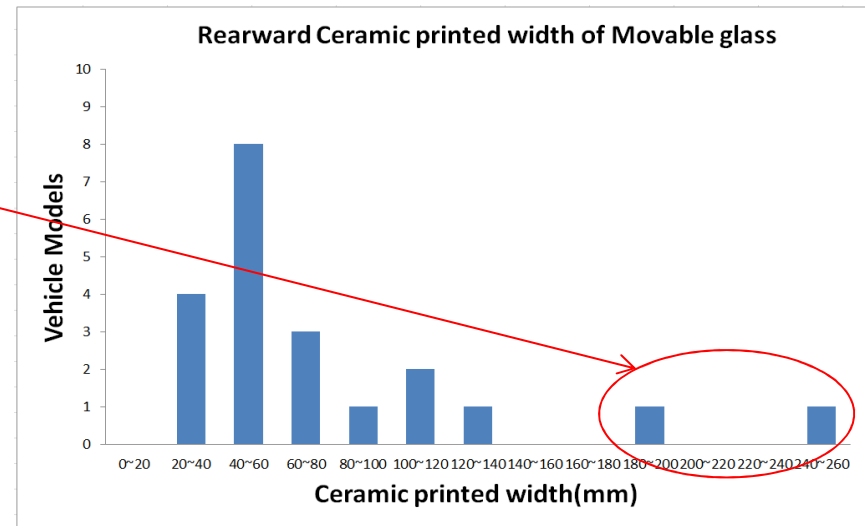
- Width of CPA at each location in movable glass of PSG

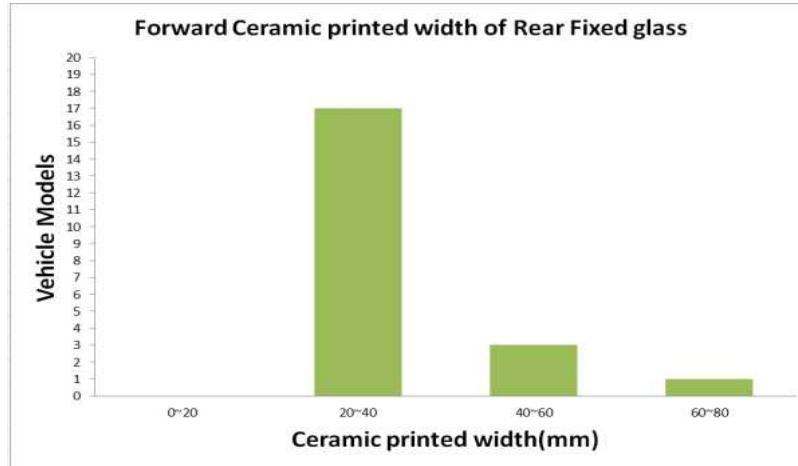
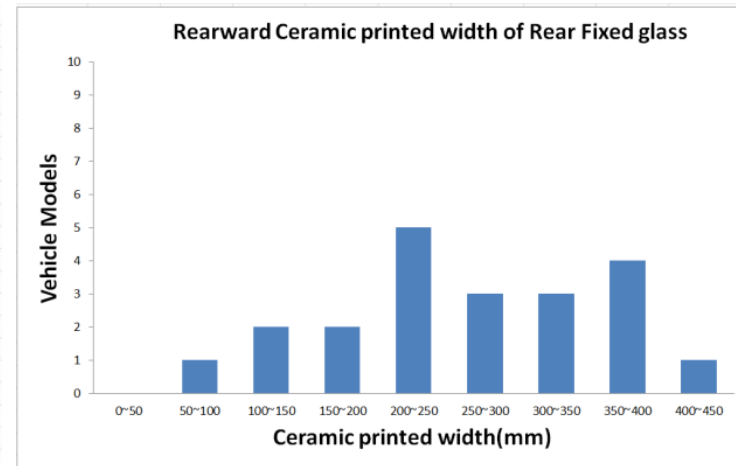
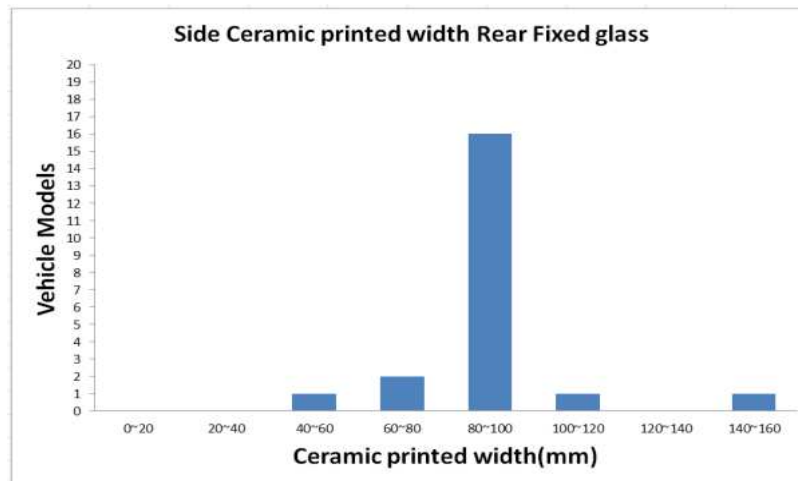
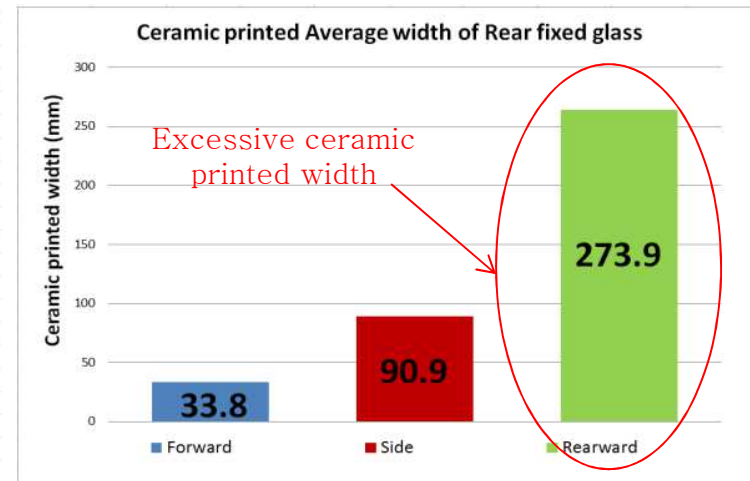
- Survey of Ceramic Printed Area(CPA) in PSG
 - Width of CPA at each location in Rear fixed glass of PSG

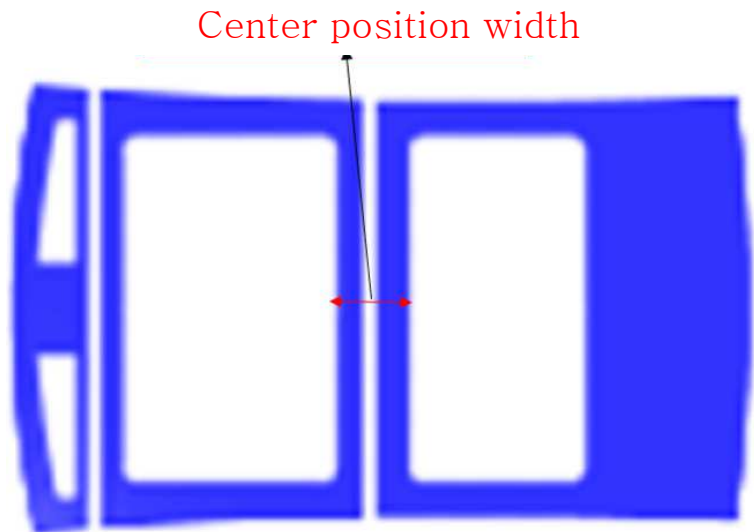
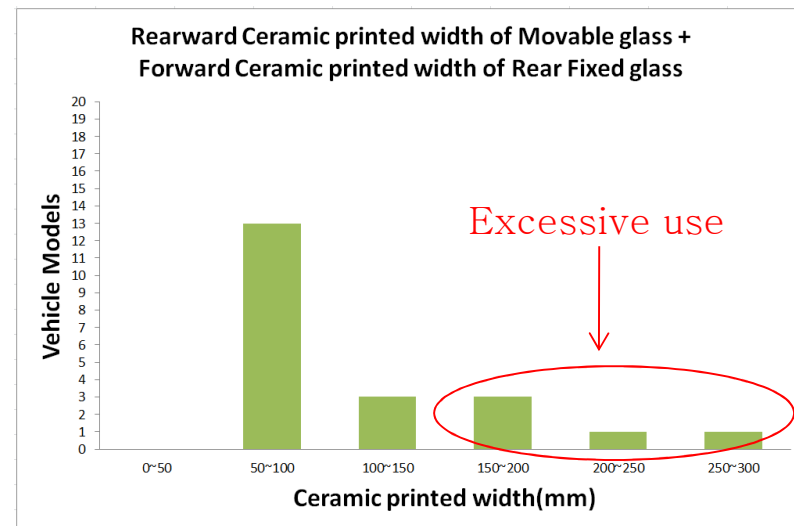
- **Survey of Ceramic Printed Area(CPA) in PSG**
 - **Width of CPA at the center position in PSG**
 - The location where two sheets of toughened glass adjoins becomes the center of a panoramic sunroof owing to the structural characteristics of a panoramic sunroof. Therefore, the width of ceramic printed area of that location shall be considered

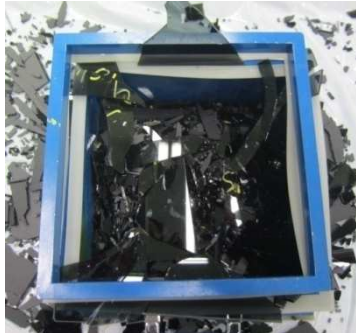
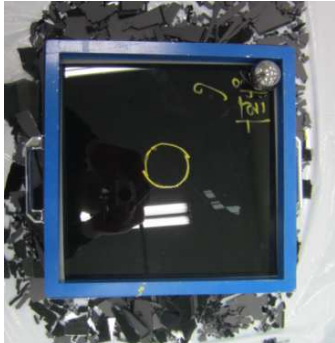
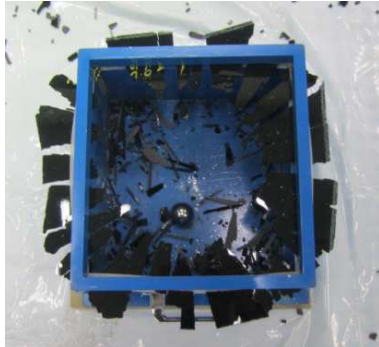
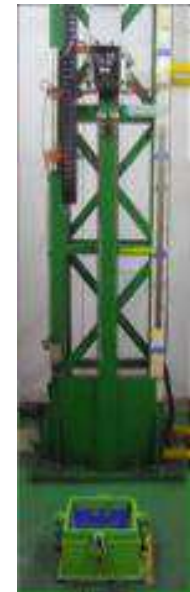
- **227g ball drop test** (in accordance with GTR No.6)

Glass Type	Annealed Glass	Toughened Glass	Ceramic Printed Toughened Glass
Fracture Drop Height (m)	3.0 m

More than 10m

1.4m

➔ The mechanical strength of ceramic printed toughened glass is weaker than that of annealed glass

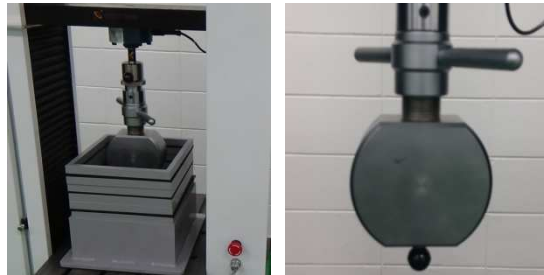
- Samples : Annealed, Toughened, Ceramic printed Toughened Glass
 - Sample size : 300 x 300 mm
 - Sample thickness : 4mm
- Test Vel. : 10mm/min

- Indenter : Plastic ball(Ø30mm)

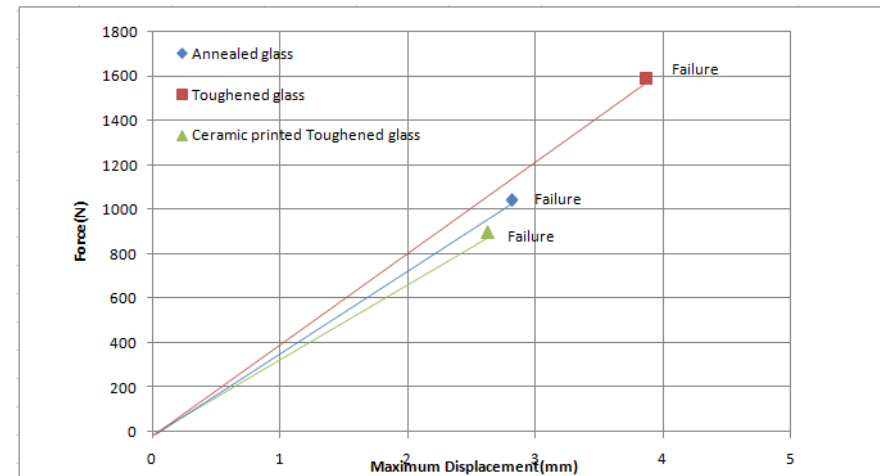
<Apparatus>

Glass Type	Annealed Glass	Toughened Glass	Ceramic Printed Toughened Glass
Max. Displacement (mm)	2.81	3.87	2.63
Fracture Strength (N/m ²)	11,577	17,666	9,977

- **Strength of Ceramic printed toughened glass is 43% lower than that of toughened glass**
