DAIMLER

Q3 Scapula – Proposed Modification

2016-03-04

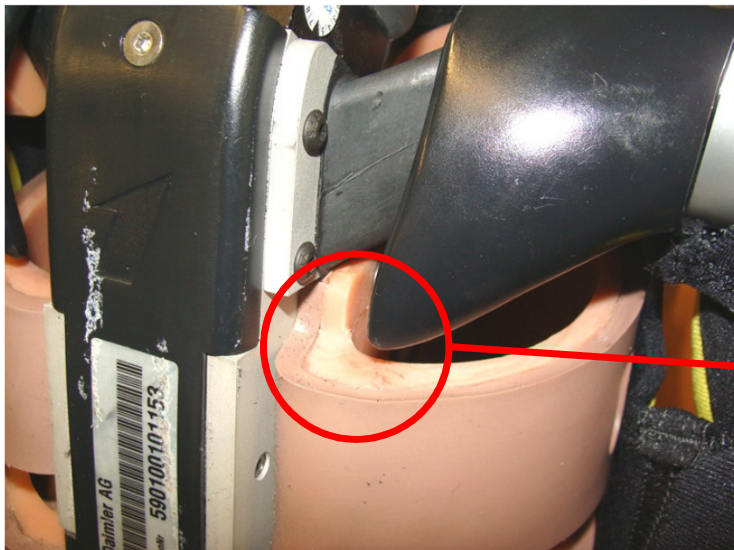
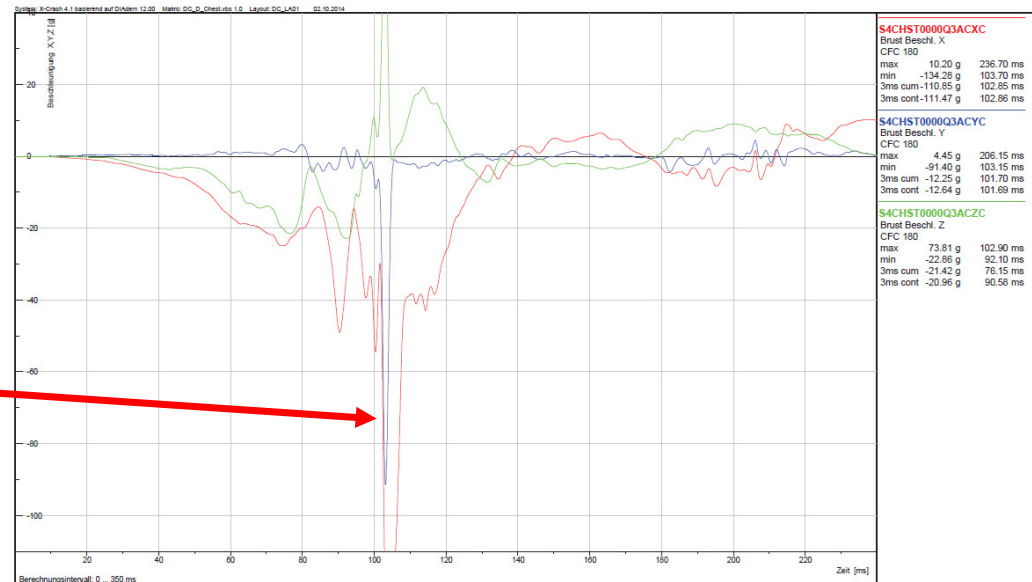
Q3 scapula to rib cage contact

- Daimler is using the Q3 dummy in full scale crash tests
- In tests with the Q3 dummy contact interactions between the scapula and the rib cage are observed
- This results in noise on the rib accelerations
- Issue was reported to German AK5 group in April 2015 and discussed with Humanetics over the past period

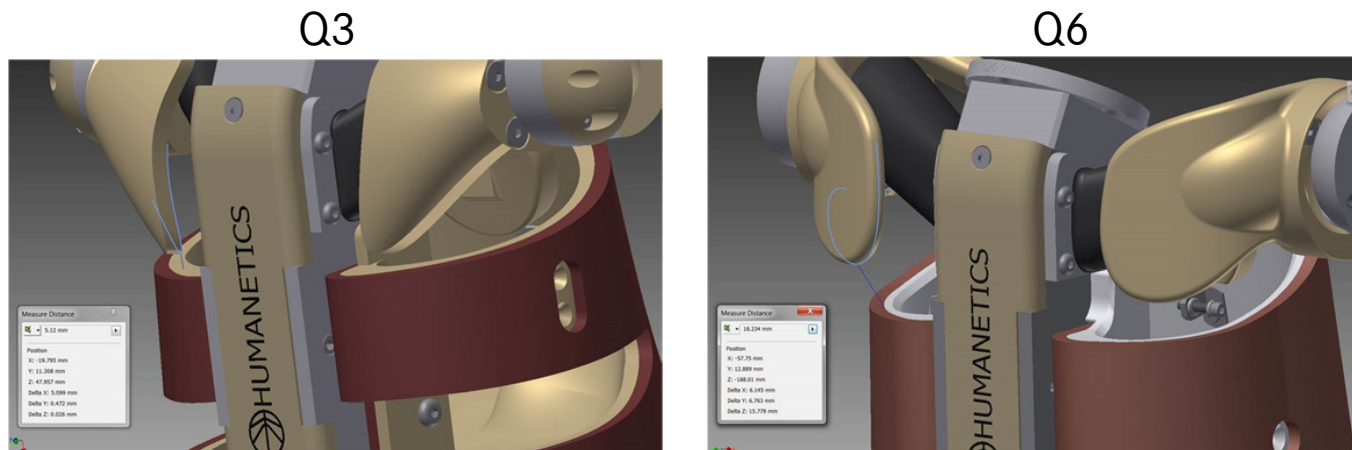
Q3 versus Q6 scapula

- As recommended by Daimler Humanetics compared the Q3 design against the Q6 design
- The Q6 has 13 mm more clearance between scapula and rib cage.
- The Q3 seems to have a more natural shape of the scapula while in the Q6 it is reduced in size.
- No documentation was found on the reasoning for this but when checking with the design engineers this was related to risk for contact in the Q6

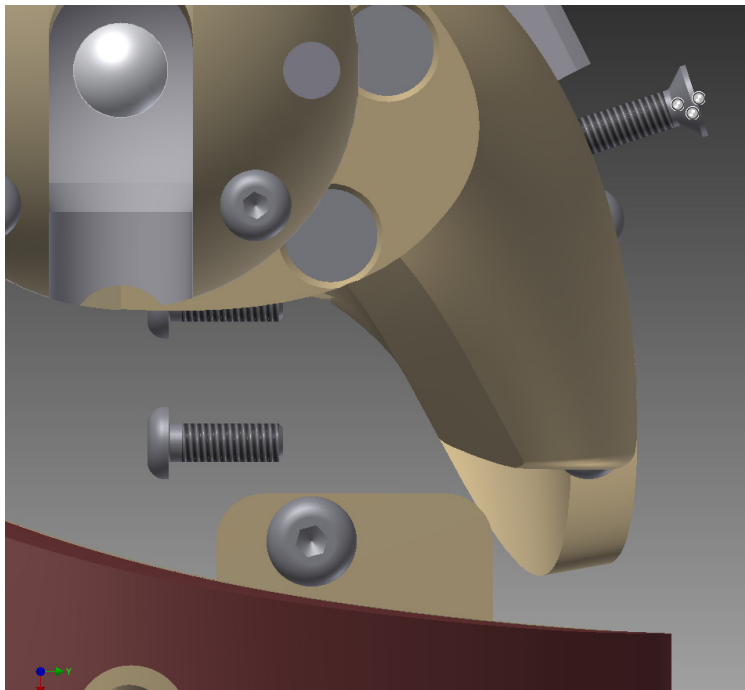
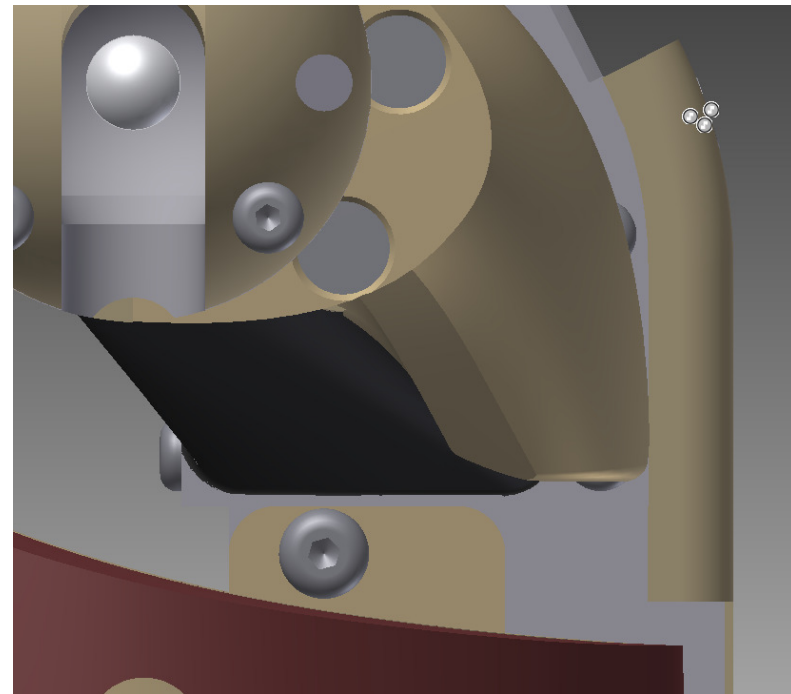
Comparison for Affect on Seating

- Below on the left shows a CAD picture looking directly from the side with the current scapular behind. Spine, shoulder rubbers and cable cover hidden. On the right these parts are shown.
