BioRID II C4 Issue for GTR7 TEG meeting September 12, 2019

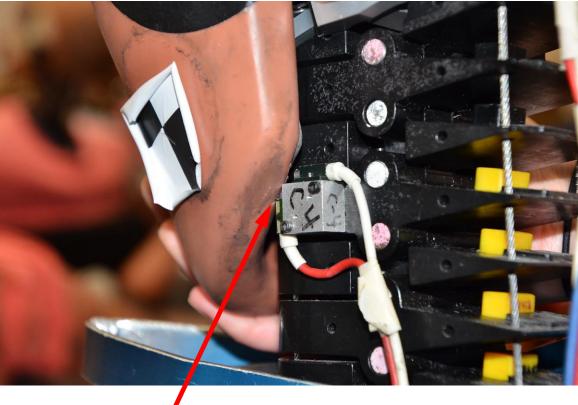
Sufficient Flexion is possible for the chin to hit the
C4 accelerometer or mount on either side of the

neck

We have observed witness marks on multiple customer dummies showing contact has occurred during testing.

• For several years Humanetics has been recommending to remove the C4 accelerometer mount from all testing.

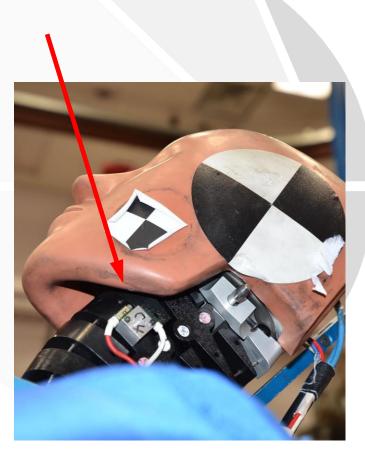
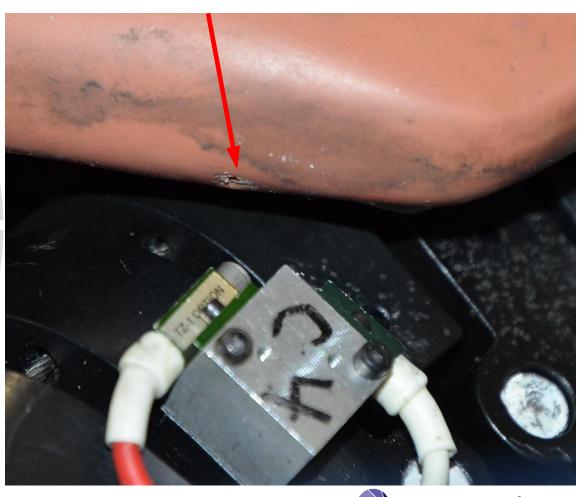
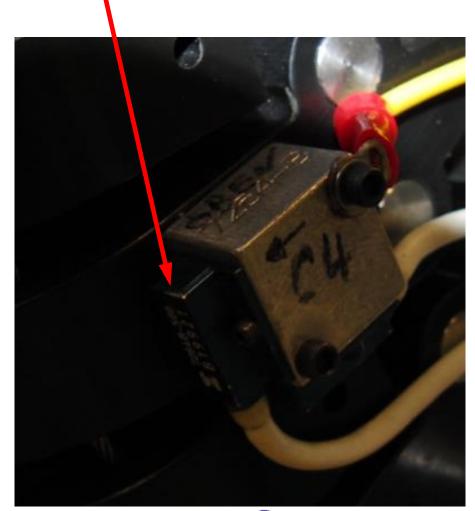
- We have seen
 - damage to skin as in the previous pictures.
 - damage to the aluminum skull
 - Anodize scuffed off of accelerometers (shown here)

- Why do we care?
 - Chin to C4 contact creates a load path around the upper neck load cell
 - This makes all upper neck loads invalid and meaningless!
 - »It is impossible to determine the real upper neck load values when this occurs!
- We do not know how often this occurs, but when it does upper neck loads are invalid
 - It is probably not an abrupt enough change to determine that it has occurred from the data

BioRID II Design Checklist VERIFY S1 IS PRESENT, WHICH USES A LUMBAR LOAD CELL OR STRUCTURAL REPLACEMENT TO IMPROVE DURABILITY AND INTERCHANGABILITY. REFER TO GTR DWG # ARA-562 GLOBAL, REFER TO GTR DWG # ARA-564 GLOBAL REFER TO GTR DWG # ARA-200 K10, AND PADI SECTION 5.2.4 Remove C4 Accelerometer and mount. This will cause a load path around upper neck load cell and produce erroneous results.
