Progress update – TRL/EC Test Programme

Presented by David Hynd
23 February, 2012

Seat Test Results

20 baseline tests with 028, 068, 077 and 100

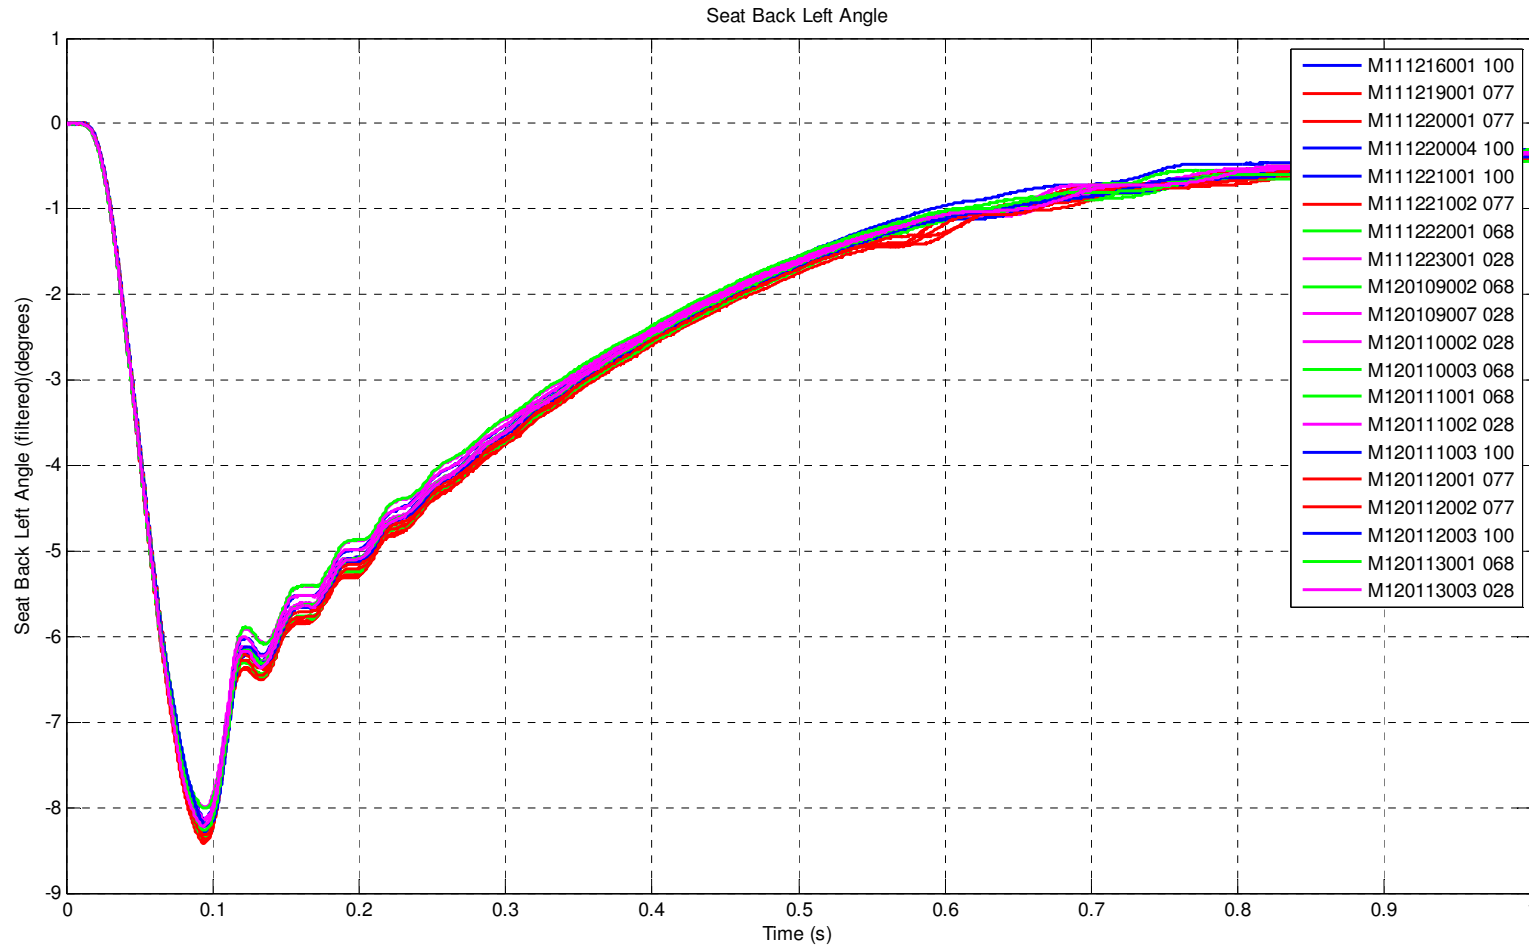
Seat Test Results

20 baseline tests with 028, 068, 077 and 100

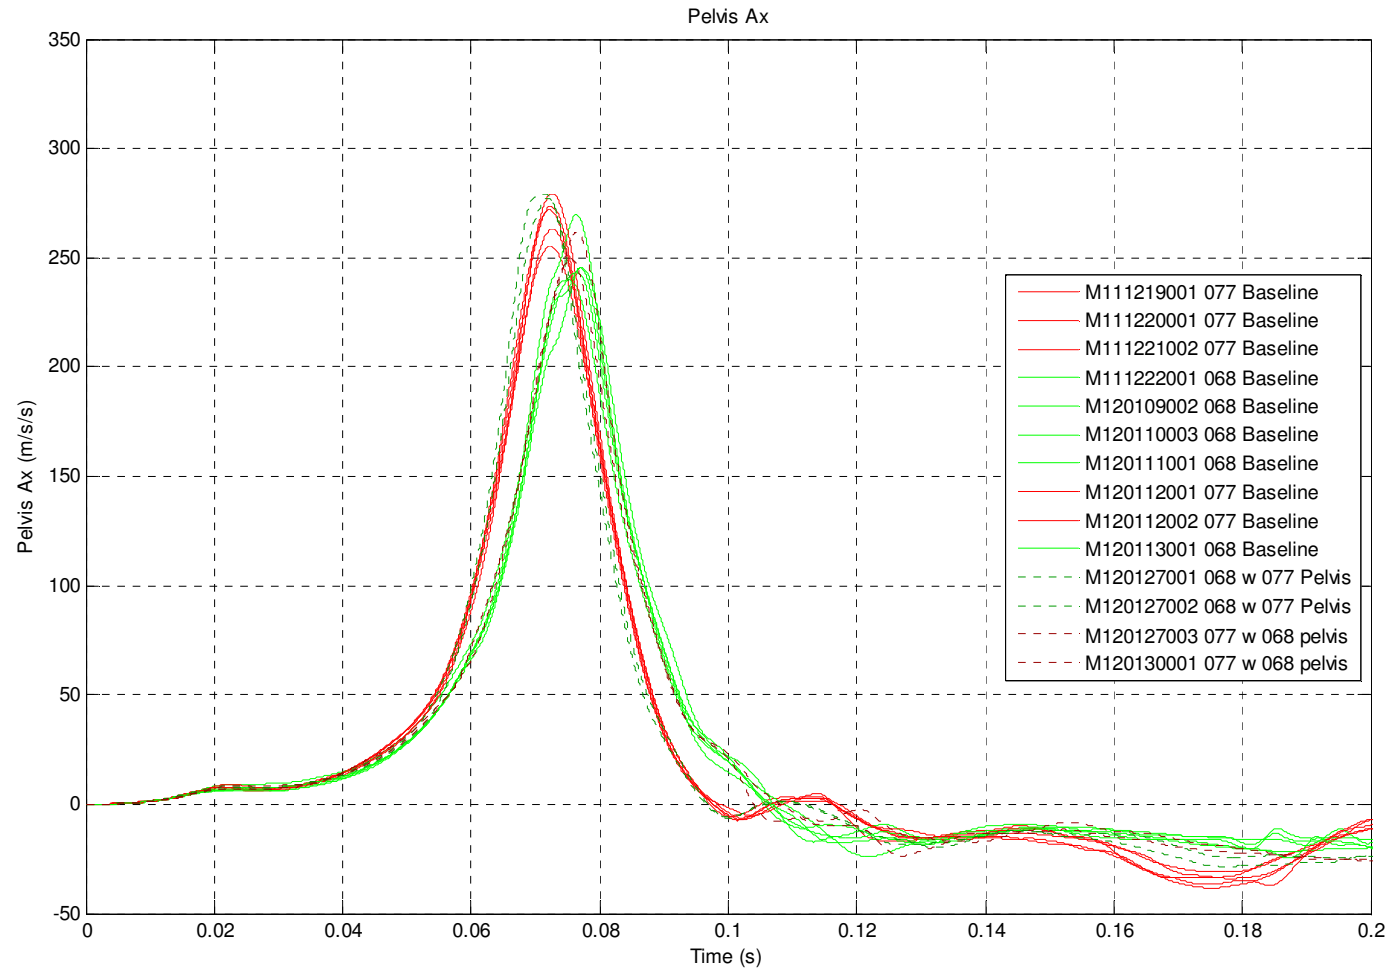
Seat Test Results

Baseline tests with 068 and 077 + pelvis swap

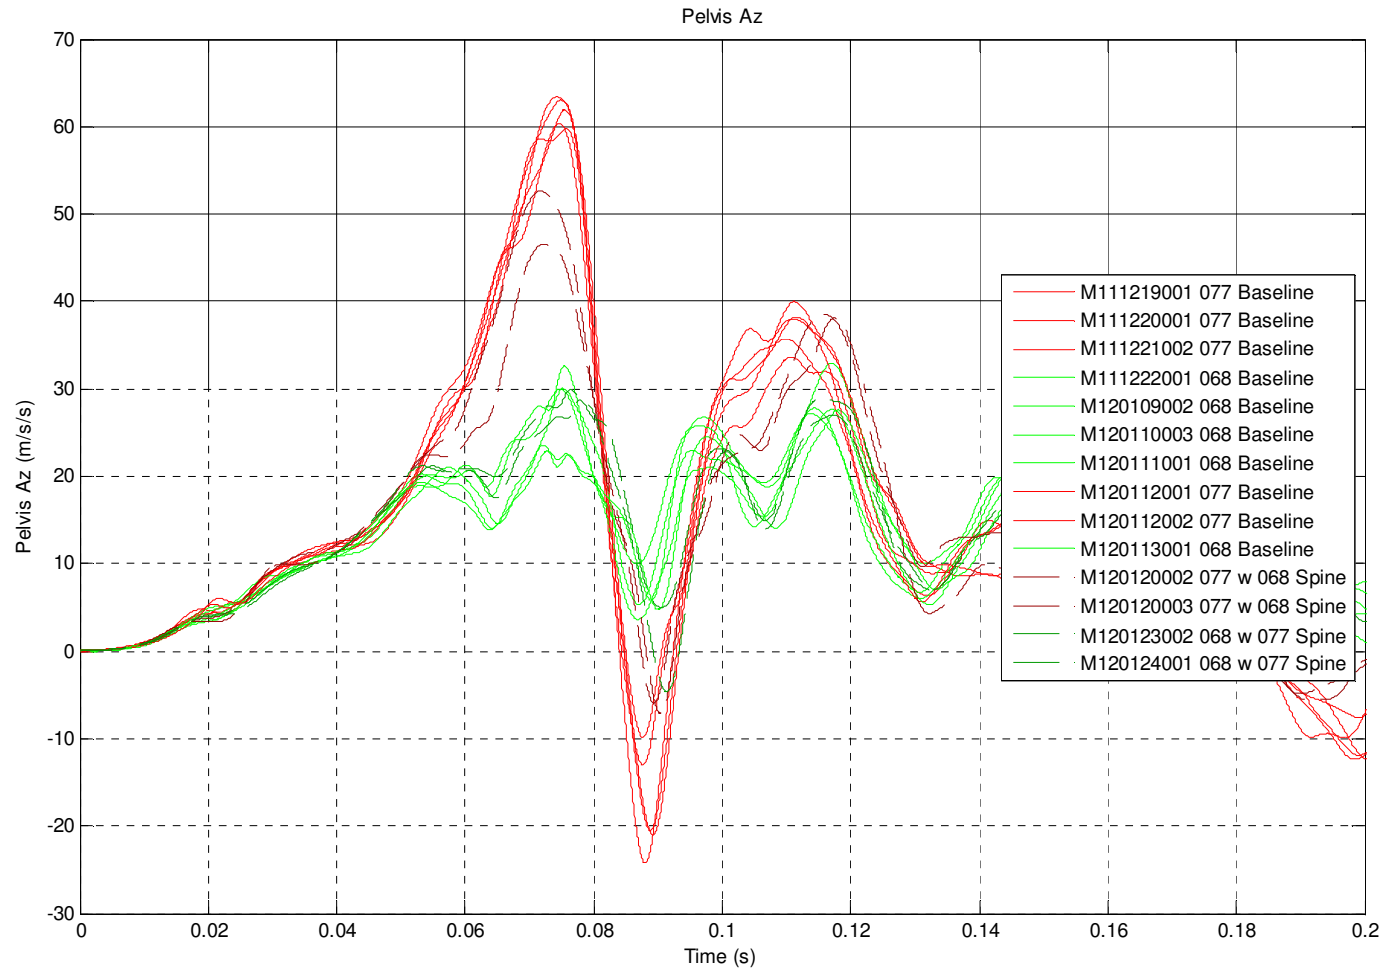
Seat Test Results

Baseline tests with 068 and 077 + spine swap

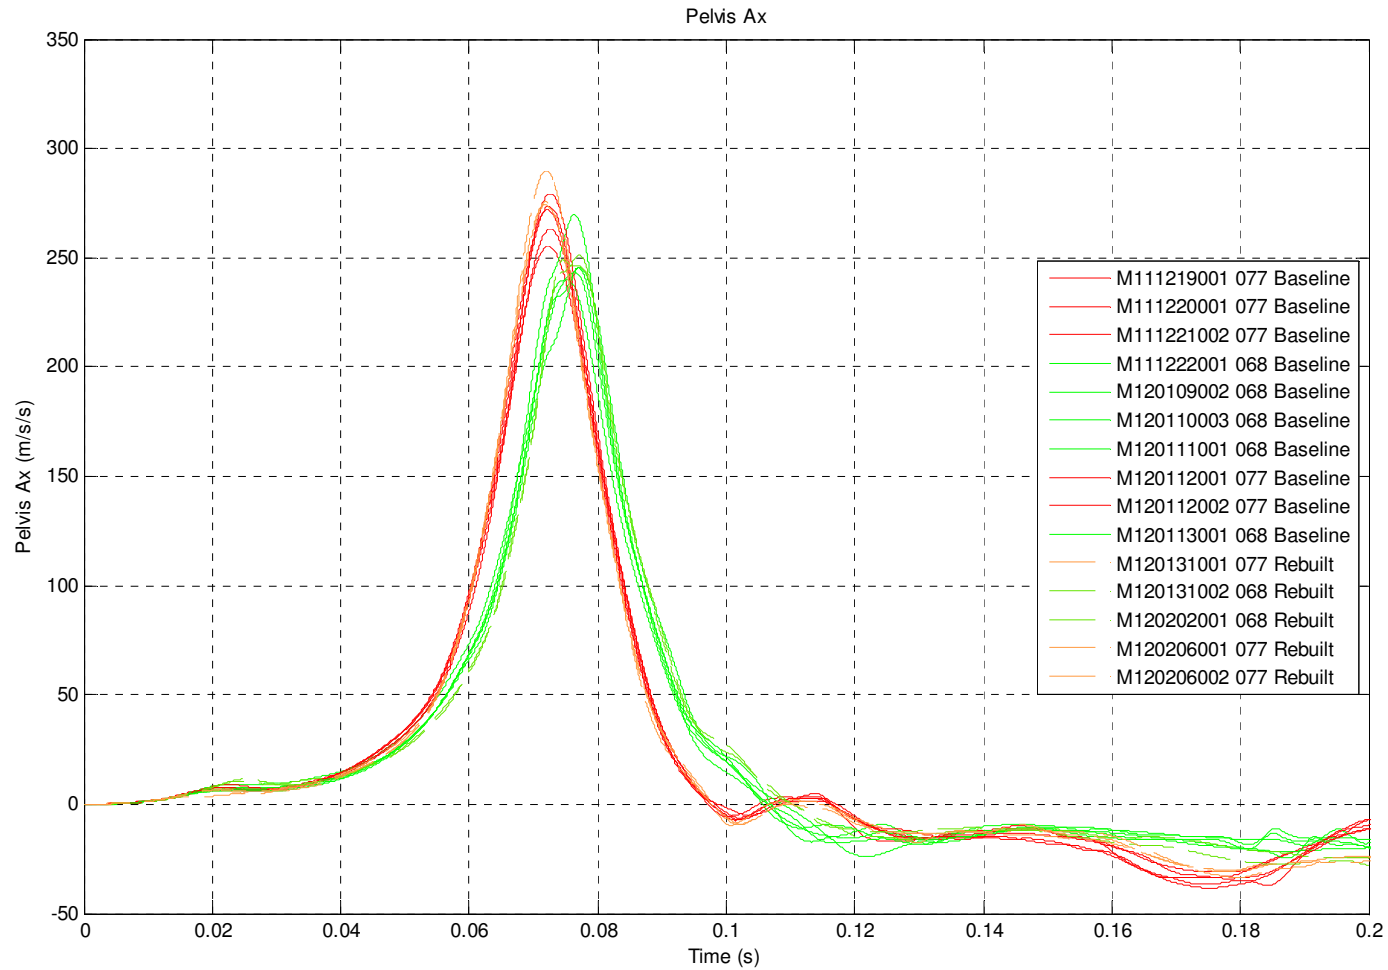
Seat Test Results

Baseline tests with 068 and 077 + rebuilt

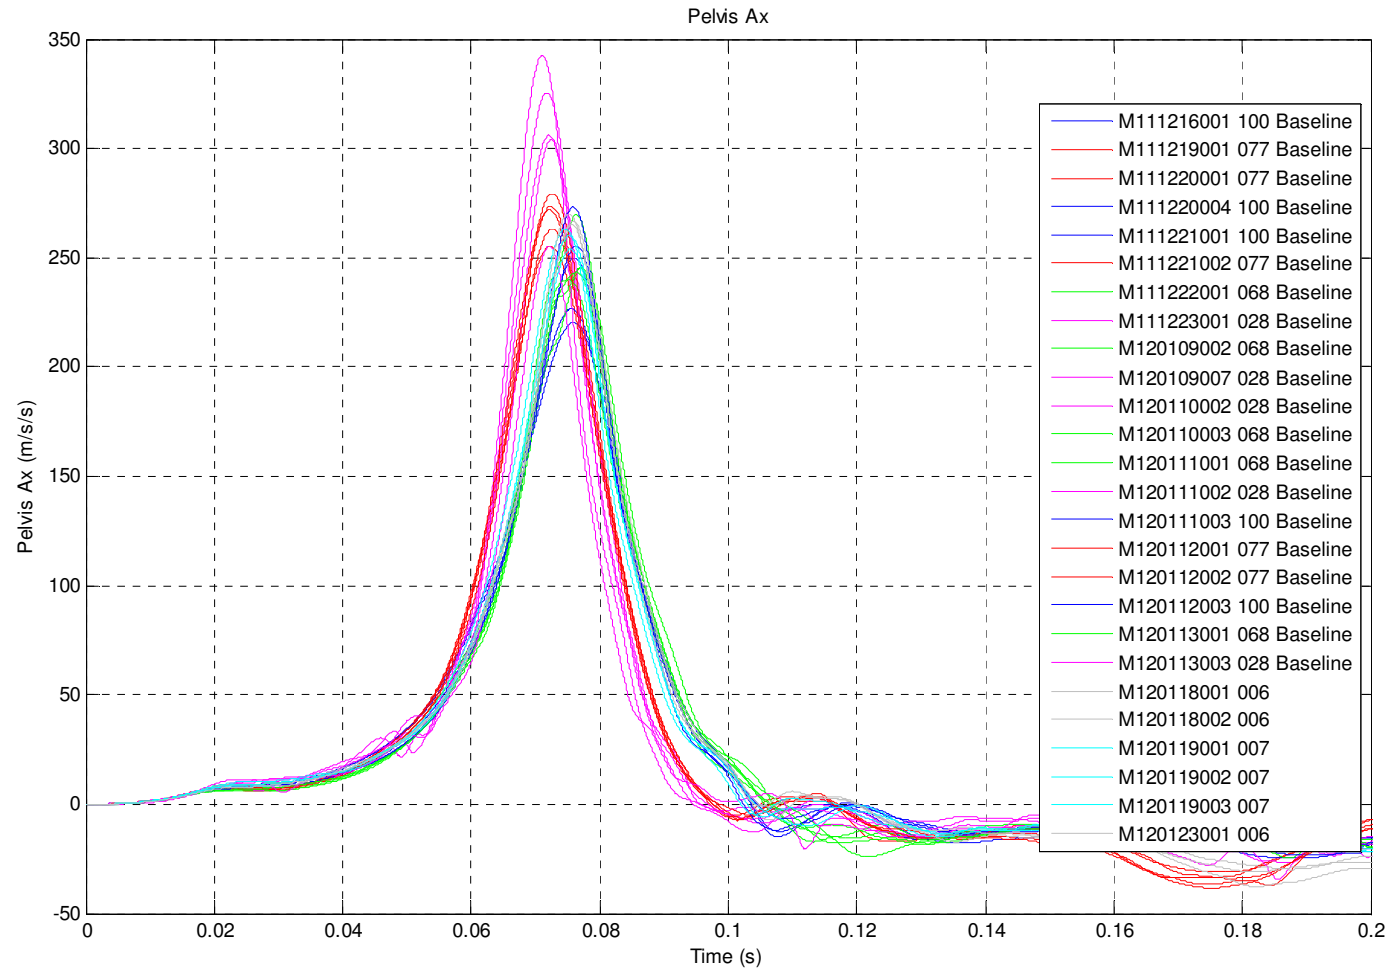
Seat Test Results

Baseline tests + refurbished 006 and 007

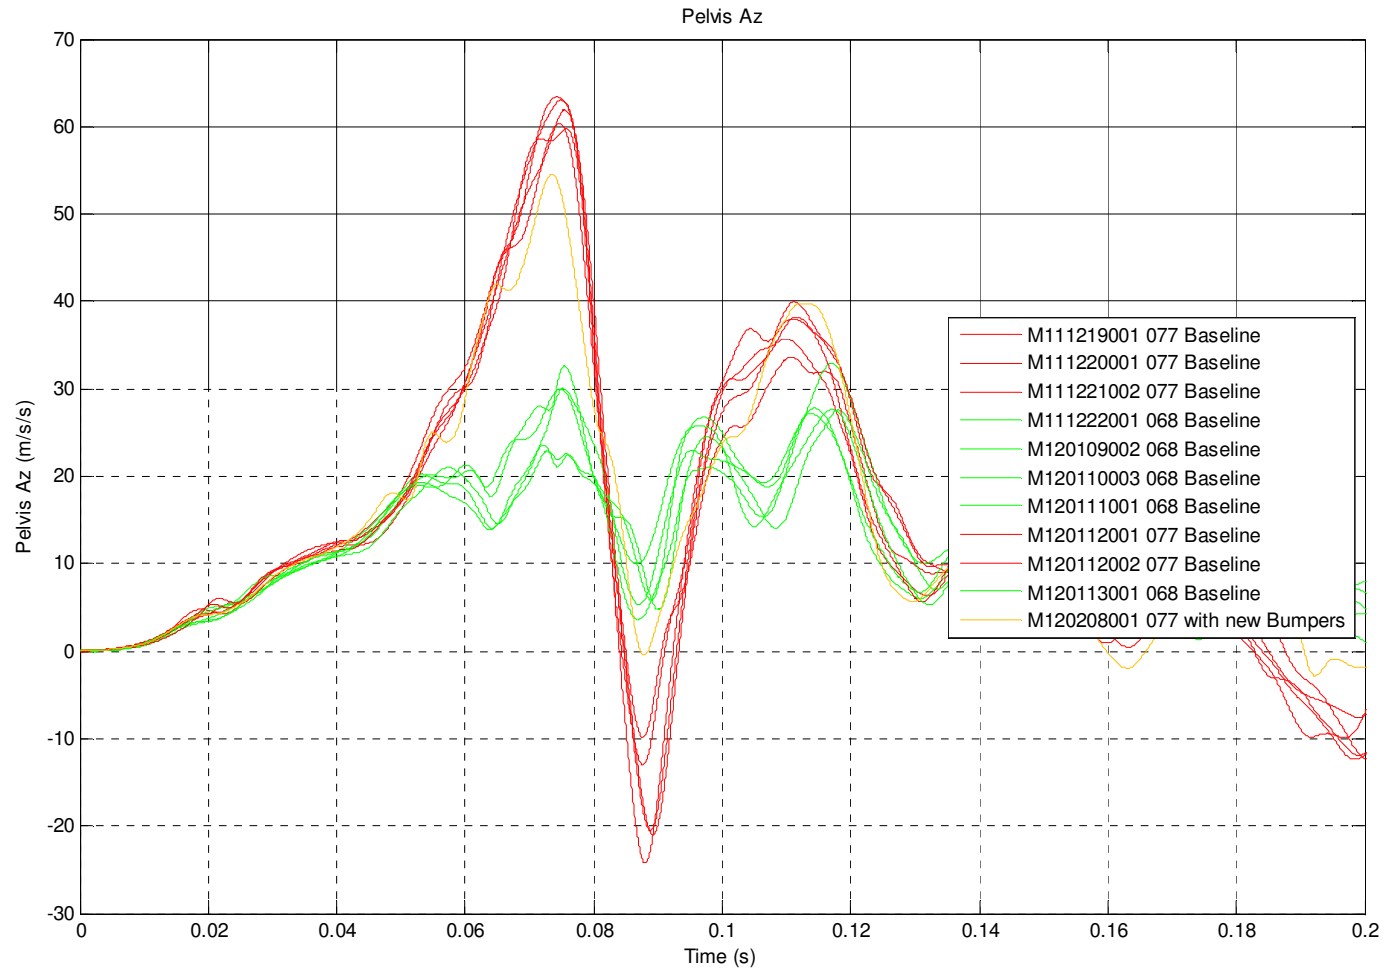
Seat Test Results

Baseline tests with 068 and 077 + bumper swap 007

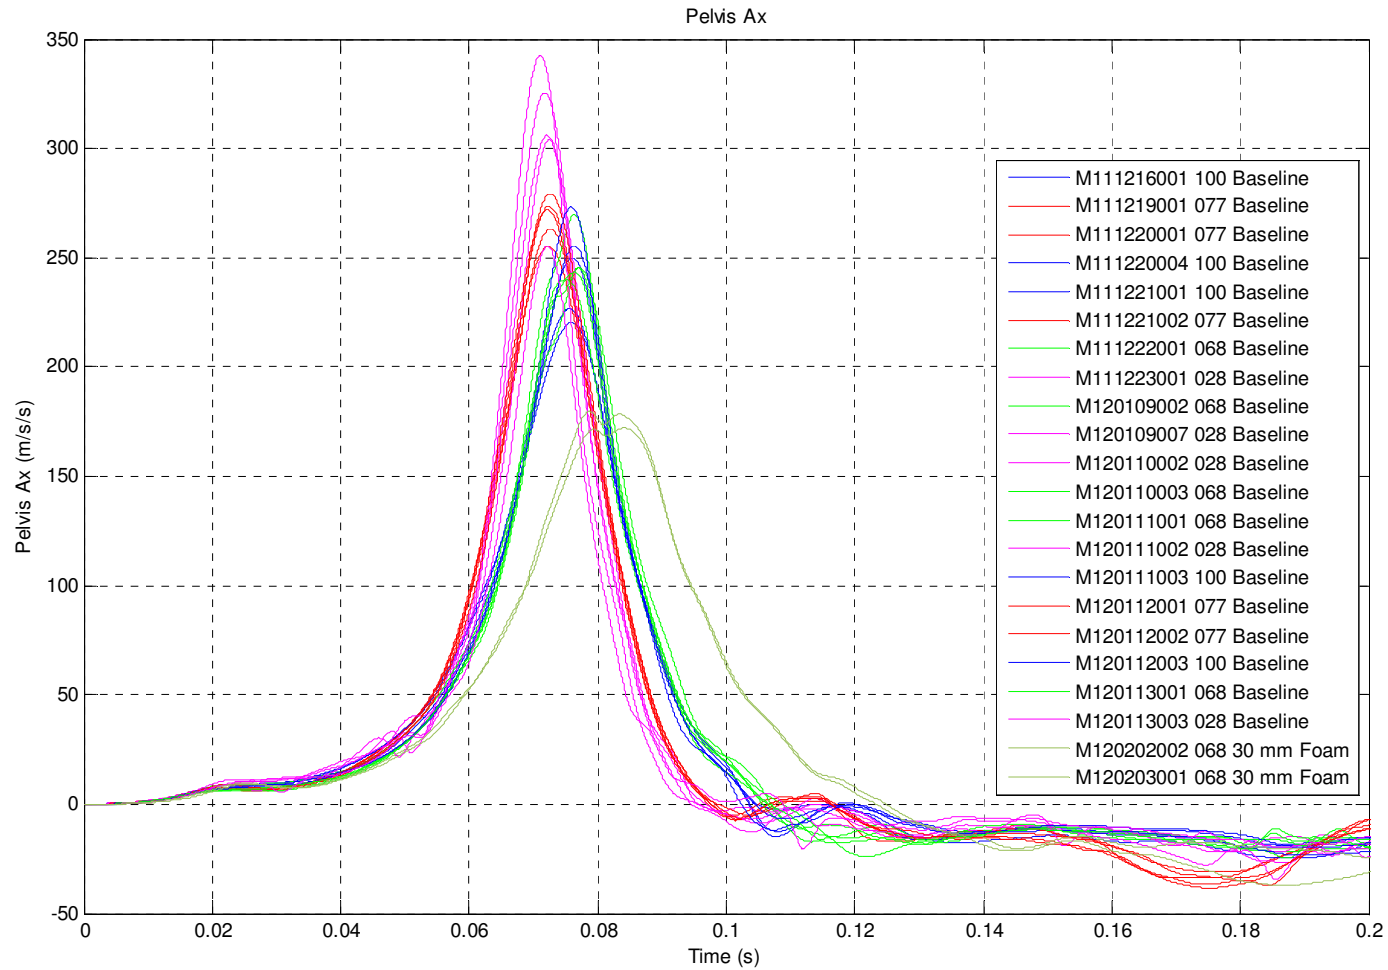
Seat Test Results

Baseline tests with + 068 with 30 mm foam on seat base

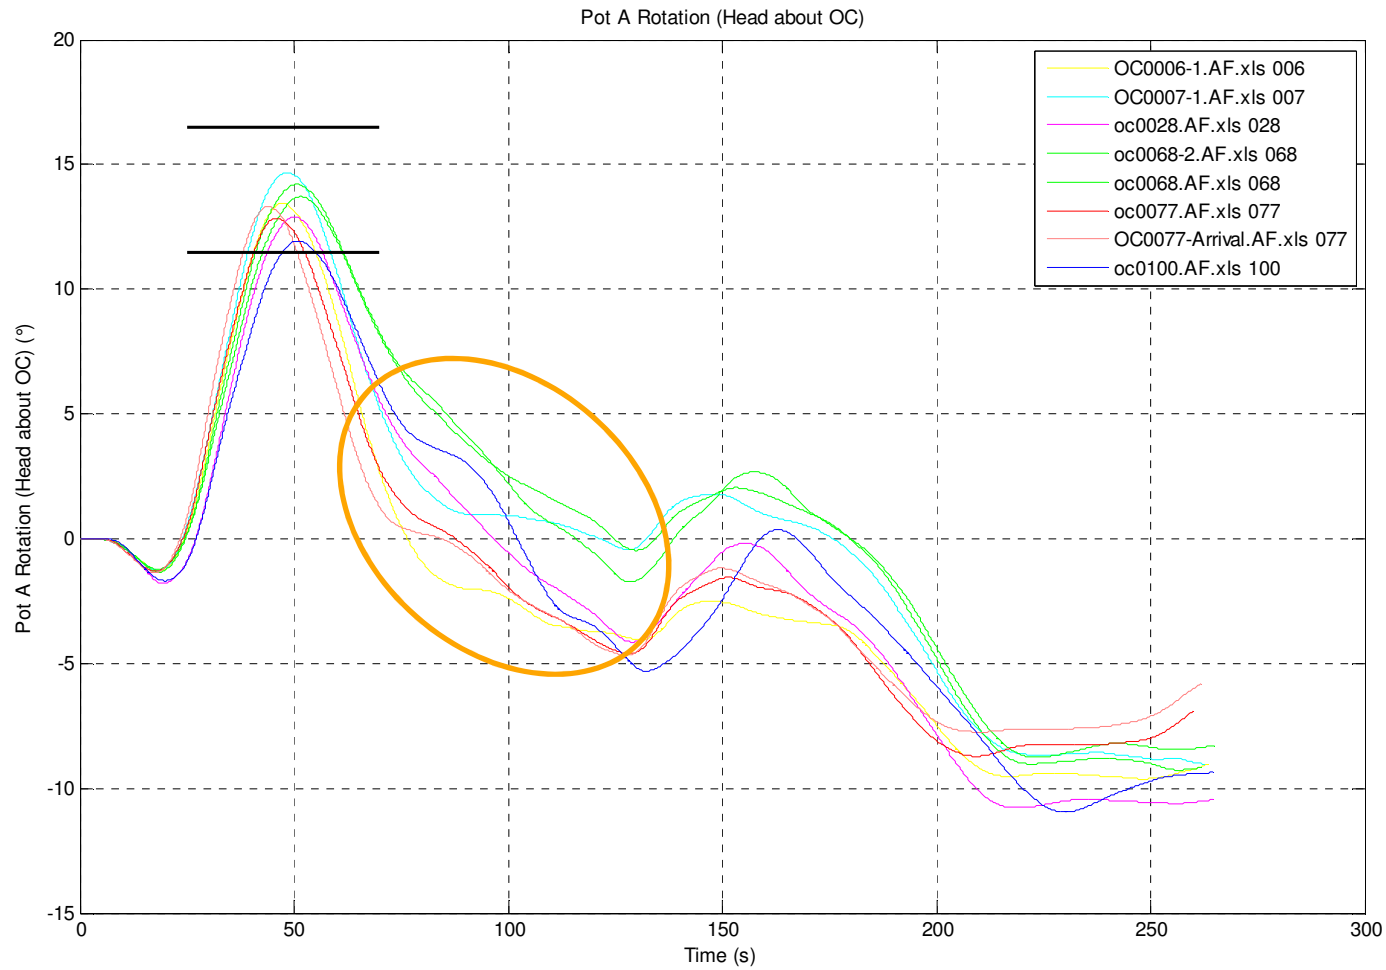
Certification Test Results

Without HR Cert

- Certification
 - Need pelvis flesh stiffness
 - Looking at quasi-static spine stiffness test
 - May need much tighter control of Pot A **after** initial peak which has the current corridor
 - Looking at source of oscillations in upper neck My in no-HR cert test (40 Hz)

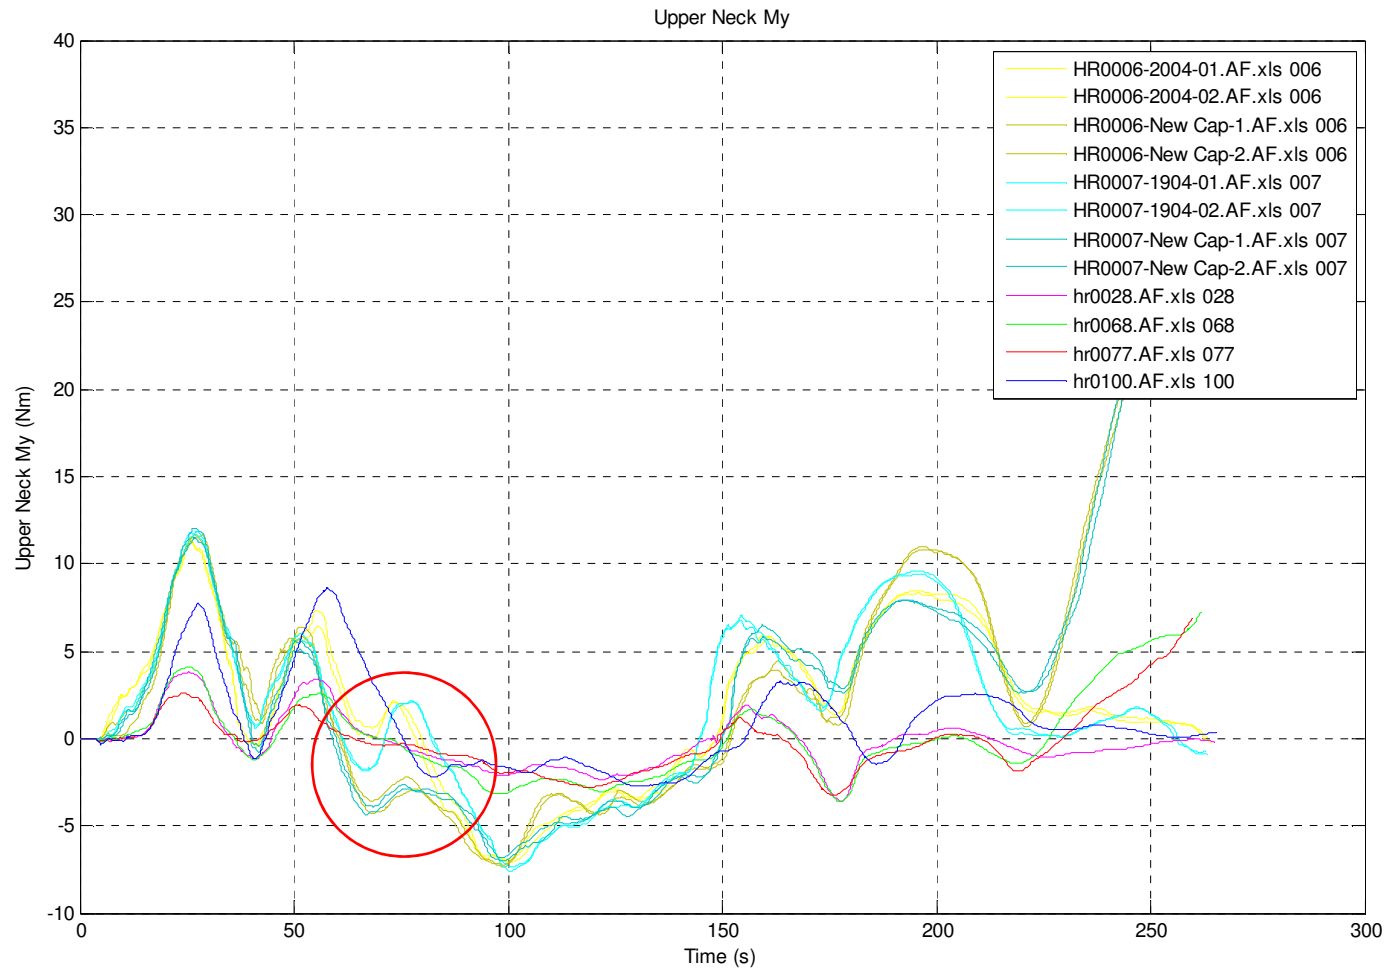
Certification Test Results

With HR Cert

- Sled tests
 - T1 and upper neck Fx quite good
 - T1 My quite good
 - T1 and upper neck Fz very variable
 - Not related to small changes in seat / head restraint over time because no change in phase of responses (phase change seen with different backset)
 - Also big oscillations in Fz in certification test
 - Fz difference correlate in time with pelvis Az differences
 - Recommend improving pelvis flesh reproducibility
 - Upper neck My very variable
 - Correlates quite well with Pot A in no HR cert test and My in with HR cert test
 - Recommend much tighter control on Pot A response
