FEEDBACK FOR WORKSHOP HELD AT BRITAX WITH END-USERS

Philippe LESIRE (LAB)

David BRAUN (Britax)

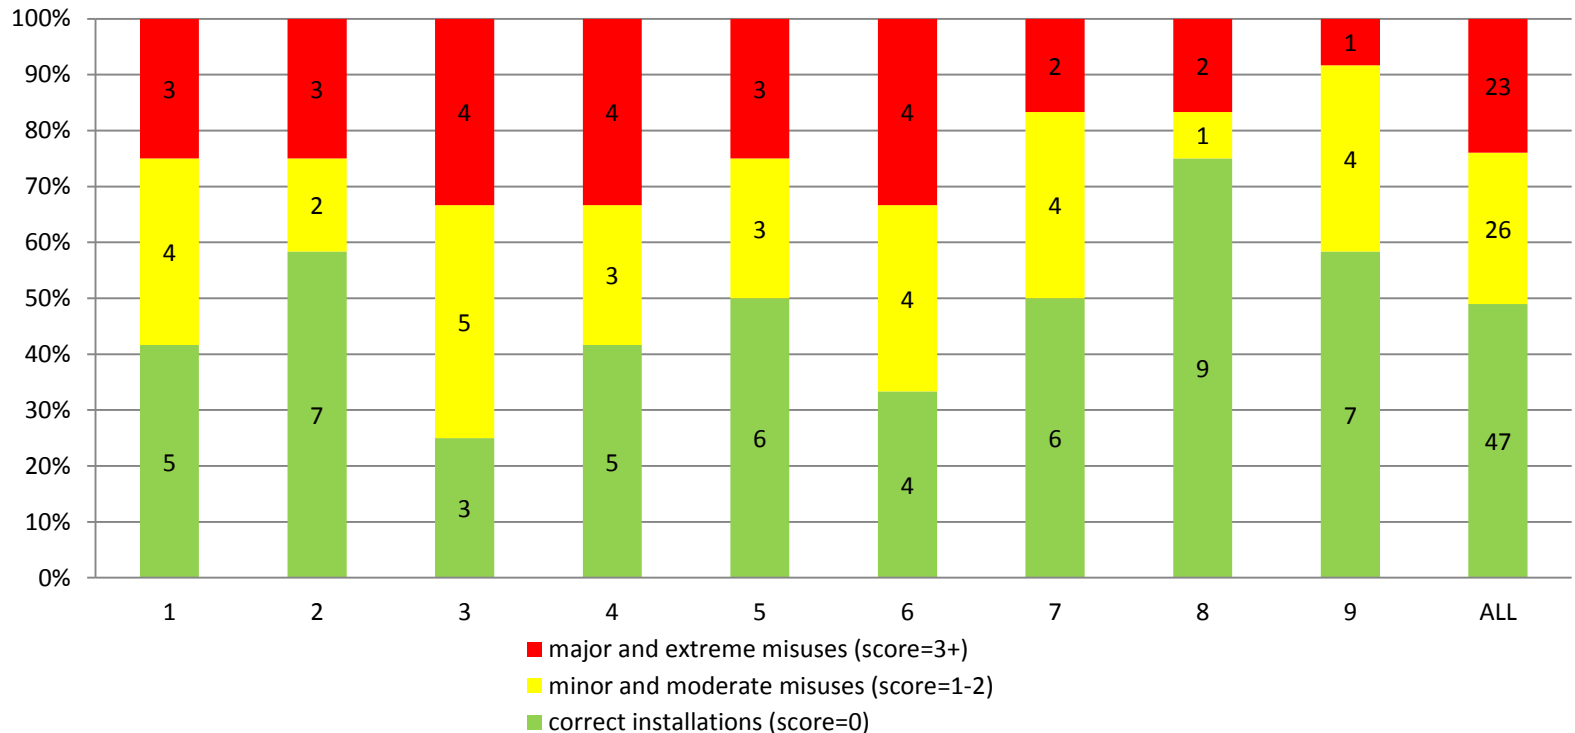
- Installer performances:

- Average time for all CRS = 5'

difficulty	3,1	4,1	3,3	2,9	2,8	3,1	3,6	3	3	2,9
confidence	3,1	3,7	3,2	2,9	3,4	3,6	3,6	4,1	3,75	3,1

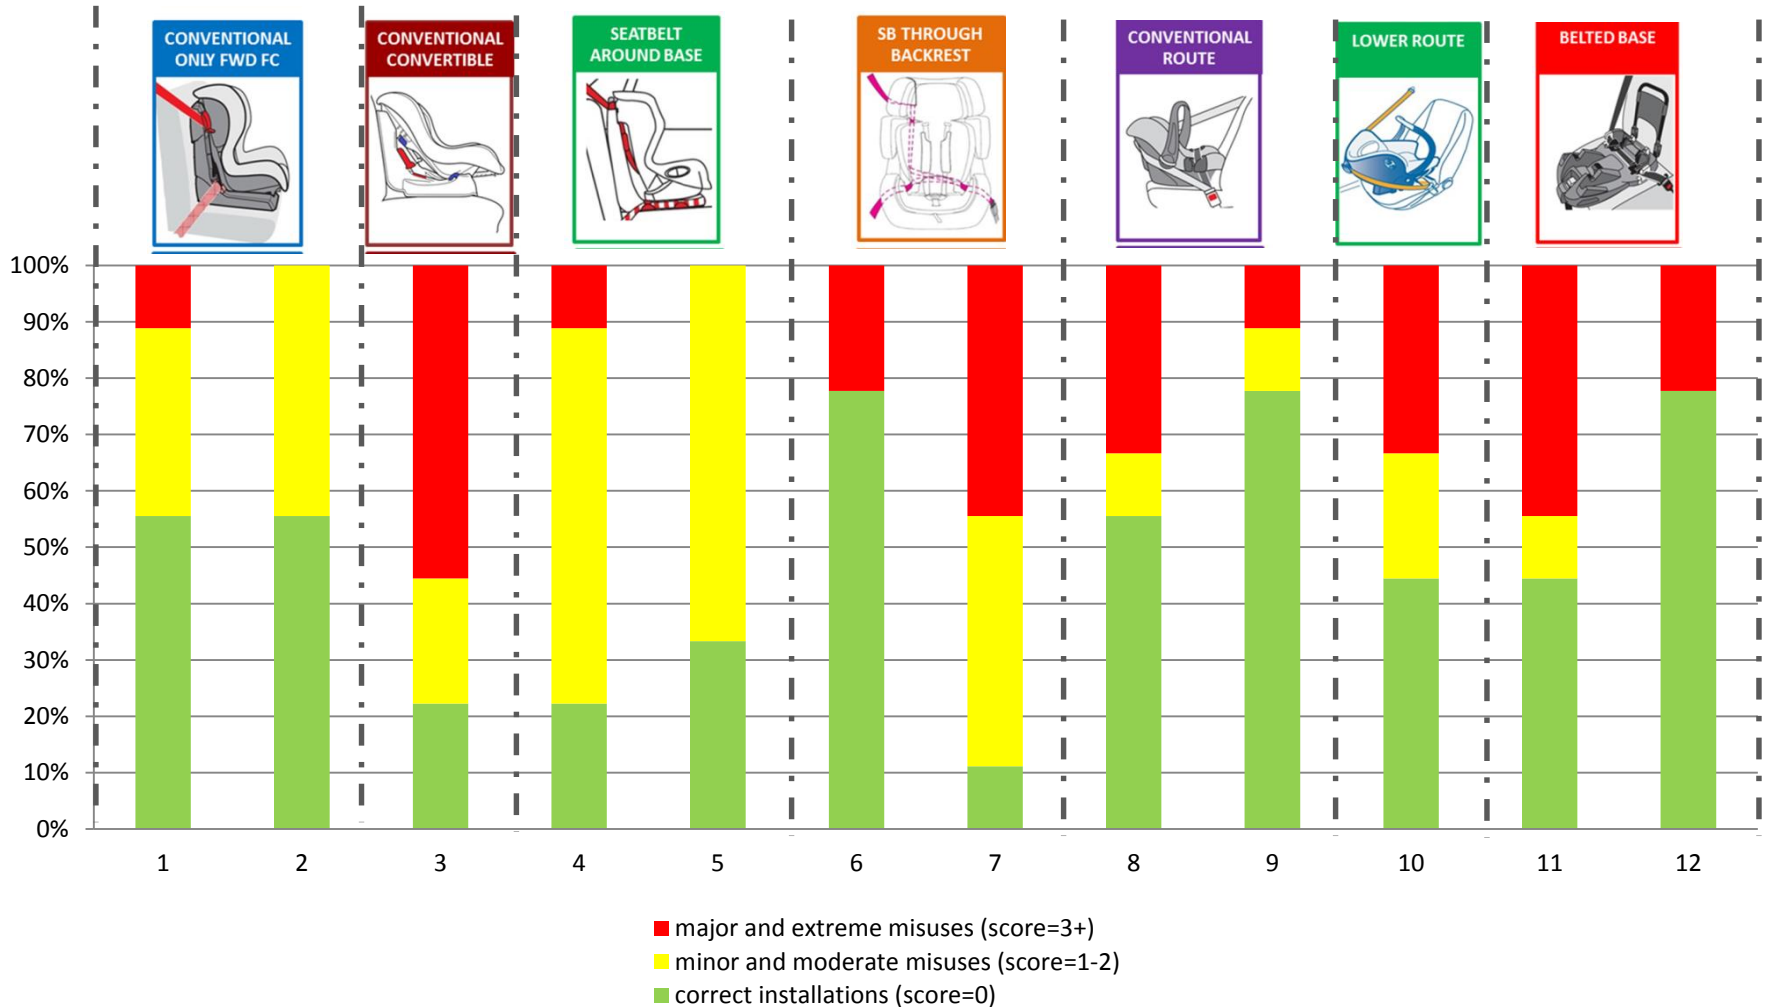
- Misuse rate per CRS

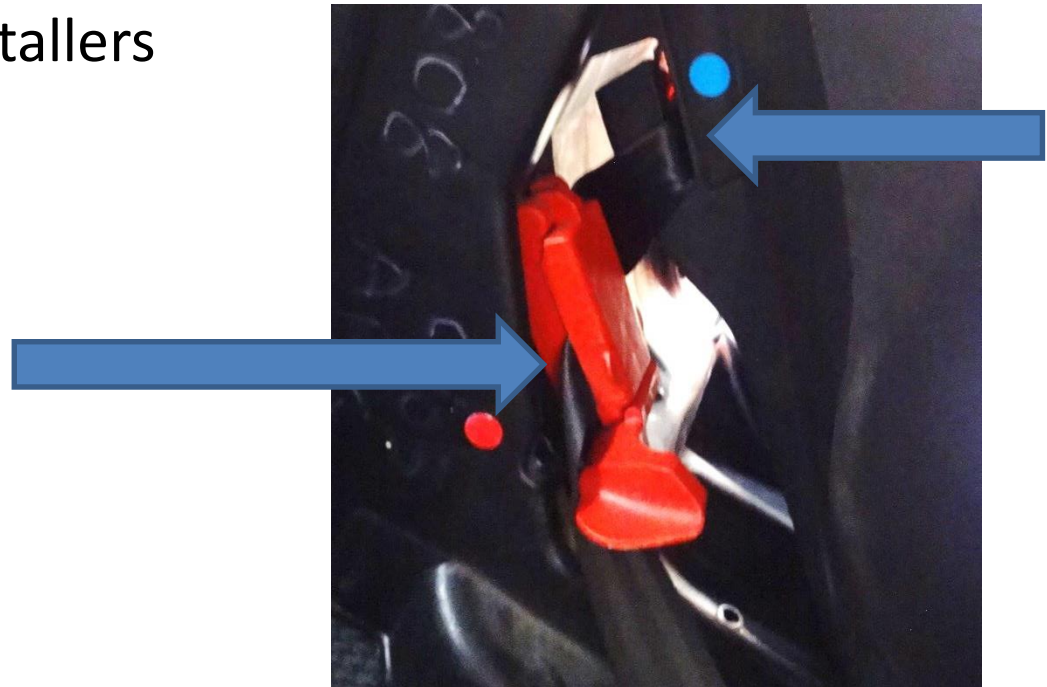
3

- FOCUS ON CRS n°3
 - Convertible CRS
 - Instructions were given to install it forward facing
 - Installed 5 times rearward facing
 - Not coded as a misuse (even if not what was required)
 - Only installation misuse coded according to the facing direction user instructions
 - Confusing for installers

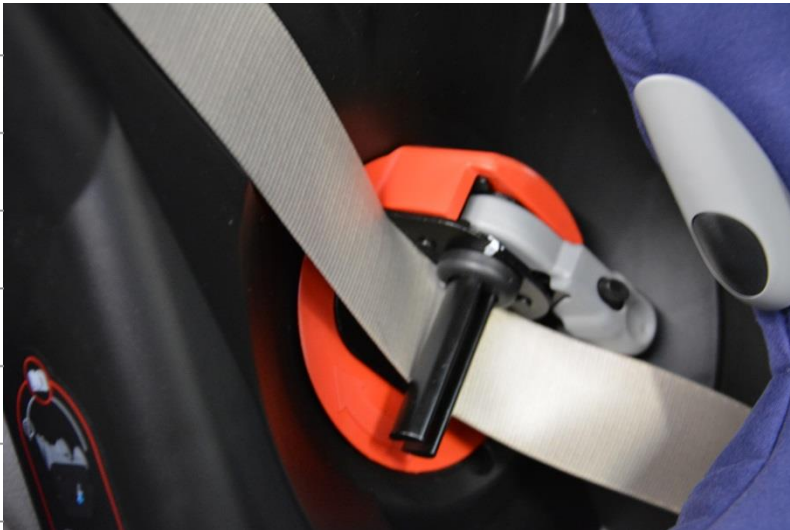
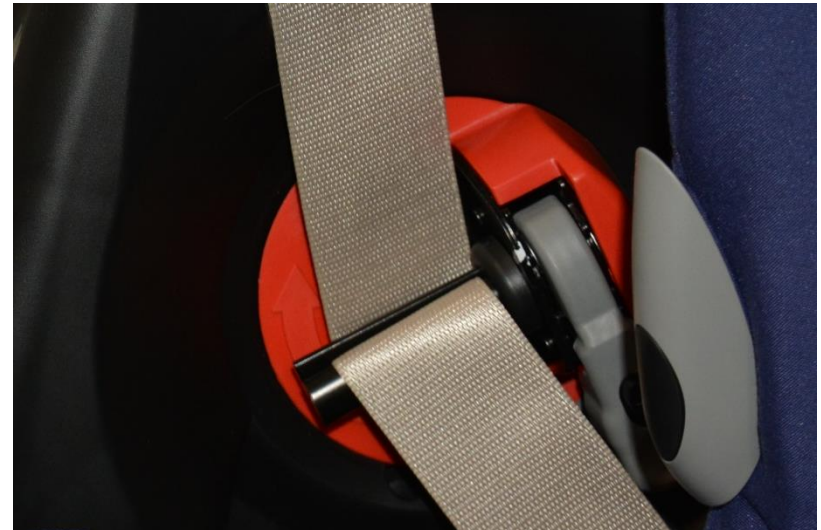
- FOCUS ON CRS n°4
 - Equipped with a seatbelt tensioner
 - People were not used to such a device and use it as a seatbelt guide only which lead to coding of misuse (severity = moderate)

CRS n°4 : the seatbelt tensioner was not always used and not always correctly
lap belt was not always correctly routed

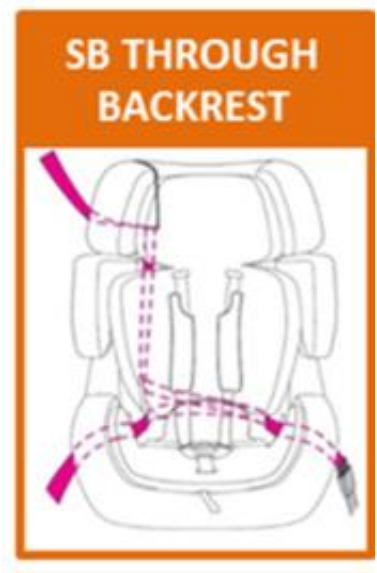
- FOCUS ON CRS n°7

- Only installed correctly one time

- In one case 10 minutes haven't been sufficient to have it installed (so coded in the study as not restrained)

- All installers complained about the seatbelt route difficulties
- Pictograms and user manuals unclear and not really useful

"Elsa" (=CRS n°7) has nearly never been properly installed
