# **Test Procedure on Exhaust Gas Entering into Vehicle Cabin**

2017. 4. 25

Korea Transportation Safety Authority

Korea Automobile Testing & Research Institute

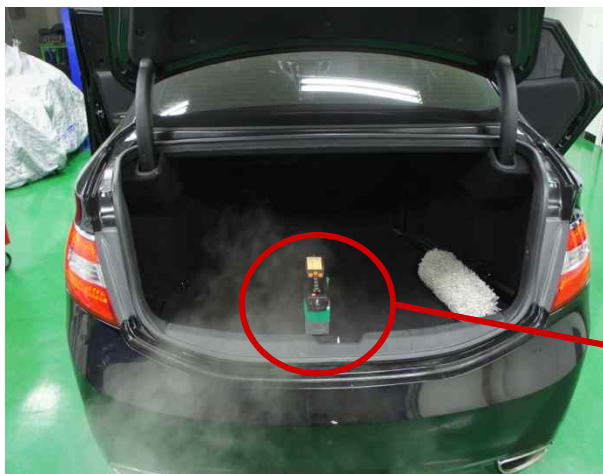
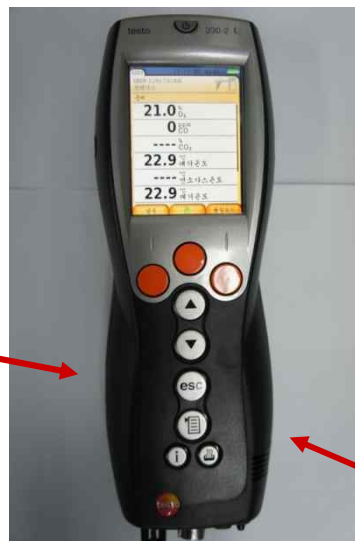
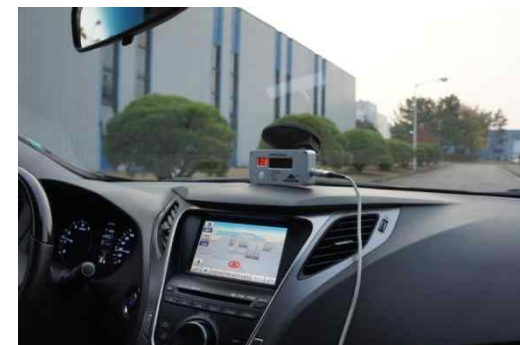
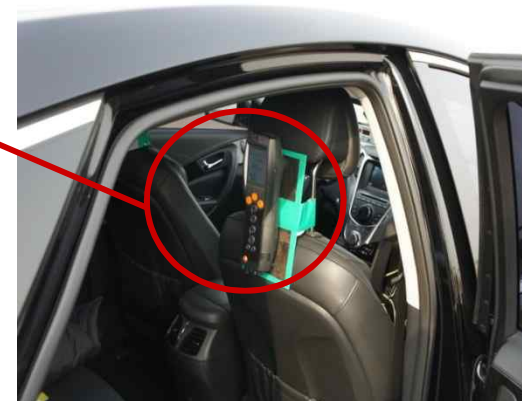
- Measuring point : Head position of driver and passenger seat, center position of trunk

### ➤ Test Device : Testo 330 LL

- CO Low Range : 0~500 ppm
- Resolution : 0.1 ppm
- Accuracy :  $\pm 2$  ppm(0.0 ~ 39.9 ppm), Other range  $\pm 5\%$

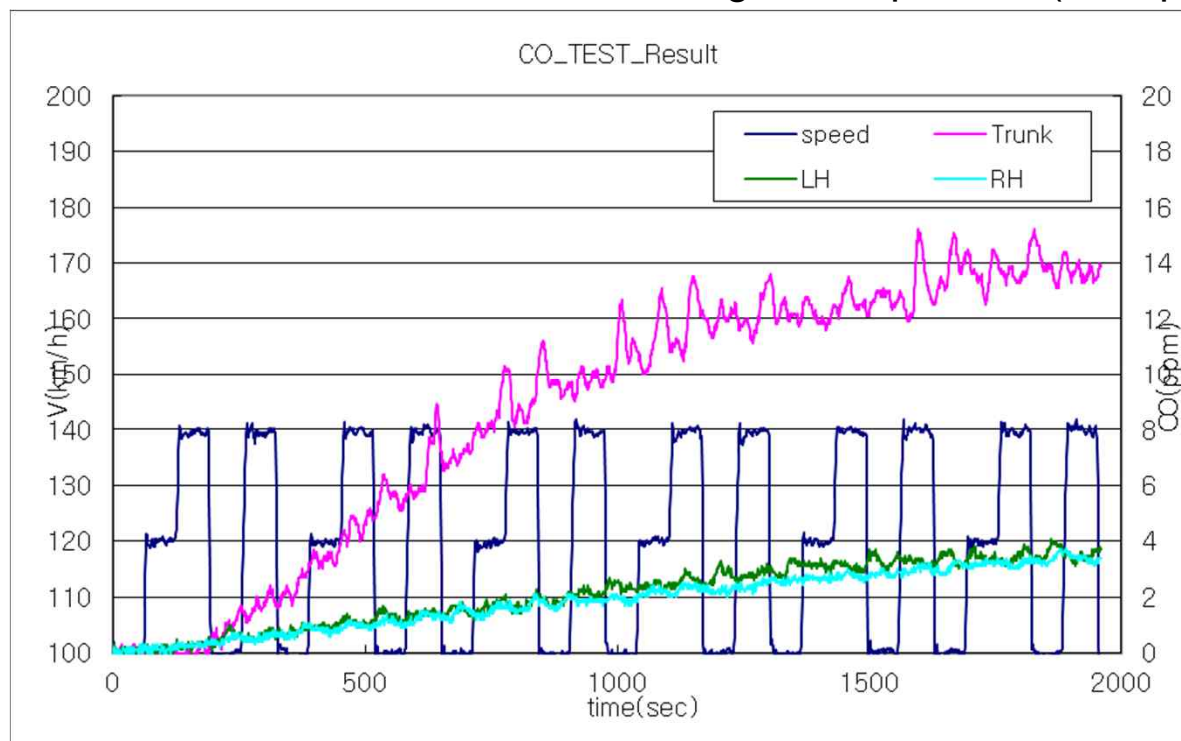
✓ Vehicle testing results using the test mode in 2011

- CO concentration increases gradually in trunk area ( 10~14 ppm )
- CO was detected in vehicle cabin at the left and right seat position ( 2~4 ppm )

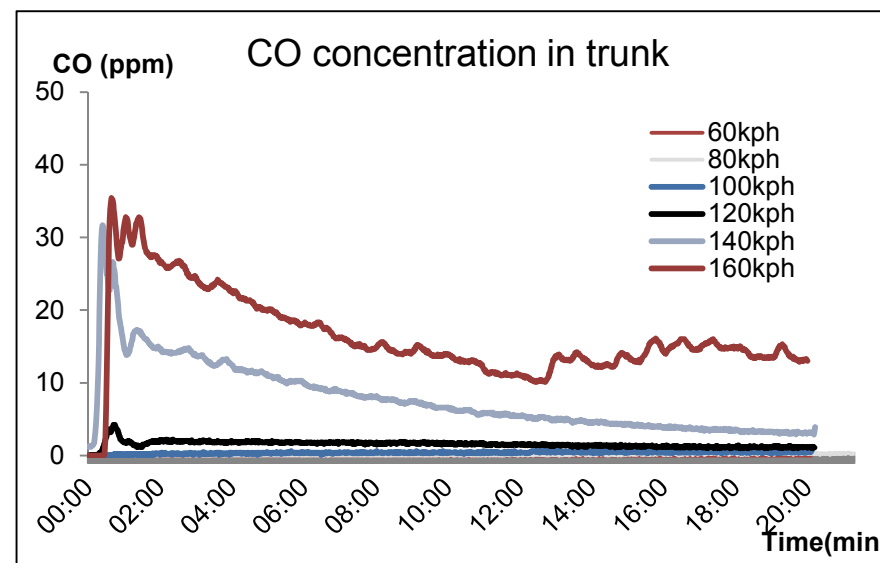
### ✓ Vehicle testing result using the constant speed test

- CO concentration increases gradually depending on vehicle speed
- CO was detected in high speed more than 140 km/h

Vehicle Speed	CO concentration (unit : ppm)	
	Cabin	Trunk
60 km/h	0.7	0.1
80 km/h	0.6	0.4
100 km/h	1.0	0.7
120 km/h	1.8	4.2
140 km/h	4.3	31.7
160 km/h	11.3	35.4

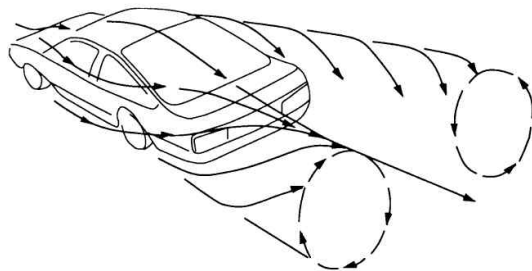
<Vortex flow in back part of vehicle>

- ✓ The vortex flow occurs in the back part of sedan vehicles depending on vehicle speed

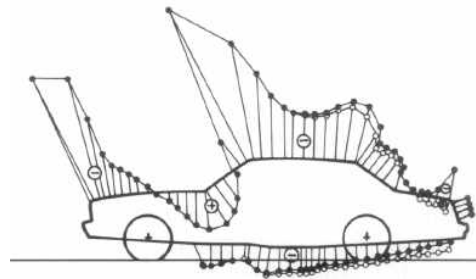
< Pressure of vehicle surface in high speed >

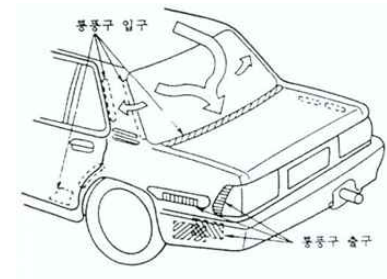
< position of extractor >

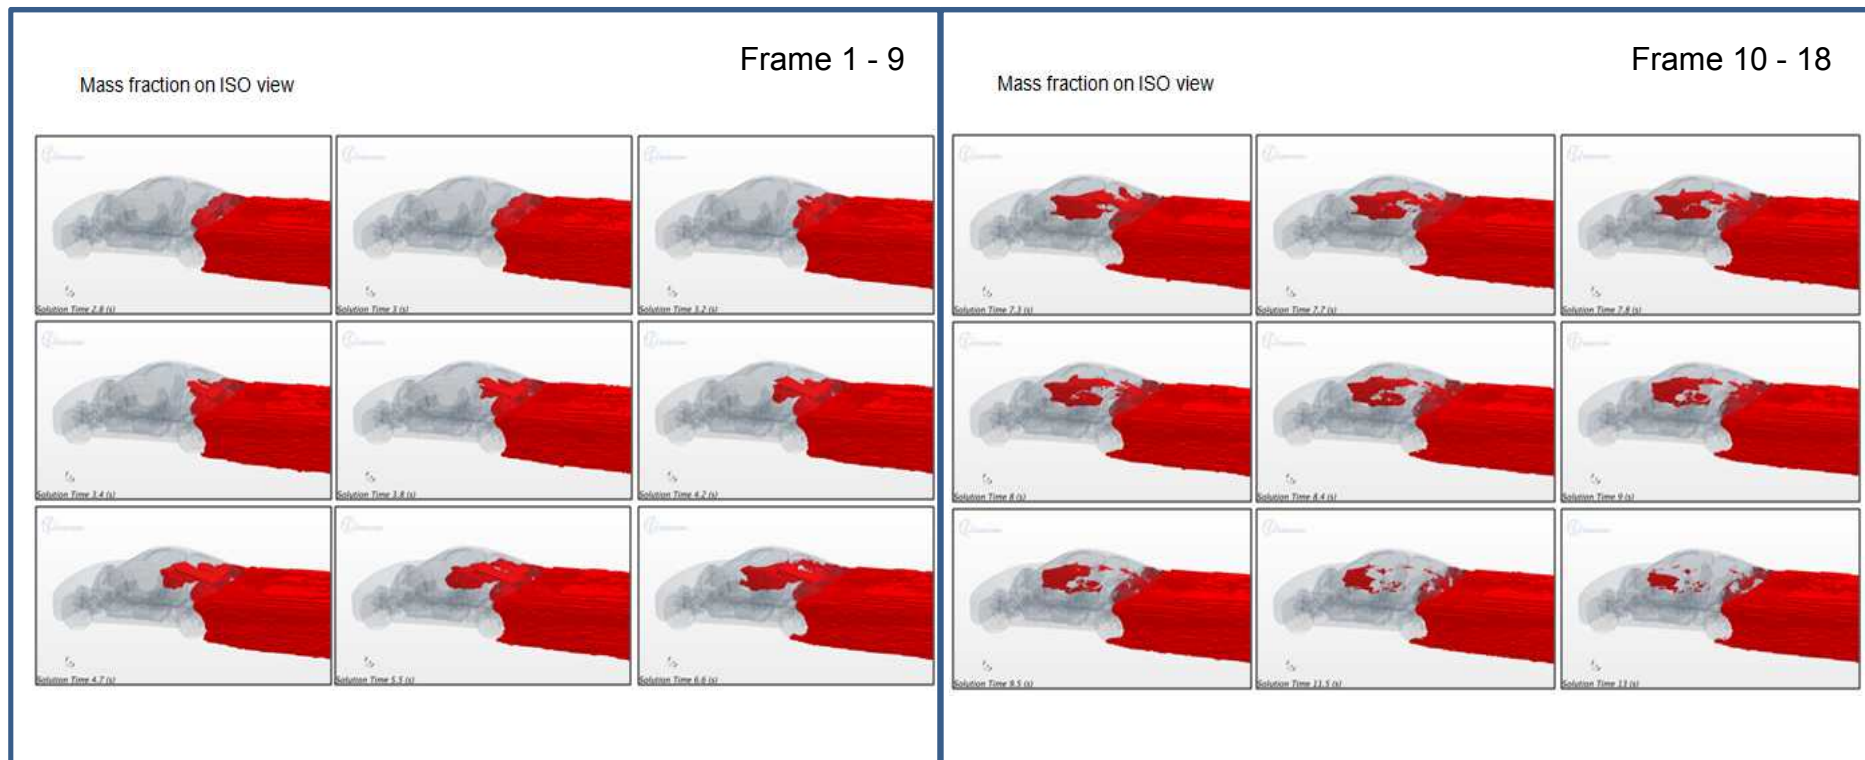
- ✓ Simulation for exhaust gases entering into cabin using the CFD method

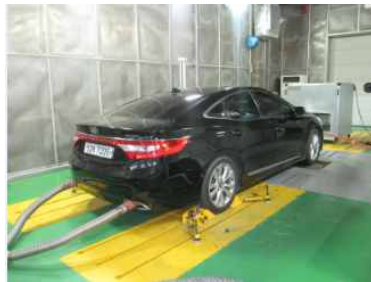
<Chassis dynamometer>

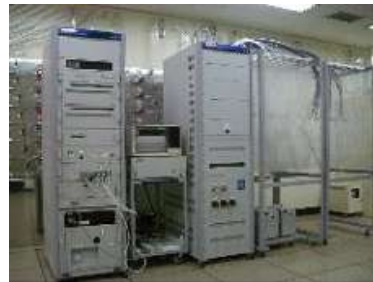
<Exhaust gas analyzer>

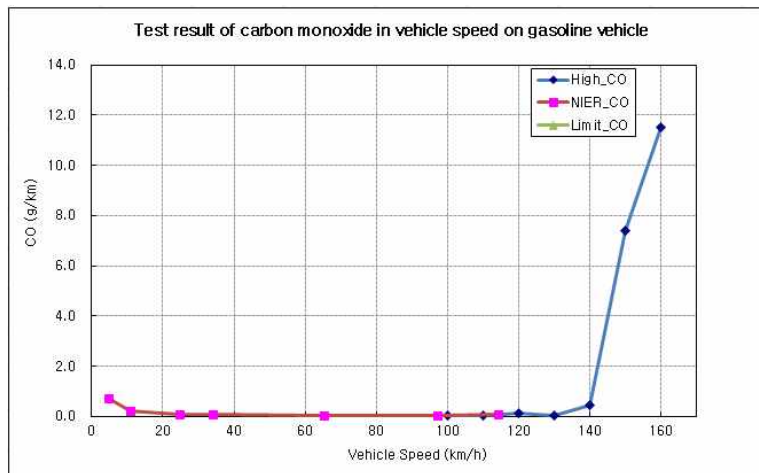
- ✓ Carbon monoxide occurring from high speed (over 140 km/h) and high acceleration(WOT)

<Test result of carbon monoxide in vehicle speed on gasoline vehicle>

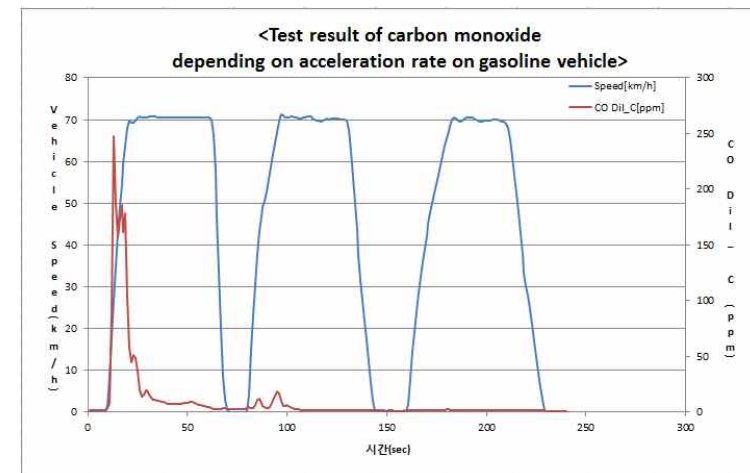
<Test result of carbon monoxide depending on acceleration rate on gasoline vehicle>

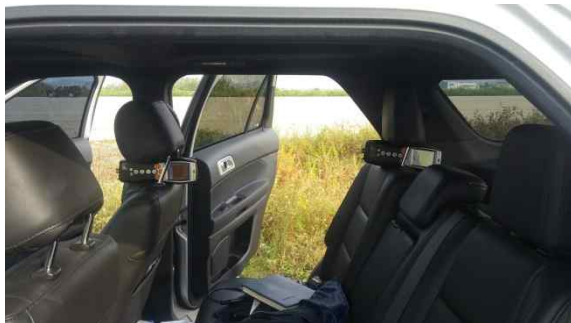
- Nose position of front seat, back seat
- Center position of truck
- Rear of vehicle

〈front and rear seat〉

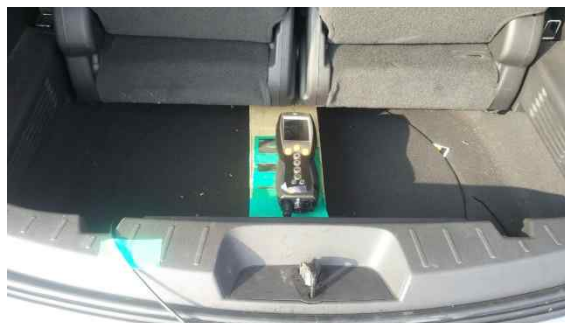
〈center of trunk〉

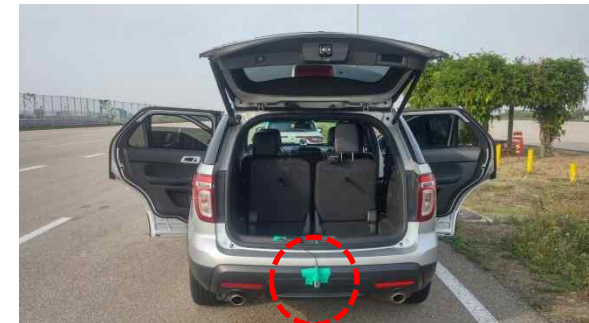
〈rear of vehicle〉

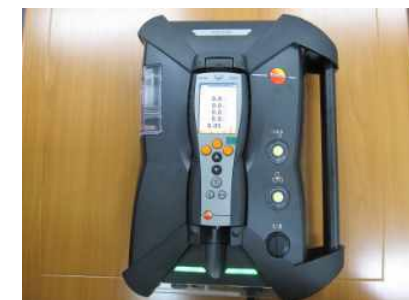
- ✓ Test Device : Vbox mini
  - Speed Range : 0.1 ~ 1,609 km/h
  - Resolution : 0.1 km/h
  - Accuracy : 0.2 km/h
- ✓ Test Device : Testo 330 LL
  - CO Range : 0~500 ppm
  - Resolution : 0.1 ppm
  - Accuracy :  $\pm 2$  pm(0.0 ~ 39.9 ppm), Other range  $\pm 5\%$
- ✓ Test Device : Testo 350K
  - NO Range : 0~300 ppm
  - Resolution : 0.1 ppm
  - Accuracy :  $\pm 2$  pm(0.0 ~ 39.9 ppm), Other range  $\pm 5\%$
  - NO2 Range : 0~500 ppm
  - Resolution : 0.1 ppm
  - Accuracy :  $\pm 5$  pm(0.0 ~ 39.9 ppm), Other range  $\pm 5\%$

**<NO, NO2 device>**

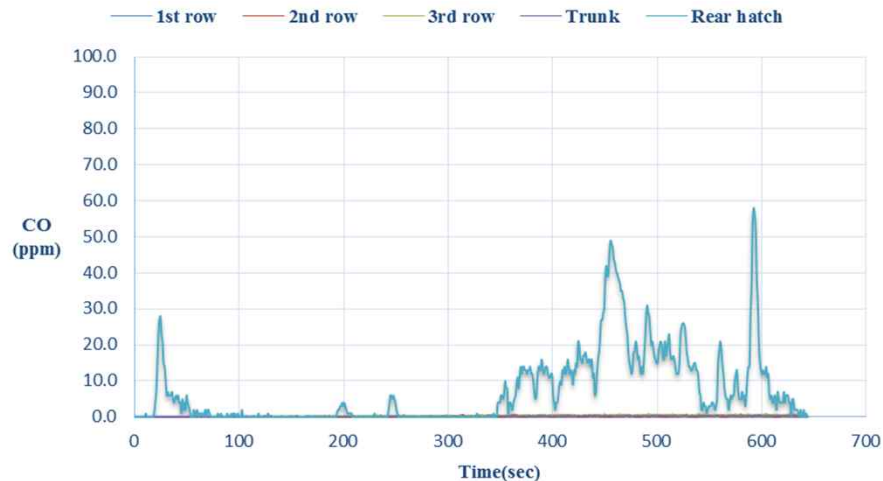
- ✓ Engine idling in normal conditions, not moving
- ✓ Total test time : 10 min
- Stabilizing time : 5 min, Measuring time : 5 min
- ✓ CO was detected in the rear hatch, but not detected in cabins

**Idle mode, CO test results in rear hatch**  
(Idle, Sunroof closed, recirculation mode)

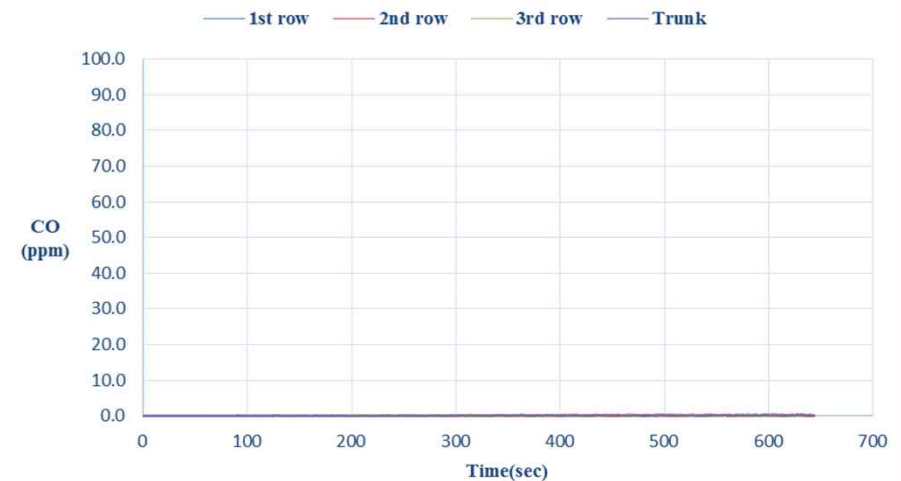
**Idle mode, CO test results in cabin**  
(Idle, Sunroof closed, recirculation mode)

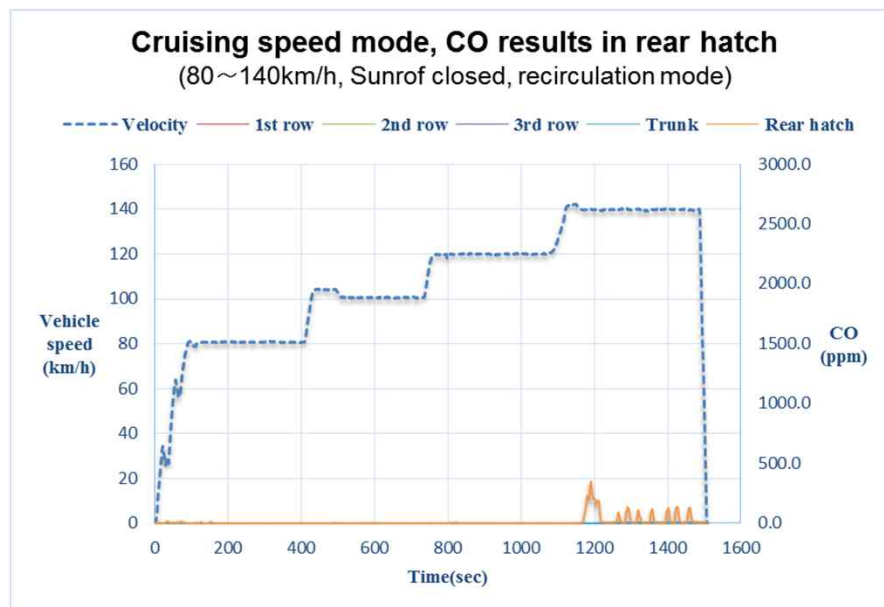
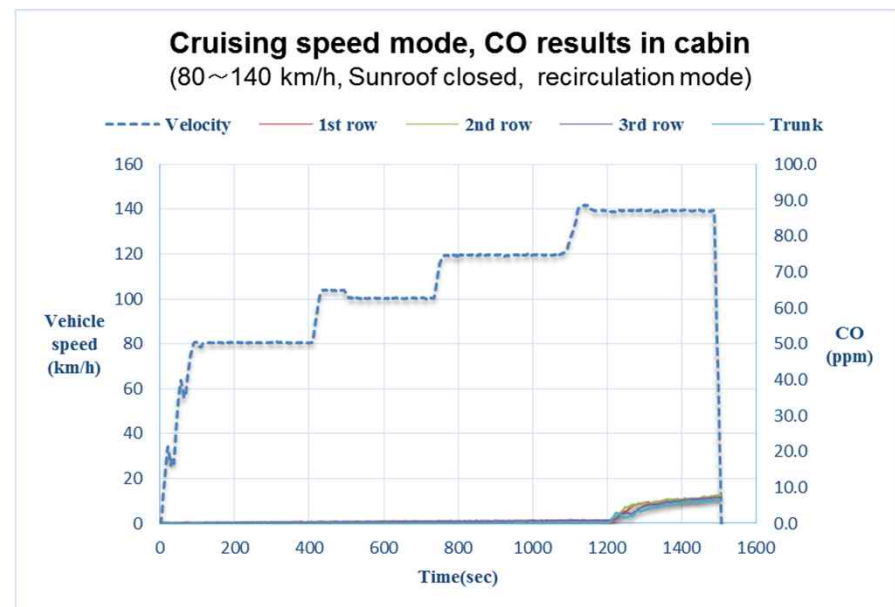
- $80 \pm 5$  km/h,  $100 \pm 5$  km/h,  $120 \pm 5$  km/h,  $140 \pm 5$  km/h
- Each test time in stated speed : 5 min
- If CO is detected in test speed, test again in that speed for 20 min duration
- CO was detected in 140 km/h,

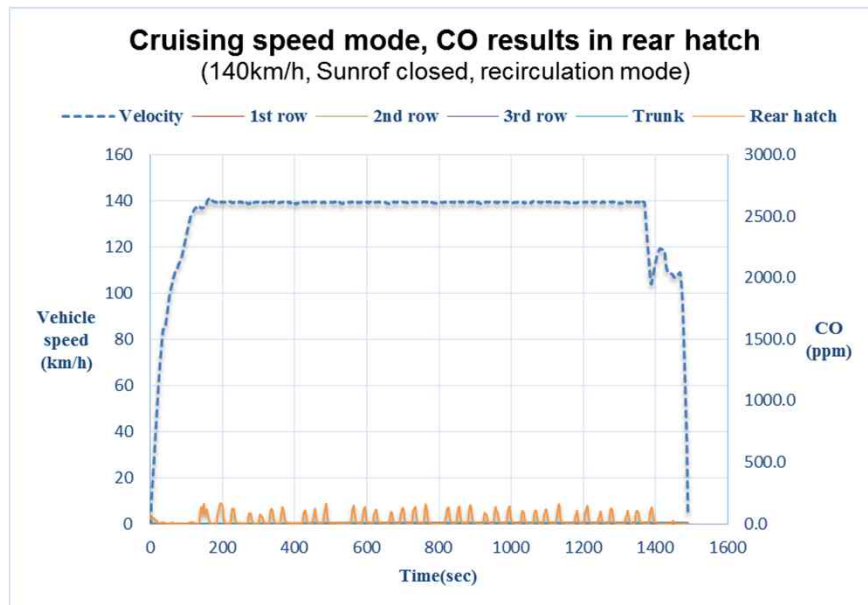
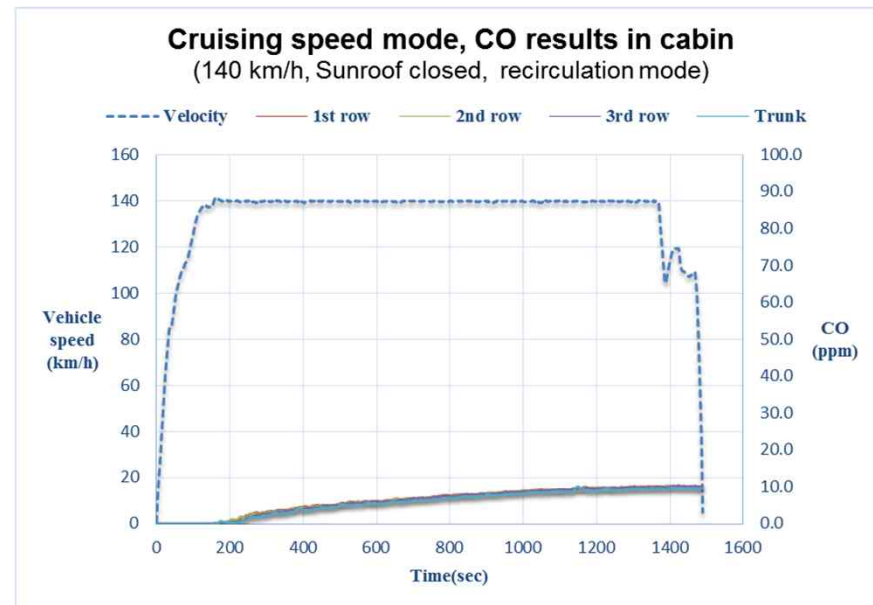
- $140 \pm 5$  km/h
- Total test time : 20 min (stabilizing time 10 min, measuring time 10 min)
- CO was detected in cabin with 140 km/h ( 8 ~ 9 ppm)

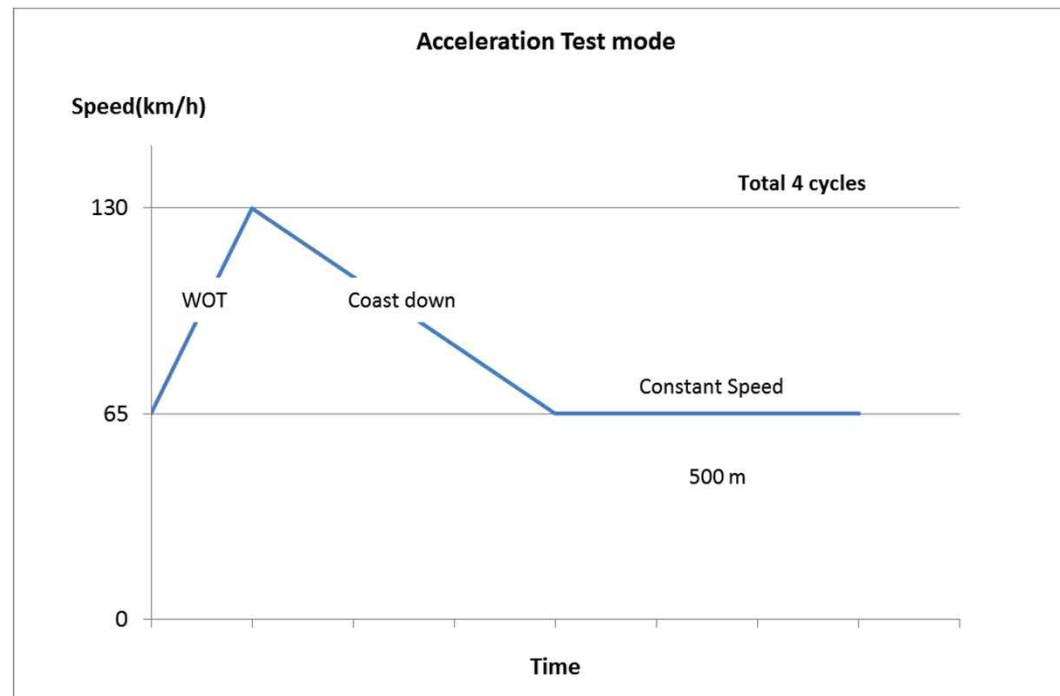
- Accelerate vehicles from 65 km/h to 130km/h, followed by an immediate coast-down (deceleration) to 65 km/h, then cruise drive 500 meters, repeat for 8 cycles
- Total 8 cycle ( 4 stabilizing cycle, 4 measuring cycle)

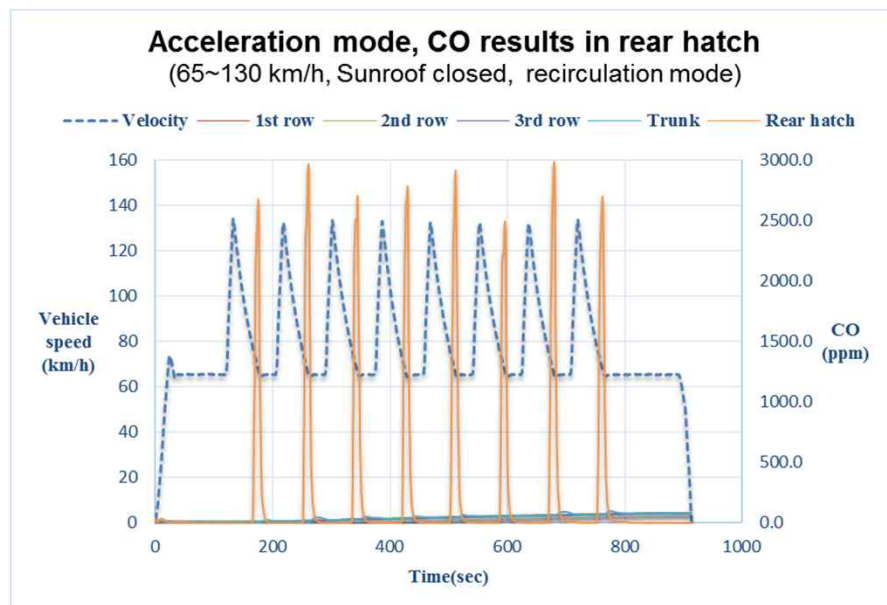
- When accelerating, high concentration of CO was detected in rear area (max 3,000 ppm)
- When accelerating, CO entered into the trunk zone through the rear hatch (max 100 ppm)
- CO concentration was increased gradually from 40 ppm to 80 ppm in the cabin

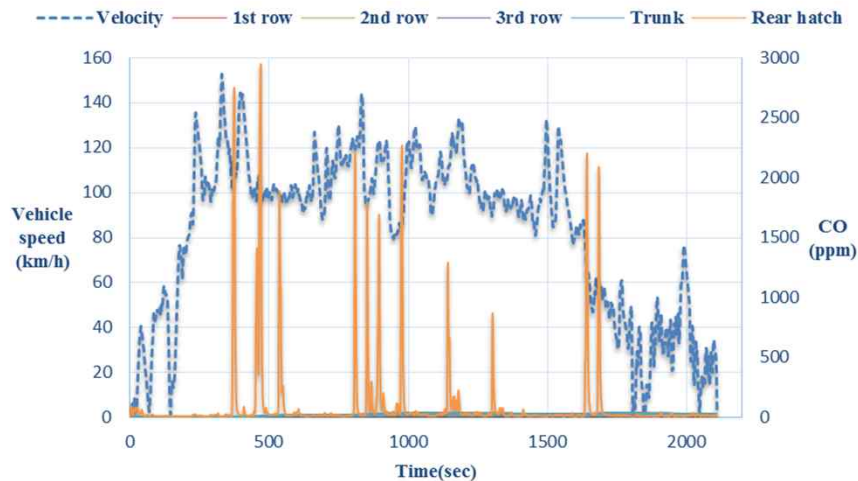
- Real-road driving test in same course with acceleration (near WOT)
- Overtaking driving depending on road traffic as traffic required
- CO was detected in cabin 20 ~ 35 ppm, in response to acceleration
- Car acceleration : 11 times over 35 minutes

**Real-road driving mode, CO result in rear hatch**  
(Overtaking driving, Sunroof closed, recirculation mode)

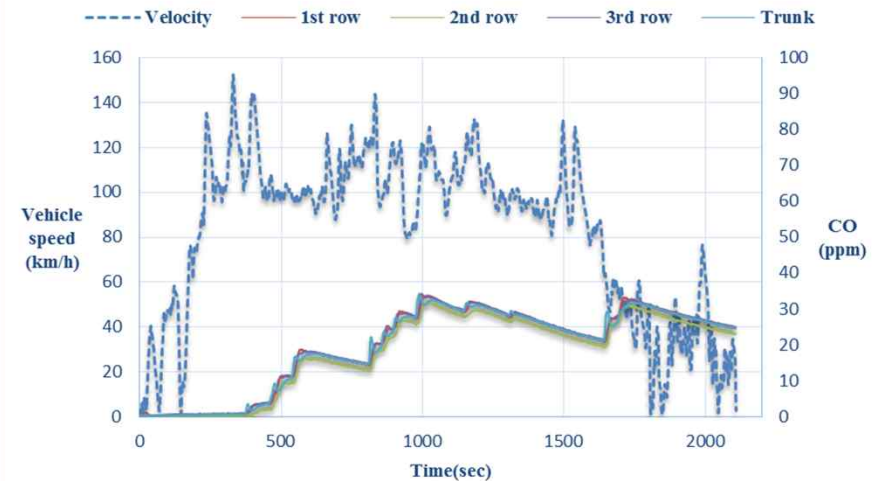
**Real-road driving mode, CO result in cabin**  
(Overtaking driving, Sunroof closed, recirculation mode)
