## MOTOR VEHICLE SAFETY

### Commercial Vehicles

### Vulnerable Road User (VRU) Safety

February 23, 2017

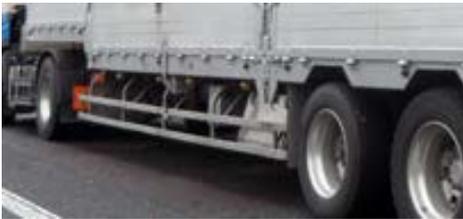
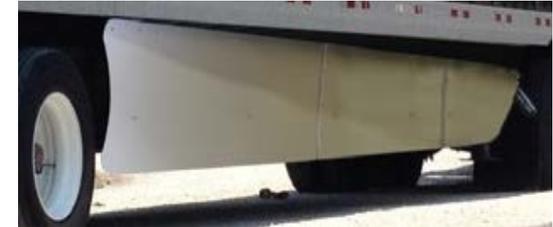
# TC Review – Side Guards

- **TC commissioned 2 NCR studies**
  - **1<sup>st</sup> NRC Study - Side Guards for Trucks and Trailers (2010)**
    - Literature and statistical review
    - Not clear if side guards will reduce deaths and serious injury or if the guards will simply alter the mode of death and serious injury
  - **2<sup>nd</sup> NRC Study – Side Skirts (2012)**
    - Market ready trailer side skirts offer fuel savings potential of 4% - 7%
    - A side skirt would not fail when impacted at 90<sup>0</sup> by a bicycle\*

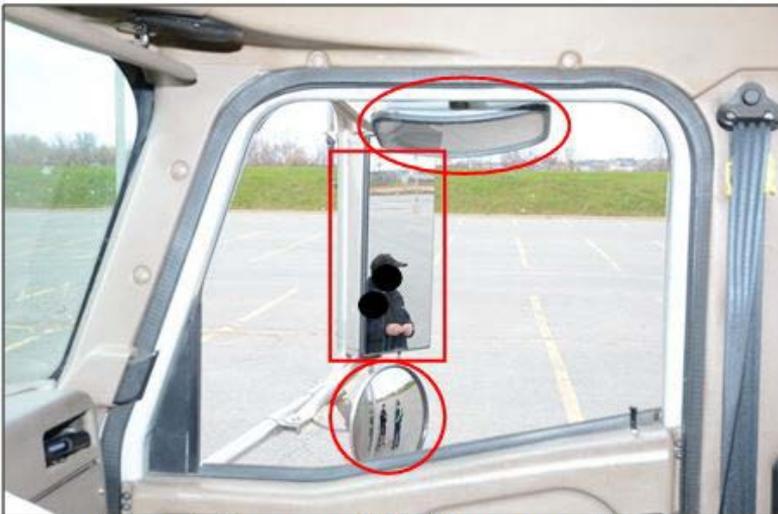
Figure 1: Passenger Side Mirrors on a Tractor

- All vehicles were equipped with exterior rear view planar mirrors on each side of the vehicle, as specified in CMVSS 111 for vehicles, other than school buses, with a GVWR over 4536 kg (section 27).
- Additional mirrors were nearly always installed by the truck operators, or owners, to improve the driver's field of view.
- 91% of the vehicles had additional mirrors installed.
- Note that external mirrors often block a driver's direct field of view and create blind spots.

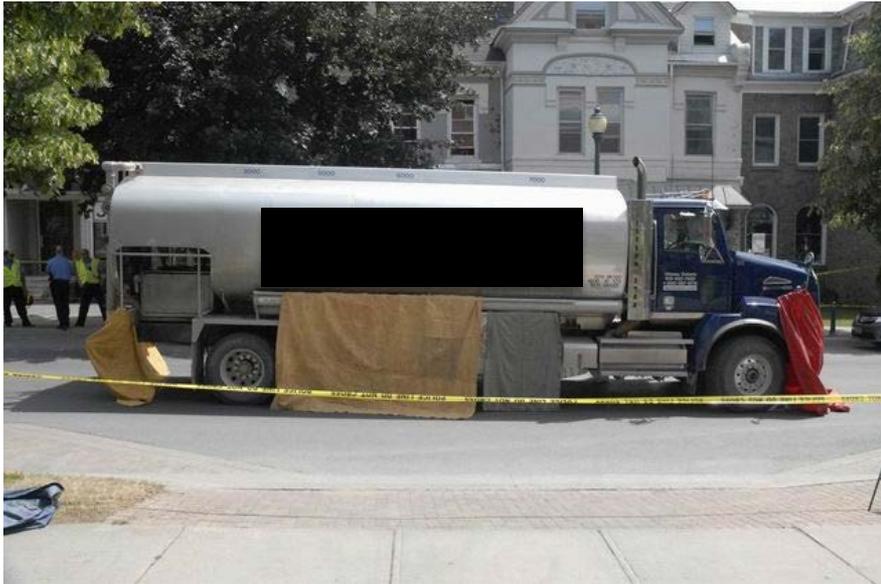
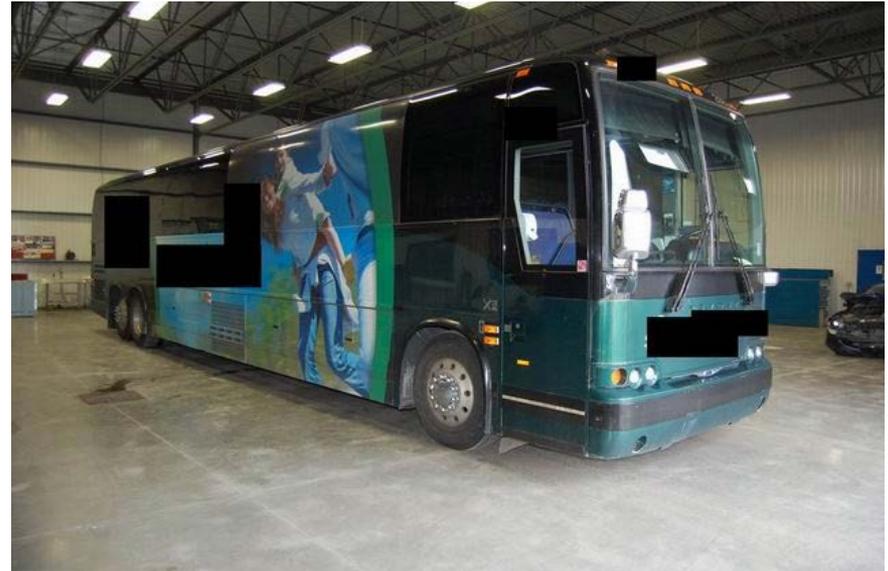
# Data Summary: Side Guards

- No commercial vehicle in the sample was equipped with side guards, however, observations can be made regarding the potential effectiveness of side guards from sampled cases.

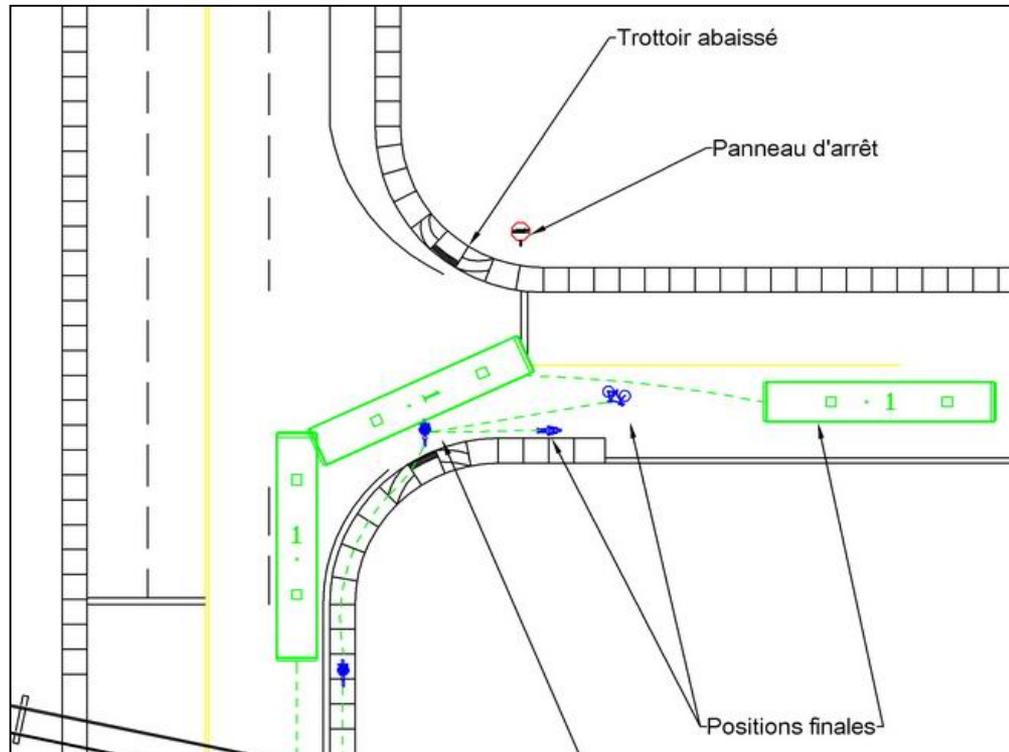
- ASF6-1335 involved a coach bus and a 14-year-old cyclist.
- Cyclist was on sidewalk and fell while trying to avoid turning bus.
- Cyclist went under bus and was run over by RR wheels.

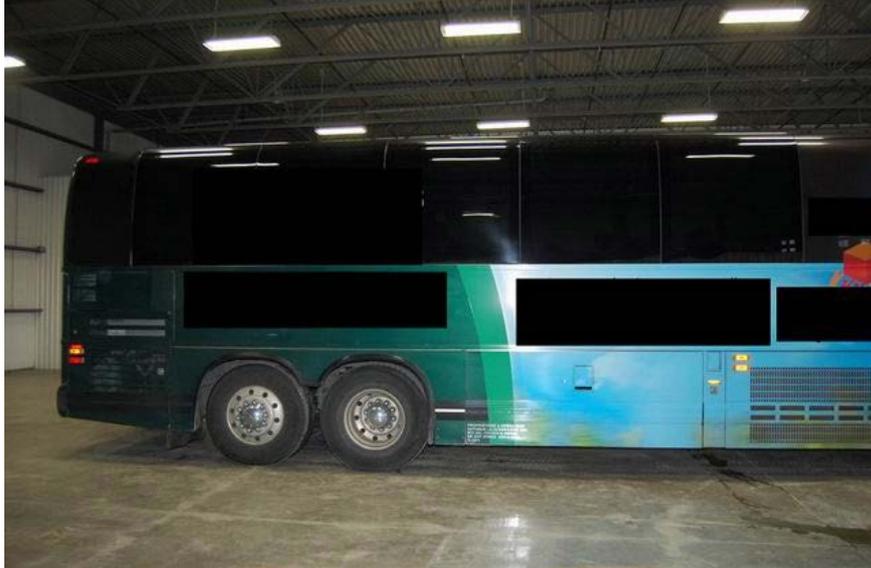
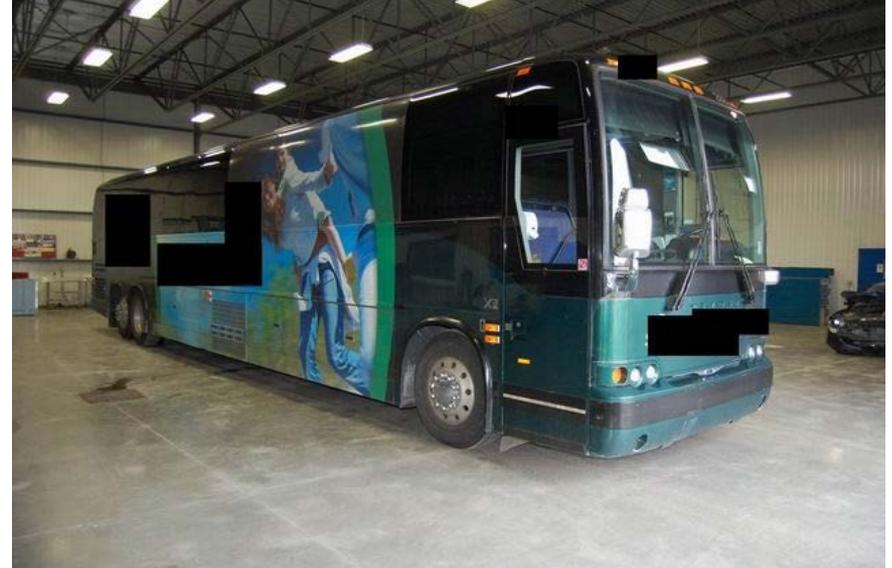
- Bus had a side height of only **280 mm** (ECE Reg. No. 73 minimum height is 550 mm)
- For comparison, a Toyota Sienna minivan has a rocker panel height of **260 mm**

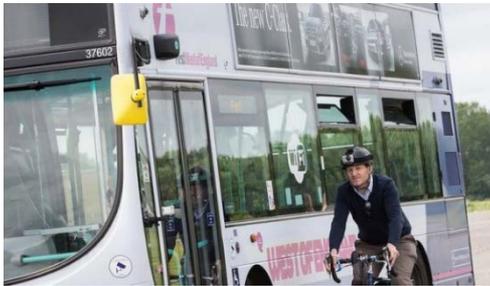
Camera & Radar

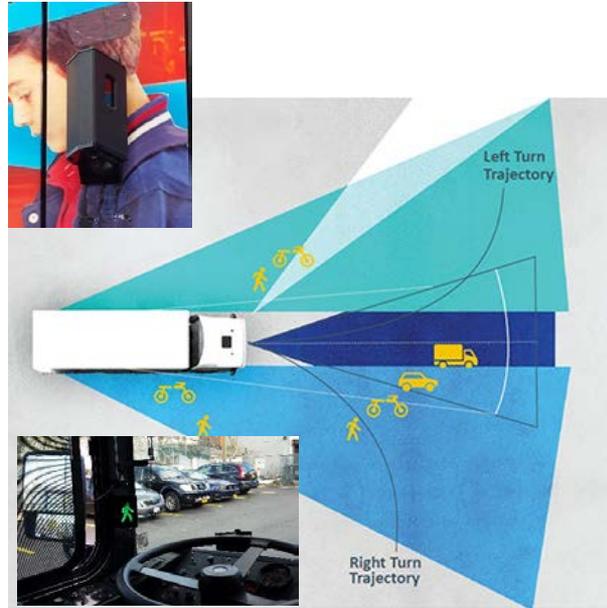
Intelligent Detection Systems Camera based

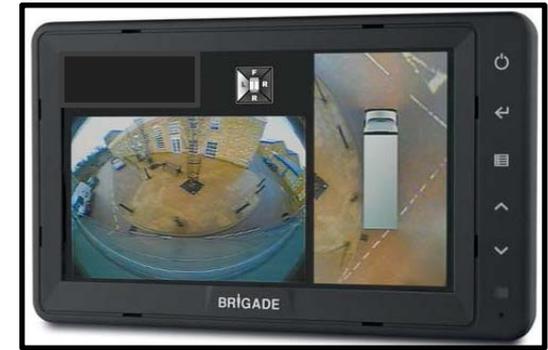
Surrounding view Camera
