GRSP INFORMAL GROUP ON CRS PHASE III - 3rd WORKSHOP

Schemas of seatbelt routes and main results

Philippe LESIRE – April 2017

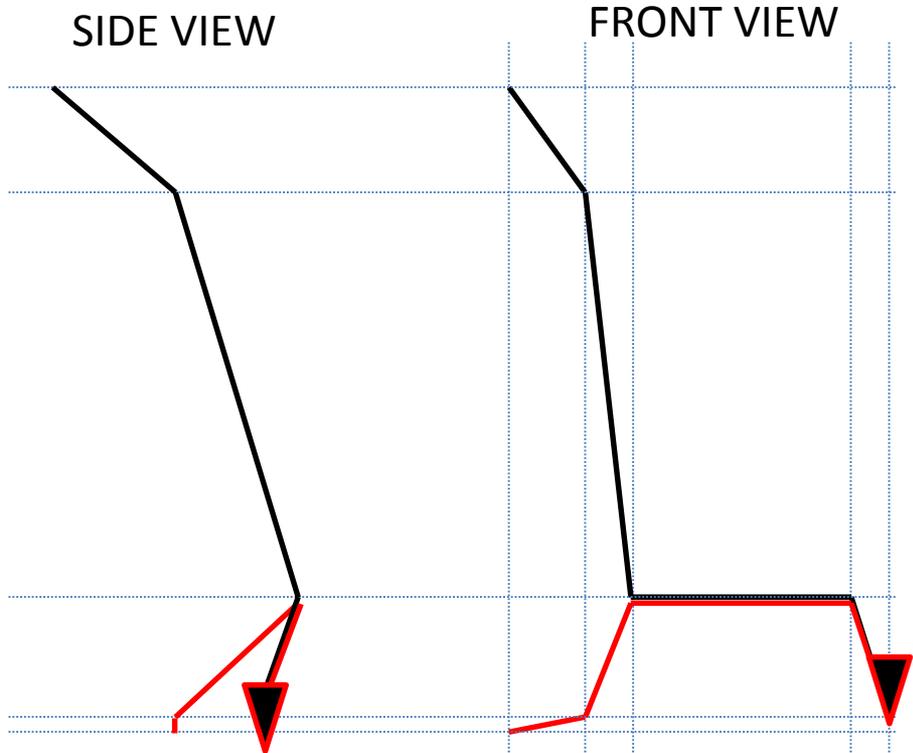
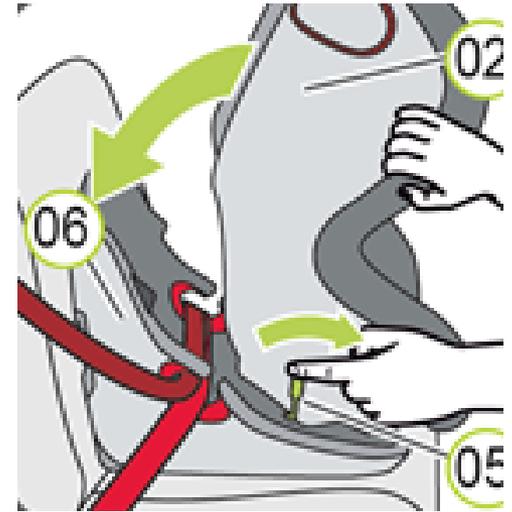
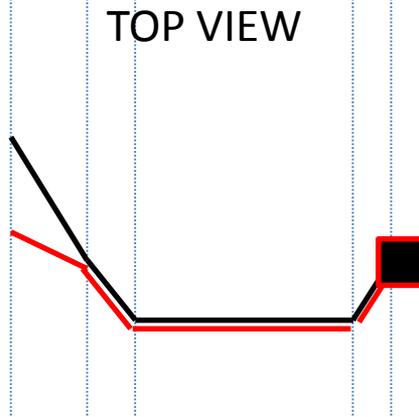
Ease of use: 4,4

Confidence installation: 4,6

Notes:

- Parents during the workshop « intuitive installation »
- Rocking shell
- Pretension of seatbelt when shell is pulled back.

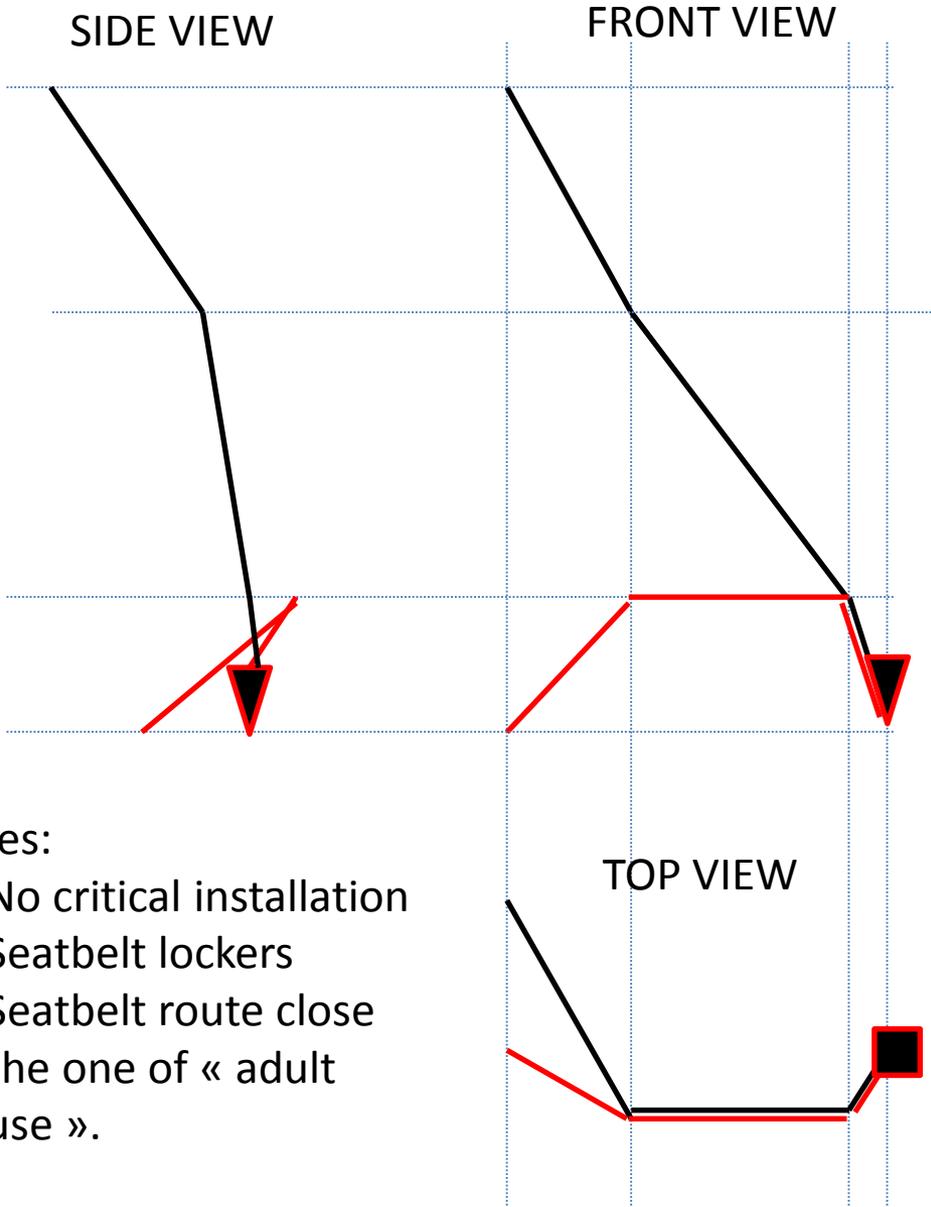
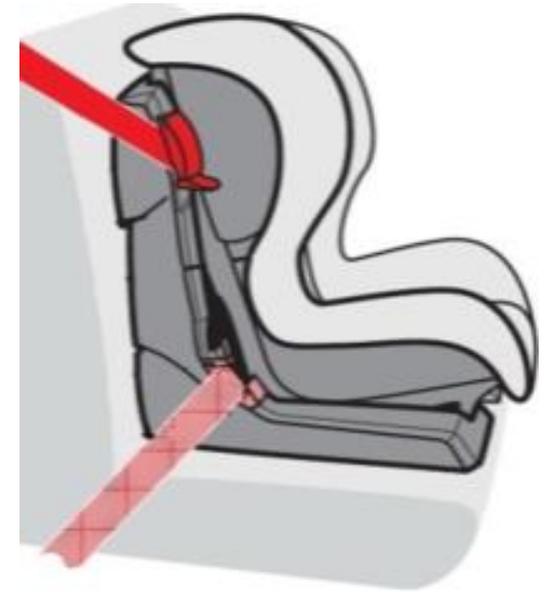
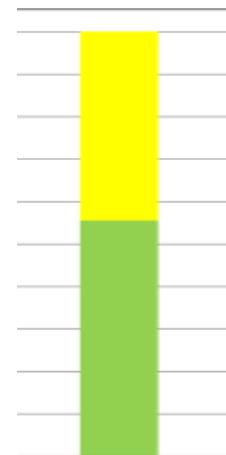
Notes:

- No critical installation
- Seatbelt lockers
- Seatbelt route close the one of « adult use ».

Ease of use: 3,7

Confidence installation: 3,7

1vs2vs3: seatbelt route not very far one from the other but n°3 has 2 possible seatbelt routes which is confusing users (too many routing devices).

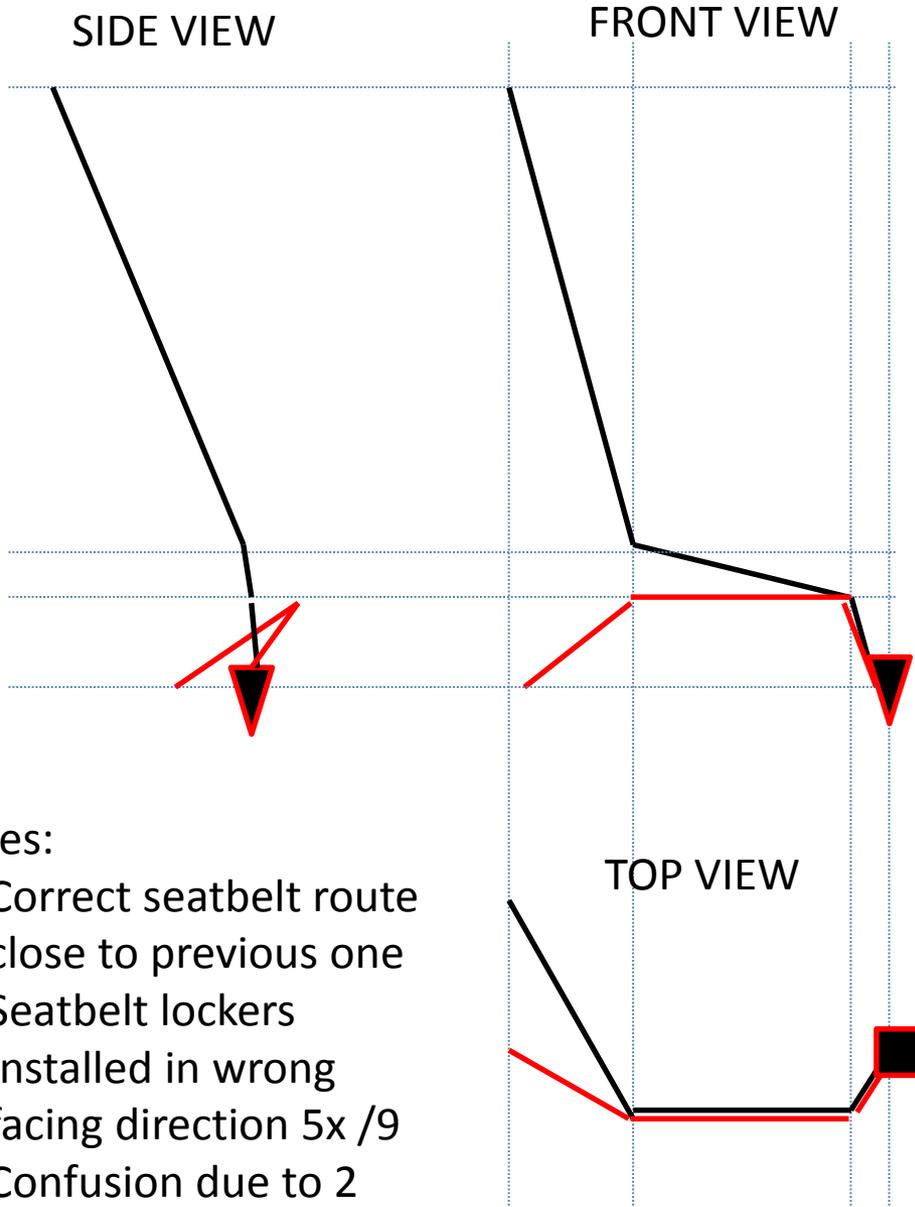
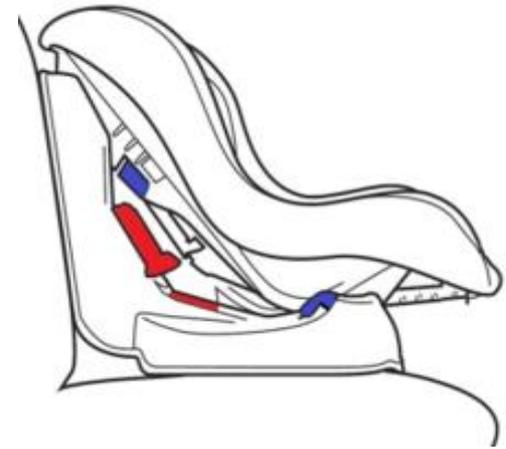
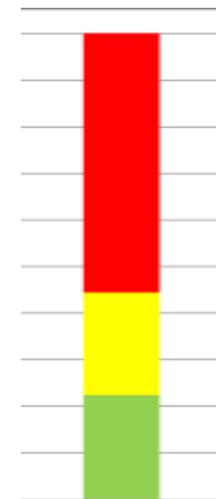
3

Ease of use: 1,9

Confidence installation: 1,6

Notes:

- Correct seatbelt route close to previous one
- Seatbelt lockers
- Installed in wrong facing direction 5x /9
- Confusion due to 2 seatbelt routes

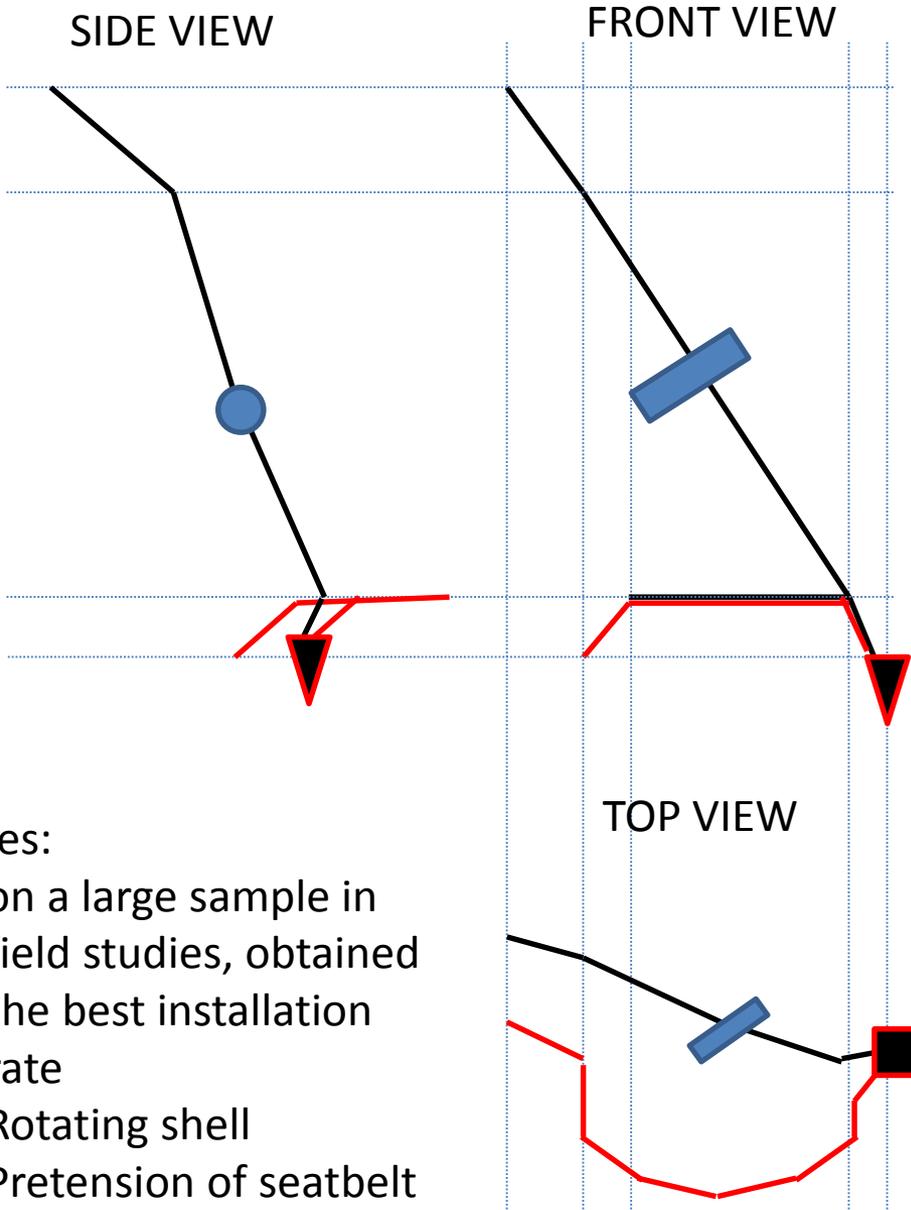
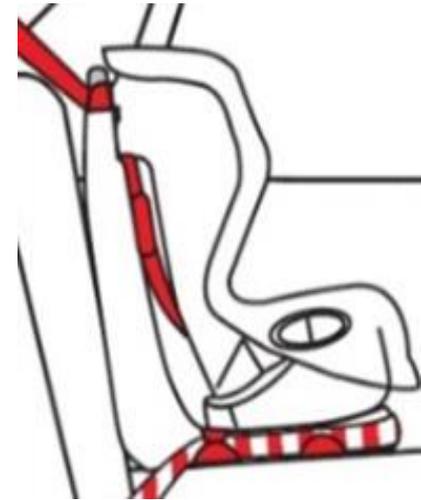
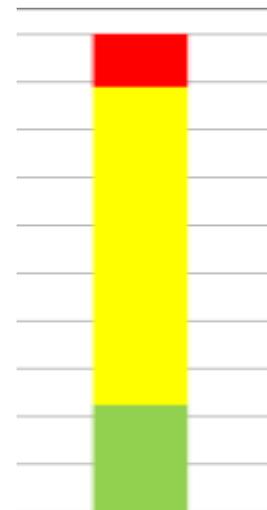
Notes:

- on a large sample in field studies, obtained the best installation rate
- Rotating shell
- Pretension of seatbelt

Ease of use: 2,4

Confidence installation: 3

4 and 5: seatbelt route really different from other systems but leading to few severe misuse: most of them are linked with CRS specificities (seatbelt pretensioner, ...)

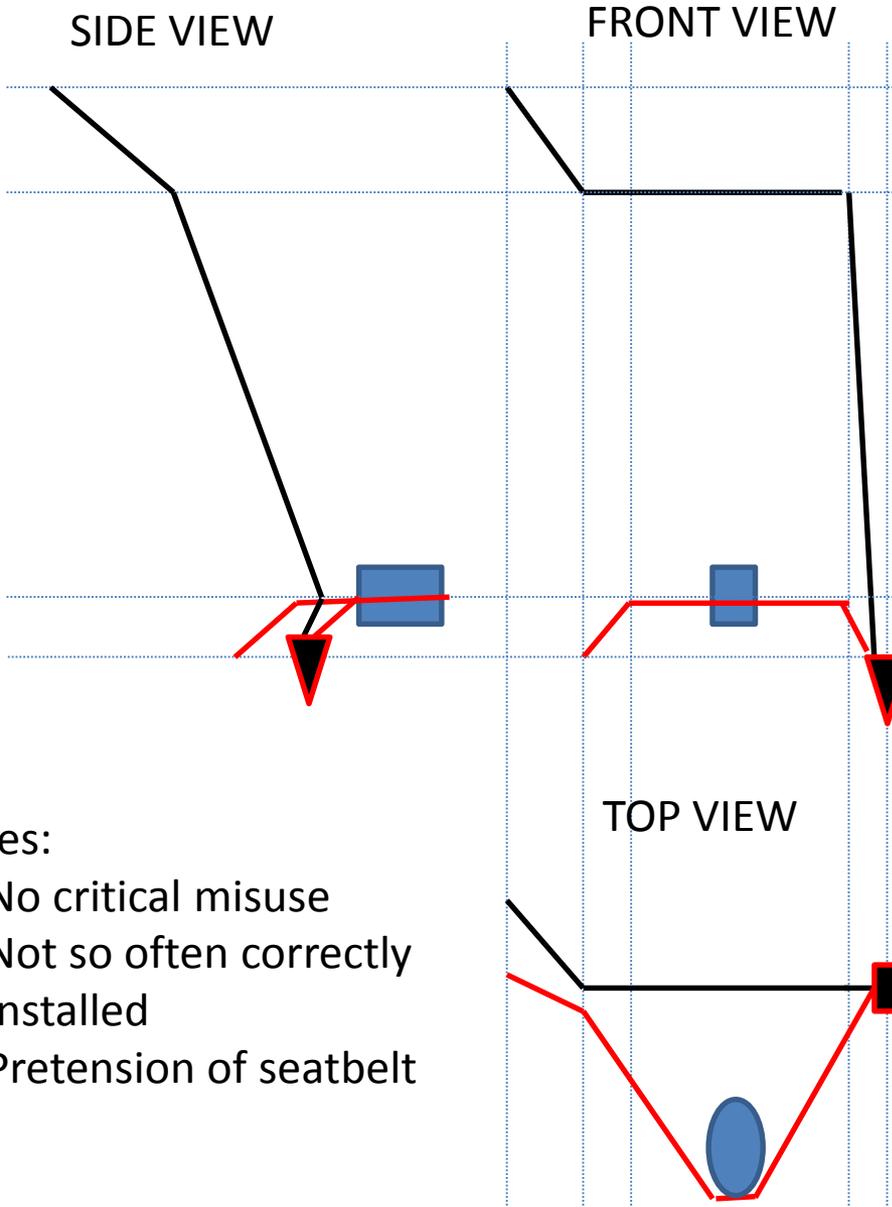
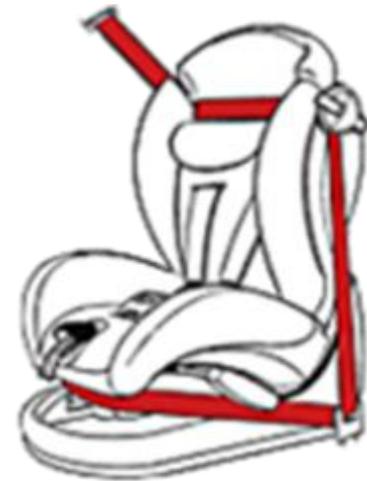
5

Notes:

- No critical misuse
- Not so often correctly installed
- Pretension of seatbelt

Ease of use: 3,6

Confidence installation: 3,8

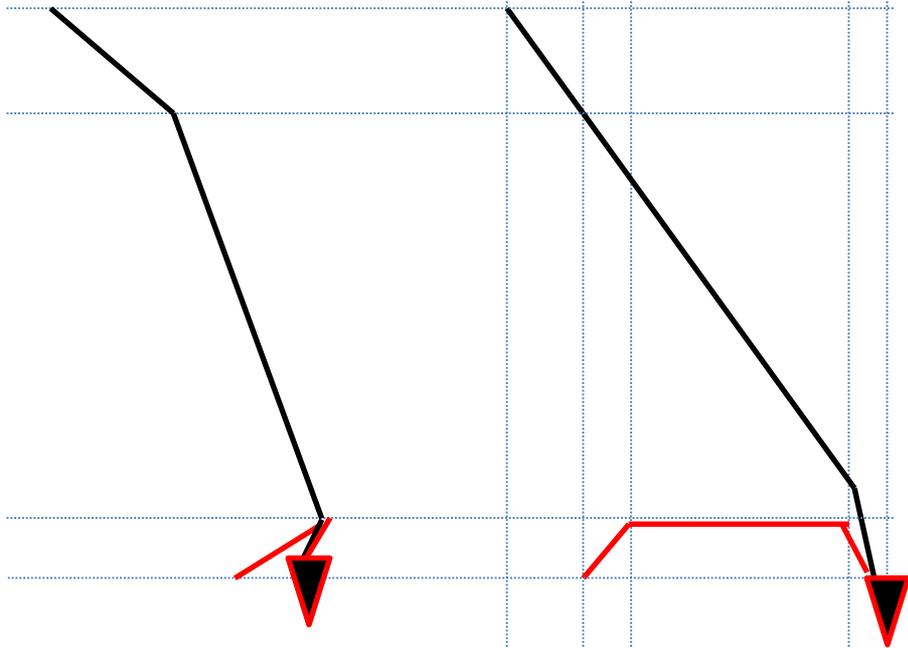
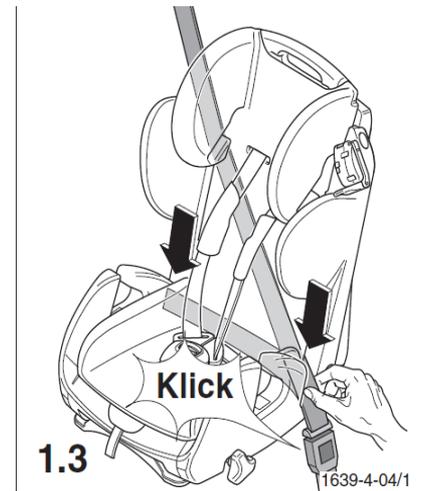
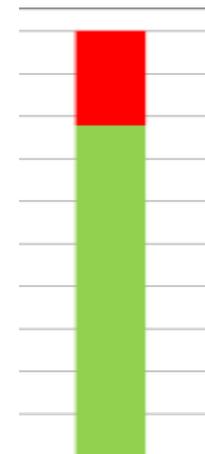
6

SIDE VIEW

FRONT VIEW

TOP VIEW

Notes:

- Harness absent during exercise
- Best rate of correct installation
- Seatbelt lockers

Ease of use: 3,8

Confidence installation: 4

6: seatbelt route close to the one of n°1 and 2, two possible seatbelt routes, not leading to confusion during the workshop (but observed in field studies)

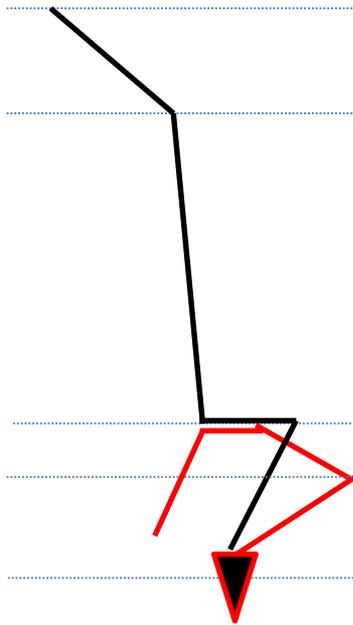
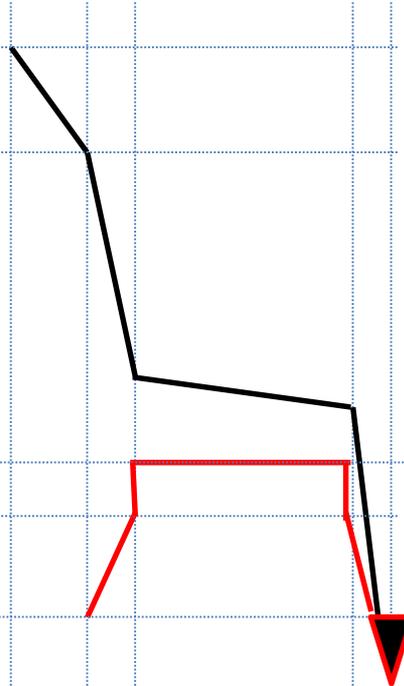
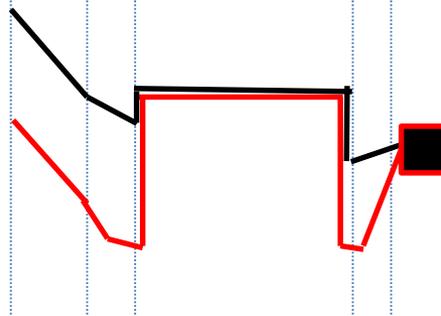
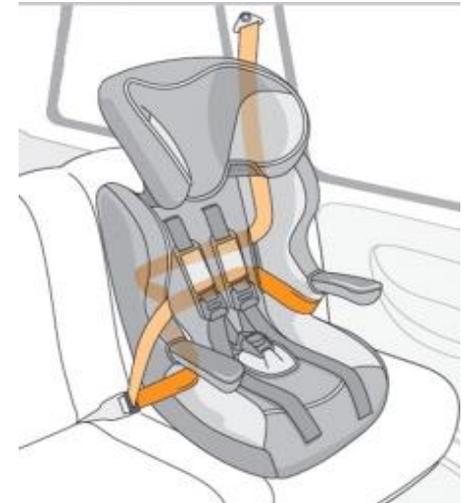
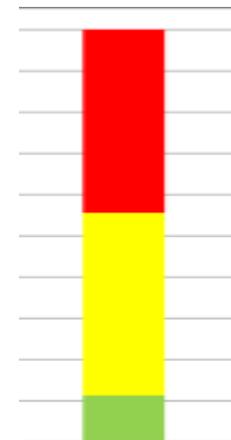
7

SIDE VIEW

FRONT VIEW

TOP VIEW

Notes:

- Highest incorrect installation rate
- Lot of severe misuse
- Rated as worst system during workshop

Ease of use: 2

Confidence installation: 2,5

7: seatbelt route difficult to understand and to properly reproduce.
Two possible seatbelt route, many severe misuse
