INSTALLATION OF CRS WITH VEHICLE SEATBELT COMPLEMENT OF PRESENTATION

GRSP Informal group on CRS – Phase III

Philippe LESIRE – LAB - 31st of August 2017

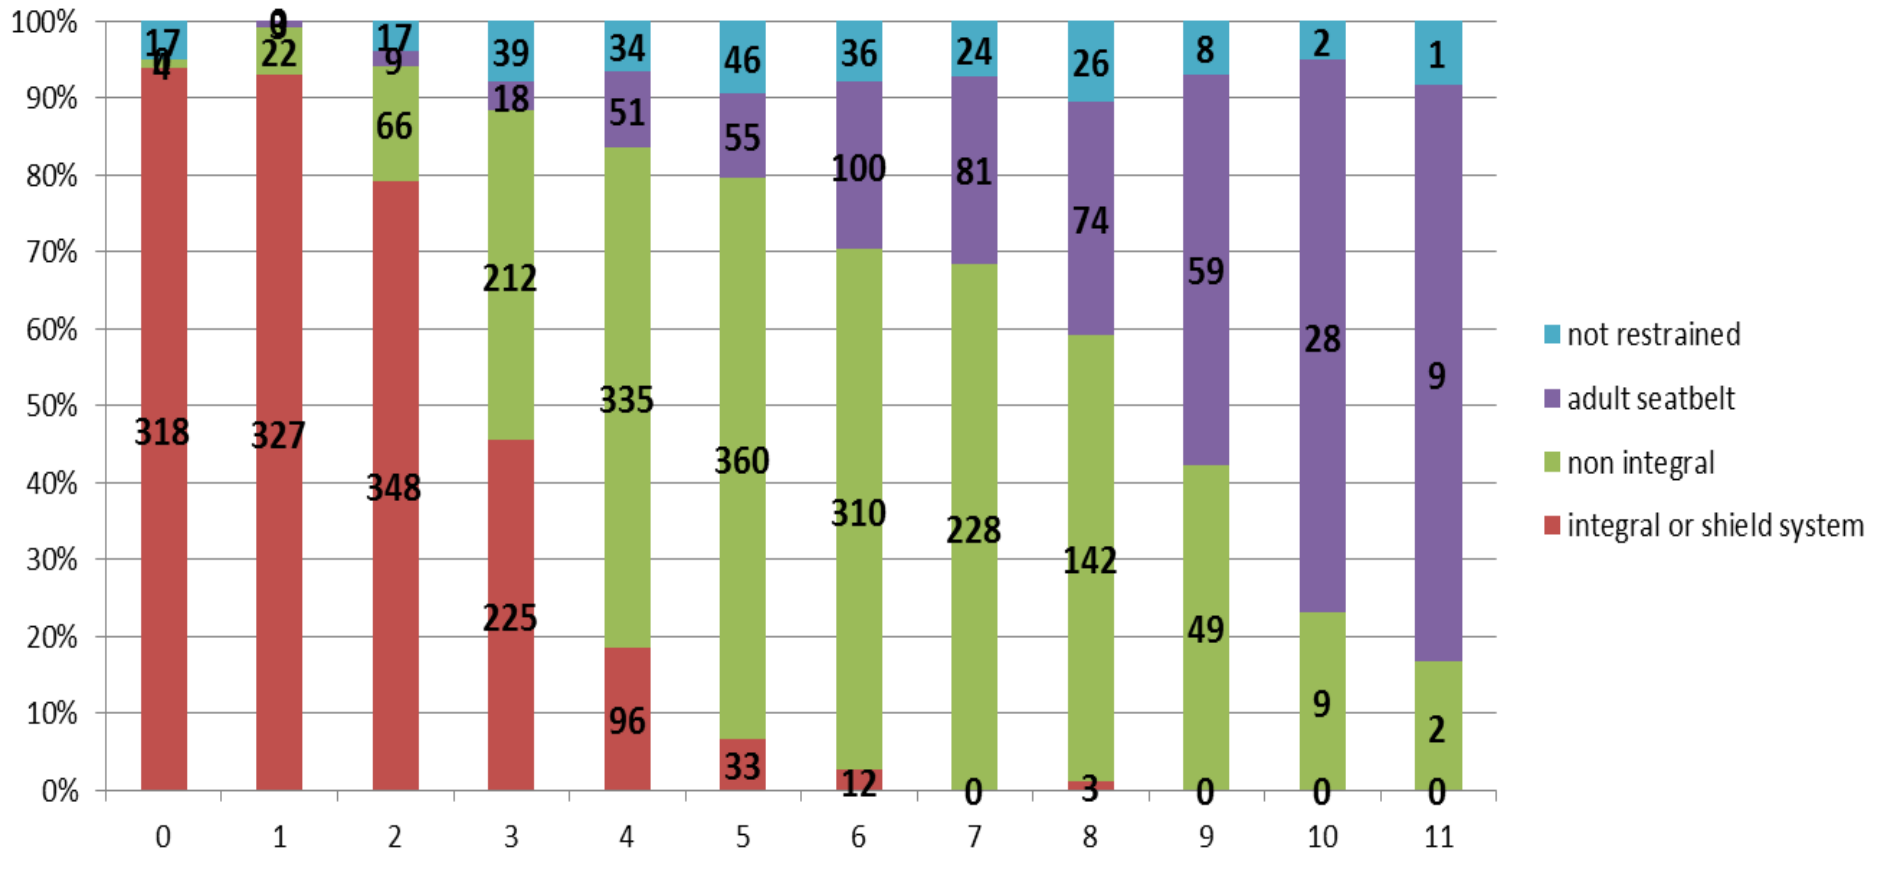
Is it possible to see when transfert from integral to non integral is made by parents/children?

Children under 12 with age and restraint system type known: 3838

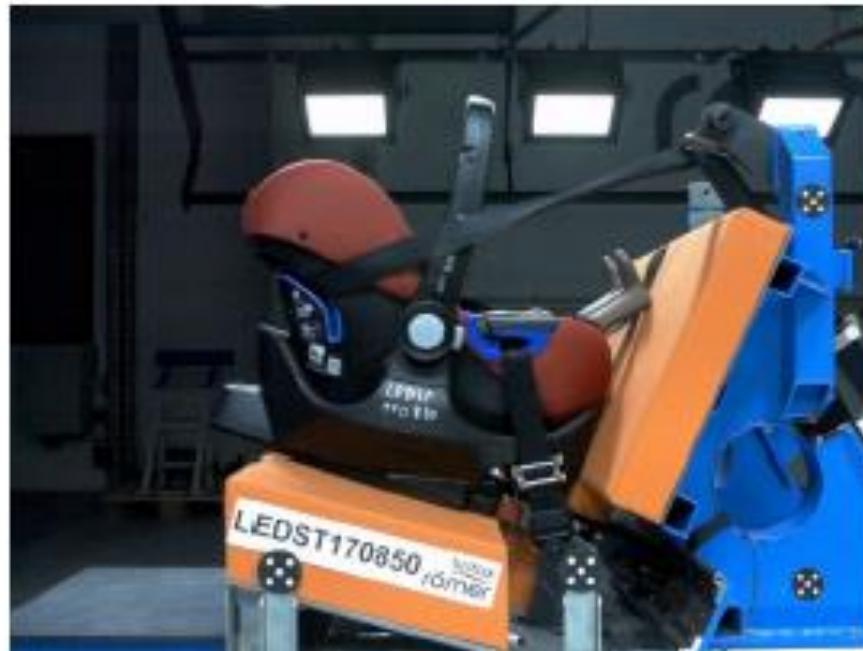
Is there any cases of RIC carrier on a belted base for which the misuse of restraining at the same time the base and the module with the seatbelt has been observed ?

Misused belt installation,
w/o ISOFIX and support leg

!!! - 13 RIC on belted base observed - !!!

7 cases with misuse of installation = 8 misuse observed
