Width of the Bumper Testing Zone and Legform Protection Area

► Audi A6

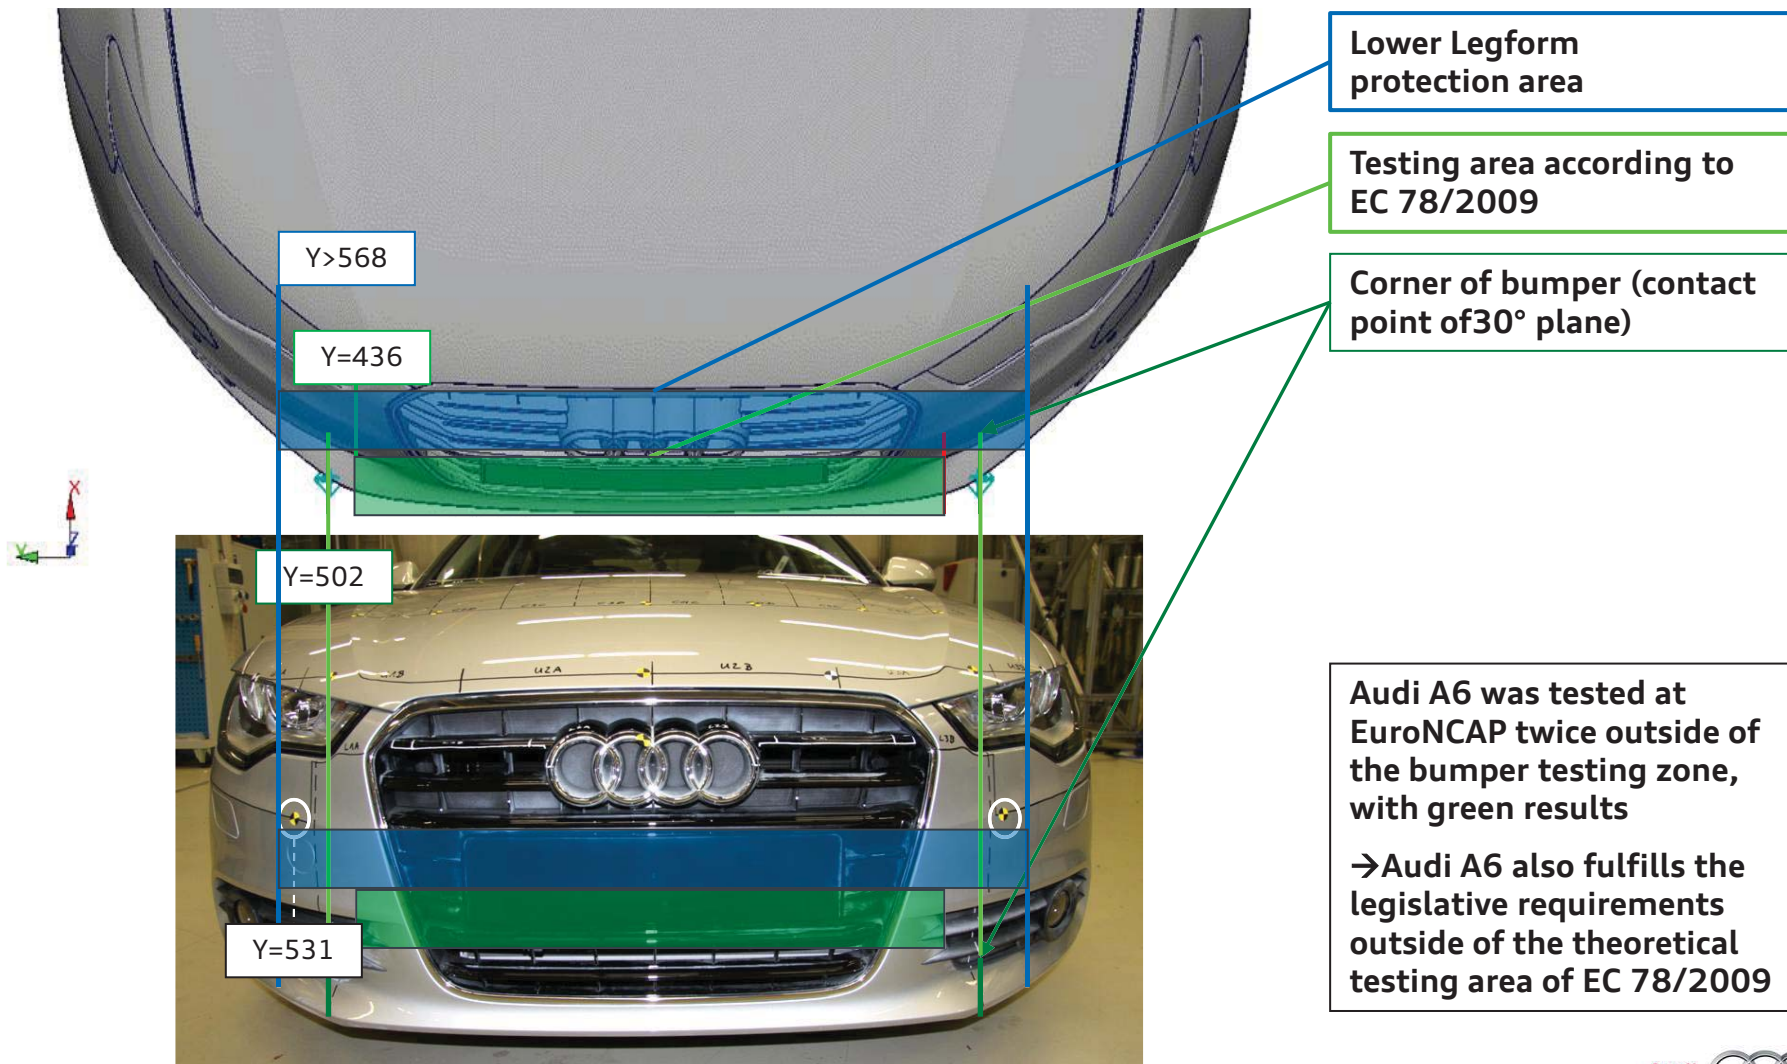
Lower Legform protection area

Testing area according to EC 78/2009

Corner of bumper (contact point of 30° plane)

Audi A6 was tested at EuroNCAP twice outside of the bumper testing zone, with green results
 → Audi A6 also fulfills the legislative requirements outside of the theoretical testing area of EC 78/2009
