Shape Corp

GTR09 NA vs EU Vehicle

Modified Round Robin

Shape Corp Flex PLI Testing

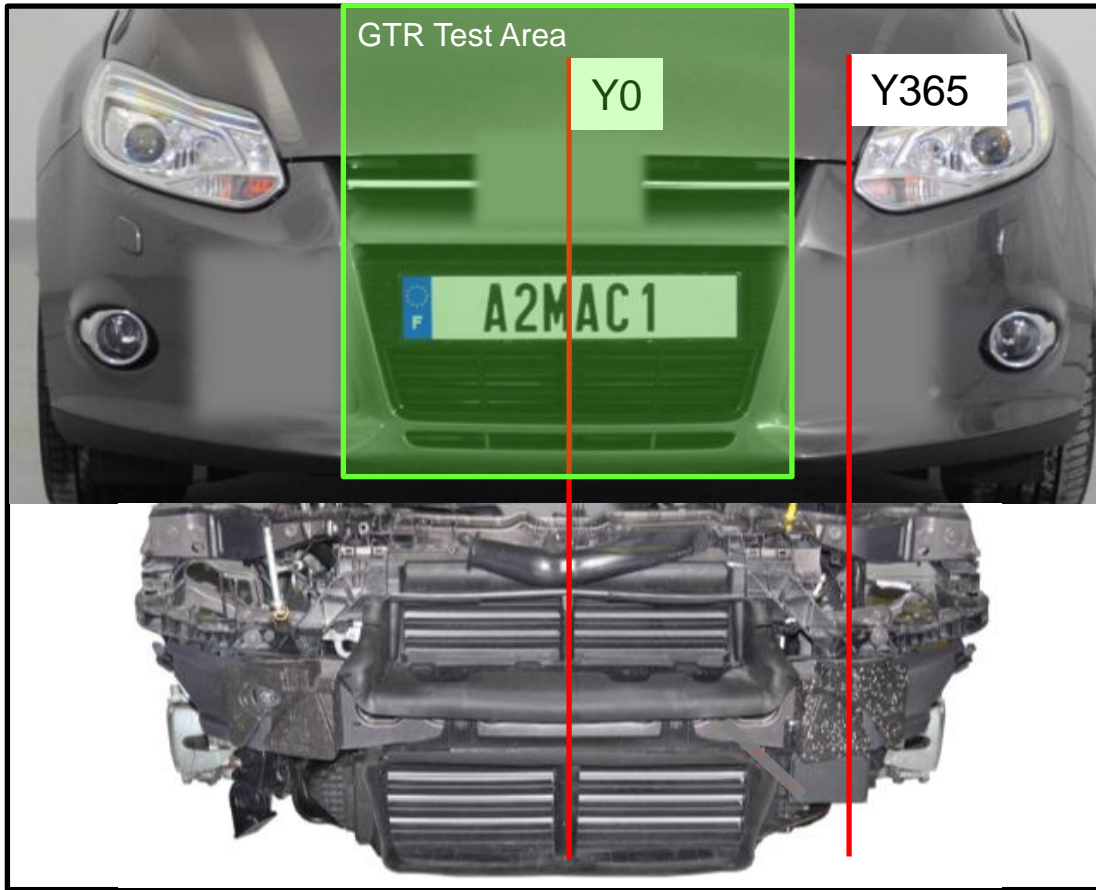
Test Locations

NA vehicle w/ EU system applied

*Offset location established from EuroNCAP protocol

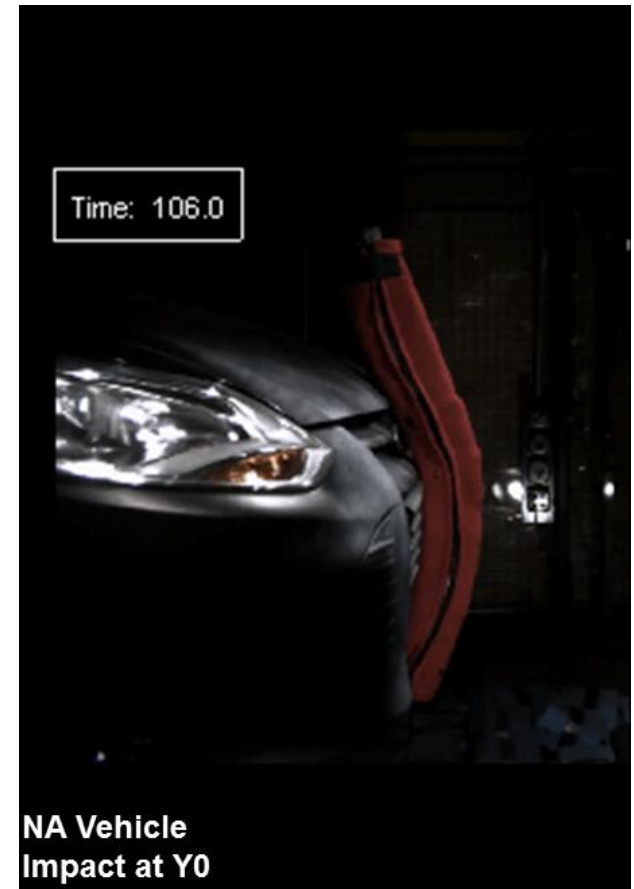
NA Vehicle Impact at Y0

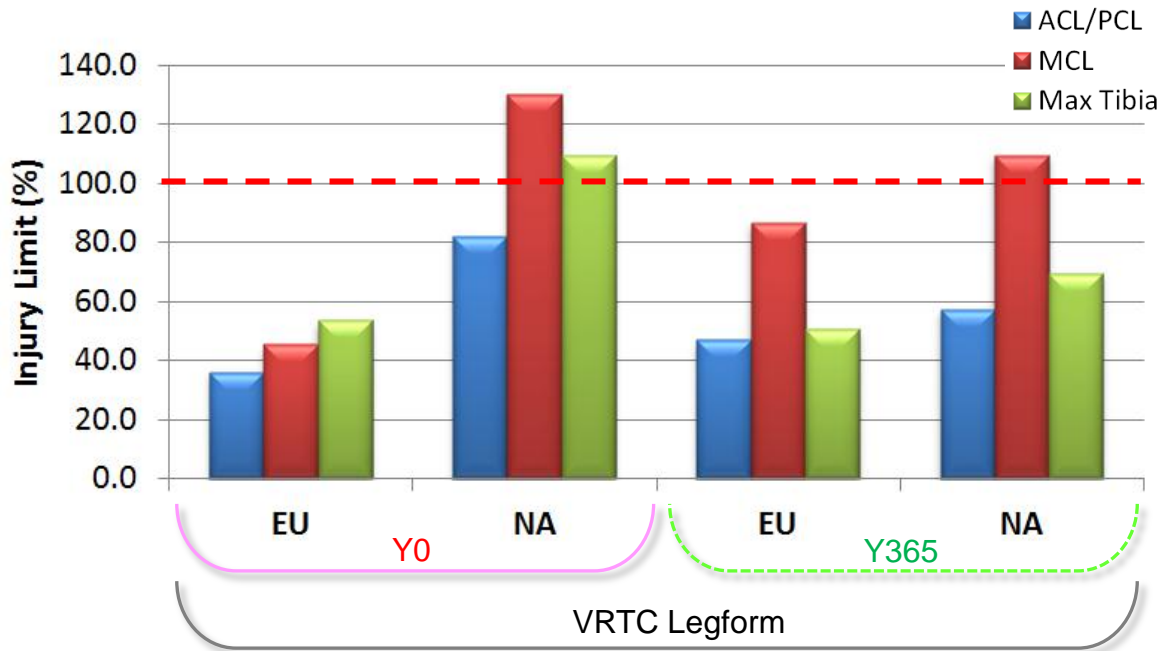
Vehicle #1: EU & NA

VEHICLE #1	Location		Velocity @ Impact (kph)	Leg	ACL/PCL	MCL	Max Tibia
	Location	Velocity @ Impact (kph)	ACL/PCL		MCL	Max Tibia	
					13	22	340
	EU	Y0	40.39	VRTC	4.7	10.0	182.2
	NA	Y0	40.52	VRTC	10.7	28.6	372.0
	EU	Y365	40.56	VRTC	6.1	19.1	172.4
	NA	Y365	40.09	VRTC	7.5	24.1	236.4

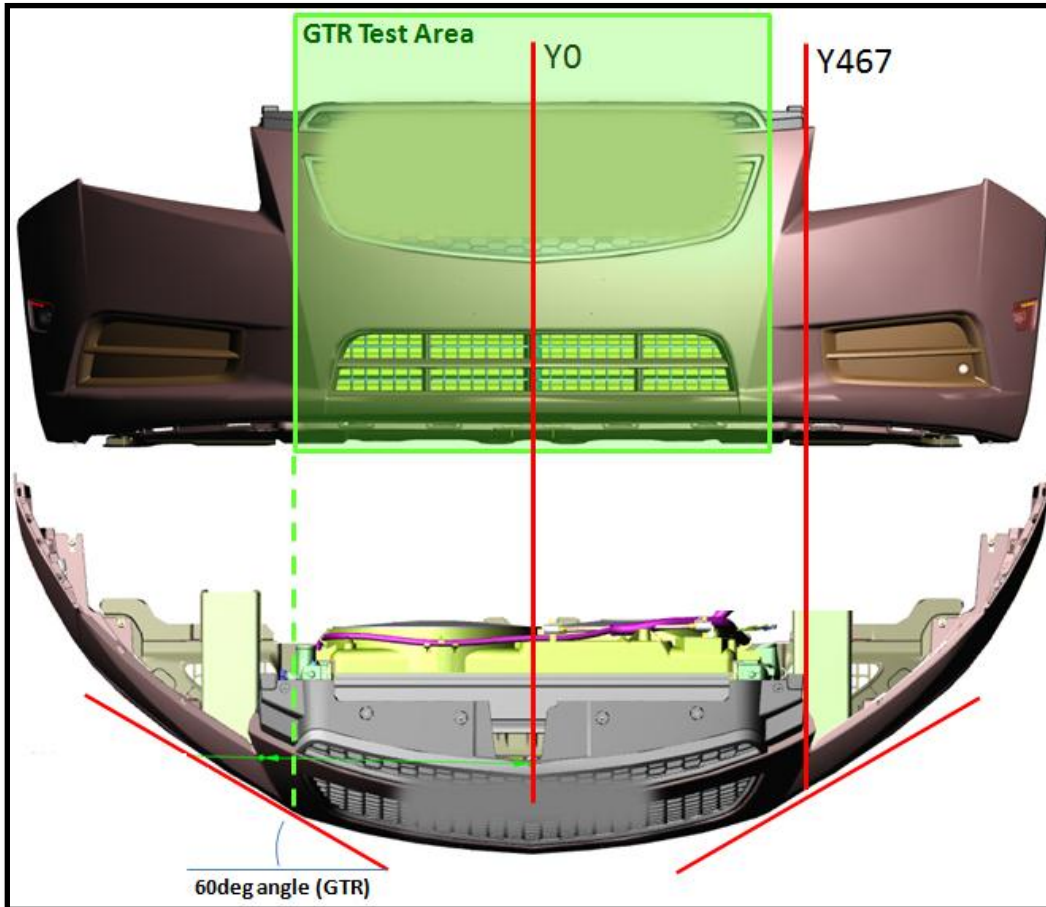
Test Locations

*Offset location established from EuroNCAP protocol

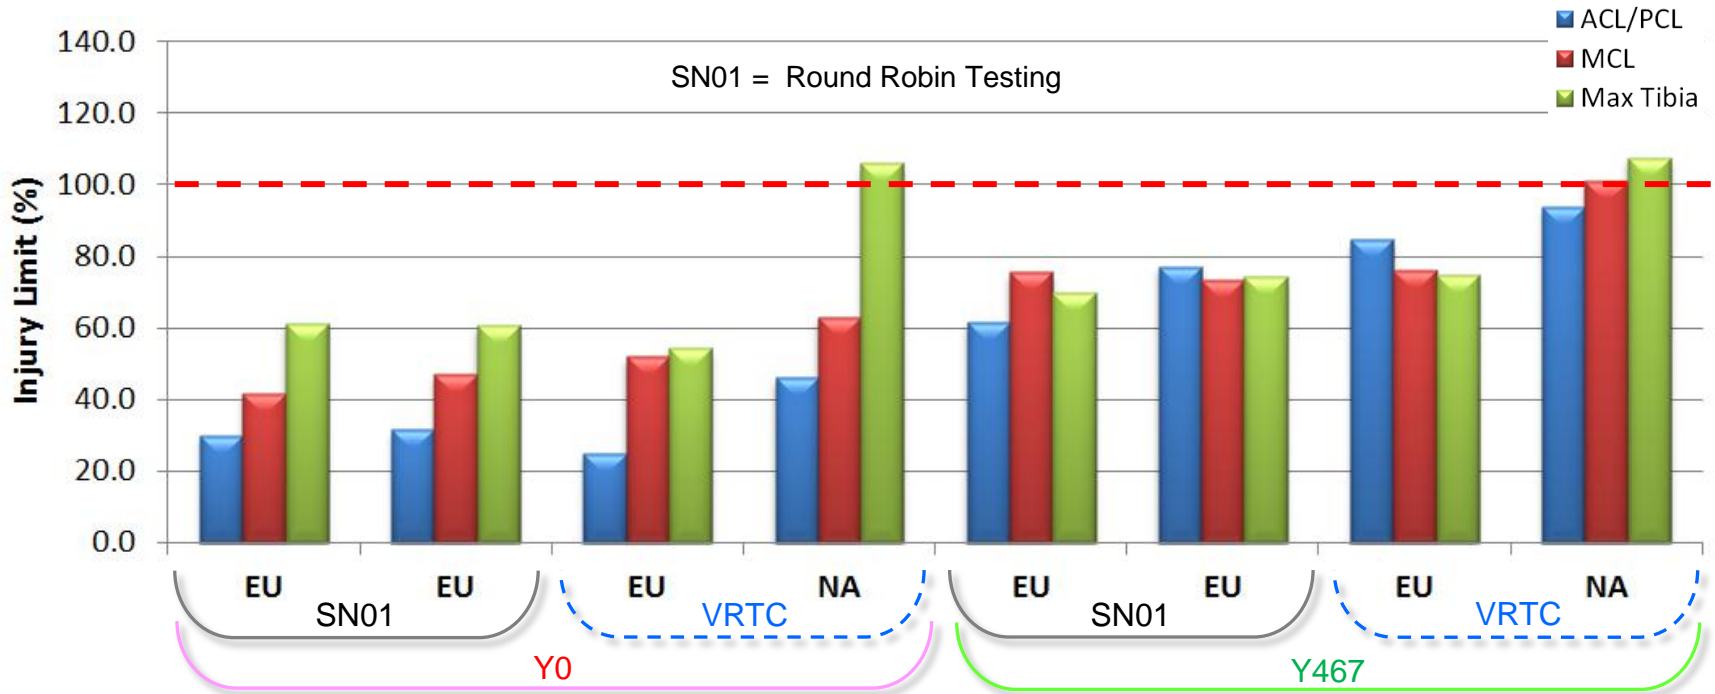
Vehicle #2: EU & NA + IWG RR Tests

VEHICLE #2	Location	Velocity @ Impact (kph)	Leg	ACL/PCL	MCL	Max Tibia	GTR9
				13	22	340	
EU	Y0	40.39	SN01	3.9	9.2	208.5	
EU	Y0	40.30	SN01	4.1	10.4	206.4	
EU	Y0	40.52	VRTC	3.3	11.4	184.9	
NA	Y0	40.28	VRTC	6.0	13.9	360.6	
EU	Y467	40.45	SN01	8.0	16.6	238.0	
EU	Y467	40.27	SN01	10.0	16.1	252.3	
EU	Y467	40.30	VRTC	11.0	16.8	253.6	
NA	Y467	39.71	VRTC	12.2	22.3	366.1

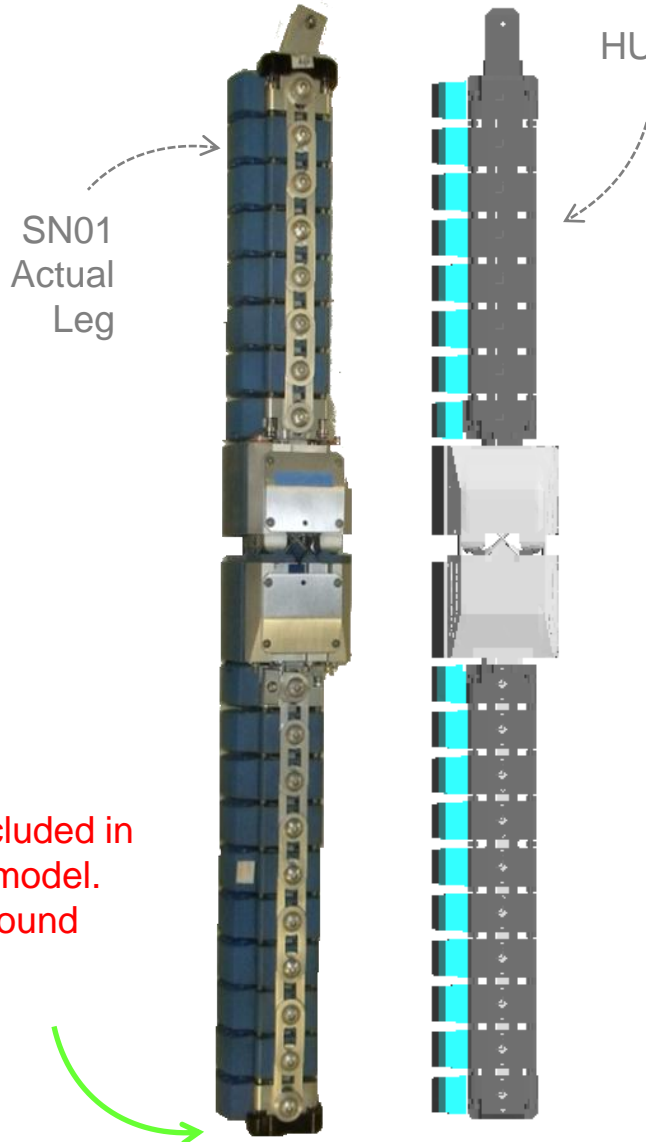
HUMANETICS_FLEX_PLI_GTR_V2.0_S3_DYNA.key

End cap not included in
V1 or V2 CAE model.
Adjust leg to ground
line by 8.6mm

- During CAE correlation it was discovered the LS-DYNA Flex PLI Ver2 legform does not include the plastic endcap at tibia bottom. Measurement to ground line should be compensated by 8.6mm (see next page).
