Task Force – Bumper Test Area: EC study update

Presented by Jolyon Carroll
Senior Researcher – 18 March 2013

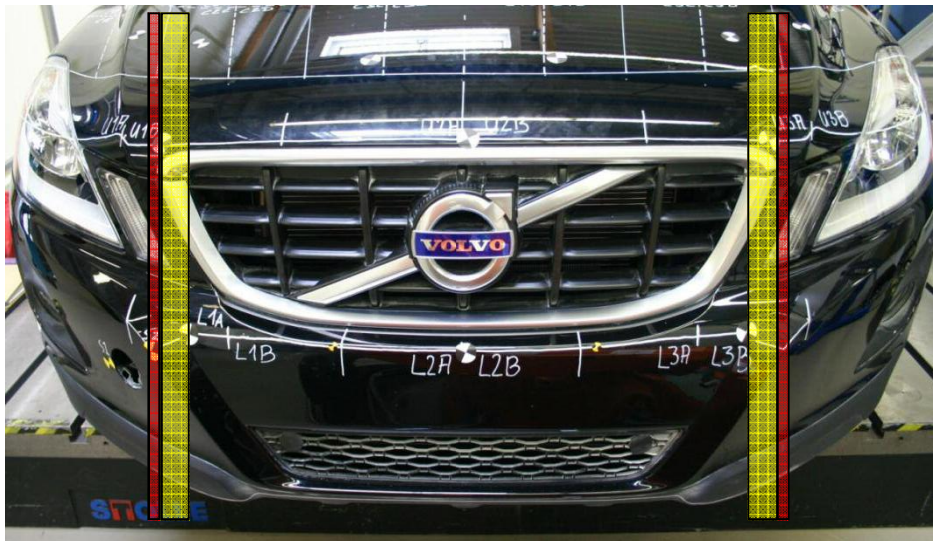
- TWG identified the Volvo V60 for monitoring
- Tested 2 points outside of conventional areas
 - “S2” – On the bumper corner (disregarding the 66mm margin)
 - “S1” – Outside the bumper corner near the tow-eye
- 3 parameters used to assess test point performance
 - Tibial acceleration (g)
 - Knee shear displacement (mm)
 - Knee bending angle ($^{\circ}$)

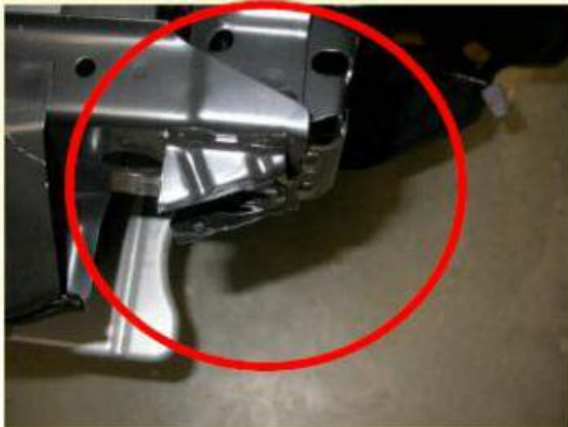
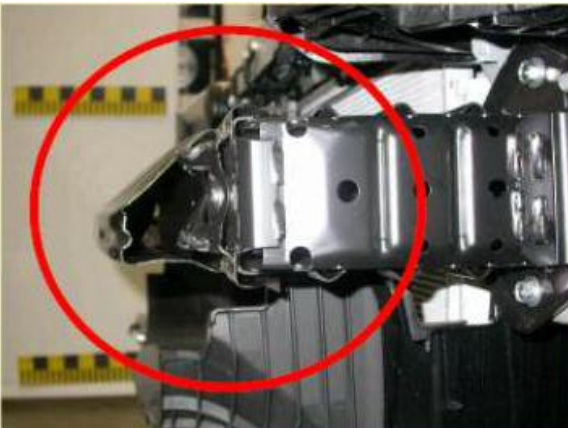
Honda Insight

- Further examination of the Insight's underlying structures revealed the potential cause of the differing performance figures.

- Stiff structures beneath the front bumper panel and outboard of the bumper bar and pedestrian protection structures were associated with the poor performance.

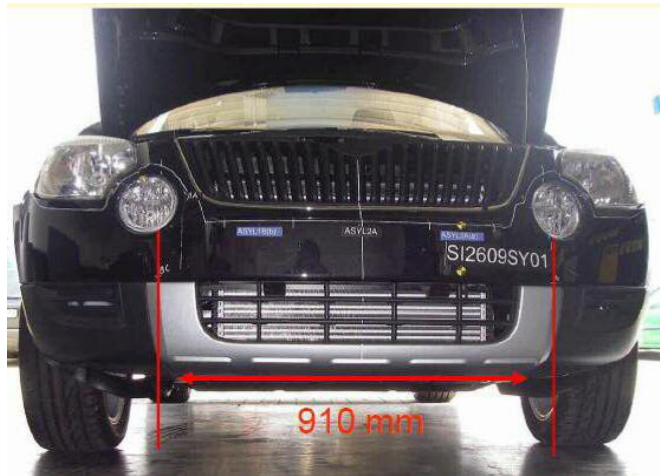
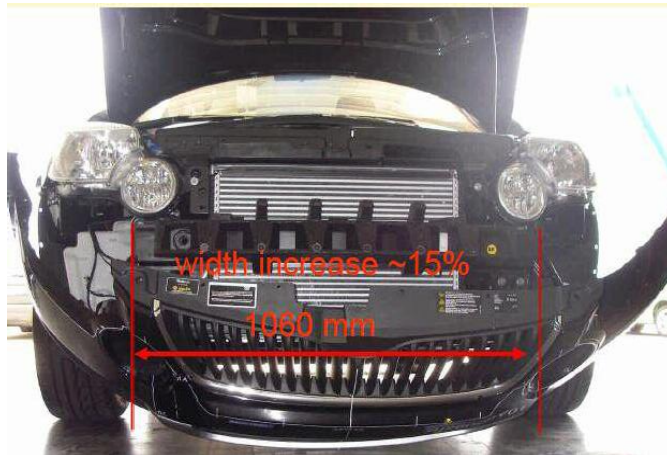
Bumper Removal

- Euro NCAP began removing the bumper panels to reveal the underlying structures
- Applied 60° plane to underlying structures (i.e. bumper bar)
- Had the general effect of increasing the bumper width
- Structures outside of the bumper bar that were still identified as potentially injurious
- But there are experimental difficulties in testing these outboard structures

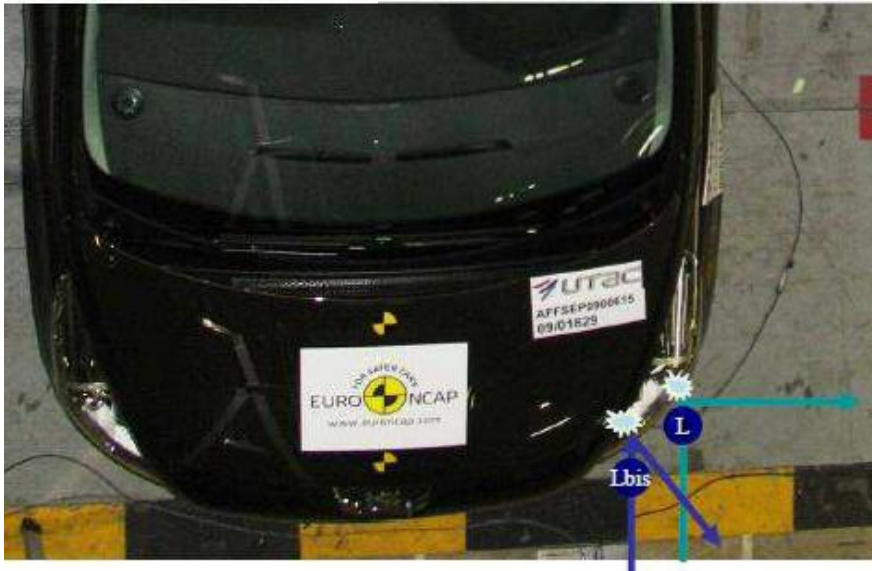
Experimental difficulties

Normal test zones			Monitored test zones	
	L1A	L2A	L3B	L3bis	L3out
Knee bending angle - deg	9.43	3.55	9.43	0.3	0.11
Knee Shear Displacement - mm	2.24	2.69	2.24	1.49	1.57
Tibial acceleration - g	109.6	108.1	109.6	50.2	70

- Monitoring highlighted experimental difficulties when testing structures outside of bumper corners
- Surfaces tend to be at oblique angles
- Inconsistencies were recorded in all parameters
- The decision was made to limit testing to within the edges of the bumper bar to prevent experimental discrepancies

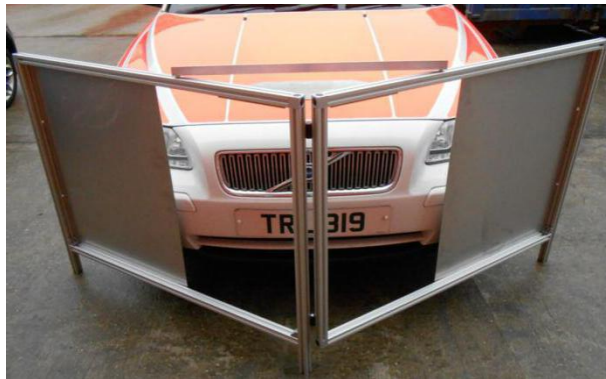
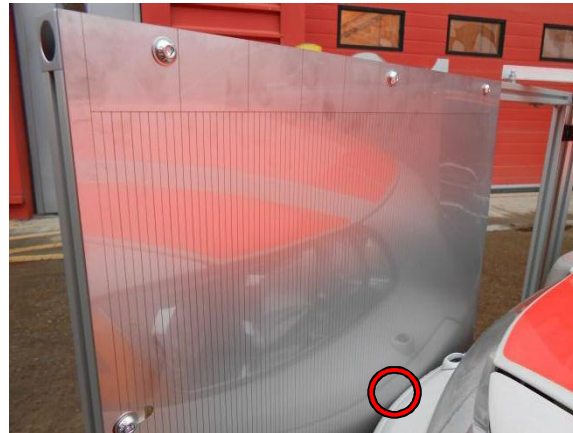
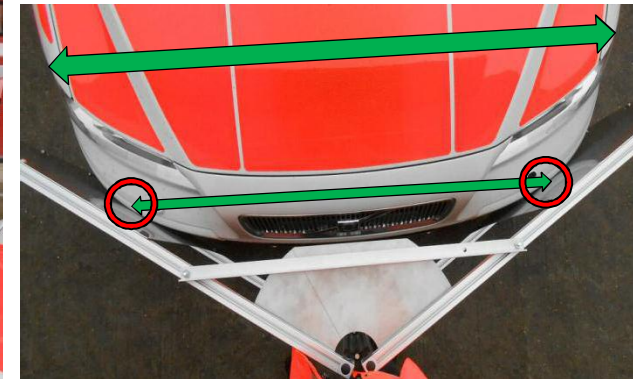
- Measuring device is locked into 120° angle
- Aligned with centre of vehicle front
- Walked forwards until contact made

- Points of contact define the “bumper corners”
- As per regulatory testing
- Gradations accurately measure distance between corners

- Distance between corners compared against the quoted total width of the vehicle (excluding door mirrors)
- Procedure is then repeated at 90° angle

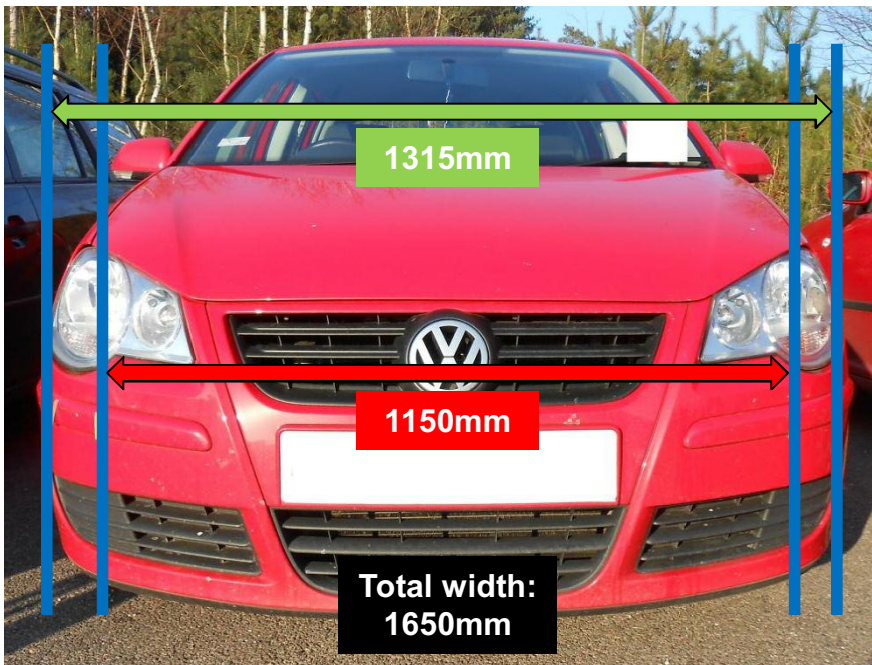
2004-2009

% of vehicle width tested

90°	80%
120°	70%
