National Transportation Safety Board

NTSB Investigations of EV Fires

Electric Vehicle Safety IWG

Global Technical Regulation Session 16

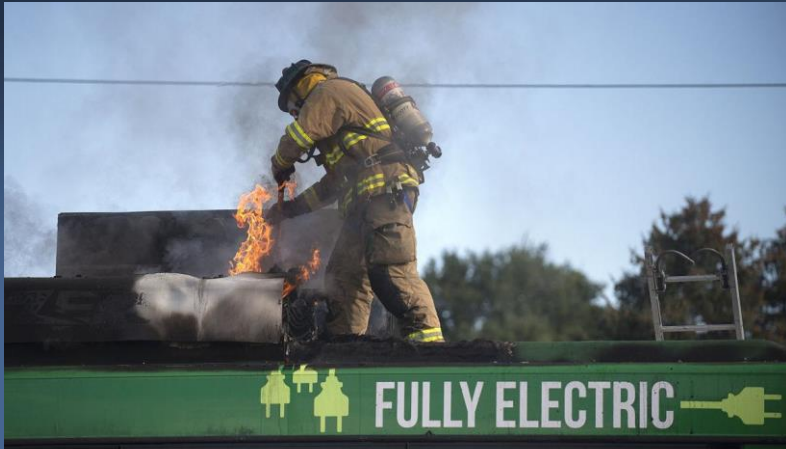
E-bus fire during operation (USA)

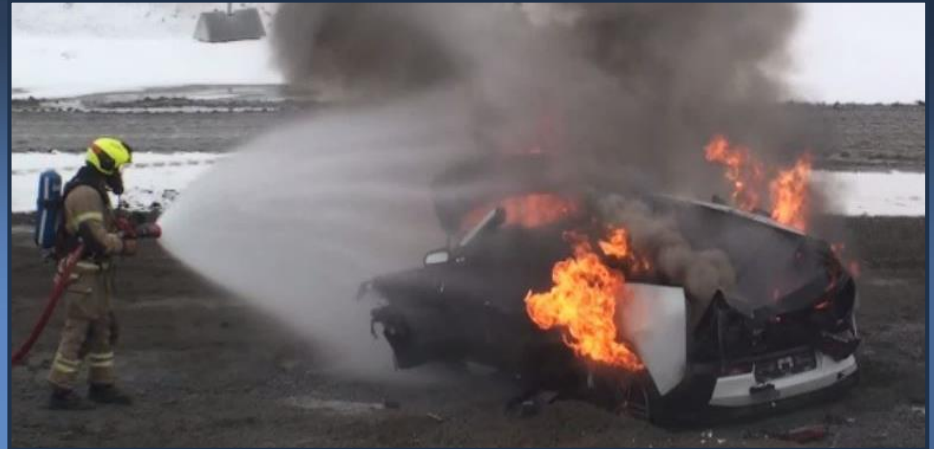
BMW i3 in Norwegian test (Norway)

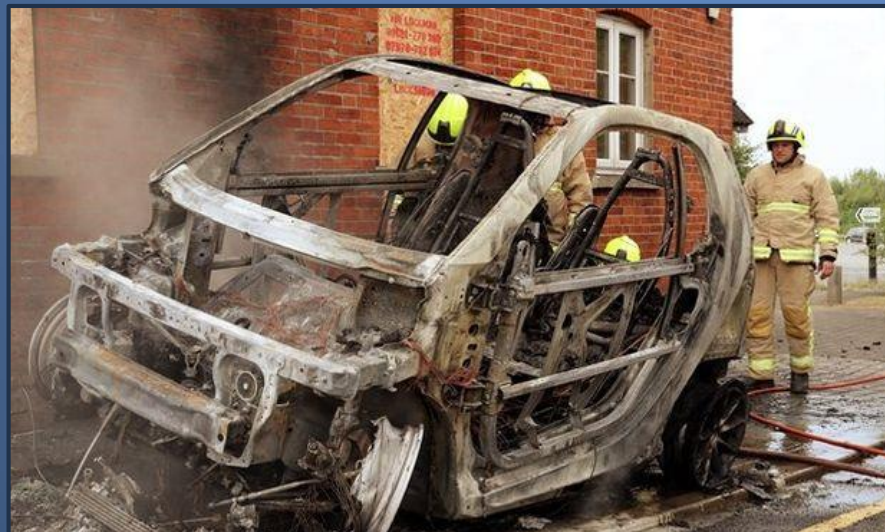
Electric Smart car on charger (UK)

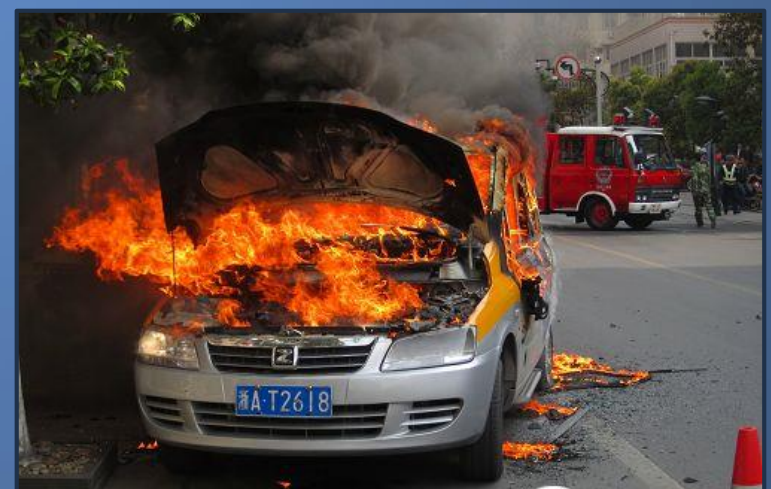
Zotye taxi in operation (China)

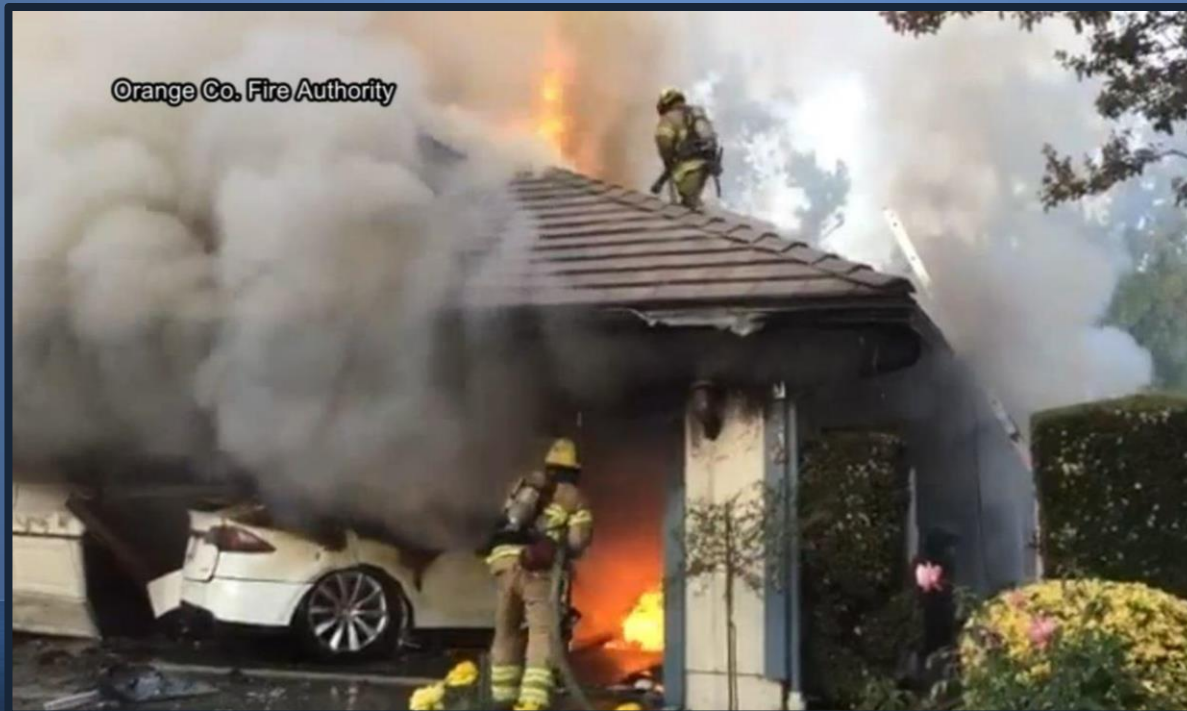
Initial Investigation: Lake Forest, California

Tesla Model X struck culvert, then home, post crash fire

- Ignited house
- Unable to extinguish
- Burn/smoke for 5+ hours
- Re-ignited on tow truck
- Re-ignited at tow yard

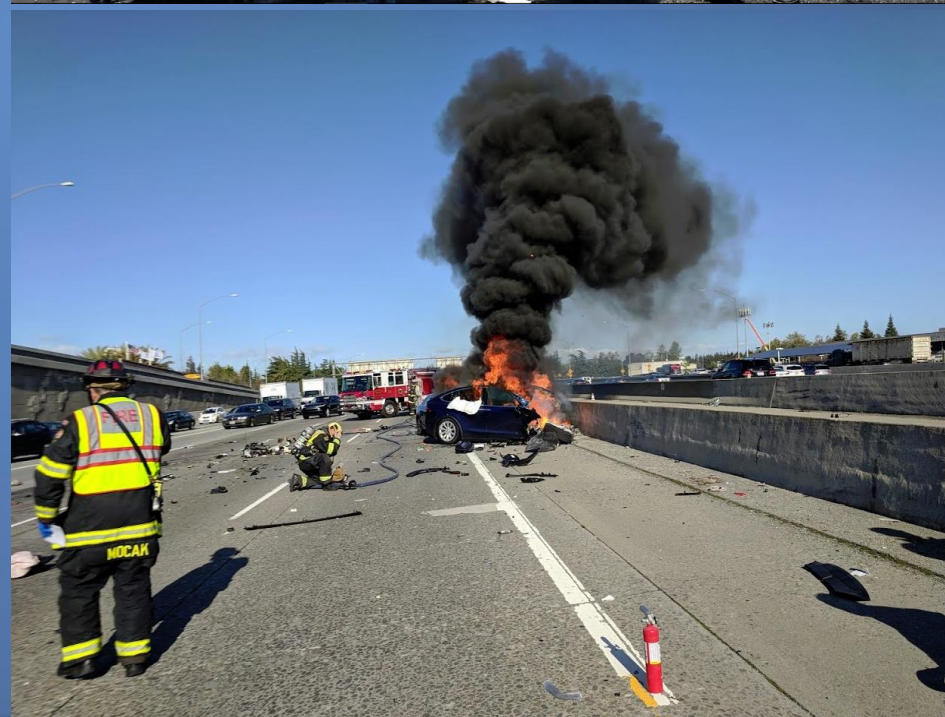
Mountain View

- Tesla Model X in “auto-pilot: mode, struck attenuator/gore area and other cars
- Fire extinguished quickly on scene
- High voltage and fire safety concerns closed important highway for hours
- Re-ignited twice at tow yard, days later

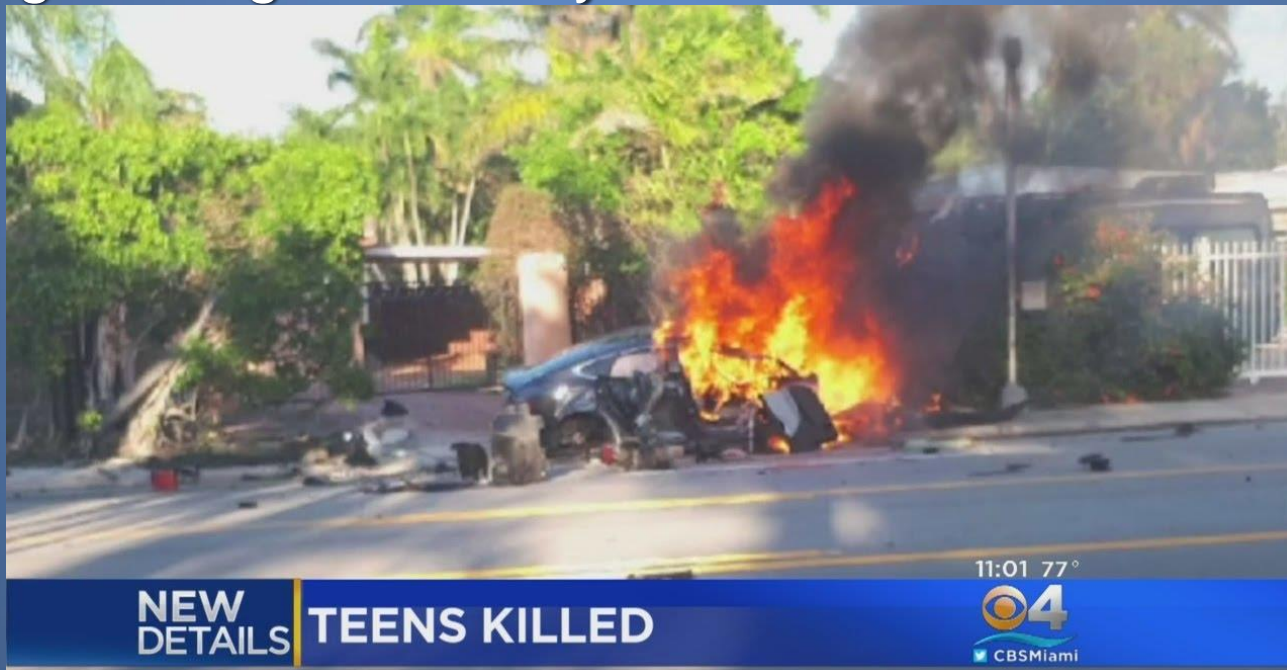
Ft. Lauderdale

- Tesla Model S struck wall and pole at high speed
- Battery case ruptured, immediate fire into cabin
- Fire initially extinguished quickly
- Re-ignited during loading on tow truck
- Re-ignited again at tow yard

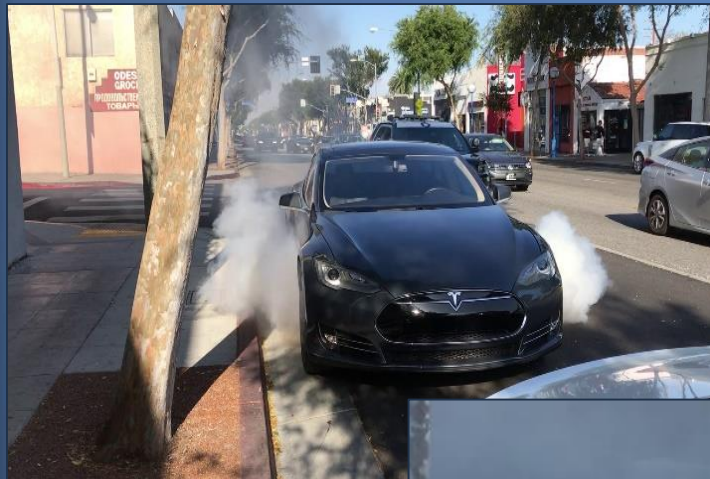
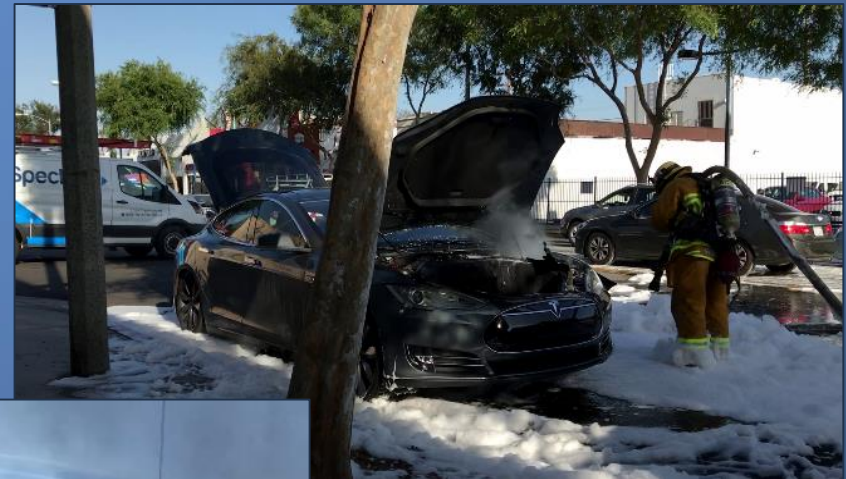
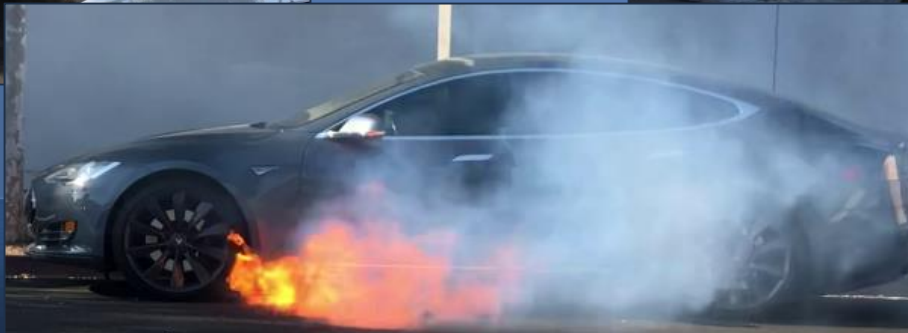
West Hollywood

- Tesla Model S primary battery fire while driving in city
- Driver pulled over, got out, recorded event, called Tesla
- Fire fighters put out flames quickly, smoke continued
- Fire fighters removed panels, severed cut loop, smoke continued
- Concern for re-ignition but did not re-ignite
- Battery pack needed removal and disassembly to drain residual energy

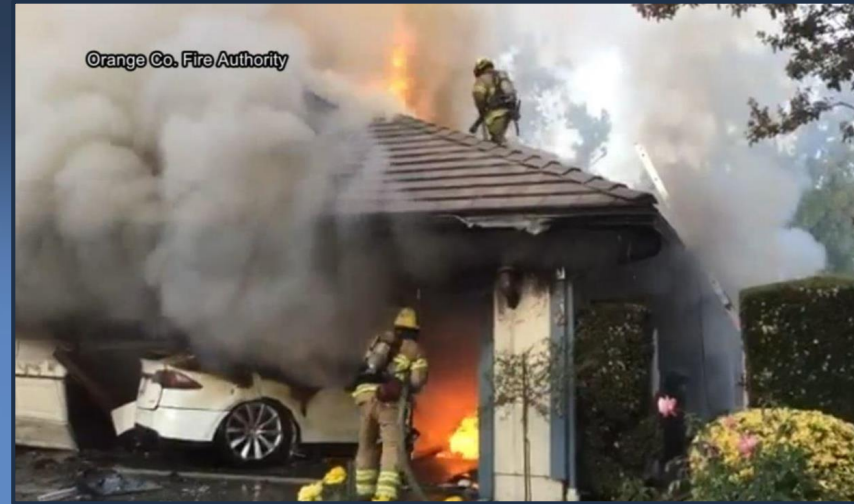
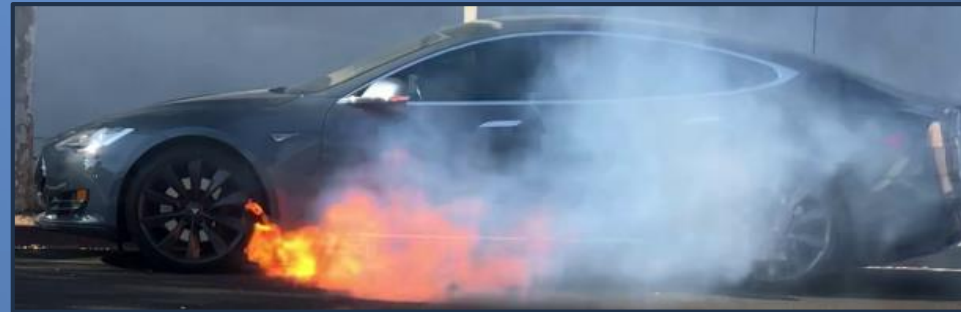
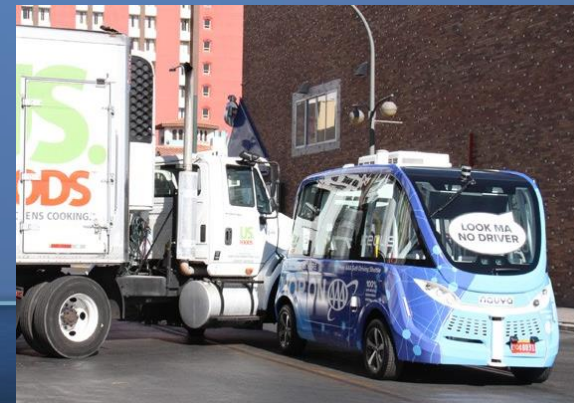
Fires with battery case damage

- Lake Forest, California →
- Mountain View, California
- Ft. Lauderdale, Florida

“Spontaneous” fires with no crash

- West Hollywood, California

Accidents with no fire

- Las Vegas, Nevada →
- Culver City, California
- South Jordan, Utah

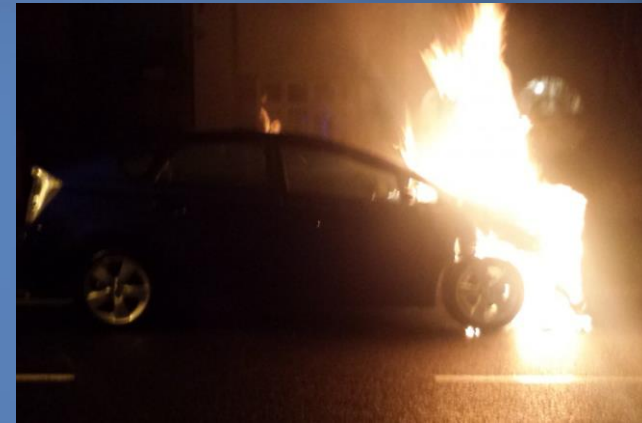
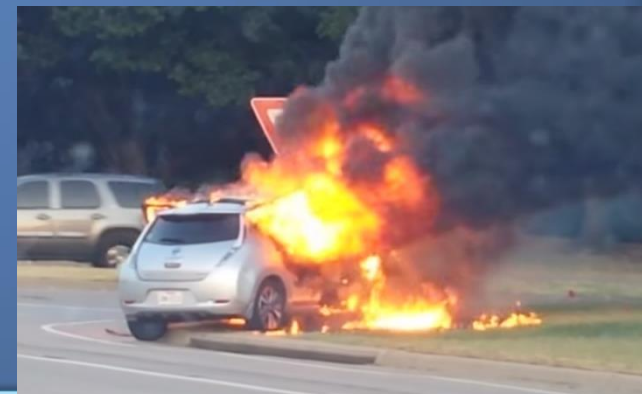
Numerous reported EV fires are not related to primary battery

- Numerous Toyota Prius ICE fires →
- BMW i3 range extender (ICE) fires
- Arsons against a series of Teslas
- Automobiles burned for TV & media
- Elect fires external to primary battery

Nissan Leaf instrument panel →

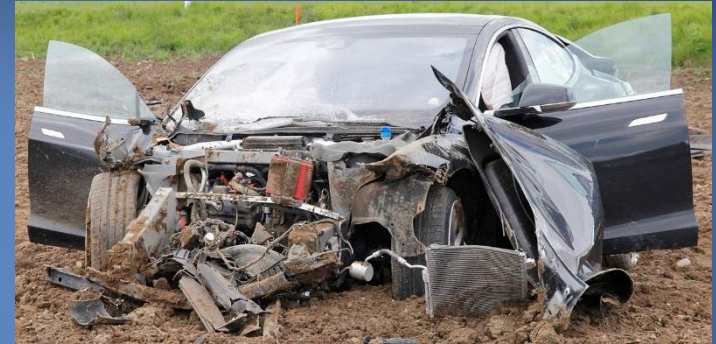
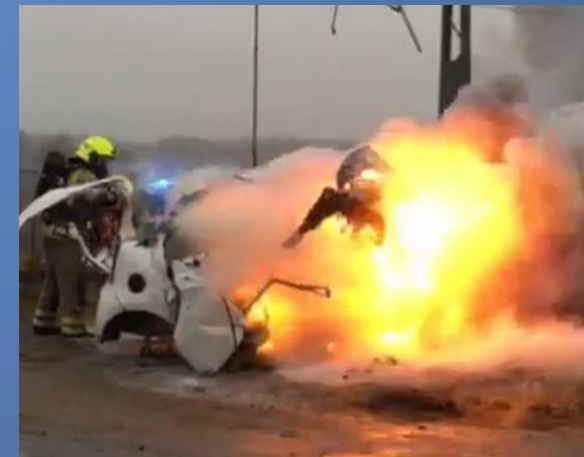
17 Tesla fires (currently)

Numerous Teslas without fire →

Fires involving other manufacturers

- BMW
- Smart
- Multiple busses
- VW →

Numerous EV/HEV/PHEV without fire

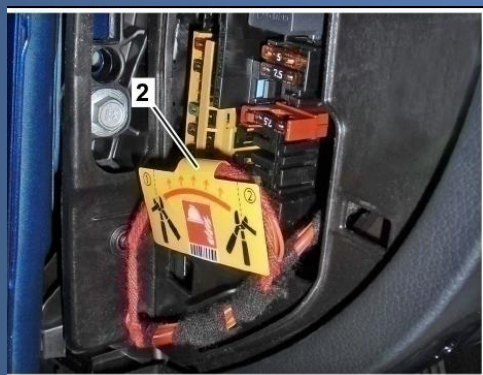
Example: Mercedes C

#1: No standardized location(s) for responders; various pull-plug and cut-loop methods; Many require some disassembly for access (note: gasoline fill ports on ICE vehicles are vulnerable)

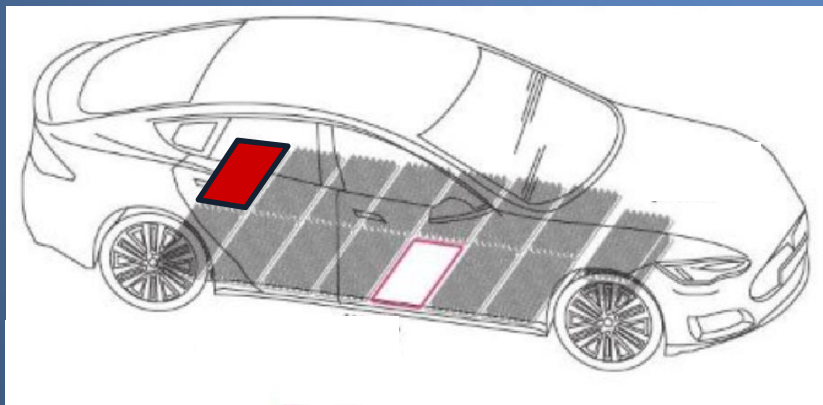
- Protected battery location
- Armored cases
- Narrow walls between modules to minimize heat transfer
- Electric isolation of damaged/runaway cells
- Separation of cells into isolated modules

(Physical damage causes trapped electrical and chemical energy at module level. Threat requires battery removal and disassembly.)

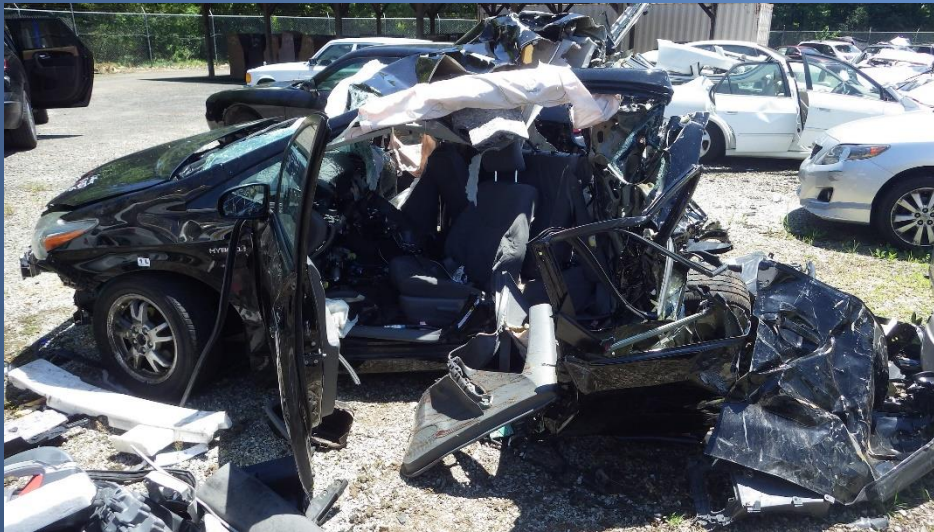
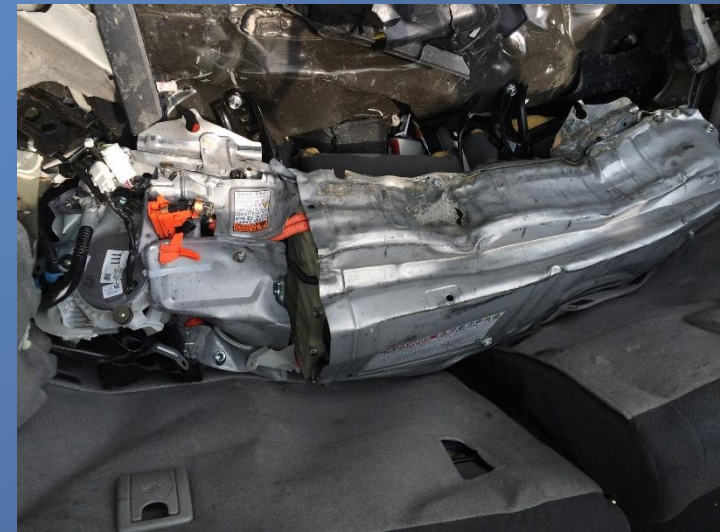
NTSB Major Investigation of Multivehicle Crash (Chattanooga TN, June 25, 2015)

- Semi-truck impacted Prius at about 80 mph in a traffic que
- Crushed Prius battery
- No fire or smoke

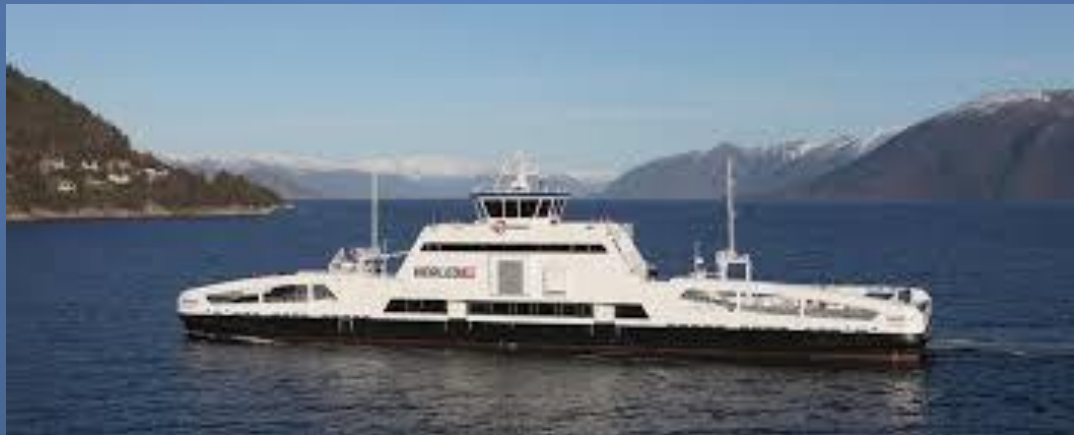
- Maritime industry and others (buildings) require ability to flood cells
- Fire department hose connectors are standardized
- A study for the New York Fire Department found "... extinguishing requirements for batteries need not be excessive if an intelligent, system-level approach is taken that includes external fire ratings, permits direct water contact, and implements internal cascading protections..."
- Large General Electric installations have flooding capability

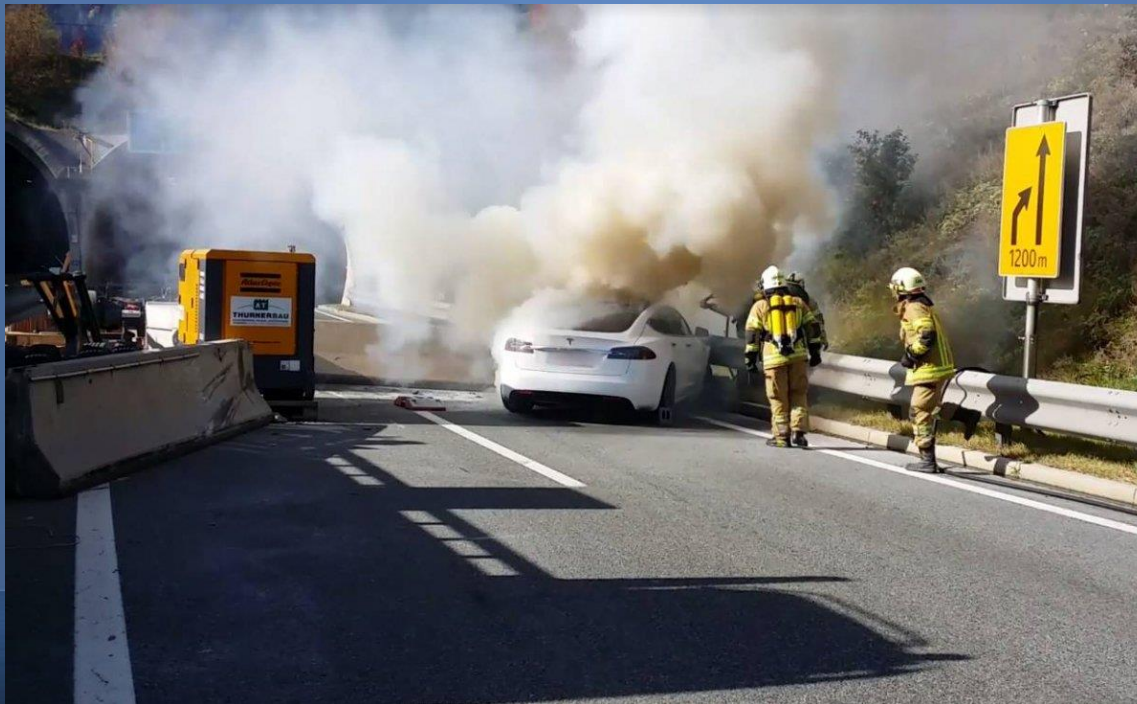
- Confined spaces (Note tunnel below)
- Injuries to first responders, potentially to public
- Lengthy closures of large areas for hours and of highways
- Potential injuries and damage to second responders
- Re-ignition has occurred six days after accident
