AEBS and trucks

Practical Test of the Detection of Trucks for the
Advanced Emergency Braking System

Client: Rijkswaterstaat – Water, Traffic & Environment

Reference: T&PBF7856R001F01

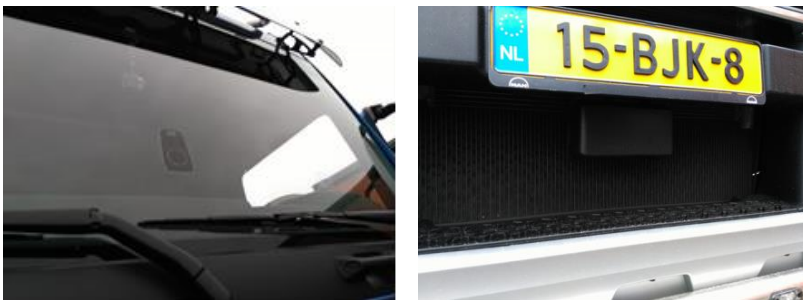
Figure 1 – Radar and camera on test vehicles.

Manufacturers are using different methods to detect traffic jams. Generally, these are radar-based and may or may not be combined with a camera. When an object with which a collision is probable is detected, the driver receives a warning signal. This signal may be visual, acoustic or a combination of the two. This warning system is called Forward Collision Warning (FCW). If the situation persists and the driver fails to intervene, the system must intervene. In a number of systems used, the system first brakes the vehicle lightly (approx. 3 m/s²) to attract the driver's attention. After this, the system intervenes within 1.4 seconds through means of an emergency stop. An emergency stop by the system (> 5 m/s²) must reduce the speed by at least 20 km/h in order to as much as possible reduce the impact of a potential collision. This braking system actually is the AEBS. In other words, AEBS is always implemented in combination with FCW, where FCW warns and AEBS brakes.

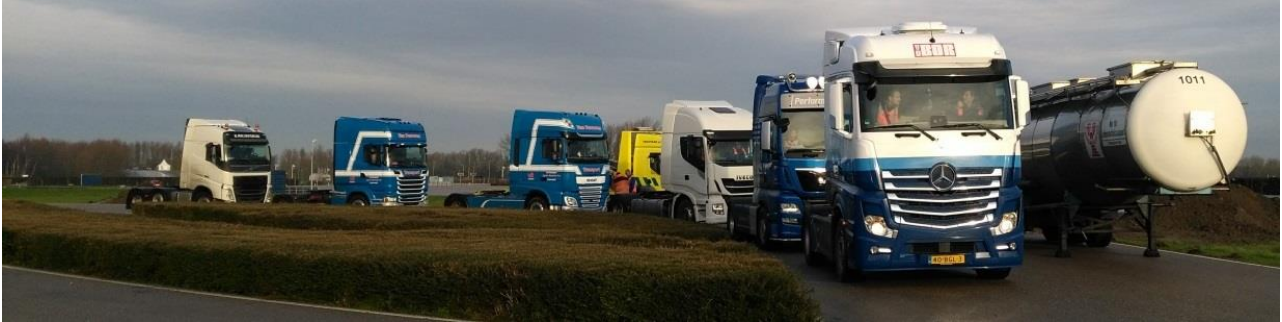
Figure 2 – Test Vehicles.

Six different trucks equipped with AEBS were used for the test (see the figure below). It concerns trucks of the following brands:

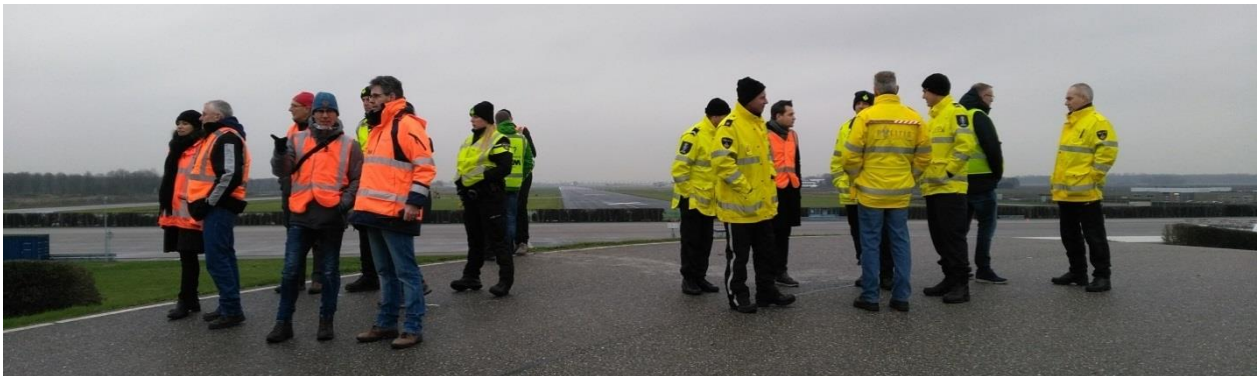
Figure 4 – Observers/spectators on the hill.

Observers/spectators were located on the hill, designated in purple, from which the three test sites were clearly observable.

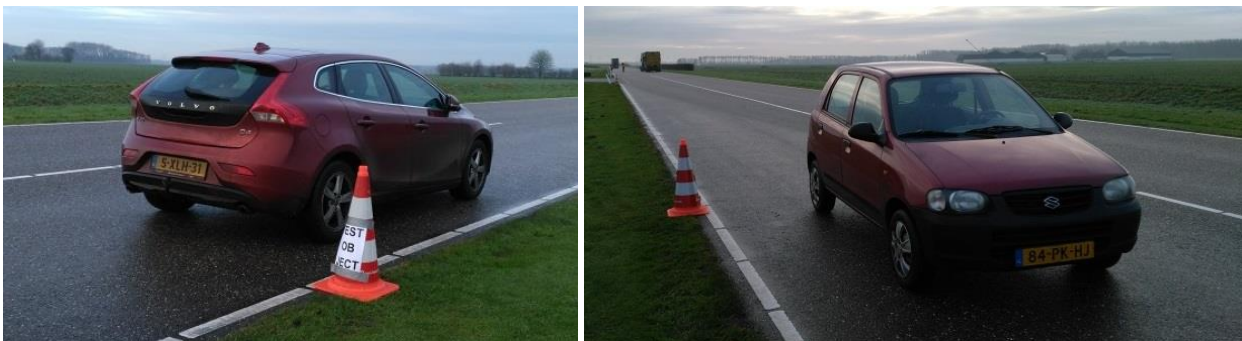
Figure 8 – Passenger car 1 (left) and passenger car 2 (right).

Car 1 was parked very far to the right (tightly against the roadside). This made it difficult for the trucks to approach straight from behind. This probably affected the test. Therefore, car 2 was parked a bit further from the roadside, which resulted in a higher score for some test vehicles.

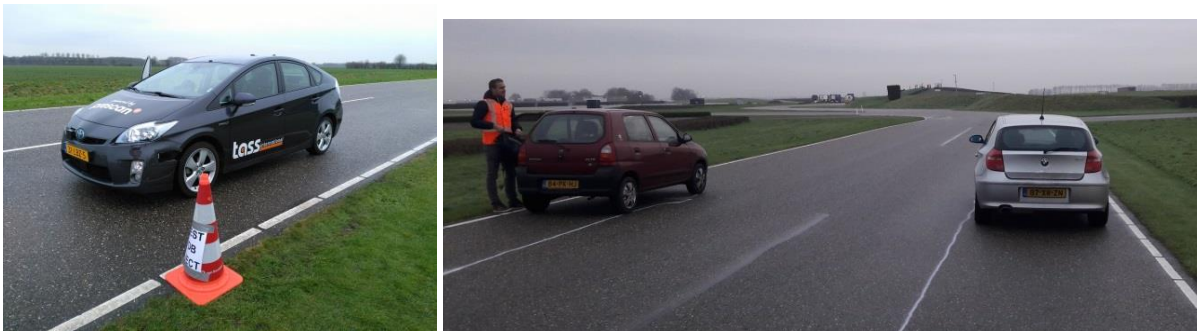
Figure 9 – Passenger car 3 (left) and the parked passenger cars (right).

Contrary to passenger cars 1 and 2, passenger car 3 was parked facing forward. The low scores of test vehicles 5 and 6 stand out in this situation.

During the verification test, the systems must not respond when the trucks drive between two vehicles, which are 4.50m apart. During the test, all systems met this requirement.

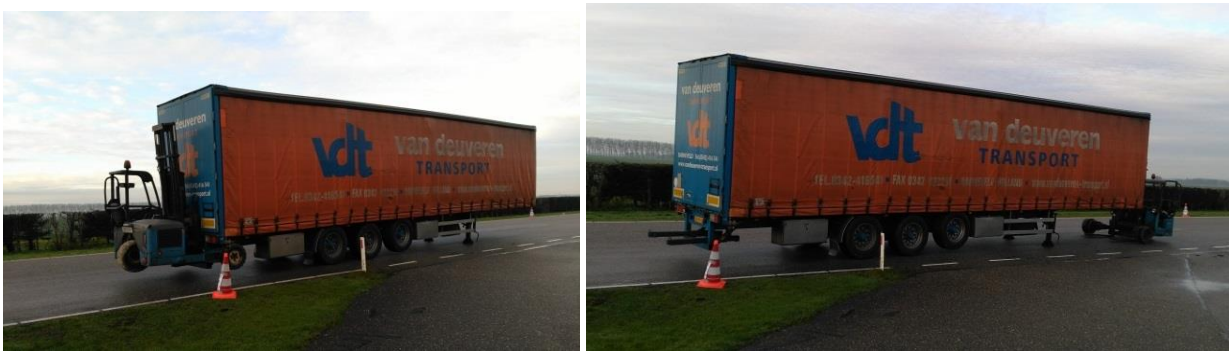
Figure 10 – Tilt semi-trailer with (left) and without (right) forklift.

The low score of test vehicle 1 stands out. 4 out of 6 vehicles score 80% or higher. We also observe that test vehicle 6 detects the trailer better without the forklift in place, while the other test vehicles detect the object better with the forklift in place.

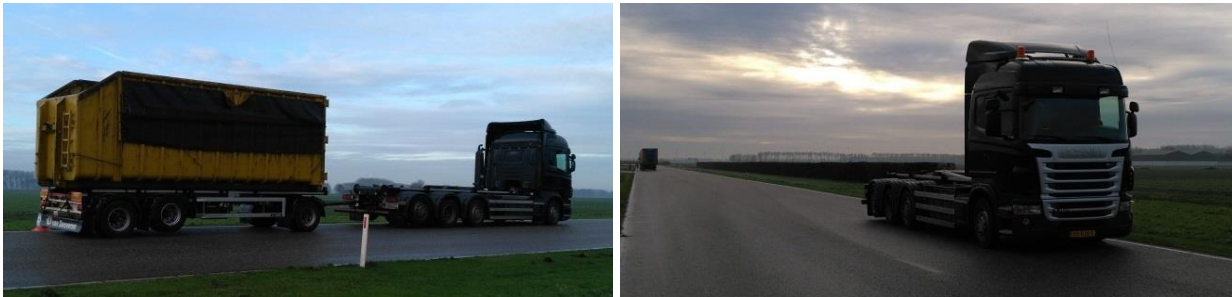
Figure 11 – Container truck with (left) and without (right) container.

The fact that 5 of the 6 test vehicles do not or barely detect the container truck with and without the container is remarkable. Test vehicles 2 and 3 detect the container truck with container and score 80-100%, but without the container the scores are 20 and 0%.

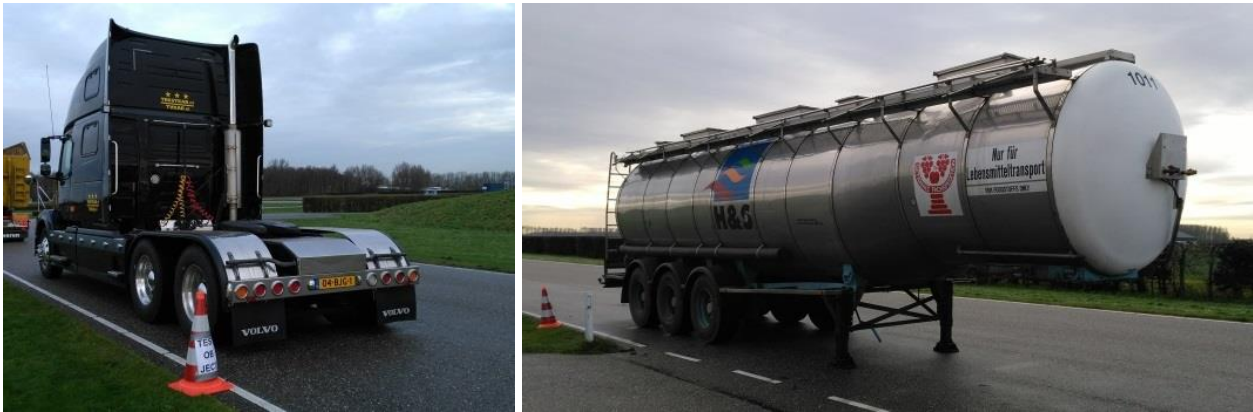
Figure 12 – Tank truck (left) and road tractor (right).

The low score of test vehicle 4 stands out in the test with the tank truck. With only the road tractor in position, only test vehicle 3 obtains a high score (80%). The AEBS systems of the other vehicles gave (almost) no warning for the separate tractor.

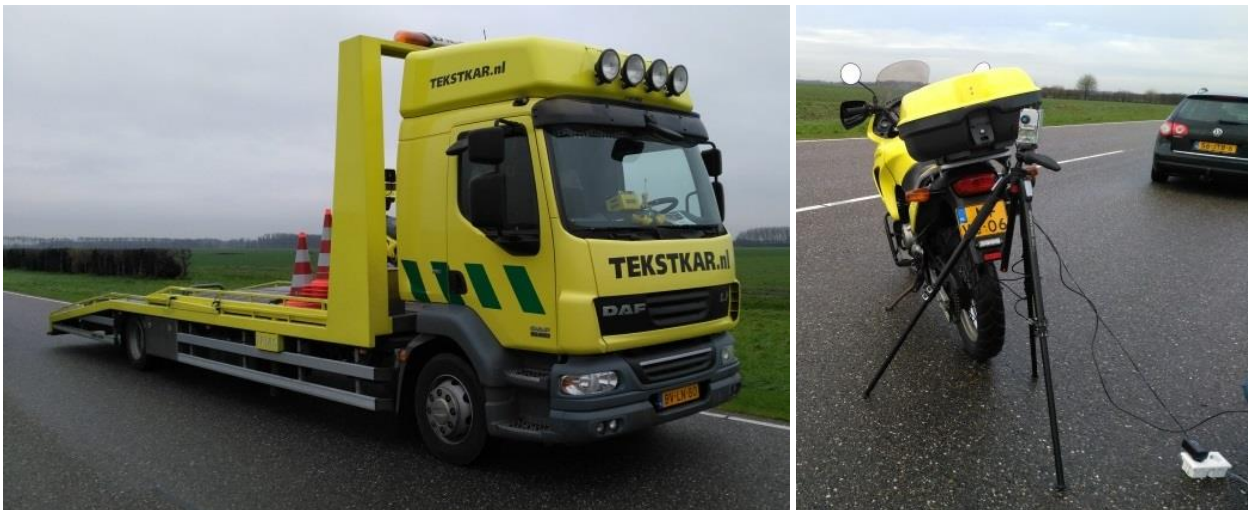
Figure 13 – Flatbed trailer (left) and motorcycle (right).

The flatbed trailer is hardly detected. Only test vehicle 3 scores 75%.
The motorcycle was in a fend-off position and was not detected by any truck.

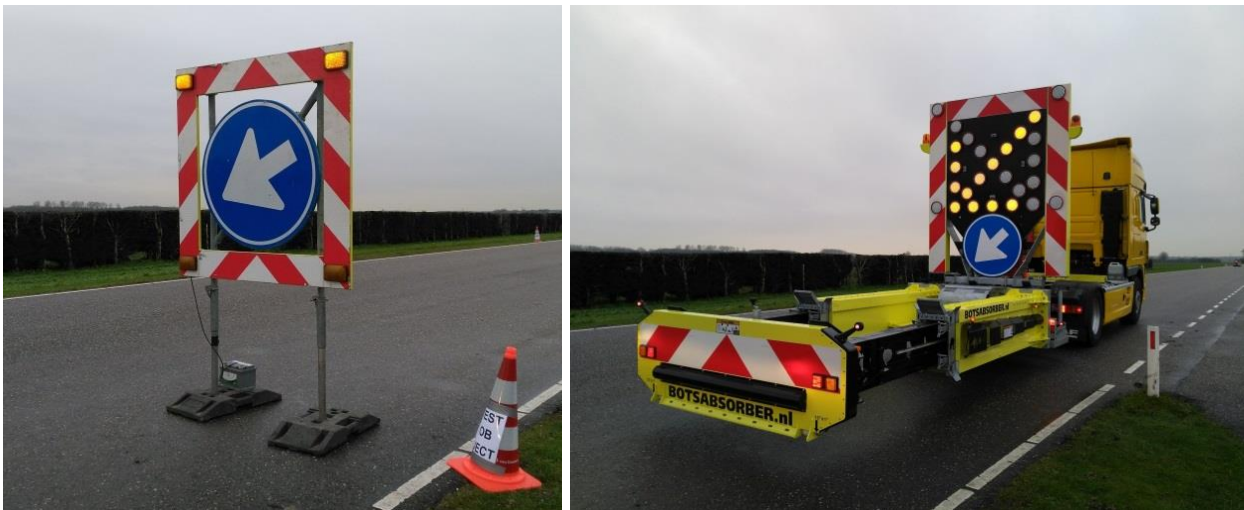
Figure 14 – Mobile road sign (left) and collision absorber (right).

The mobile road sign is almost always detected by test vehicles 1 and 4, but not by the other trucks.

The collision absorber obtains varying scores. It should be noted that the scores are considerably higher than those obtained during the test in January 2017. This can be explained by either the improvement of the AEBS systems used and/or by the other type of collision absorber used.

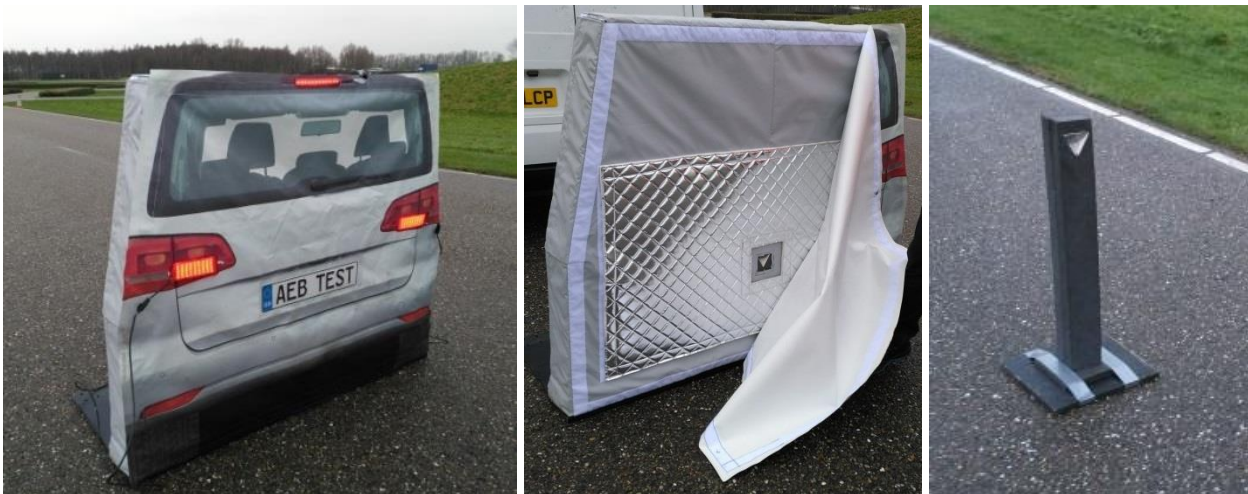
Figure 15 – Moshon Data Slab Foam Target (left and centre) and Moshon Data Delineator (right).

A foam test target was also tested. The target consisted of a foam shape with a print of the back of a passenger car, including lighting and licence plate. A reflective surface and a prism-shaped reflector were applied on the test target below the print. The test target is a flat copy of the Global Vehicle Target as applied in the Euro NCAP test protocol. 5 out of 6 vehicles properly detect this test target (80% or higher). Only test vehicle 6 obtains a lower score (40%).

The prism-shaped reflector from the test target was also tested separately. It is properly detected by test vehicles 4 and 6, and barely by the other test vehicles.

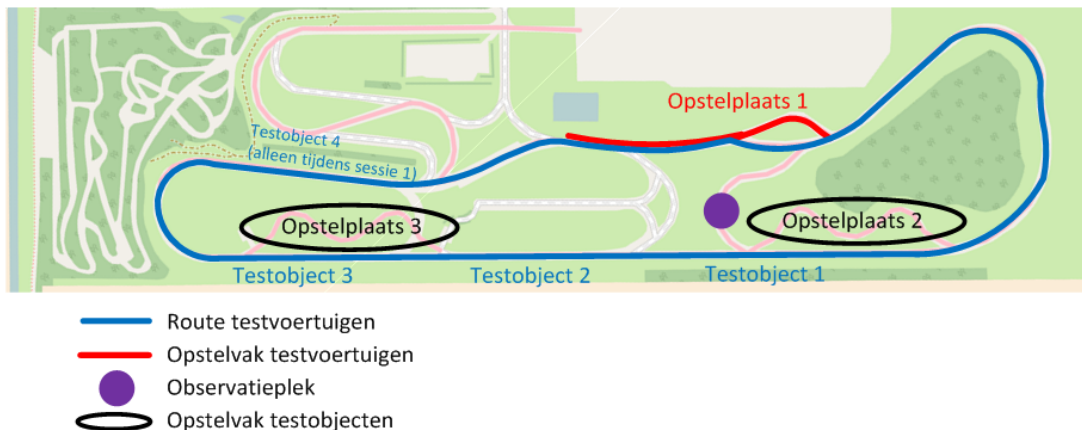
Testopstelling - bovenaanzicht

- Voertuigen stellen op in rode gebied.
- Testende voertuigen rijden blauwe ronde, vijf keer. Rondetijd is ongeveer 2:30 minuten
- Observanten staan op de heuvel, aangegeven in paars
- Testobjecten die niet getest worden, worden in de zwart omcirkelde gebieden opgesteld.
