# Proposal for the test mode

Based on VIAQ-07-08,  
VIAQ-08-08,  
VIAQ-14-15

Korea Transportation Safety Authority

Korea Automobile Testing & Research Institute

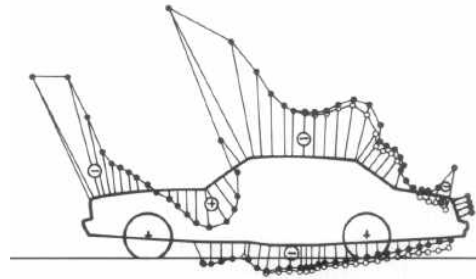
< Pressure of vehicle surface in high speed >

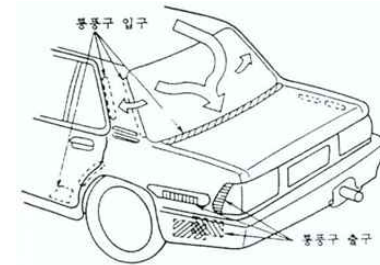
< position of extractor >

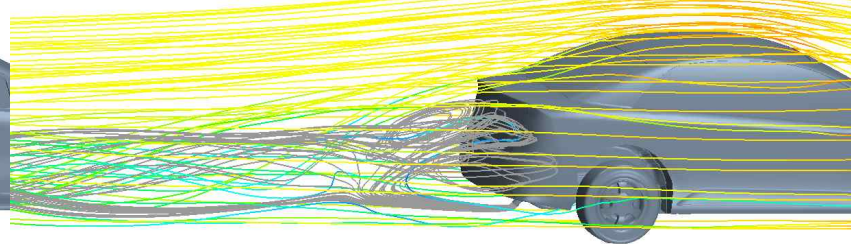
- ✓ The vortex flow occurs in the back part of sedan vehicles depending on vehicle speed

0.00000 12.000 24.000 36.000 48.000 60.000  
Velocity: Magnitude (m/s)

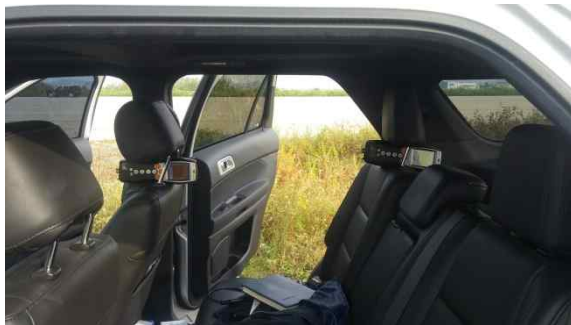
- ✓ Proving ground driving test
  - Idling condition, cruising speed condition, acceleration condition
- ✓ Test vehicle : Gasoline vehicle, 3,000 cc, sedan
- ✓ Measurement devices setting position
  - Nose position of front seat, back seat
  - Center position of truck
  - Rear of vehicle

<front and rear seat>

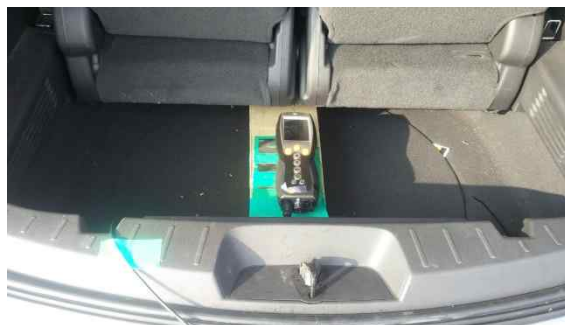
<center of trunk>

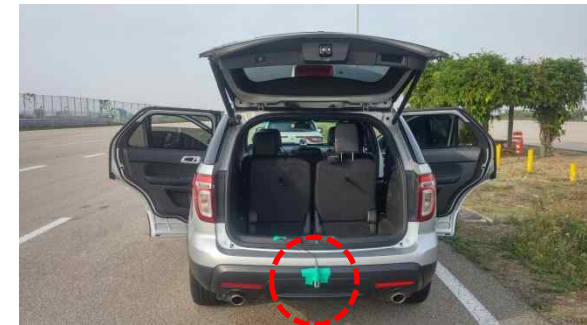
<rear of vehicle>

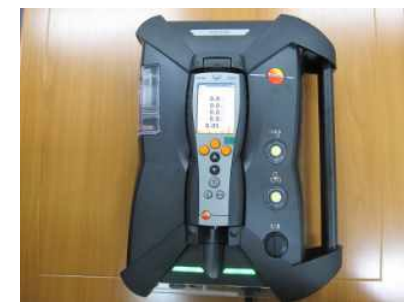
- ✓ Test Device : Testo 350K
  - NO Range : 0~300 ppm
  - Resolution : 0.1 ppm
  - Accuracy :  $\pm 2$  pm(0.0~39.9 ppm), Other range  $\pm 5\%$
  - NO2 Range : 0~500 ppm
  - Resolution : 0.1 ppm
  - Accuracy :  $\pm 5$  pm(0.0~39.9 ppm), Other range  $\pm 5\%$

<NO, NO2 device>

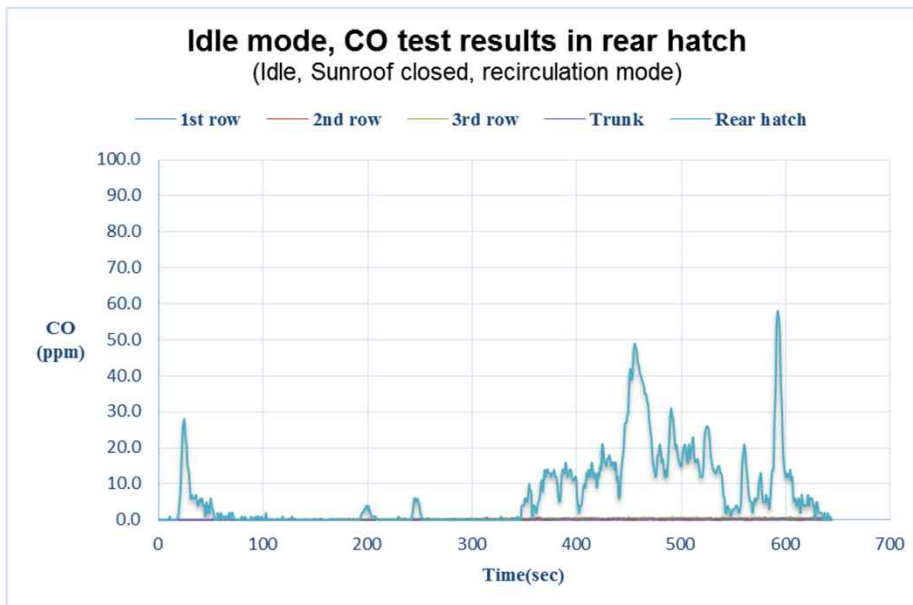
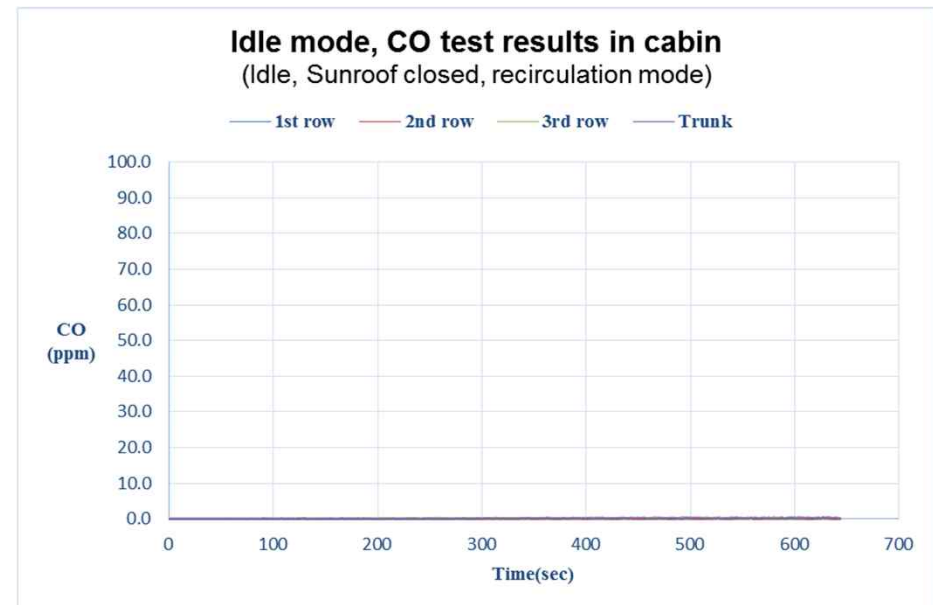
- ✓ Engine idling in normal condition, not moving
- ✓ Total test time : 10 min
- Stabilizing time : 5 min, Measuring time : 5 min
- ✓ CO was detected in the rear hatch, but not detected in cabins

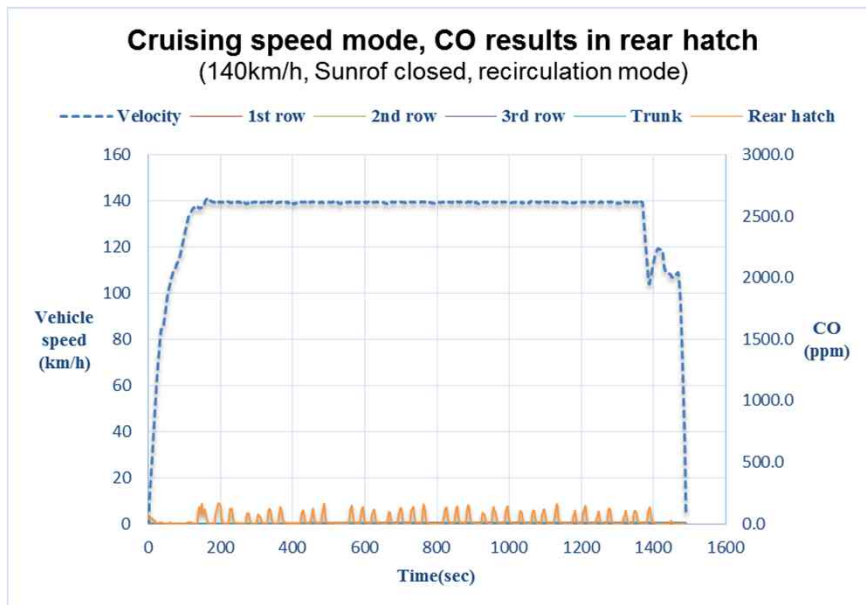
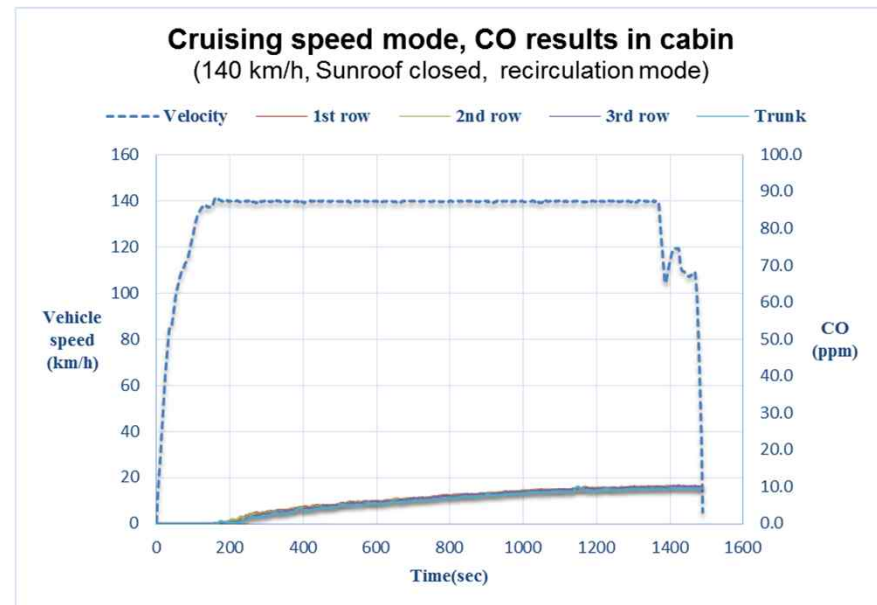
- $140 \pm 5$  km/h
- Total test time : 20 min (stabilizing time 10 min, measuring time 10 min)
- CO was detected in cabin with 140 km/h ( 8 ~ 9 ppm)

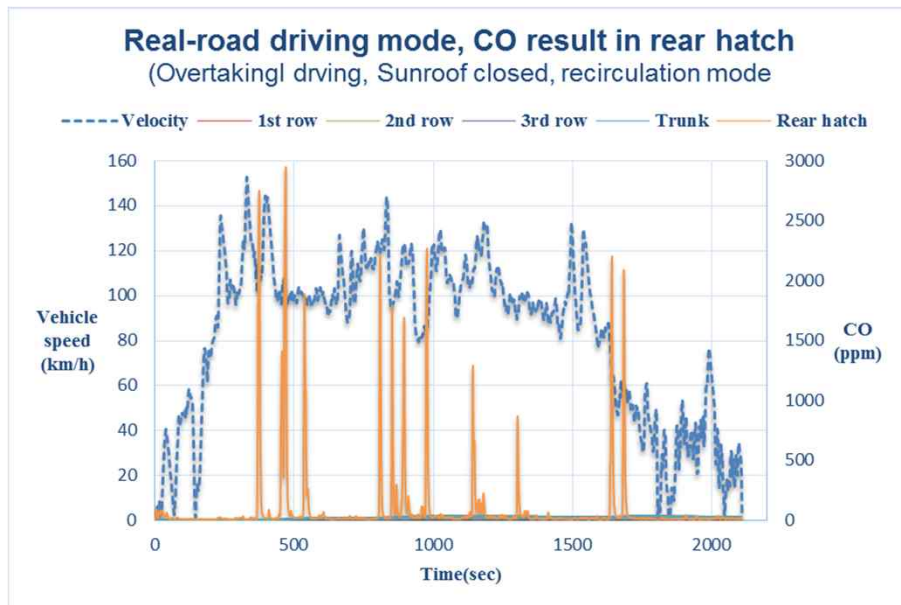
- Real-road driving test in same course with acceleration (near WOT)
- Overtaking driving depending on road traffic
- CO was detected in cabin 20 ~ 35 ppm
