Research Review about Fuel Integrity Safety Assessment from Rollover Test of Hydrogen Bus in Korea

Vehicle Safety Research Office
Chief Researcher

Korea Transportation Safety Authority
Korea Automobile Testing & Research Institute

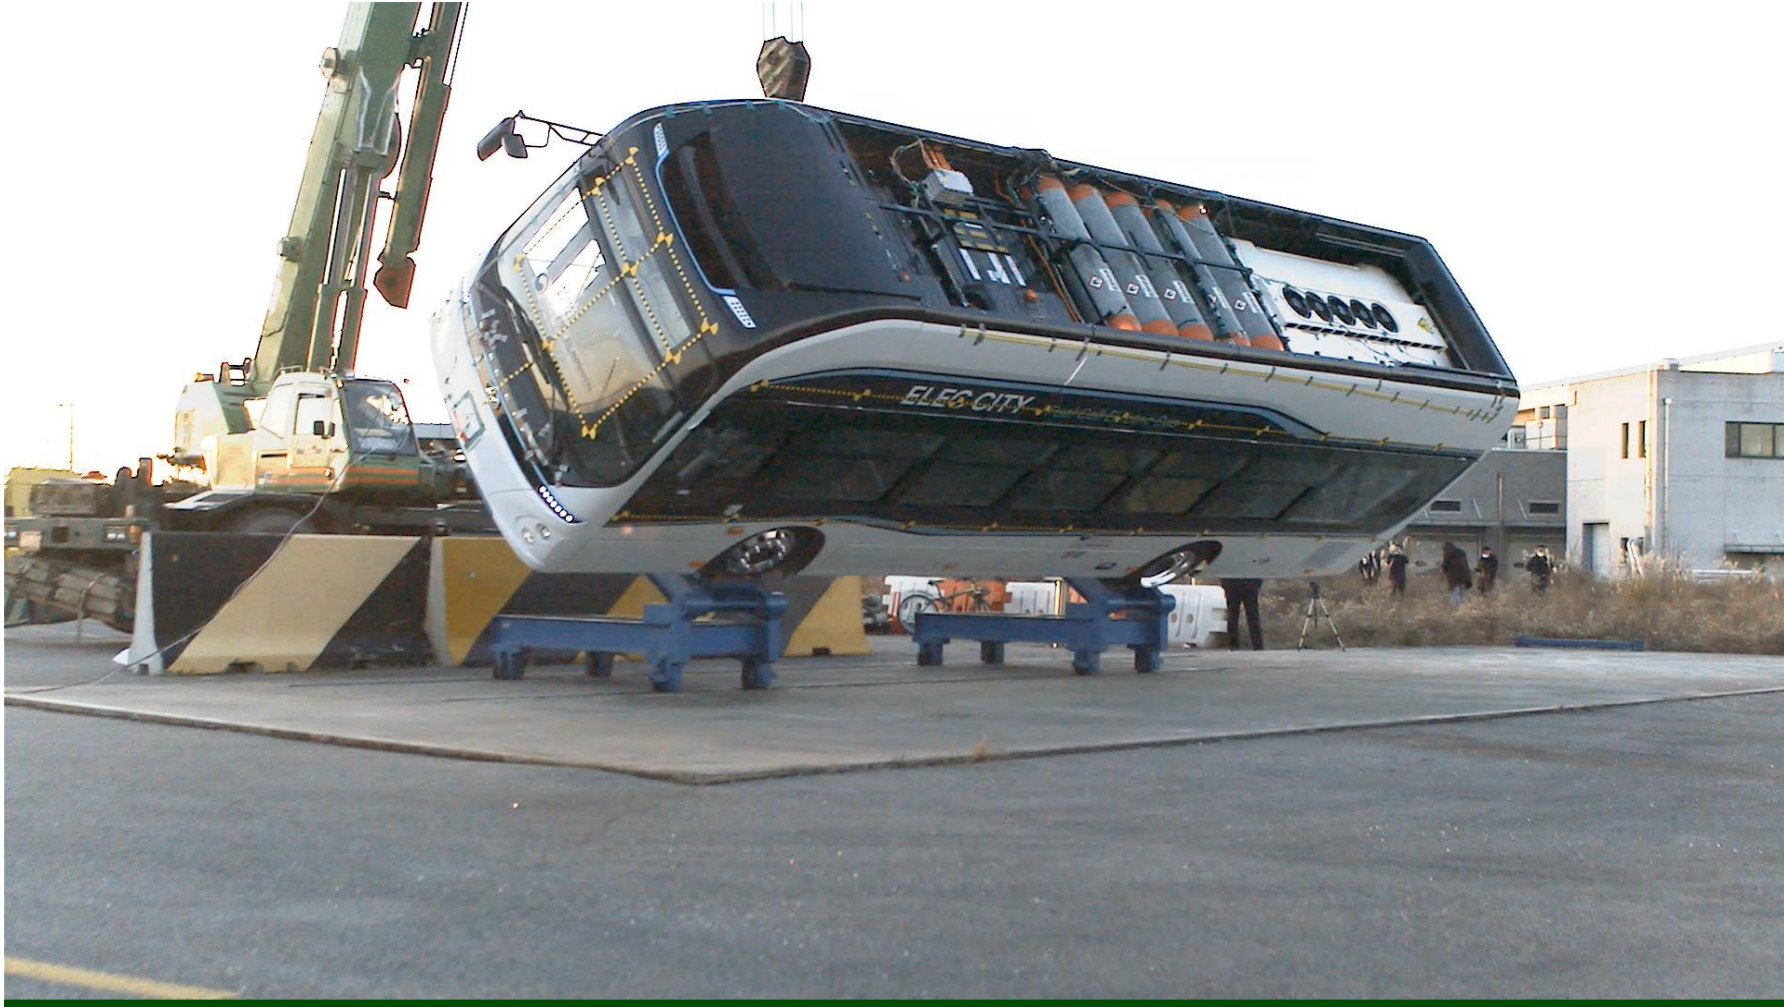
High Speed Image of Rollover test

- Direct contacts were observed between fuel system (fuel lines and valves) and vehicle side wall during rollover test.
 - High accelerations of 60 ~ 80g were measured in terms of impact severity of fuel tanks. But no leak of hydrogen gas.
- Direct contacts were observed between REESS and vehicle side wall during rollover test, too.
 - Failure of isolation resistance between high voltage bus and electrical chassis.
 - ※ 65~90 Ω/V were measured from the test (Regulation : equal or over 500 $\Omega/V(A/C)$)

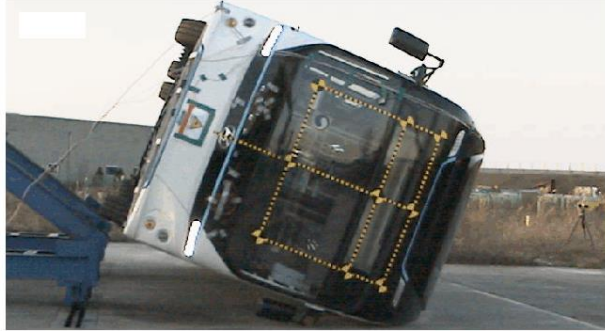
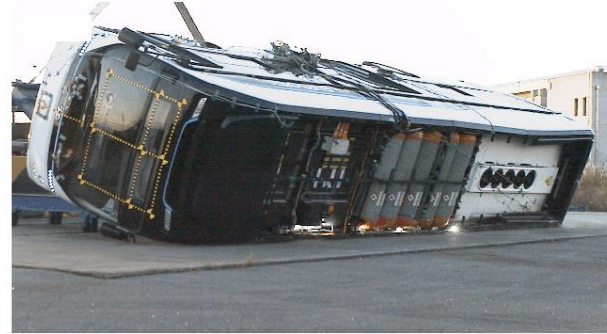
Comparison between actual test and computer simulation (1)

- Confirm the good correlation (equivalent level) about deformed shape of fuel system and structure.
 - 1) Direct contacts are observed between fuel system and vehicle side wall in both test and simulation.
 - 2) Deformed shapes of vehicle structures are similar.
