Rapid Heating Test Methodology : Vehicle (using cylindrical cells) Test

November, 2022

EVS 25 – GTR

Vehicle test with cylindrical cell pack architecture

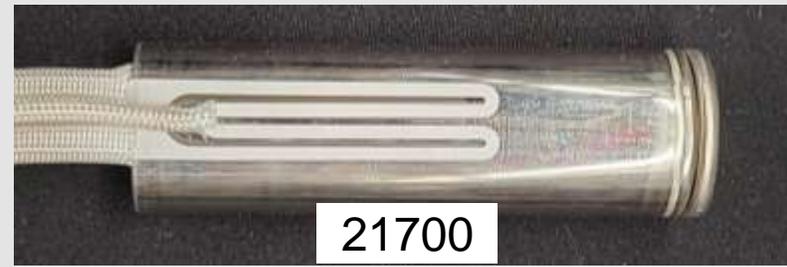
Pack Instrumentation

9mm x 36mm
x 0.7mm

Extraction / heater install / reseal / reinstallation following OEM service manual;
No battery related error codes present after reinstallation and vehicle could be placed in drive or charge mode (heater is “invisible”).

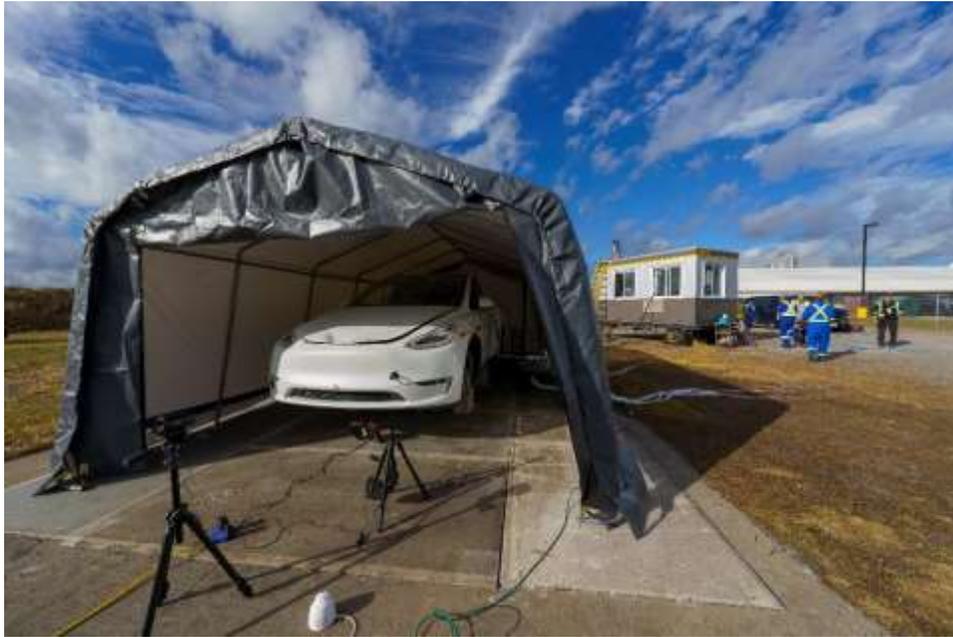
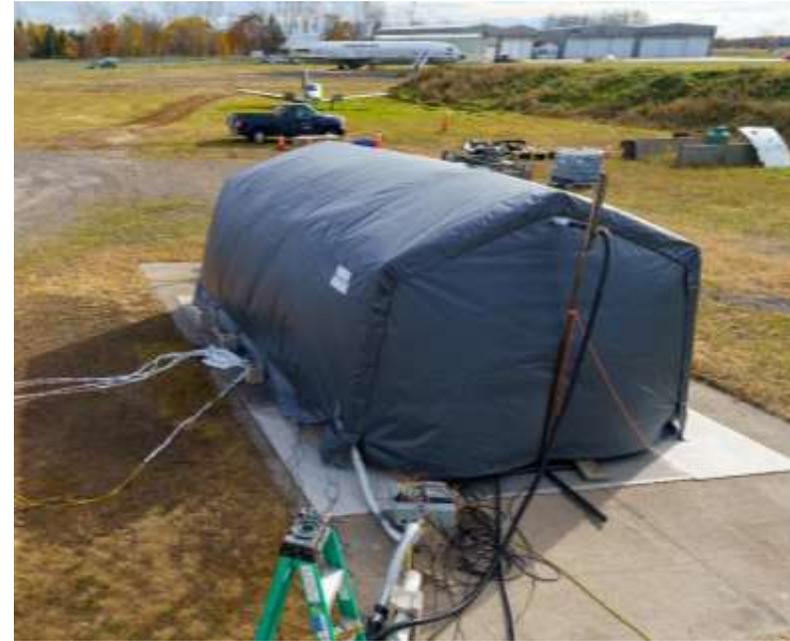
Test Setup

- 35 temperatures (20 internal pack, 11 in/on vehicle, 3 in tent, 1 outdoor ambient)
- 4 module voltages, 4 brick voltages (2 targets, 2 adjacent)
- Pressure inside HV Pack
- 2 boroscope camera, 4 video cameras, 1 IR camera
- FTIR (tent atmosphere)
- 244 signals over CANBus
