Li-Ion Battery Pack Immersion Exploratory Investigation

UN GTR No. 20 – EVS 25th IWG

November 2022

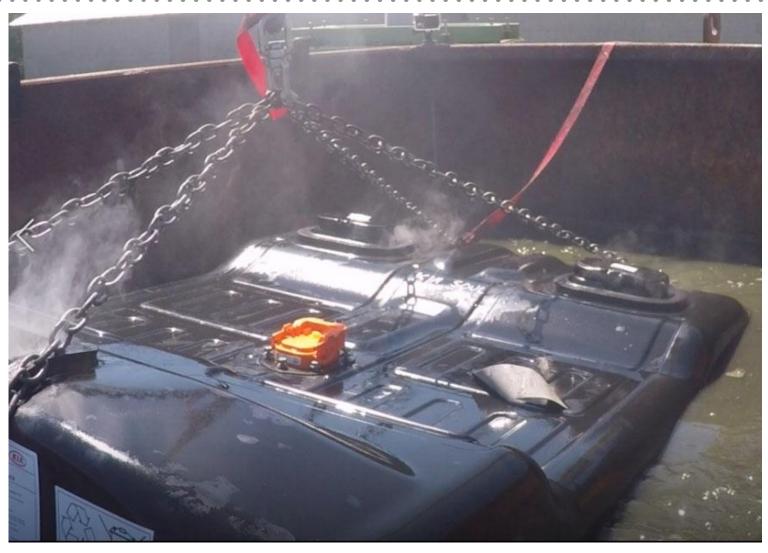
Battery Immersion

- All the batteries degraded with no adverse reaction while immersed
- 2 batteries had smoke/venting issues post-immersion:
 - ¹st Battery was immersed for 20 minutes in water (3.5% salinity)
 - 2nd Battery was immersed for 15 minutes in water (0.1% salinity)
- Primary reactions during immersion appeared to last between roughly 30 minutes and 1 hour. Larger capacity batteries took longer.
- Post immersion batteries were under 50V
- Battery degradation/discharge occurred quicker in 3.5% salinity water.
