National Highway Traffic Safety Administration

Lithium-ion based Rechargeable Energy Storage System Real-World Incident Review

GTR Status Update

May 2014

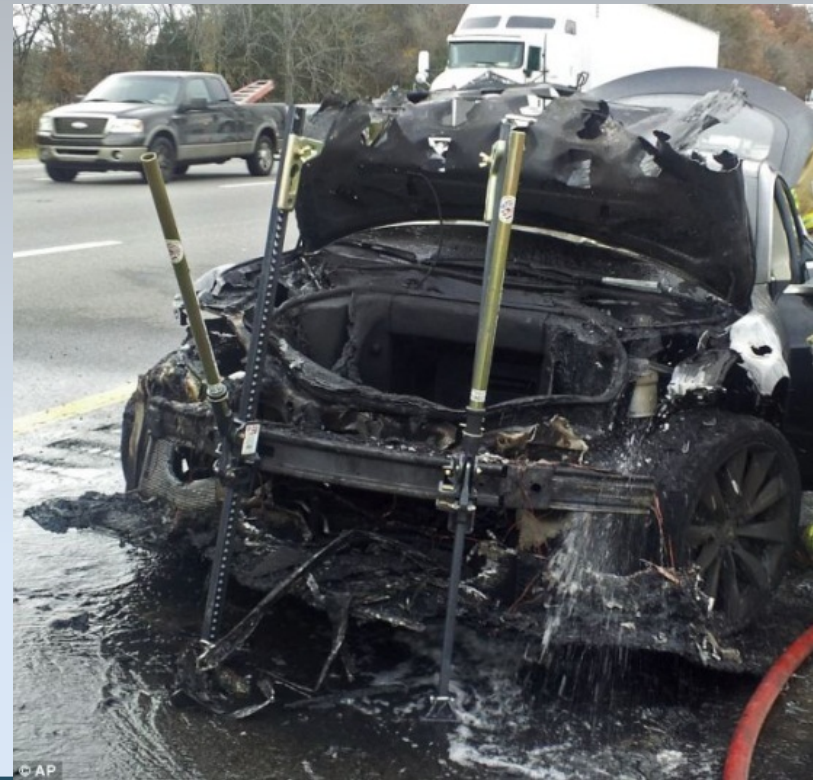
Tesla Model S Incidents

- Safety related concerns
 - Multi-cell Abuse/Crush
 - Thermal Propagation
 - Containment
 - Operator Messaging
 - Monitoring/Fault Detection
 - Discharge
 - Passenger compartment isolation

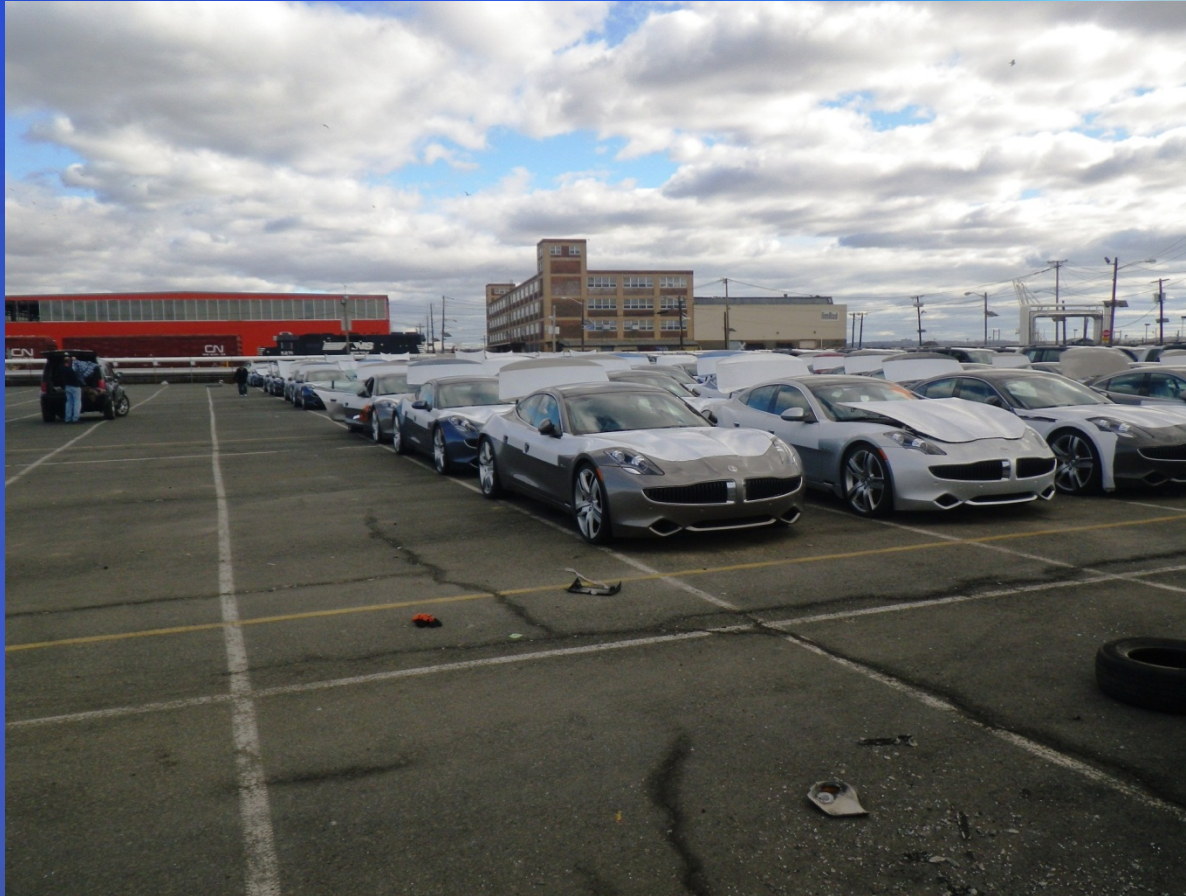
338 Fisker Karmas were flooded in Newark, NJ

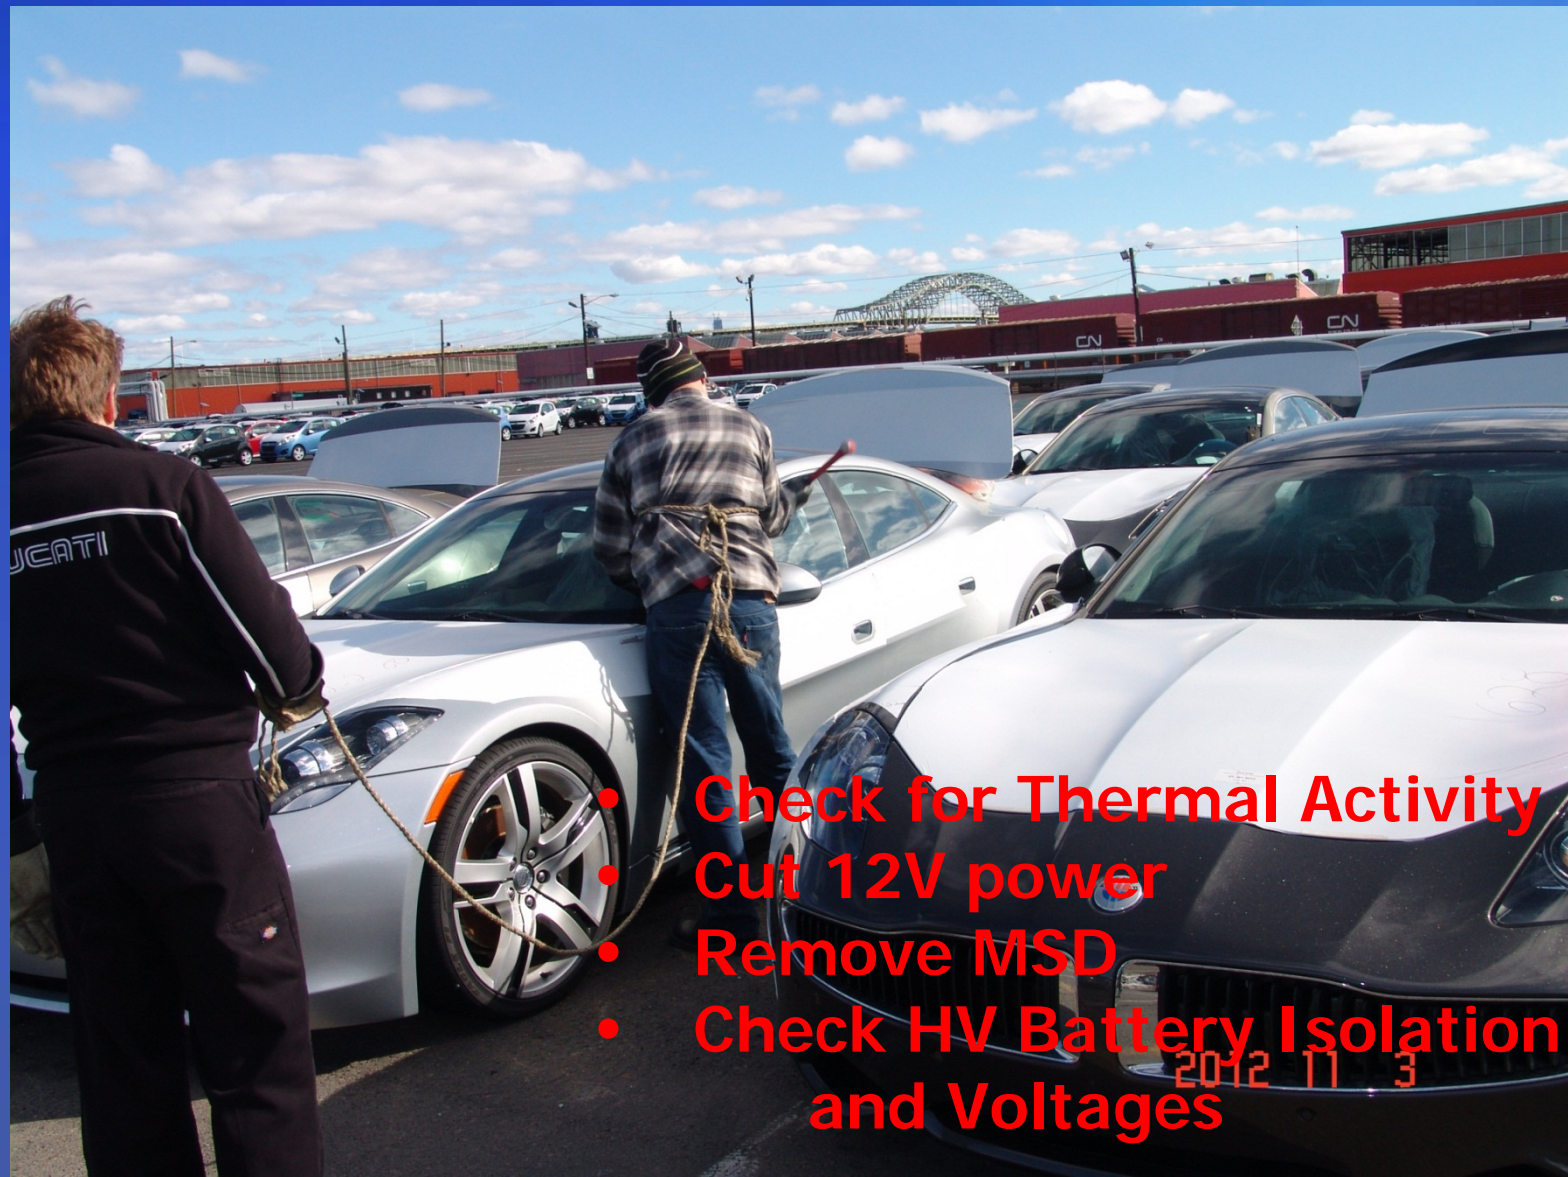
- Check for Thermal Activity
- Cut 12V power
- Remove MSD
- Check HV Battery Isolation and Voltages

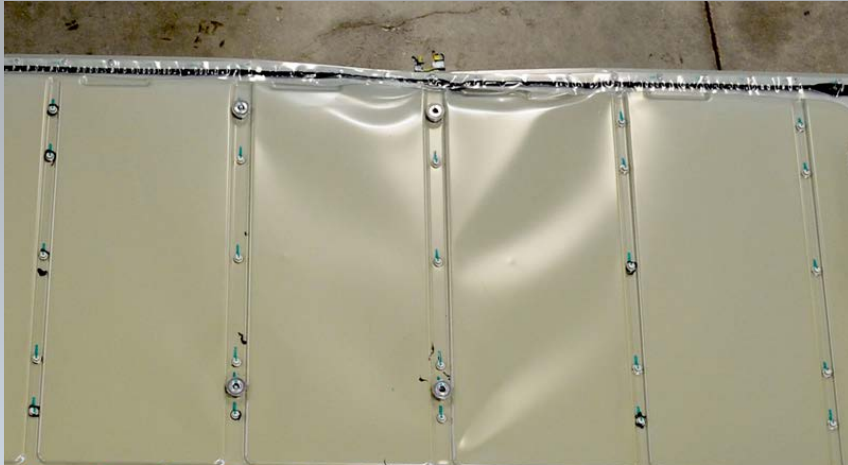
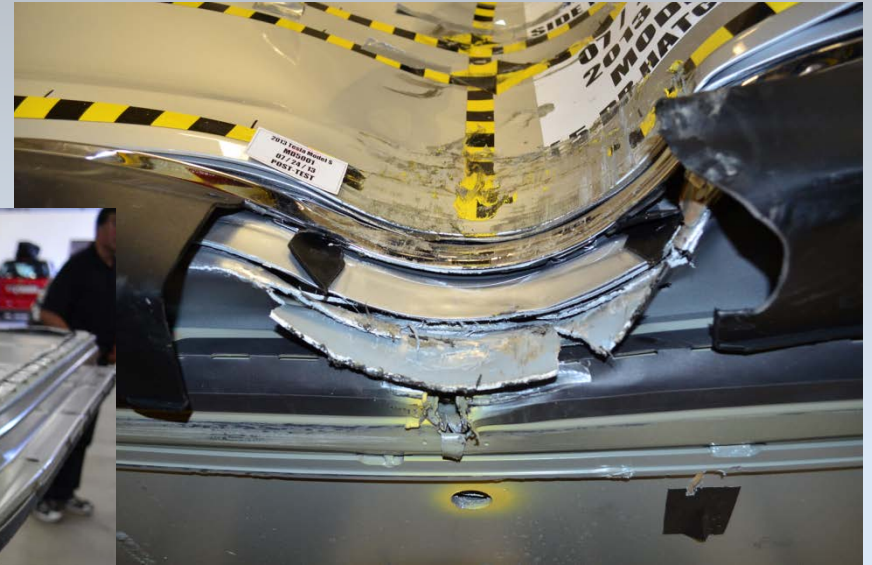
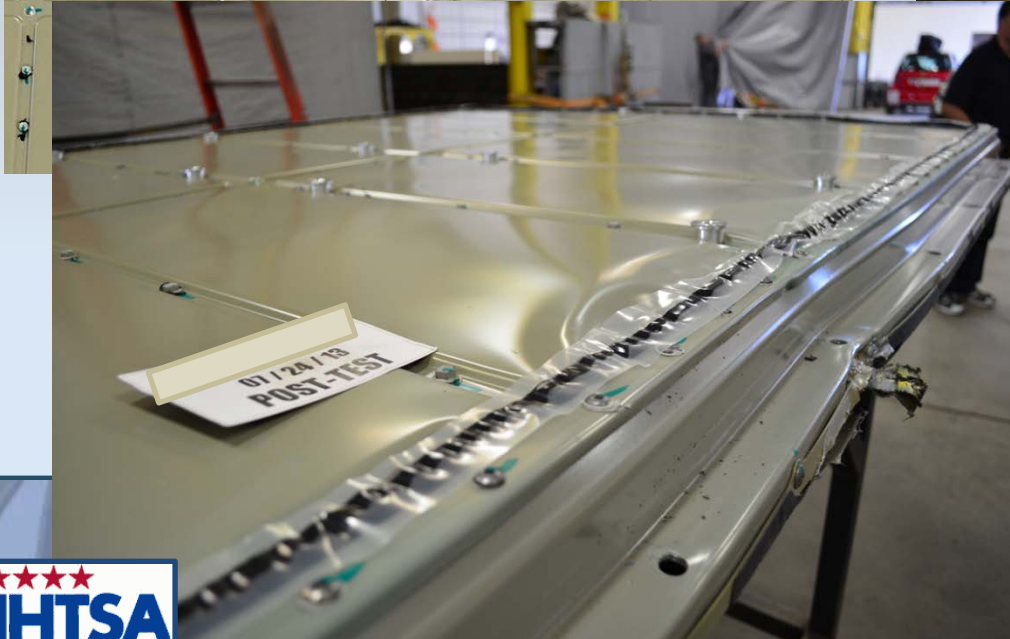
Example of a Post Test Crashworthiness Inspection

- Mechanical crush/structural integrity of the battery pack
 - No battery cell damage was observed
- Electrical Isolation
 - Isolation was maintained
- Battery monitoring
 - Utilizes manufacturer support to monitor battery
 - No standard measurement solution available currently
- Battery health assessment
 - Based on physical (visual) inspection and prolonged post-test observation
 - Research would identify performance metrics that could be measured using better tools to evaluate the battery post-crash
