EVS GTR IWG #14

Evaluation of traction battery safety under Vehicle immersed accident

Video clips for Failed water immersion test

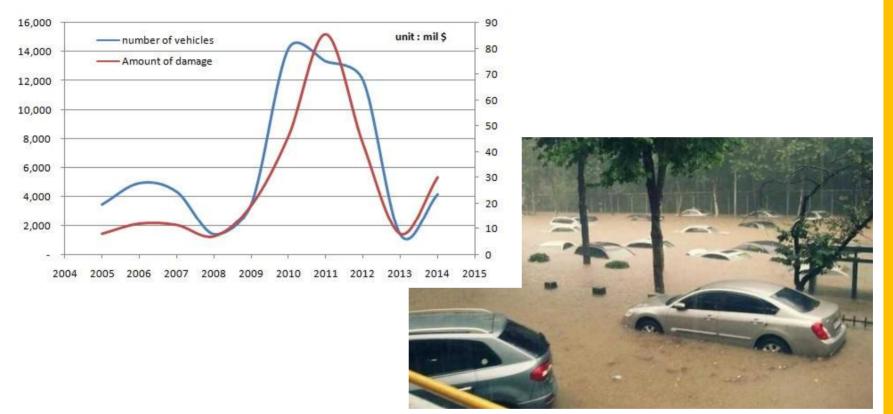
> Number of Vehicle immersed accident in Korea

- Increased accidents caused by localized heavy rains or storms
- Need to consider in the event by immesion during parking
